Australian Transport Safety Bureau

MH370 – Search and debris examination update

Outboard flap failure analysis

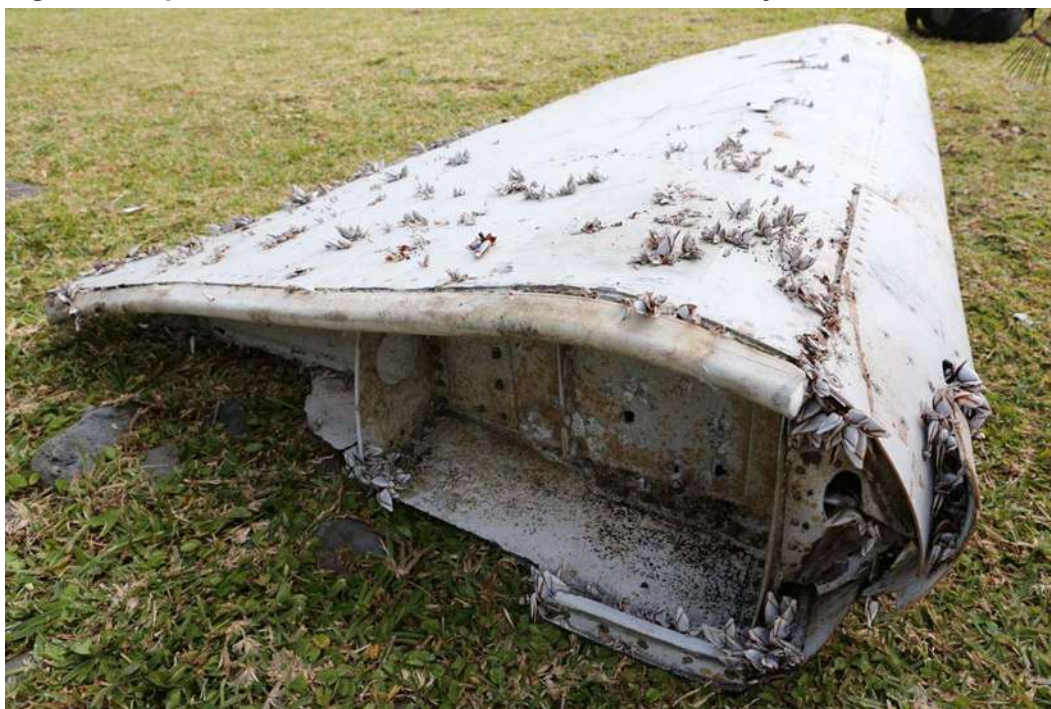
Figure 7: Flaperon recovered from Reunion Island on 29 July 2015

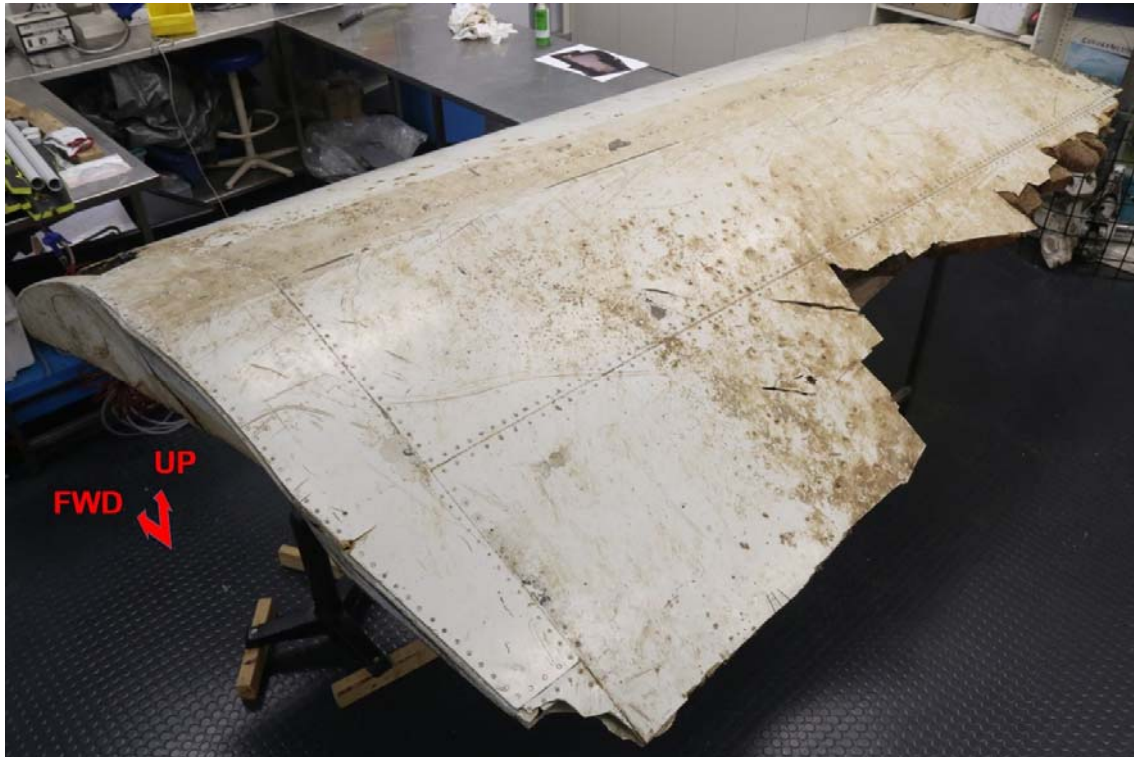
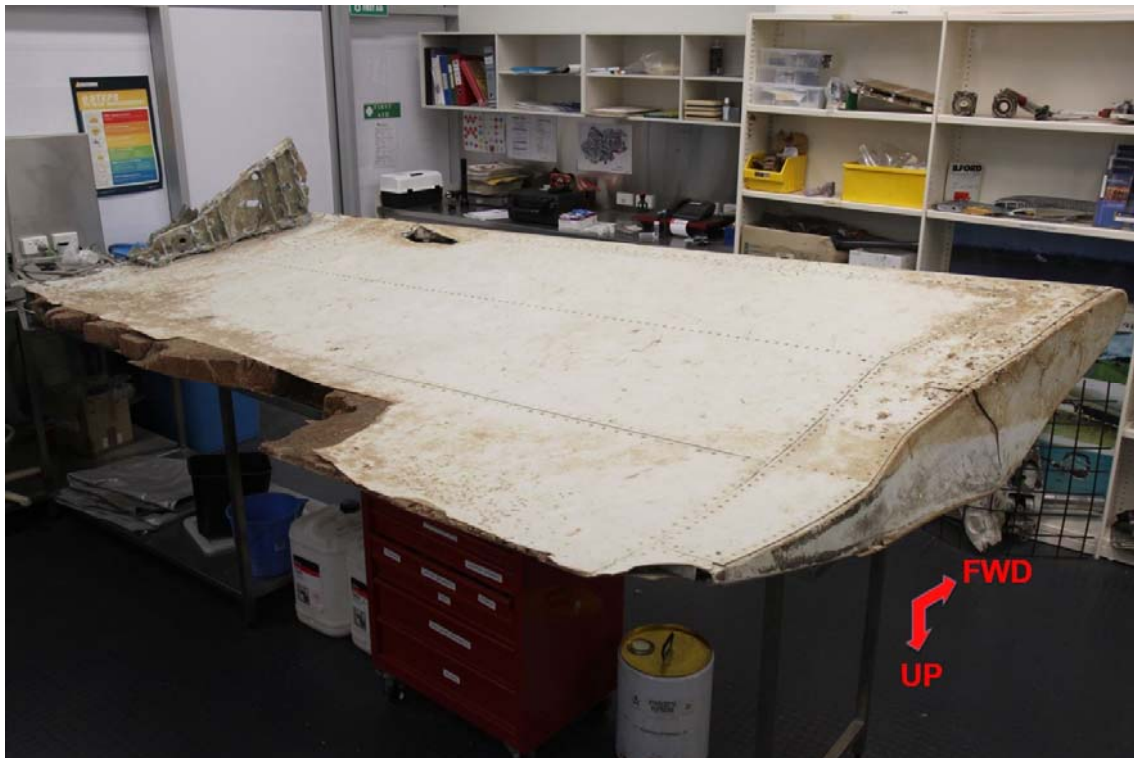
The recovered right, outboard wing flap section (Figures 12, 13 and 14) was examined for any evidence of interaction with mechanisms, supports and surrounding components that may indicate the state of flap operation at the time of fracture and separation from the wing. The purpose of the examination was to inform the end-of-flight scenarios being considered by the search team. The most significant items of evidence in relation to this are documented below.

Figure 13: Inboard section of outboard flap

Figure 14: Inboard section of outboard flap (inverted)

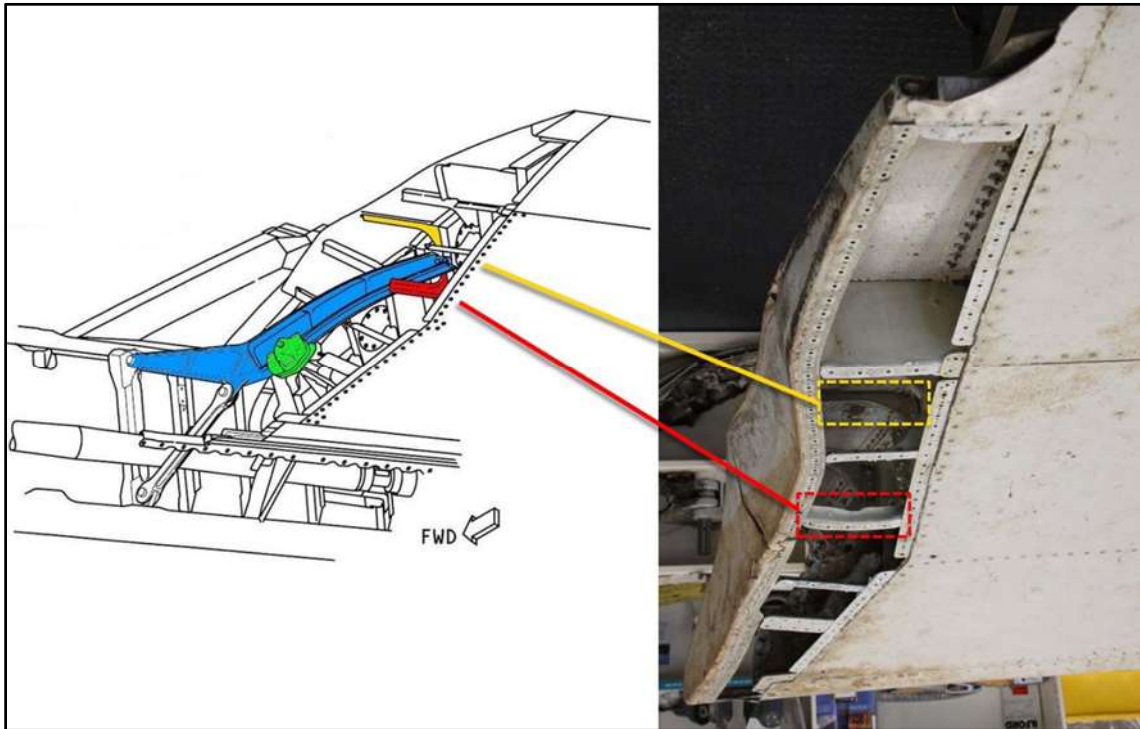
Two adjacent aluminium stiffeners within the inboard seal pan area exhibited impact damage. The damage was significant because it was indicative of impact damage and the only component in the vicinity of the stiffeners, capable of independent movement within the seal pan, was the support track. Measurements of the support track position at the various stages of flap deployment, indicated that the track would have to be fully inserted into the flap in the retracted position to be adjacent to the damaged stiffeners (Figures 16, 17 and 18).

Figure 16: Outboard flap location of damaged stiffeners within the seal pan cavity

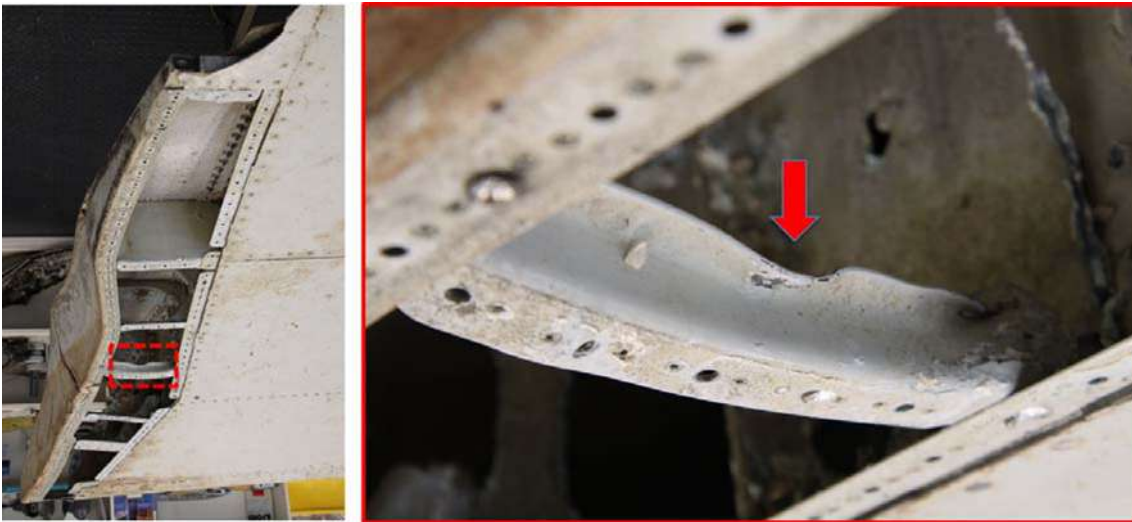
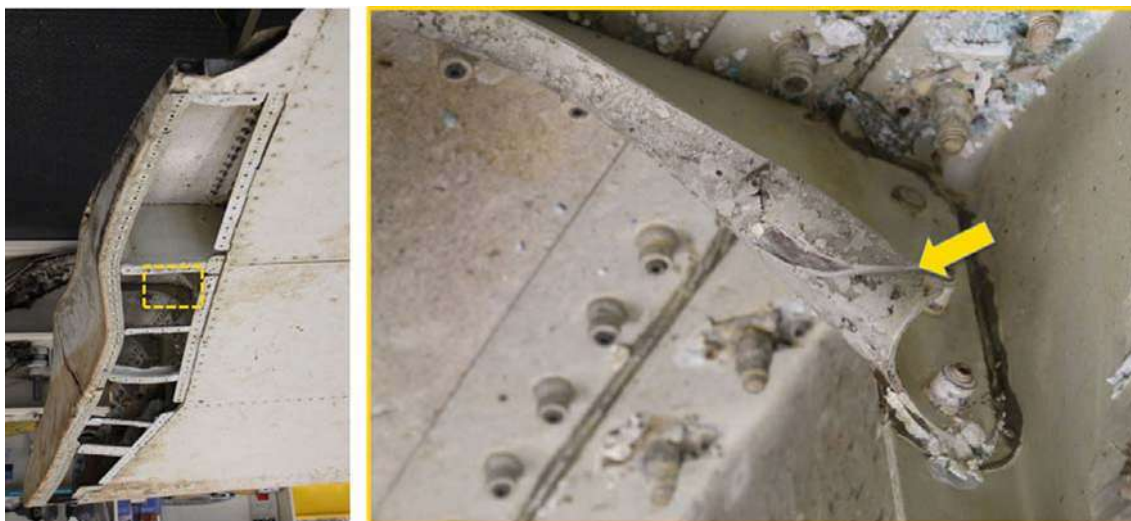
Figure 17: Outboard flap, damaged stiffeners within the seal pan cavity

Figure 18: Outboard flap, damaged stiffeners within the seal pan cavity

Damage to the internal seal pan components at the inboard end of the outboard flap was possible with the auxiliary support track fully inserted into the flap. That damage was consistent with contact between the support track and flap, with the flap in the retracted position. The possibility of the damage originating from a more complex failure sequence, commencing with the flaps extended, was considered much less likely.

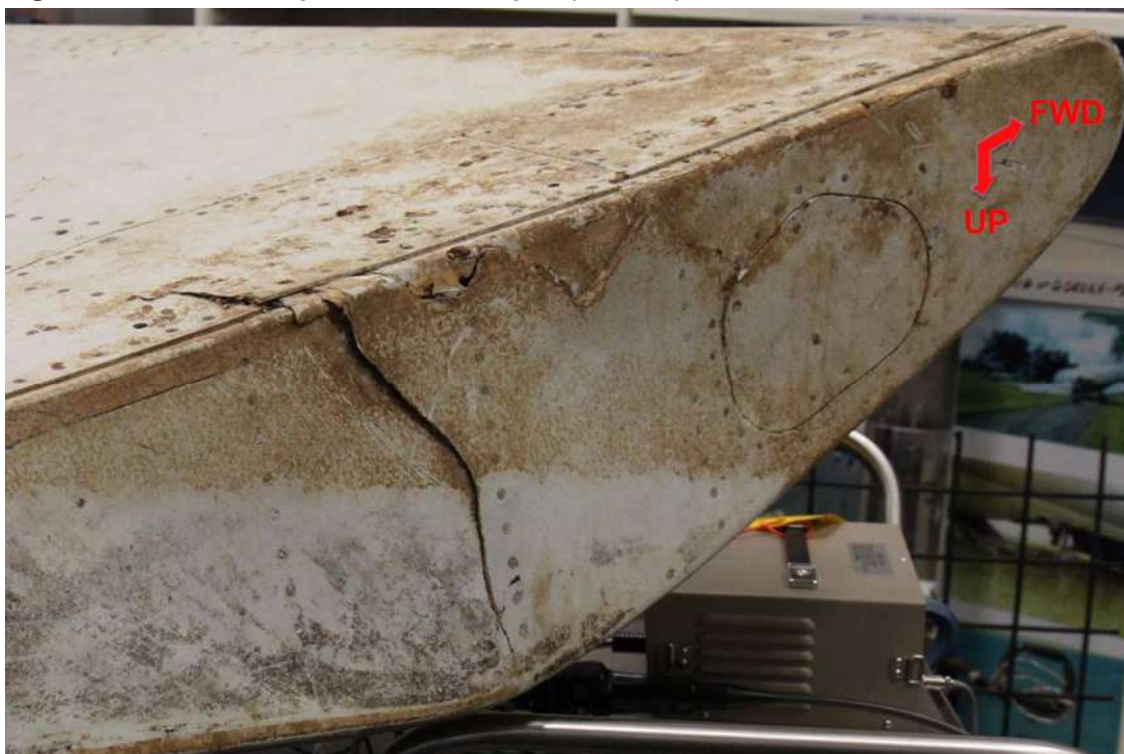
An outwards-fracture of the fibreglass seal pan initiated at a location adjacent to the damaged aluminium stiffeners (Figure 19). The damage was most likely also caused by impact from the support track. That damage provided further evidence of the support track position within the flap seal pan cavity, indicating that the flaps were retracted at the point of fracture and separation from the wing.

Figure 19: Outboard flap, fractured seal pan (forward)

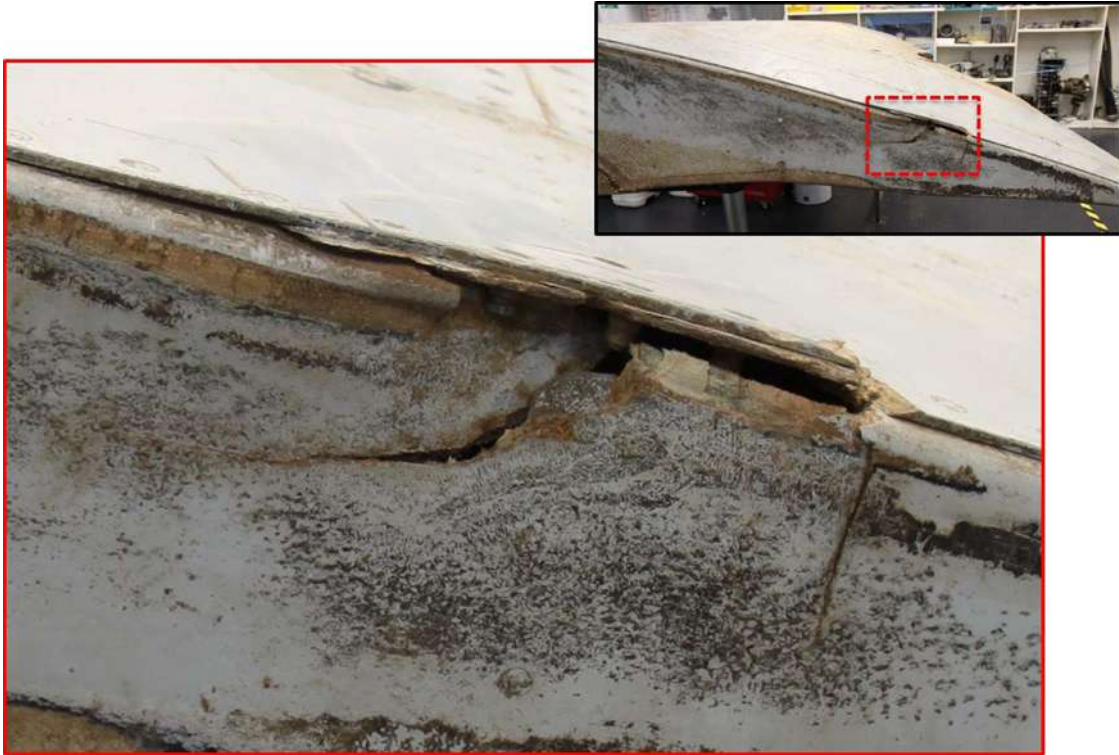
The flap seal pan was also fractured adjacent to the rear spar. The fracture resulted from external impact, puncturing the fibreglass and plastically deforming the supporting aluminium structure within the seal pan cavity (Figure 20). Comparable damage was noted at the outboard, rear spar and surrounding structure of the adjacent flaperon (Figure 21). It was noted that the two areas in question are aligned when the flaps are in the retracted position, with a significant offset existing at other stages of flap extension (Figure 22).

Figure 20: Outboard flap, fractured seal pan (aft)

With the flap in the retracted position, alignment of the flap and flaperon rear spar lines, along with the close proximity of the two parts, indicated a probable relationship between two areas of damage around the rear spars of the parts. This was consistent with contact between the two parts during the aircraft breakup sequence, indicating that the flaperon was probably aligned with the flap, at or close to the neutral (faired) position.

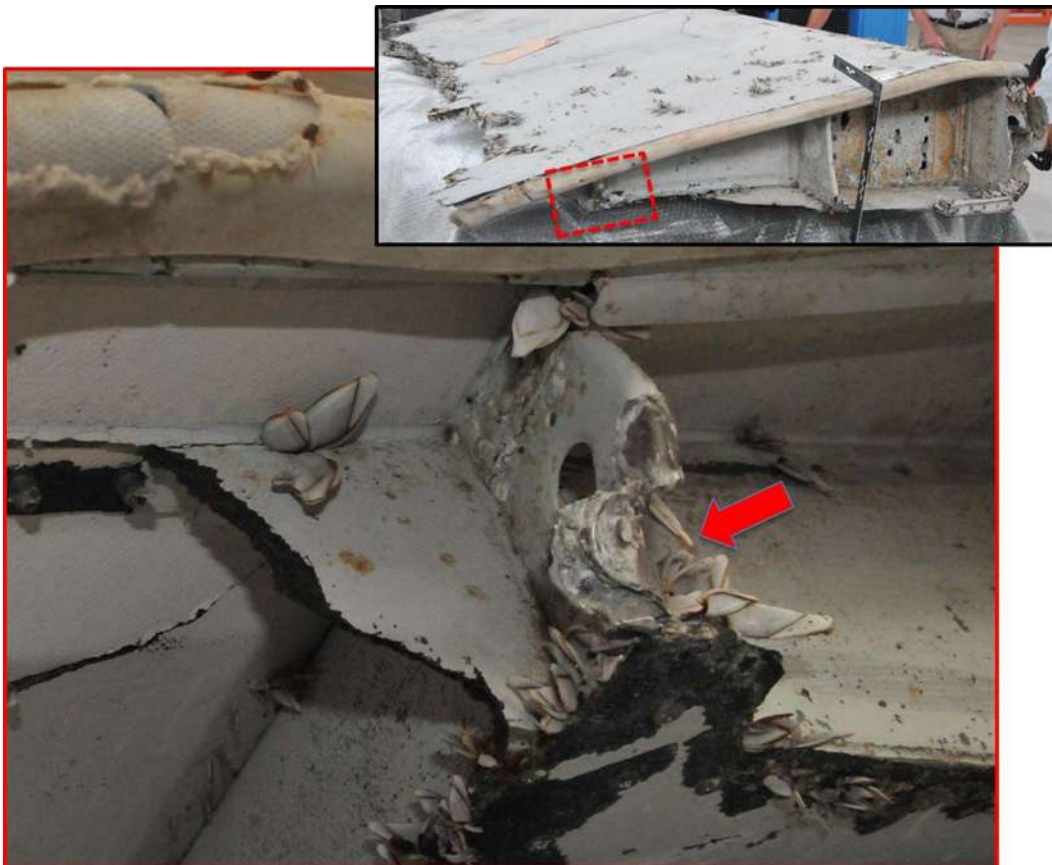
Figure 21: Flaperon, outboard side damage

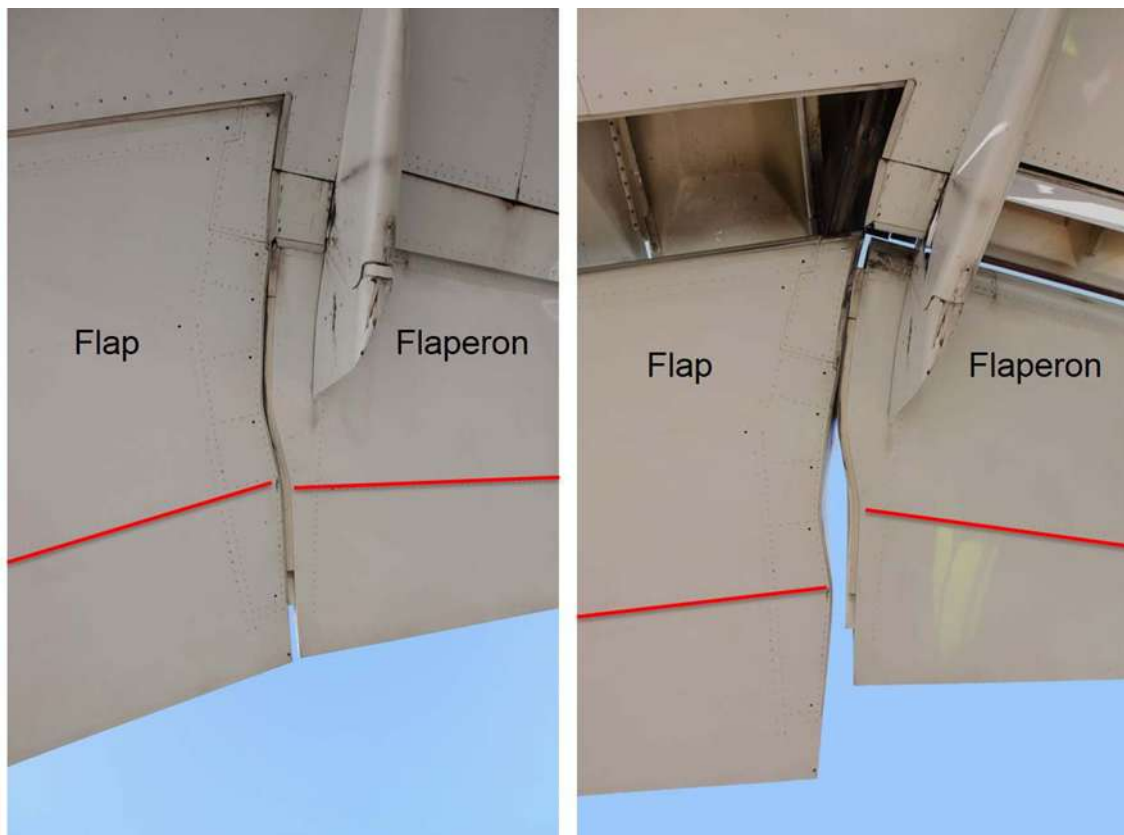
Figure 22: Flaperon and outboard flap from below, showing relative alignment of rear spar rivet line (highlighted) in the flaps retracted (left) and extended position (right)
