# Data entry and navigational issues involving Airbus A330-343X 9M-XXM

Sydney Airport, New South Wales | 10 March 2015

**ATSB Transport Safety Report**  
Aviation Occurrence Investigation  
AO-2015-029  
Final – 7 September 2016

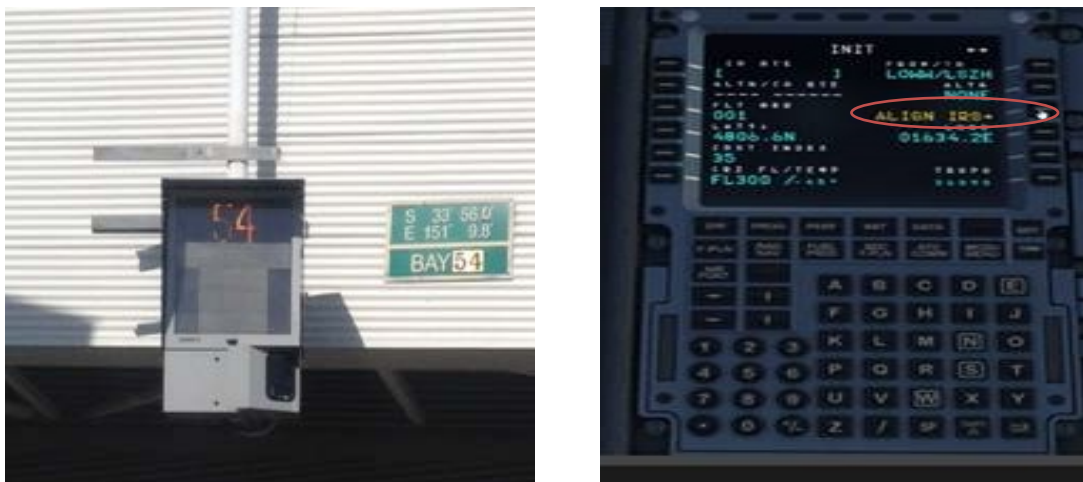
**Figure 1: At left, Gate 54 showing the coordinates sign and, at right, the MCDU used during the ADIRS initialisation with the ALIGN IRS prompt highlighted in red (Note: the MCDU does not depict the gate 54 coordinates)**

- When manually entering the coordinates of the aircraft's position using a data entry technique that was not recommended by the aircraft manufacturer, the longitude was incorrectly entered as 01519.8 east (15° 19.8' east) instead of 15109.8 east (151° 9.8' east). This resulted in a positional error in excess of 11,000 km, which adversely affected the aircraft's navigation systems and some alerting systems.

Airbus recommended that the aircraft's position should be entered into the MCDU via that equipment's slew keys. That method of data entry inherently limited the possibility of large errors, as the incremental nature of the slew keys required significant time to effect large changes in latitude and longitude. By contrast, the entry of latitude and longitude using the multipurpose and control display unit (MCDU) scratchpad involved the input of a sequence of 16 characters consisting of 12 numerical characters, two letters and two separate decimal points. This number of characters generally increases the likelihood for error when copying such a sequence from the gate sign to the scratchpad. On this occasion the use of the scratchpad directly facilitated the large positional error.

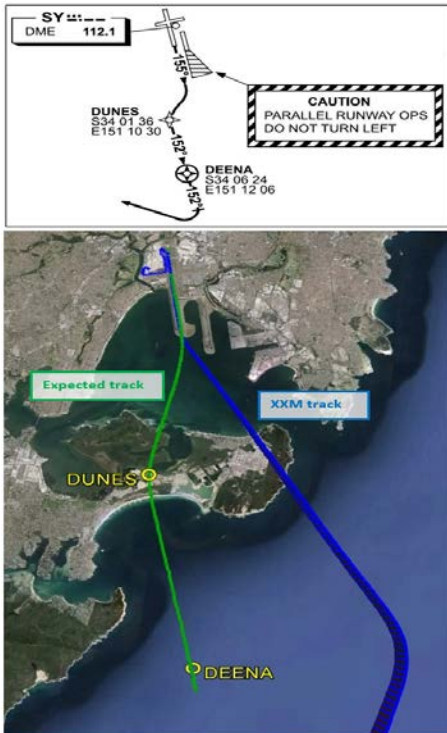
A few seconds later, ATC observed the aircraft turning left, contrary to the SID, and tracking towards the flight path for the active parallel runway, runway 16L. In response, ATC contacted the crew and requested confirmation that they were tracking via the SID and would be maintaining a heading of 155° before turning right. At the same time ATC held another aircraft in the line-up position for departure from runway 16L (Figure 2).

**Figure 2: During departure 9M-XXM initially turned left, instead of right, and crossed the departure flight path of the parallel runway 16L (displayed here in blue). Note the standard instrument departure chart caution against turning left. The DEENA 5 SID is depicted in green**

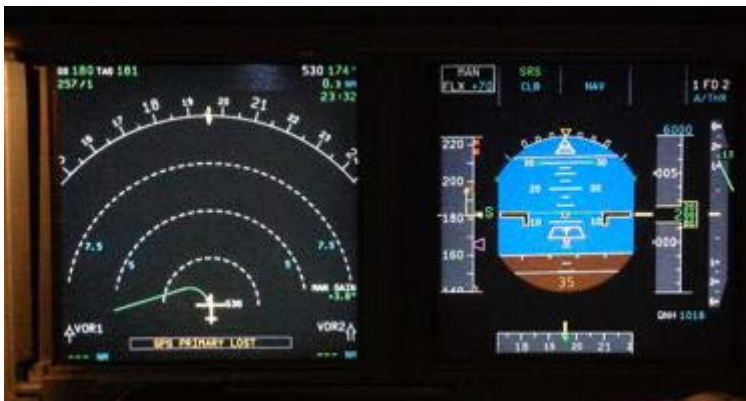
ATC audio recordings indicated an initial hesitation in the captain’s reply to ATC, first confirming the heading and then asking ATC to standby as they had lost their primary instruments. During interviews the crew stated that once the EGPWS alert was assessed as spurious, and the decision not to carry out an EGPWS escape manoeuvre made, the crew noticed that all of the expected navigation waypoints and tracking information were not displayed on the ND. Instead, an amber GPS PRIMARY LOST message appeared on the NDs together with an unusual tracking line without an associated waypoint (Figure 3).

**Figure 3: Photograph of an exemplar ND and the primary flight display during a simulated recreation of the flight scenario. Note the GPS PRIMARY LOST message (in yellow) at the bottom-left of the photograph and the green tracking line emanating from the white aircraft depiction at the centre of that representation**

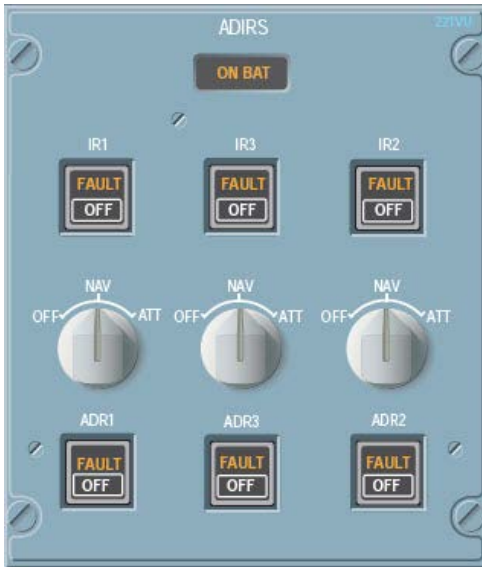
The FO informed the captain that, in order to attempt to reset the system, it was intended to cycle the three air data and inertial reference unit (ADIRU) rotary switches on the overhead panel from NAV to OFF (Figure 4), and that this would likely cause the autopilot to drop out. The ADIRU rotary switches influence both the ADR and inertial reference parts of the respective ADIRU, and have a greater combined effect on aircraft systems compared with the individual ADR and/or inertial reference push-buttons available on the same overhead panel (Figure 4) (see the section titled *Context*).

During interview the captain and FO stated that the captain's response was simply 'Yes'. The FO recalled initially holding their hand in the vicinity of the rotary switches awaiting confirmation from the captain to cycle them to OFF. Both crew recalled that ATC instructions then disrupted the normal process of confirmation before actioning critical flight deck switches. Once the ATC instruction was acknowledged and complied with, the FO turned ADIRU 1 and 3 OFF without clarifying the captain's confirmation for the action. In response, several flight guidance and navigation systems degraded and the autopilot disengaged. The captain instructed the FO to stop actioning the switches, with ADIRU 2 remaining in the NAV position.

**Figure 4: ADIRU rotary switches and individual inertial reference and ADR fault lights and OFF push-buttons on the A330 flight deck overhead panel**

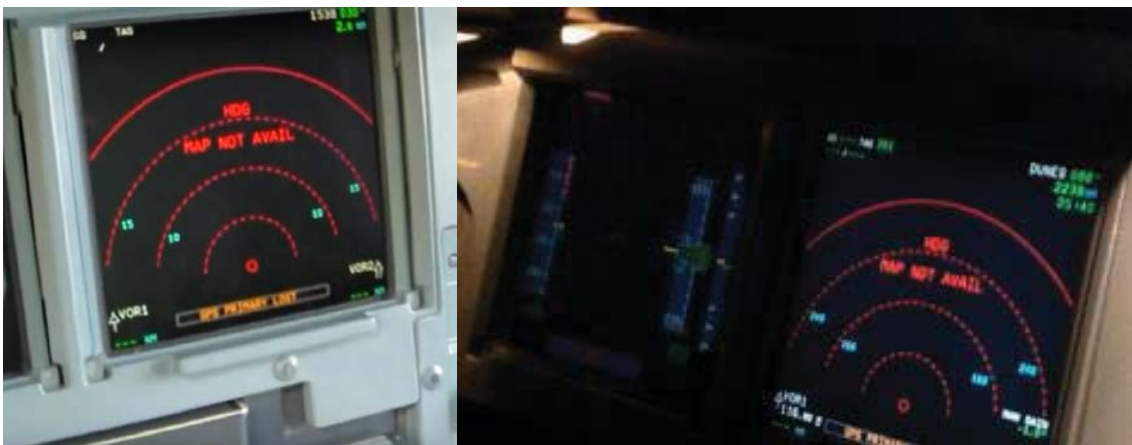
Once ADIRUs 1 and 3 were selected OFF, the captain's primary flight display (PFD) lost all information except accurate airspeed and vertical speed, and the captain's ND displayed the GPS PRIMARY LOST, HDG and MAP NOT AVAILABLE warning flags (Figure 5). In addition to the information remaining on the captain's PFD, the FO's PFD continued to display accurate airspeed, vertical speed and attitude information, but the displayed heading information was incorrect. The FO's ND also displayed incorrect heading information and there was no usable map, waypoint or tracking information. The autopilot and autothrust systems were also unavailable, and the aircraft had reverted from 'normal law' to 'alternate law'. This affected some of the aircraft's handling characteristics and flight envelope protections (see the section titled *Flight control laws and Alternate law*). The integrated standby instrument system, located on the forward instrument panel, continued to provide aircraft attitude from its own internal accelerometer and gyrometer, and uncorrected airspeed from the standby pitot and standby static probes. The standby compass provided heading information, but this was affected by any slight aircraft acceleration (Figure 5).

**Figure 5: Simulator recreation of the captain's PFD and ND after the ADIRU 1 and 3 switches were selected off. Note the GPS PRIMARY LOST message (in amber) at the base of the photographs and the HDG and MAP NOT AVAIL message (in red) at the centre-upper of the photographs**

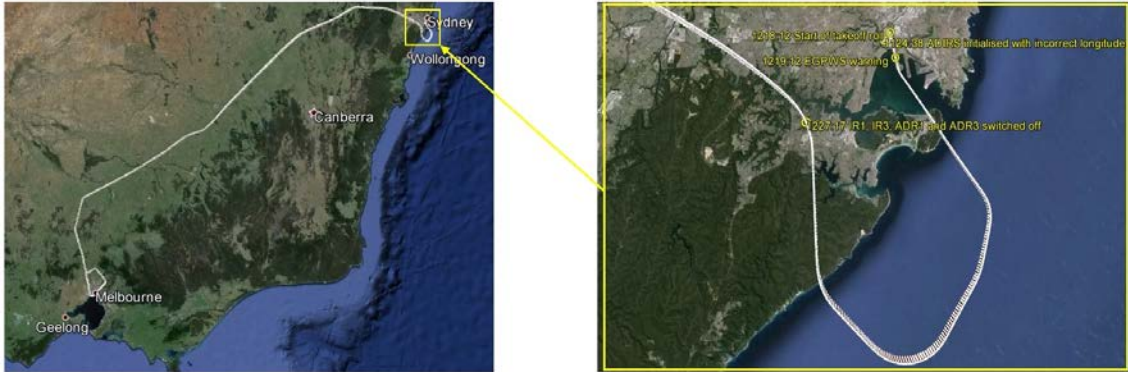
**Figure 6: Visual depiction of the flight from Sydney to Melbourne, including an inset of the departure from Sydney (right of the two graphics)**

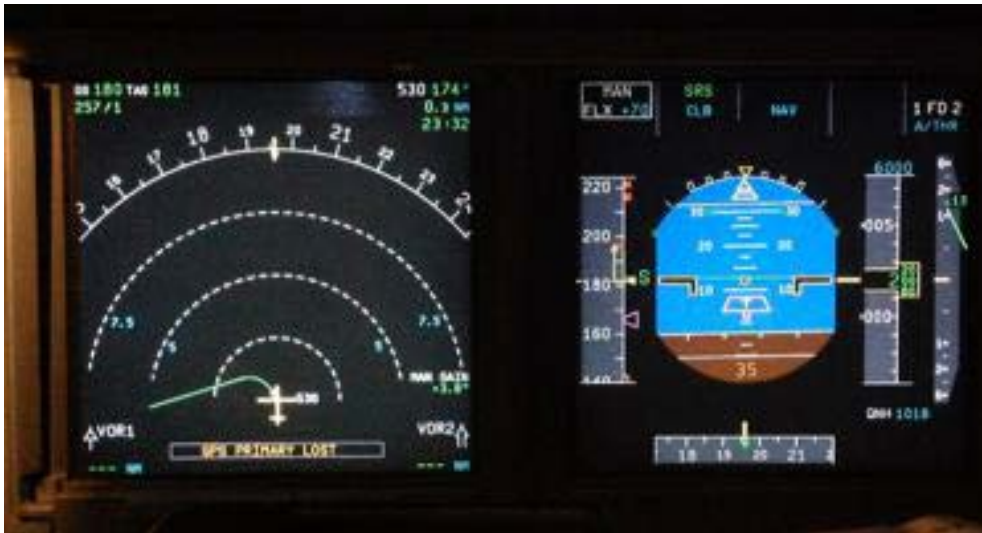
Figure 14: GPS PRIMARY LOST displayed (in amber) at the bottom-left of an exemplar ND

During the occurrence the GPS PRIMARY and accuracy HIGH displays were observed prior to pushback and provided a false confirmation that the FMGS was set up correctly. It is probable that at this time the ADIRS initialisation was either incomplete or had not had enough time to invalidate the GPS signal. Eventually the aircraft used the erroneous position from the initialisation error to compare the satellite array, and invalidated the GPS signal. That would have removed the display of GPS PRIMARY and accuracy HIGH on the MCDU progress page. However, this did not occur until the aircraft was taxiing for departure, a time when the crew would not normally be observing that page. As a result, there was limited potential to identify the error.

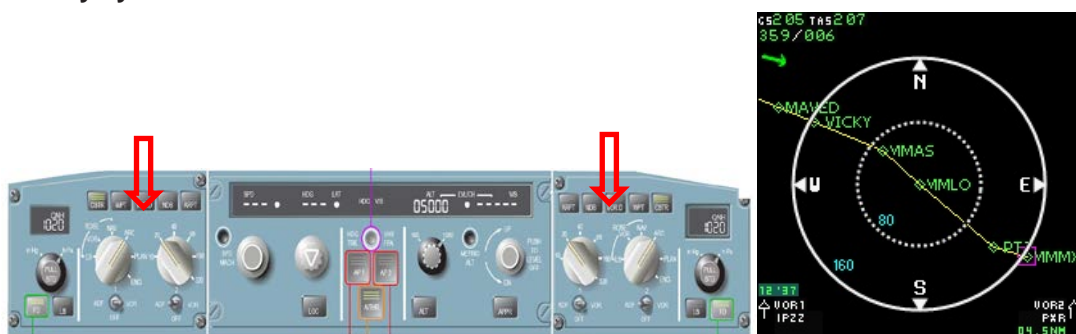
The recorded data also indicated that the FO selected plan mode and every available ND range during the line-up/take-off roll. This may indicate that the FO was attempting to interpret an unusual display on the ND associated with the positional error.

**Figure 13: ND controls and an example of a PLAN mode display (right picture). Note that the track (in yellow) and waypoints (in green) are displayed but there is no aircraft or runway symbol**
