Hard landing involving an Airbus A330-323, 9M-MTA

Melbourne Airport, Victoria | 14 March 2015

ATSB Transport Safety Report
Aviation Occurrence Investigation
AO-2015-032
Final – 5 April 2017

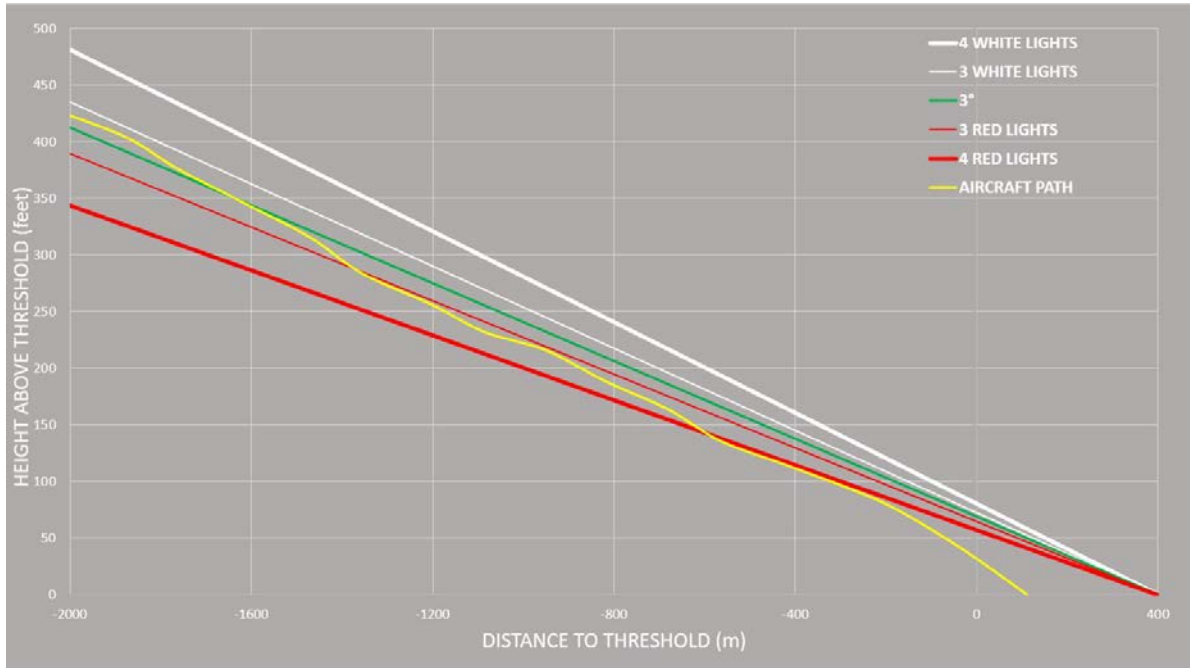
Figure 2: Aircraft path relative to the PAPI indications the pilots would have observed during the approach

As the aircraft passed 300 feet above ground level (AGL) a rate of descent of 960 feet per minute was recorded. This neared the operator's maximum stabilised approach limit of 1000 feet per minute when below 500 feet AGL. As well as a high rate of descent, actual exceedances of the operator's stabilisation criteria included:

- large changes to pitch inputted by the pilot flying, including negative pitch values,
- fluctuations in the rate of descent over a large range that were abnormal for the phase of flight,
- incorrect glide path. From approximately 250 feet AGL, the aircraft was trending low and continuing below the glide path. At this point the pilots would have been able to observe 3 red lights and one white light on the PAPI. This trend was allowed to continue until the aircraft was well below the desired glide path to the extent that the PAPI would have indicated 4 red lights from approximately 125 feet AGL (Figure 2). From this point the PF made numerous pitch commands which were mostly nose down. These included a full range nose down deflection at 24 feet AGL.

Figure 2 displays in green the ideal glide path during an approach and the PAPI thresholds in red (low) and white (high). The yellow is the actual path of the aircraft derived from the flight data. Just below 150 feet 4 red light would have been indicated to the crew.

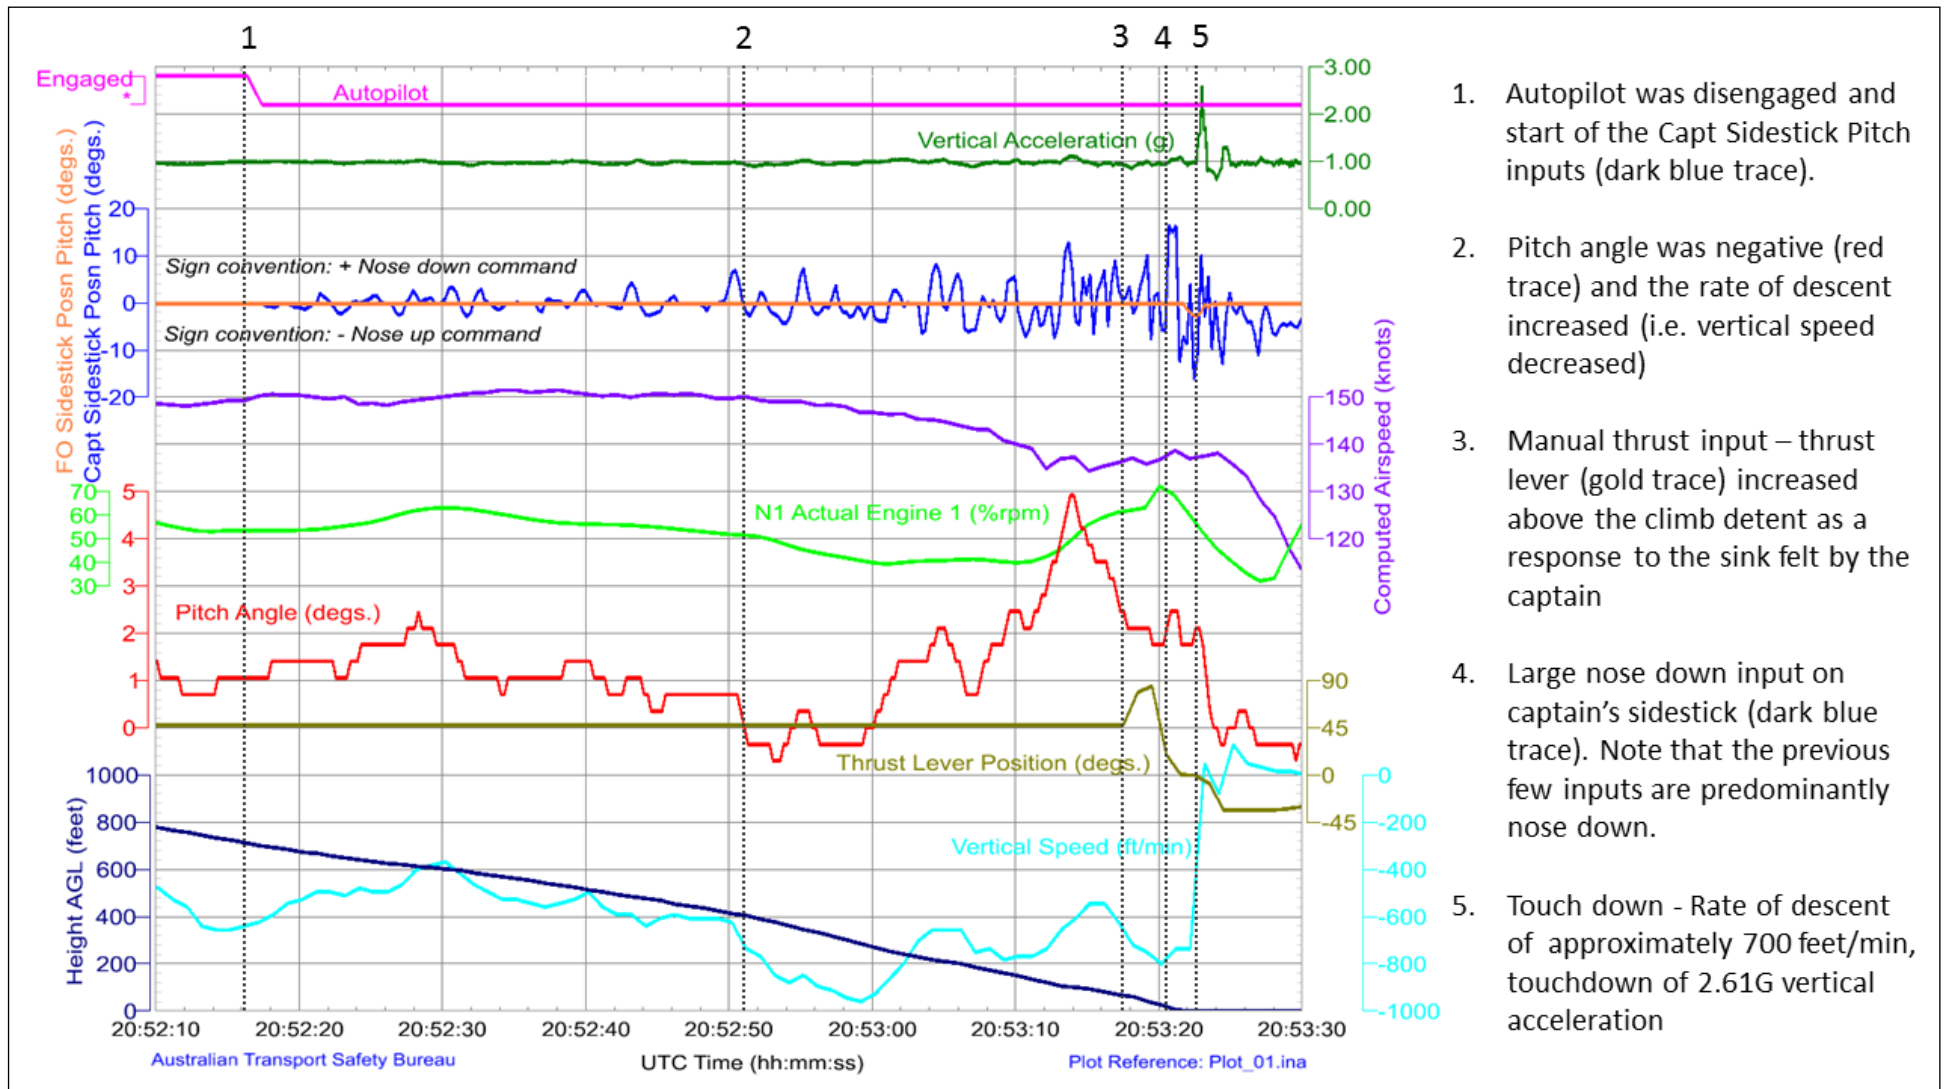
Figure 4: Graphical representation of the flight data from the incident approach

Flight data showed that the PF disengaged the autopilot at approximately 700 feet above ground level (AGL) and from that point until touchdown there was an increase in the frequency and magnitude of sidestick pitch control inputs by the PF (Figure 4).

Shortly after this action, the aircraft touched down at a vertical speed of approximately 700 feet per minute and a vertical acceleration of 2.61 G was recorded. The aircraft also touched down at approximately 170m (560 feet) from the landing threshold, short of the normal touchdown zone of between 304m (1000 feet) and 609m (2000 feet).

The manufacturer of the aircraft produced a complete load analysis of the event based on recorded flight data provided by the operator. The conclusion of this analysis was that several components in the left and right gear had “exceeded their design load limits and may have been detrimentally overloaded”.

1. Autopilot was disengaged and start of the Capt Sidestick Pitch inputs (dark blue trace).
2. Pitch angle was negative (red trace) and the rate of descent increased (i.e. vertical speed decreased)
3. Manual thrust input – thrust lever (gold trace) increased above the climb detent as a response to the sink felt by the captain
4. Large nose down input on captain’s sidestick (dark blue trace). Note that the previous few inputs are predominantly nose down.
5. Touch down - Rate of descent of approximately 700 feet/min, touchdown of 2.61G vertical acceleration
