AIRCRAFT ACCIDENT FINAL REPORT
A 15/15P
Air Accident Investigation Bureau (AAIB)
Ministry of Transport Malaysia

Piper PA-28-181, Registration N9297
at Senai Golf Course, Senai, Johor
on 15 November 2015

REPORT NO.: A 15/15P

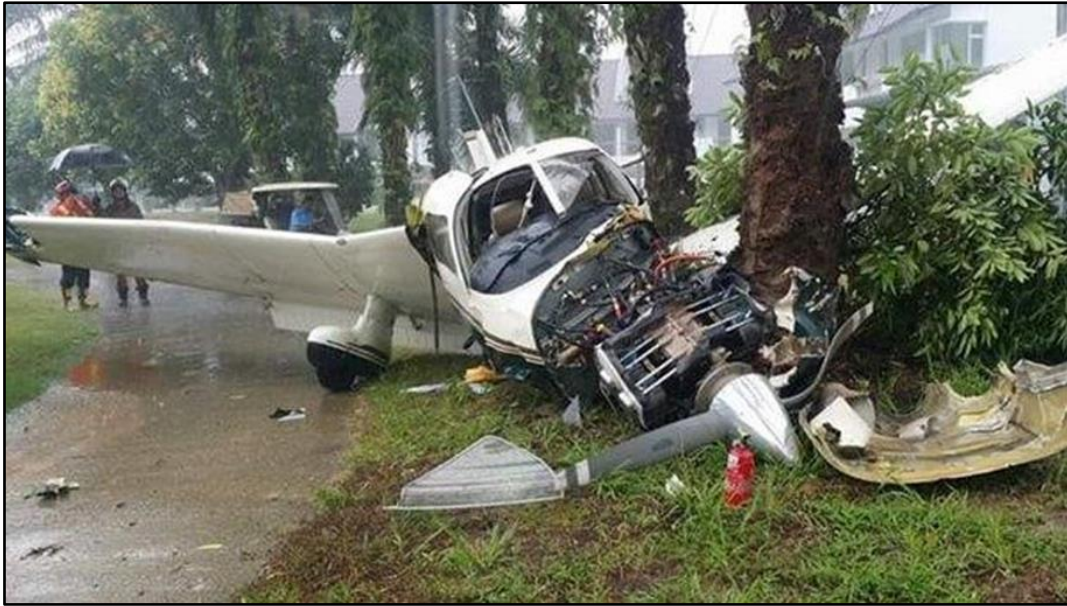
Figure 1: N9297N hit a tree during the Forced Landing

Owing to the severe hit against the tree, N9297N aircraft was severely damaged. In fact, the damage of N9297N aircraft was considered a total lost.

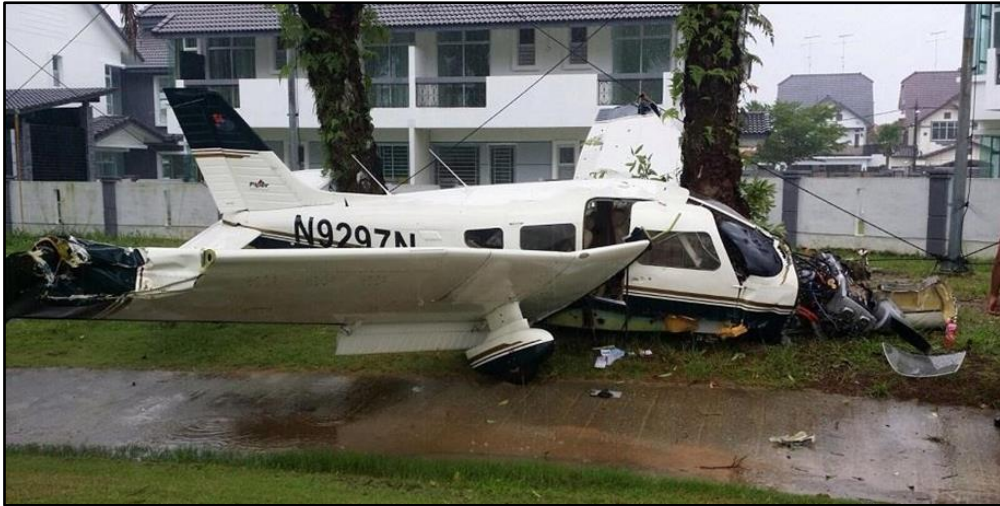
N9297N aircraft was severely damaged during the forced landing. However, the Captain only sustained minor injury.

Figure 2: Damaged N9297N Aircraft

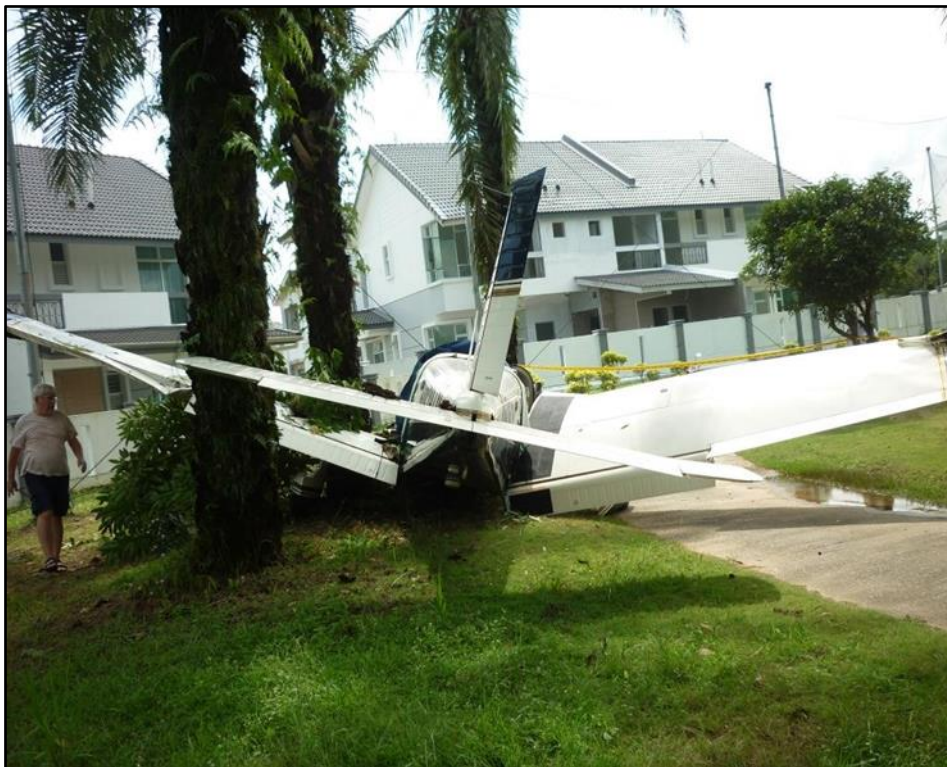
Figure 3: Real View of Damaged N9297N Aircraft

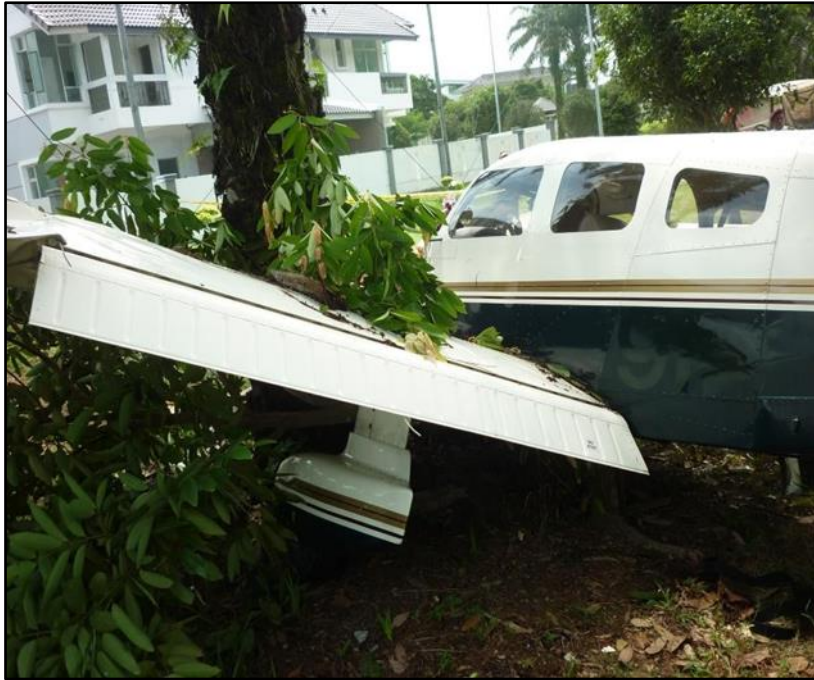
Figure 4: N9297N Aircraft Collided with A Tree

In the process of the forced landing on the Senai International Airport Golf Course, N9297N aircraft collided with a tree at the end of the forced landing, ie. during its final stop. The collision with the tree caused the severe damage to N9297N aircraft.

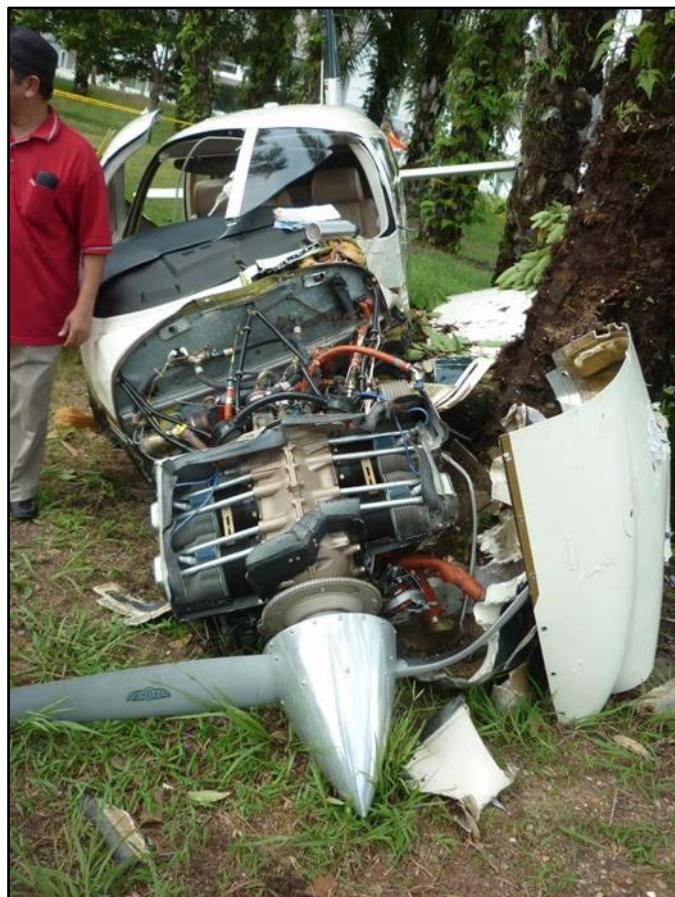
Figure 5: Engine of Damaged N9297N Aircraft

Owing to collision with the tree, the engine of N9297N aircraft was so severely damaged. Because of this fact, the engine could not be used properly to confirm the cause of the engine power loss.

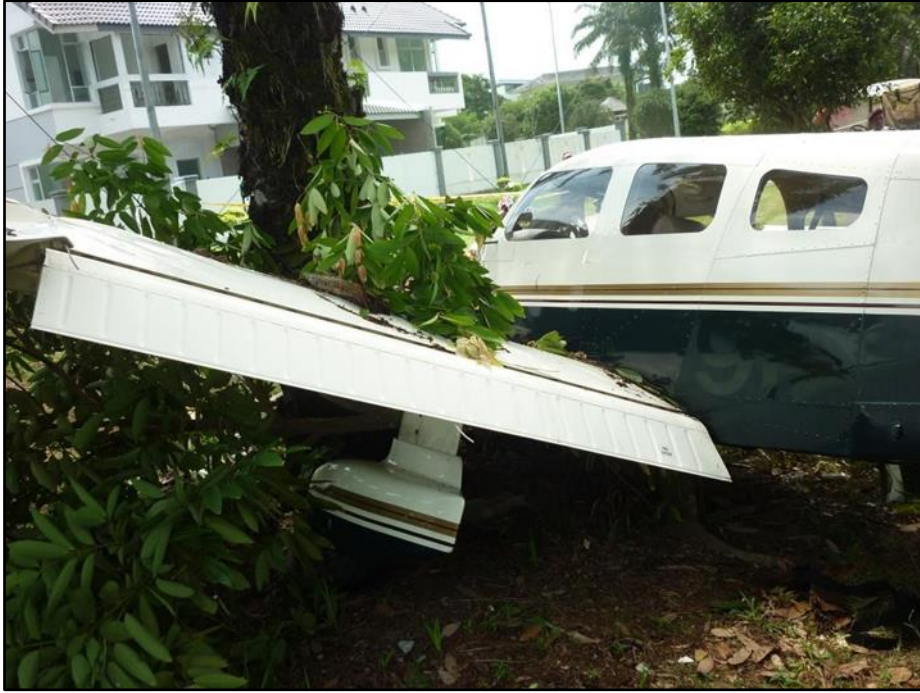
The Captain did the forced landing on the Senai International Airport Golf Course. The forced landing was good on the Senai International Airport Golf Course. Just before N9297N aircraft came to a stop, it hit at tree just next to a green. The collision with the tree caused the aircraft to be severely damaged.

Although the forced landing on the golf course was successful, the collision of N9297N aircraft with a tree caused the aircraft to suffer a Write-Off category, the Captain only suffered slight injury.

Figure 6: The wreckage
