DEFECT/INCIDENT INVESTIGATION REPORT (DIR)

TO : Flight Safety (MW) DIR REF : DIRDHC6-16.15
CC : EMD HQA, QAM (MW), HOE (MW), ASR REF :
EMD QAM (Coordinator), DCA, OR REF : MW/MOR/DHC/1615

ACFT TYPE : Viking DHC6-400 ACFT REGN : 9M-SSD
FLT NO : MH3553 SECTOR : MYY-MKM
DATE : 26 OCT 2015 MR1 NO : 61247163
ATA : 32 STATUS : Closed
DESCRIPTION : Main Wheel PART NO : 04021101
SERIAL NO : 4381 TSN/TSF/TSO : NIL
POSITION : L/H CSN/CSF/CSO : 36 CSF

1.1 Tire Deflated During Landing.

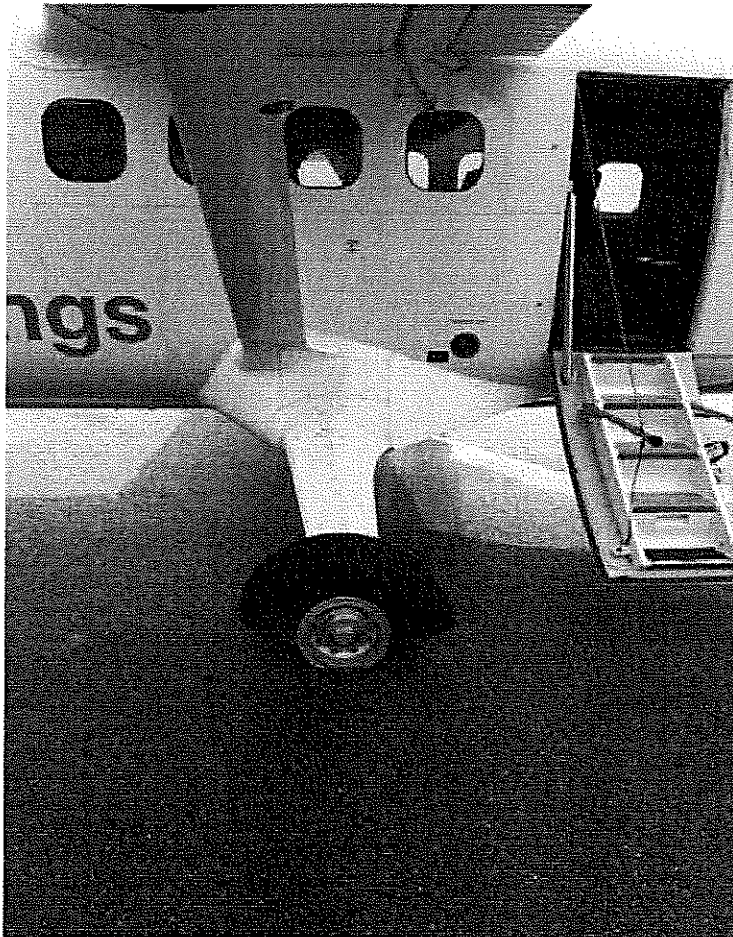
Picture 01

- 3.2 During the general inspection it was found that the aircraft's L/H main tire was deflated. Significant damage was also observed on the wheel outboard wheel hub flange due to the hub come into contact with the runway surface.

- 4.5 The tire was inspected by MH QAE in MH Wheels and Brakes Workshop in Kota Kinabalu International Airport. It was found that the tire had sufficient thread i.e. approximate 7mm on the whole tire cover's circumference. The removed tire cover was subjected to a pressure test and it was found within the limit stated in Cleveland Conversion Kit 199-92. The limit as per Cleveland Conversion Kit 199-92 allows a drop of 4% pressure over a 24 hours period. A drop of 01 psi was recorded after a period of 24 hours despite the damages caused by the skid.

- 4.6 Both the wheel hub and tire cover were deemed unserviceable due to the extent of the damages and will be scrapped accordingly.

5.1 Based the investigation above, it is believed that the tire was deflated due to the excessive force being acted on the left main wheel during the skid on the runway thus causing the tire cover bead to dislodge from the wheel hub assembly. The reason for the skid was not technically inclined as the aircraft brakes were confirmed to operating normal.
