### DEFECT/INCIDENT INVESTIGATION REPORT (DIR)

ACFT TYPE	:	Viking DHC6-400	ACFT REGN	:	9M-SSB
FLT NO	:	MH3568	SECTOR	:	MYM-MUR
DATE	:	27 Aug 2016	MR1 NO	:	61300801
ATA	:	32	STATUS	:	Closed

DESCRIPTION : Steering actuator PART NO : 71-200-15  
 SERIAL NO : H1223 TSF : 2258  
 POSITION : Nose CSF : 2258

# **SAFETY INVESTIGATION REPORT**

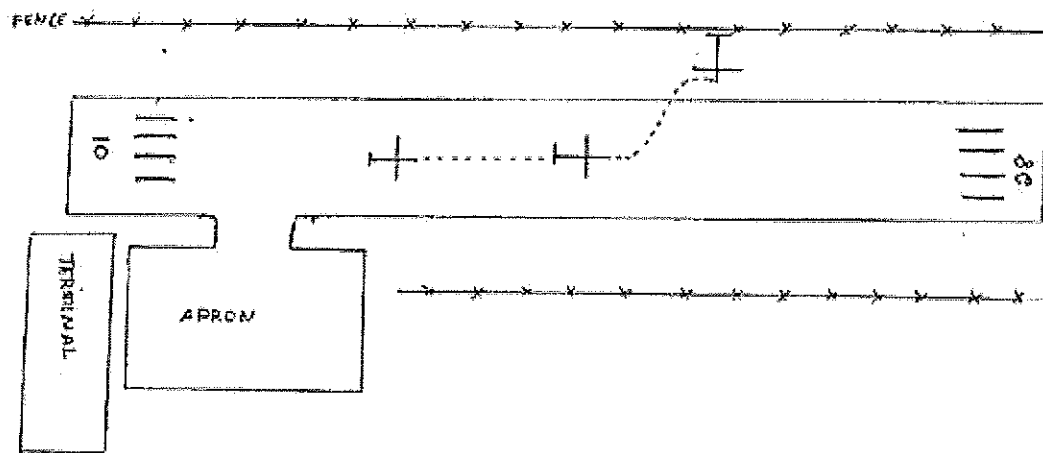
2.4 The aircraft came to a complete stop on the unpaved field at the left side of the runway. Please refer to the illustration below. The engines were shut down as per normal procedure. The crew and a total of 04 passenger were uninjured.

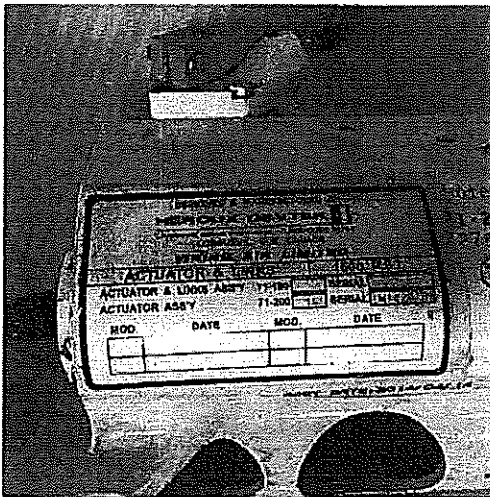
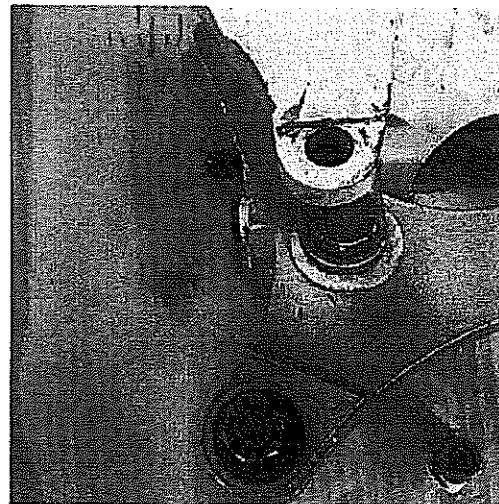
- a) Upon complaint reception, all original quality records related to unit Steering Actuator (71-200-15) and NLG shock strut 71-300-33 were verified and no irregularities were found.
- b) Visual inspection was performed to report and document any discrepancies on the unit, many defects were observed such as damage, scratches, nicks and gouges, pictures are available upon customer's request.

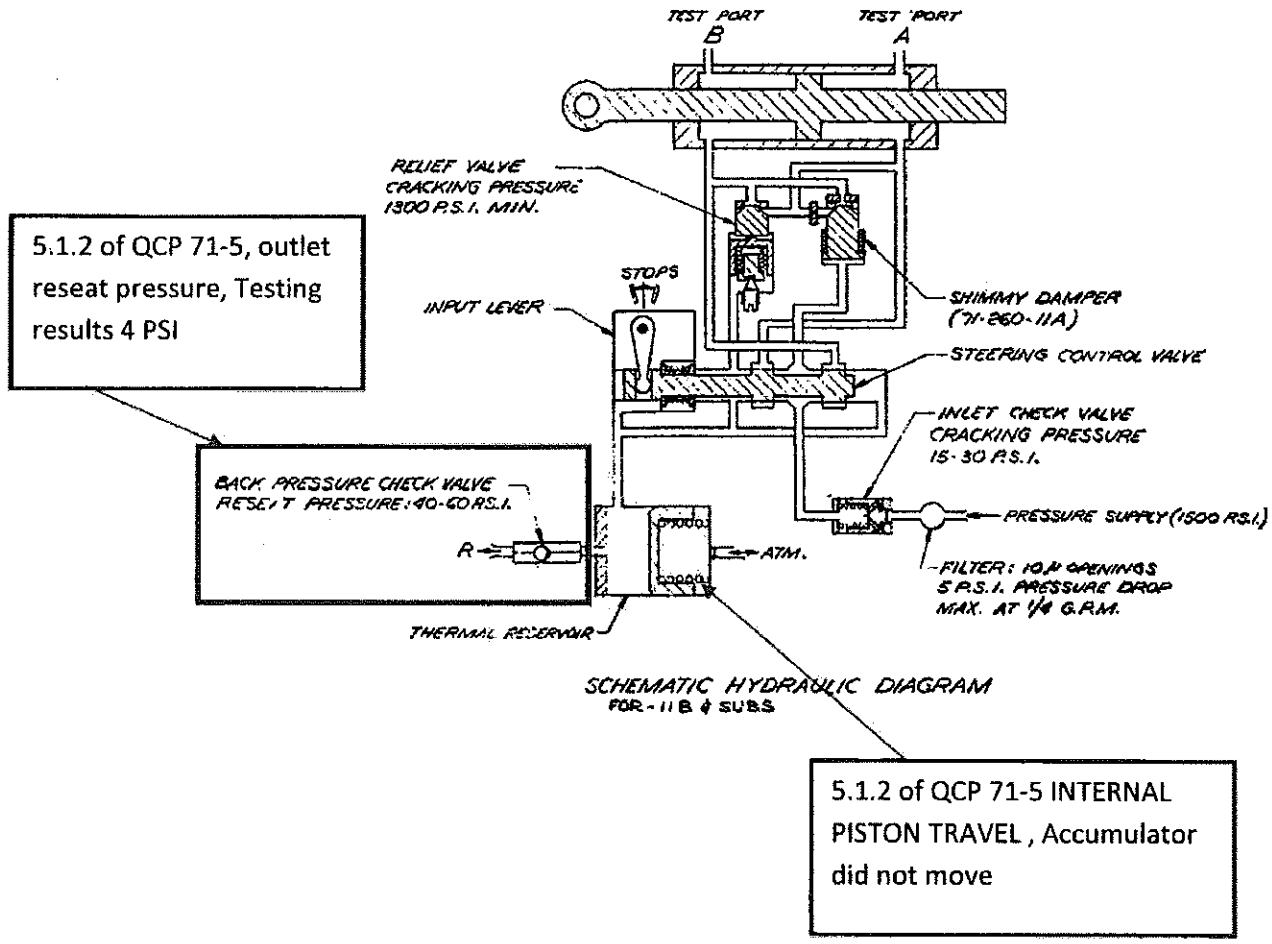
- Conducted test of 5.1.2 of QCP 71-5, outlet reseal pressure: pressure requirements per QCP 71-5 is 40/60 PSI, the testing results recorded was 4 PSI. Therefore, reseating pressure **failed the ATP**. This will lightly affect functionality of the unit. Considering that it is controlled by a small spring in the check valve at the return port. Having the reseal pressure closing at a lower value would implicate that hydraulic fluid would always flow through the valves directly to the return port.

- 3) Conducted test of 5.1.2 of QCP 71-5 internal piston travel; The Accumulator **did not move** during testing due to the low pressure ( 4psi). The pressure build up was not achieved to allow the accumulator piston to travel to its minimum 1.56'' (FAIL).

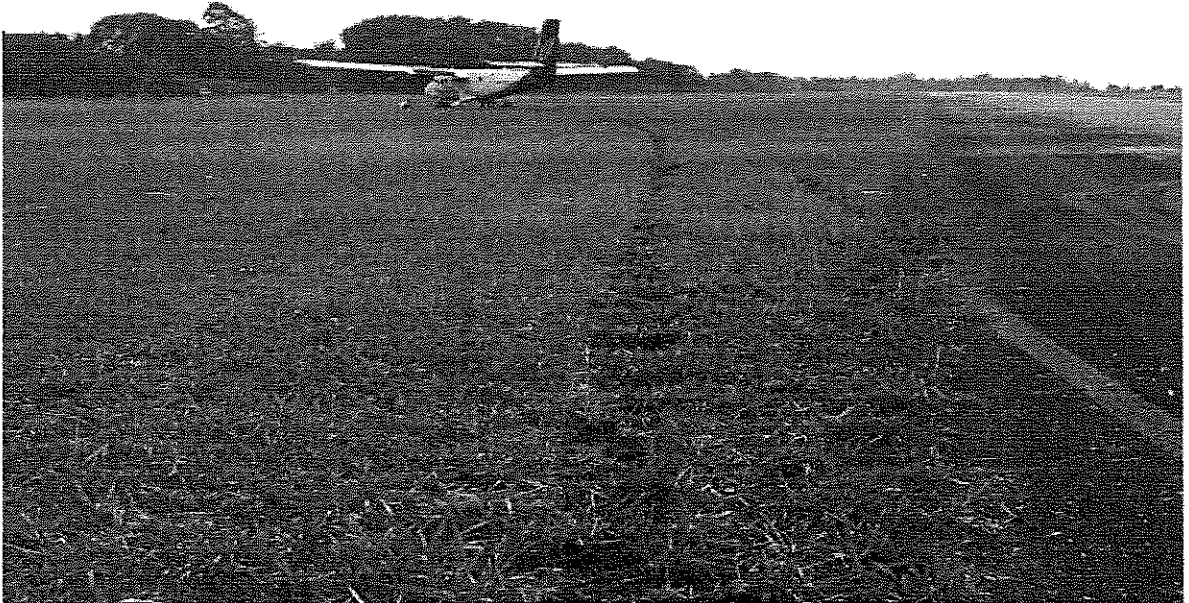
The site observation on the 26<sup>th</sup> August 2015 was made at Mukah Airport. The right main wheel and nose wheel track showed the aircraft started to veered at position 150meters (492feet) after touchdown and approximately 30meters (98feet) after passing the apron. See photos:

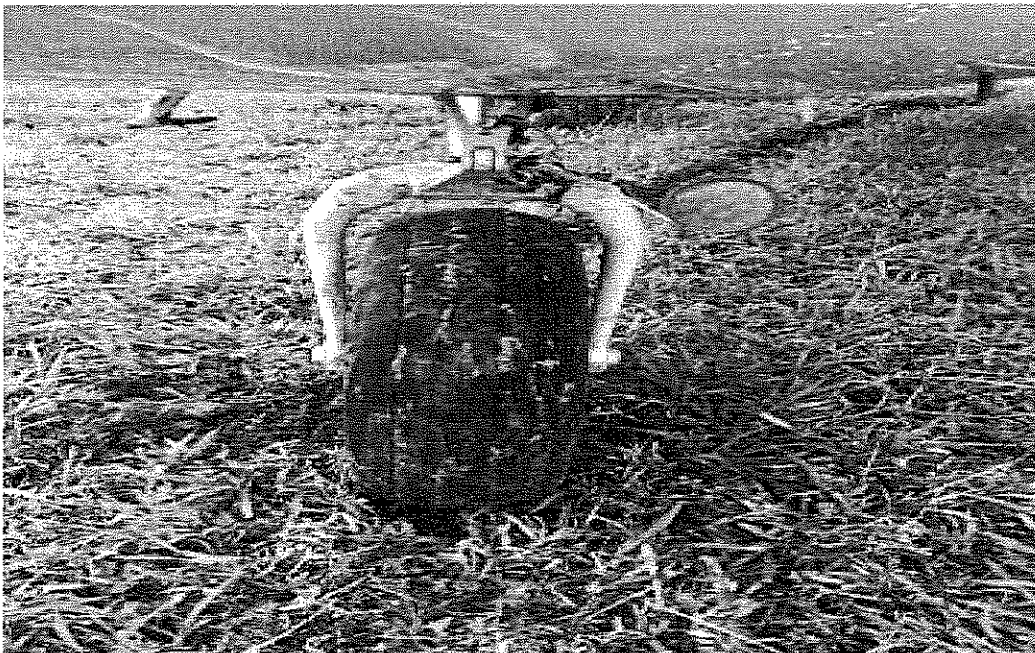
### **Rear View**

Picture shown the aircraft come to a complete stop and nosewheel marking on the grass followed by left main wheel marking.

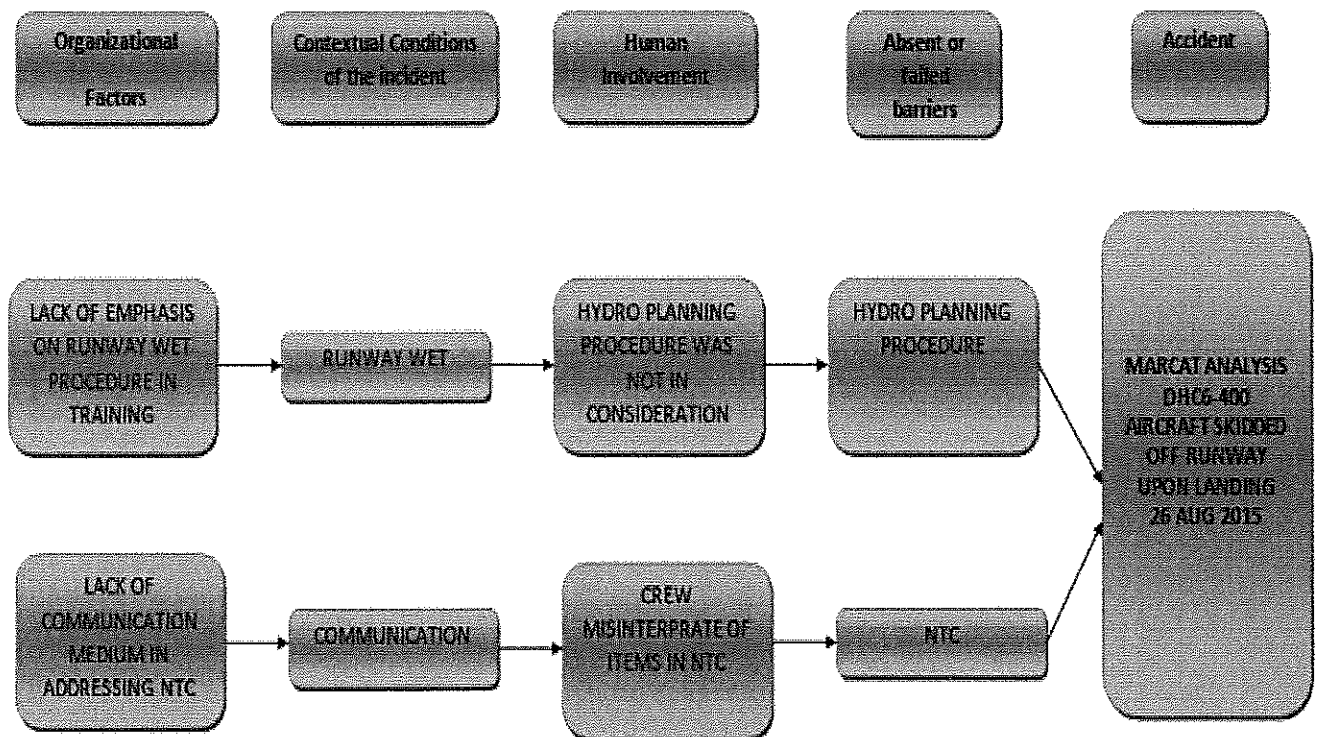
### 3.0 MARCAT Analysis

1. Weather was reported moderate rain with a wet runway condition, Crew did not plan for hydro planning
2. Crew did not aware of NTC.
3. Nose wheel landing gear veered to the left upon contact with the runway.

1. To include on next base check syllabus as discussion item on hydro planning procedure
