AIRCRAFT ACCIDENT FINAL REPORT

A 03/15P

Air Accident Investigation Bureau (AAIB)

**Helicopter Dauphine AS 365 N3, Registration 9M-IGB
40 nautical miles south east of Subang Airport, Kuala Lumpur
on 04 April 2015**

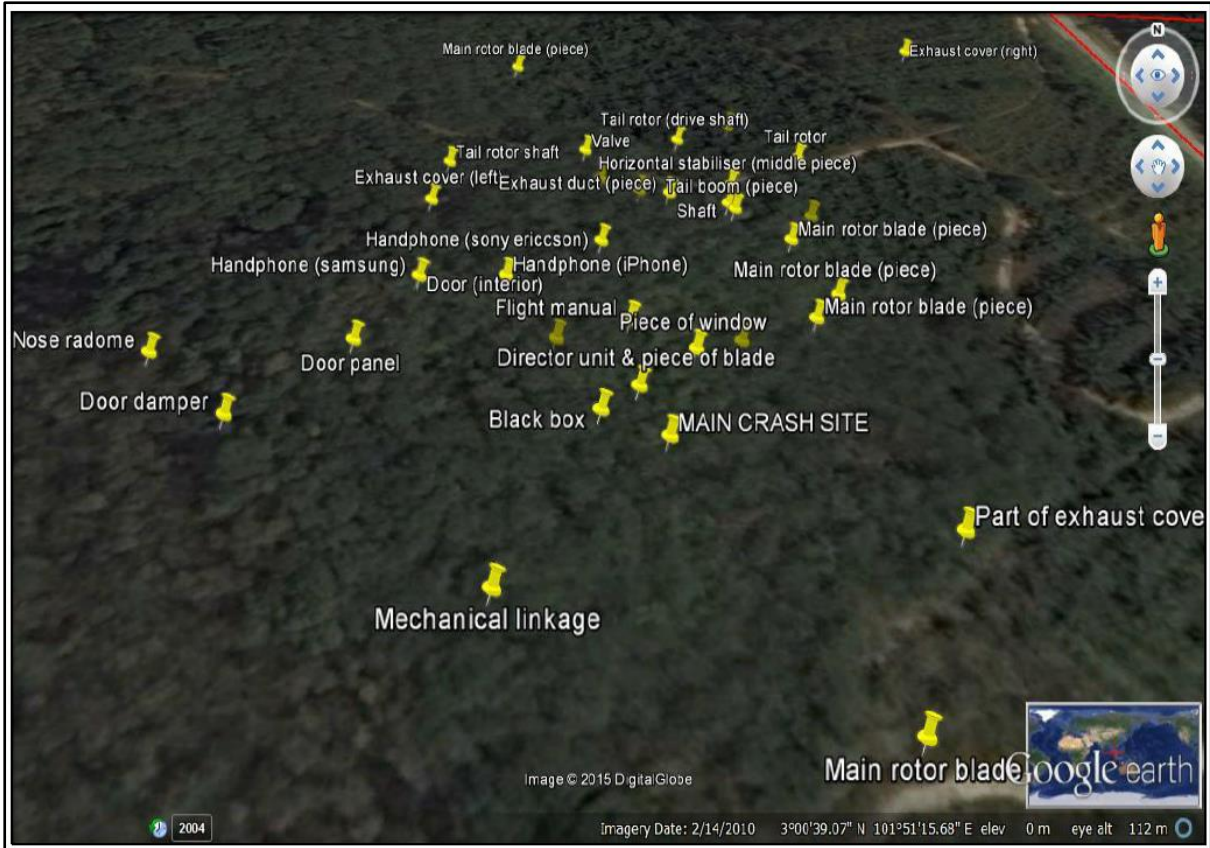
Figure 1: Wreckage distribution

The aircraft wreckage was significantly damaged by the impact forces and the post-crash fire at the bottom of a ravine. Many of the aircraft parts including MGB and engine cowling, engine exhaust pipe, main rotor head and blades, entire fenestron, main landing gears, and fuselage doors were collected from a distance of about 300 meters from the main wreckage along the steep slope of the hills. The parts recovered were on the suspected trajectory of the route flown. No evidence of aircraft contacts

with the terrain until the vertical impact of the main wreckage. All the parts recovered have been made available for examination in a hangar. The helicopter was destroyed due to high impact and consumed by post-crash fire. (See Figure 1 below)

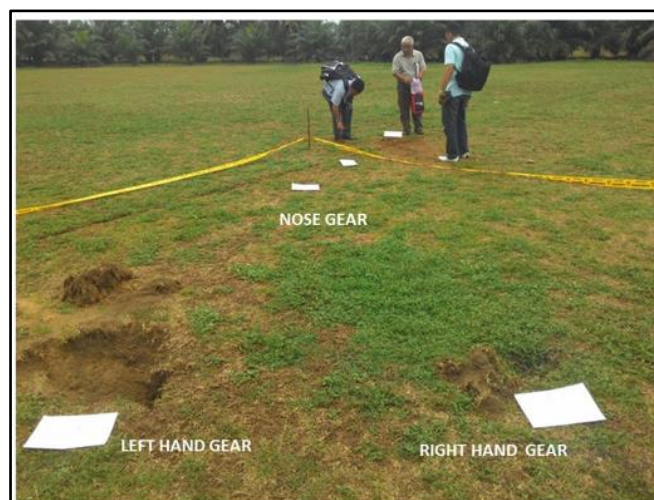
Figure 11

The helicopter made an unscheduled landing at SKLKB. While landing at the school field, the left-hand (LH) Landing Gear sunk into the ground. The photo below shows the sunk hole on the ground due to the landing gear.

The traces of fluid from the sunken hole were collected and sent to the Chemist Department of Malaysia for detailed analysis. The sample fluid was traced to meet the Mobil Jet Oil II (Synthetic) specification. See Figure 11.

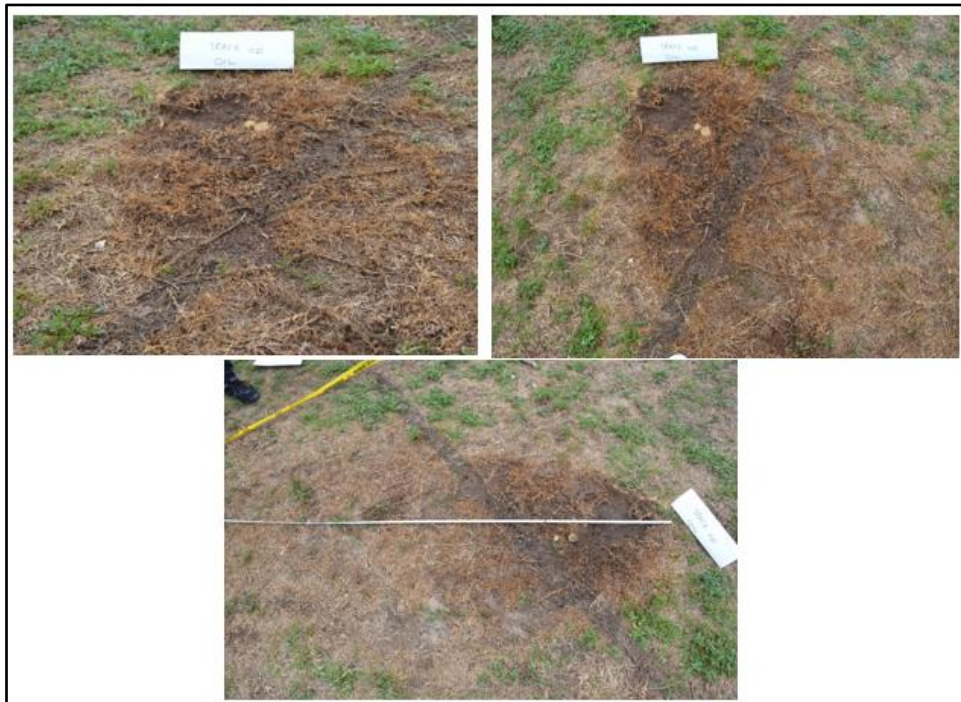
Figure 12

The photos below show the oil traces on the field at Sekolah Kebangsaan Ladang Kota Bahagia.

The hydraulic fluid may indicate evidence of some leakage from the helicopter hydraulic system at the field where the aircraft landed.

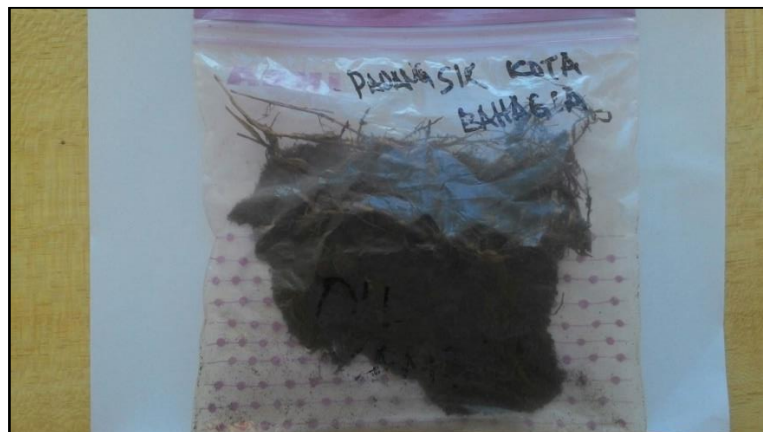
Figure 13

The traces of earth with oil samples were placed in a plastic bag and sent to the Chemist Department of Malaysia for detailed analysis. See Figure 13.

Test result from the Chemistry Department of Malaysia shows that the sample taken at the SK Ladang Kota Bahagia is consistent with the Mobil Jet Oil II (Synthetic) of the AS365N3 helicopter hydraulic fluid specifications.

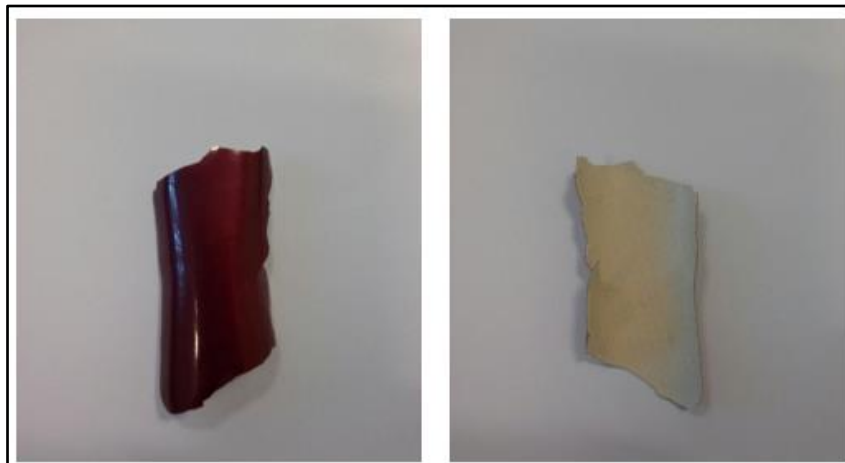
During a subsequent visit to SKLKB, the investigator found a piece of chipped-off paint that is similar to the colour of the helicopter's leading edge of the horizontal stabiliser. (Figure 15)

Figure 15 shows the piece of chipped-off paint that was sent to the Chemist Department for analysis. There was no conclusive result obtained on the analysis of the piece of sample. A further test was carried out by matching the paint contents and features from the chipped-off part and the paint from the helicopter. The Left-Hand Horizontal Stabilizer was missing; however, the RH Horizontal Stabiliser was found together with the wreckage and the piece of chipped-off paint matched the colour and contour of the aerodynamic profile of the horizontal stabiliser leading edge.

As the LH Landing Gear sunk into the ground, the vertical fin of the LH Horizontal Stabiliser contacted the ground and may have caused premature structural damage to the LH Horizontal Stabiliser. The piece of chipped-off paint found on the field provides evidence that the LH Horizontal Stabiliser and helicopter structures have been badly distorted causing the dislodgement of the piece of paint.

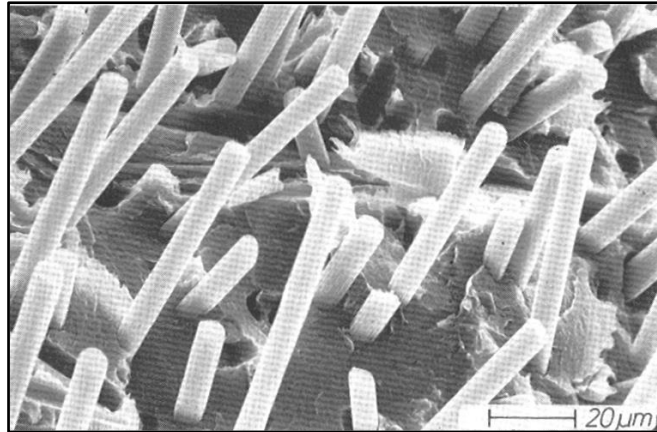
Figure 16

The following photo shows the fiber pullout resulting from the tensile load on the structure.

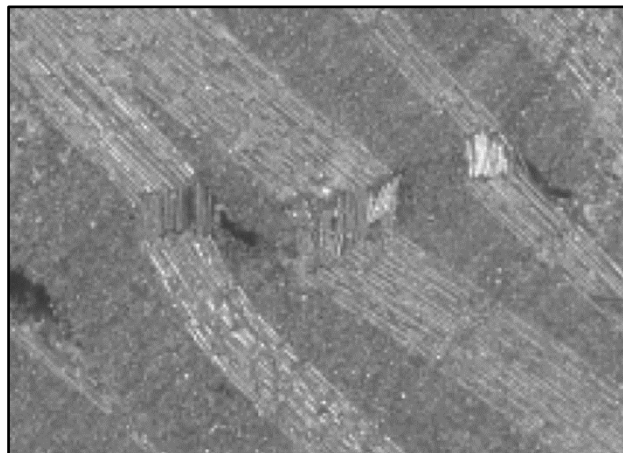
The kinking of fibers shown in Figure 17 indicates the results of compressive loads on the structure, with some applied load translated into all the fibers. It also shows the kinking of fibers in the direction of compressive load.

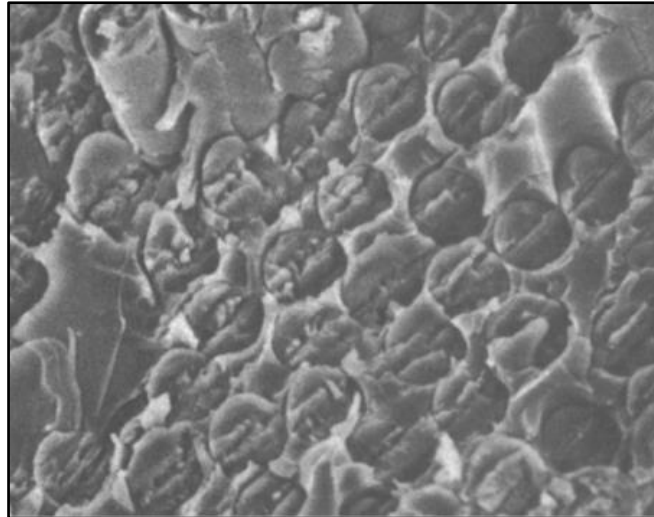
Figure 18

The following photo shows there was evidence of chop marks on the ends of the broken structure which indicate that the fibers had buckled and failed under compressive load as well.

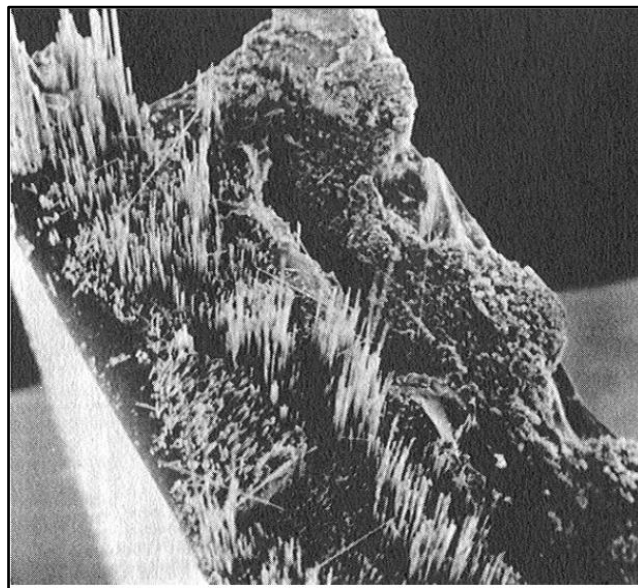
Figure 19

The following photo provides evidence of failure on the composite structure due to bending forces. See Fig. 16 – The relative rough area, visible strands of fibers and tension area, and the smooth region as shown in photos indicate failure by compression.

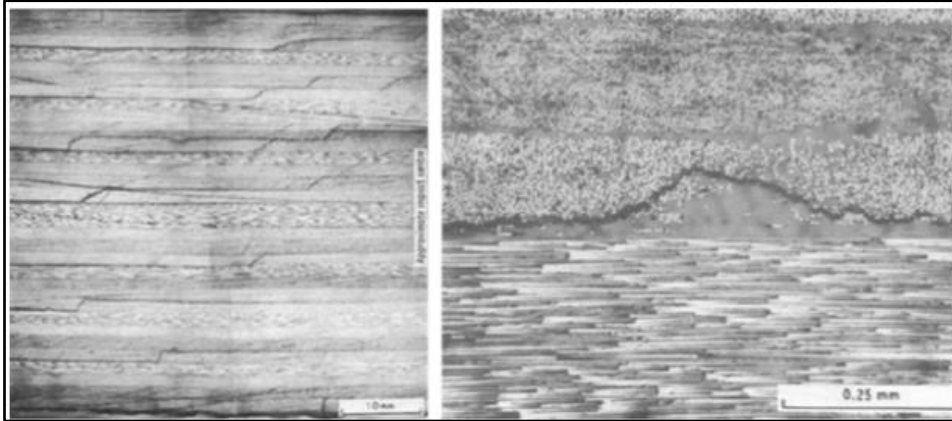
Figure 20

The following photos show the delamination between the composite plies which could be attributed to pre or post-impact.

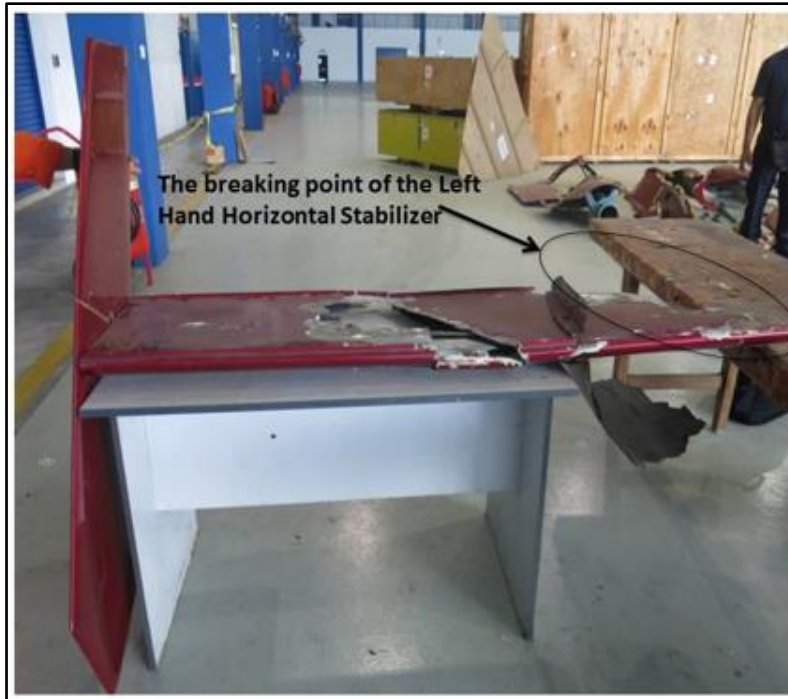
Figure 21

The above photo shows the reconstruction of the horizontal stabilizer assembly. The Left-Hand Horizontal Stabilizer was missing.

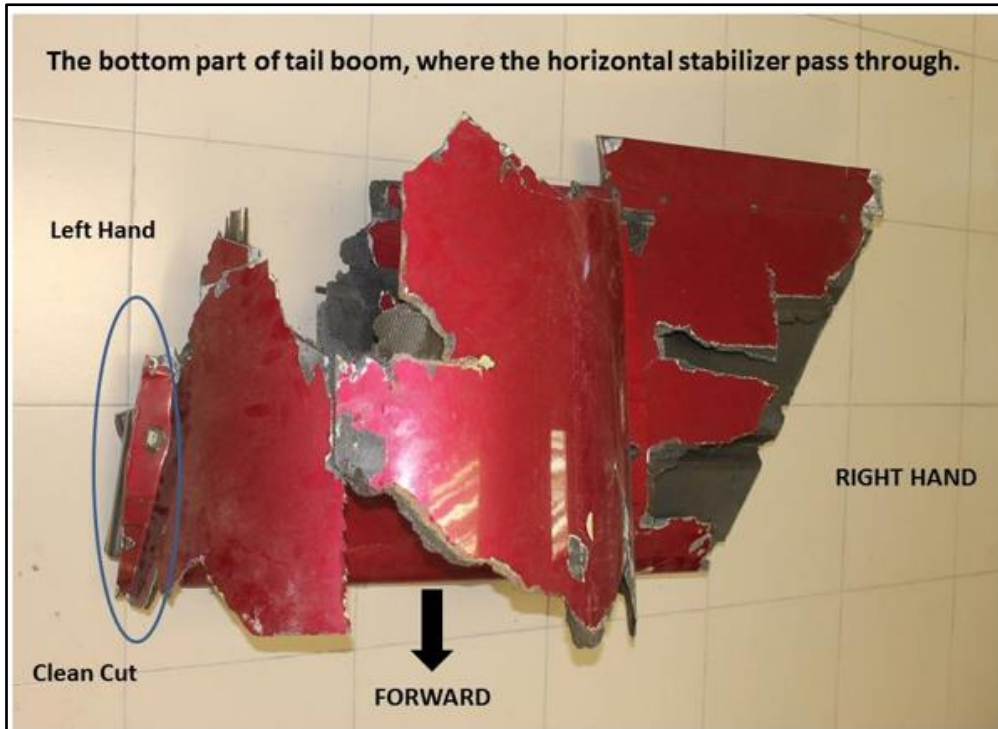
The tail boom section was reconstructed and each failure point was examined. The above photo shows the failure of the tail boom section after the wreckage of the tail boom and part of the horizontal stabilizer were reconstructed.

The tail boom section was examined in detail and the failure points show a clear cut on the tail boom skin parallel to the helicopter's longitudinal axis, as shown. (See Figure 22 and Figure 23)

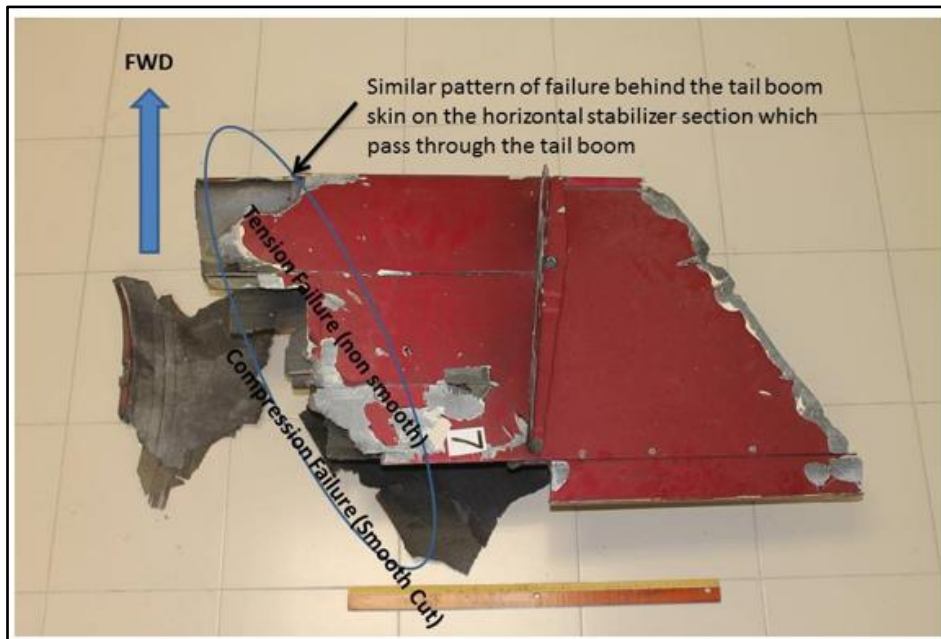
Figure 25

The examination continued with the section of the horizontal stabilizer. As the tail boom section is removed, the horizontal stabiliser section at the breaking point is visible as shown in Figure 25.

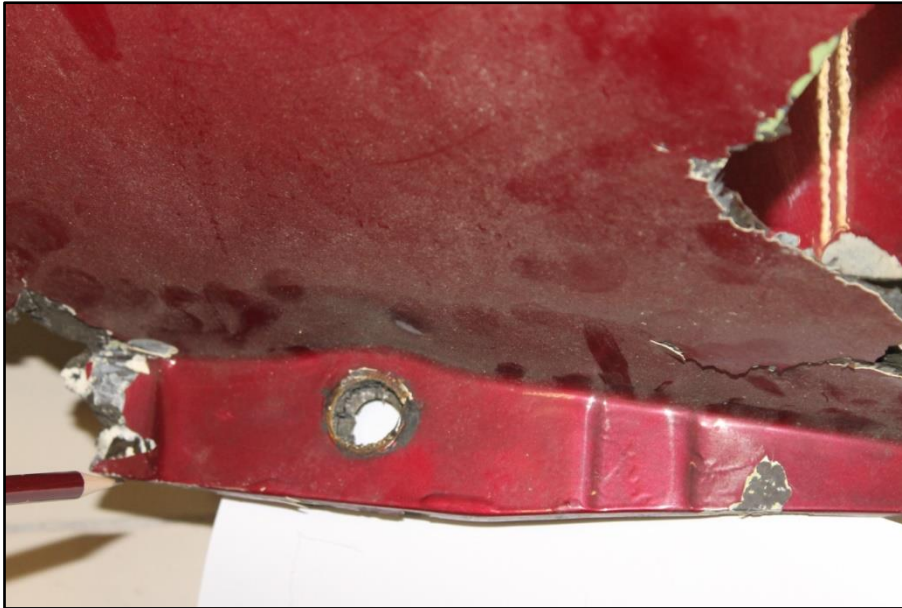
Figure 26

The top skin of the horizontal stabiliser had a smooth cut which indicates it had failed under compression load whilst the bottom skin of the horizontal stabiliser had jagged edges and failed under tension load. (See Figure 26)

The inconsistency in the LH Horizontal Stabiliser failure pattern showing the top skin under compression and the bottom skin under tension might suggest that there could be a premature failure on the LH Horizontal Stabiliser structure as the vertical fin hit the ground when the helicopter landed and the LH Landing Gear subsequently sunk into the ground at SKLKB. As the LH vertical fin hits the ground, the LH Horizontal Stabiliser will bend upwards and will hinge at the mid-span of the LH Horizontal Stabilizer as shown by the failure line parallel to the tailboom attachment.

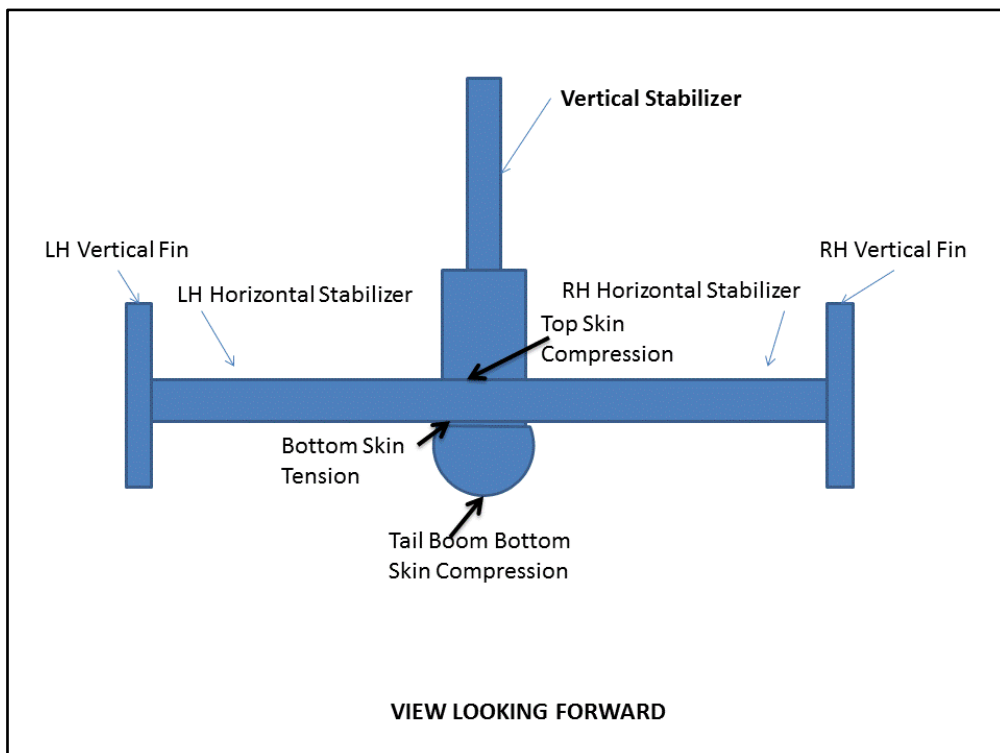
Figure 27

The tail boom attachment to the horizontal stabiliser indicates a pulled-through failure. A review of the structure failure lines is shown in the following diagram (See Figure 27).

If we consider the down load force, the LH Horizontal Stabiliser will bend downward which will result in the top skin under tension and the bottom skin under compression.

However, the examination of the structure of the bottom skin of the tail boom appears consistent with the failure mode of the LH Horizontal Stabiliser bending downward as evidenced by the clean fracture line along the tail boom. (See Figure 27)
