AIRCRAFT ACCIDENT FINAL REPORT
A 13/16
Air Accidents Investigation Bureau (AAIB)
Ministry of Transport

Accident Involving an Airbus Helicopter AS350 B3e
Registration 9M-APL
at SK Batu Melintang, Kelantan, Malaysia
on the 18 November 2016

ACCIDENT REPORT NO. : A 13/16

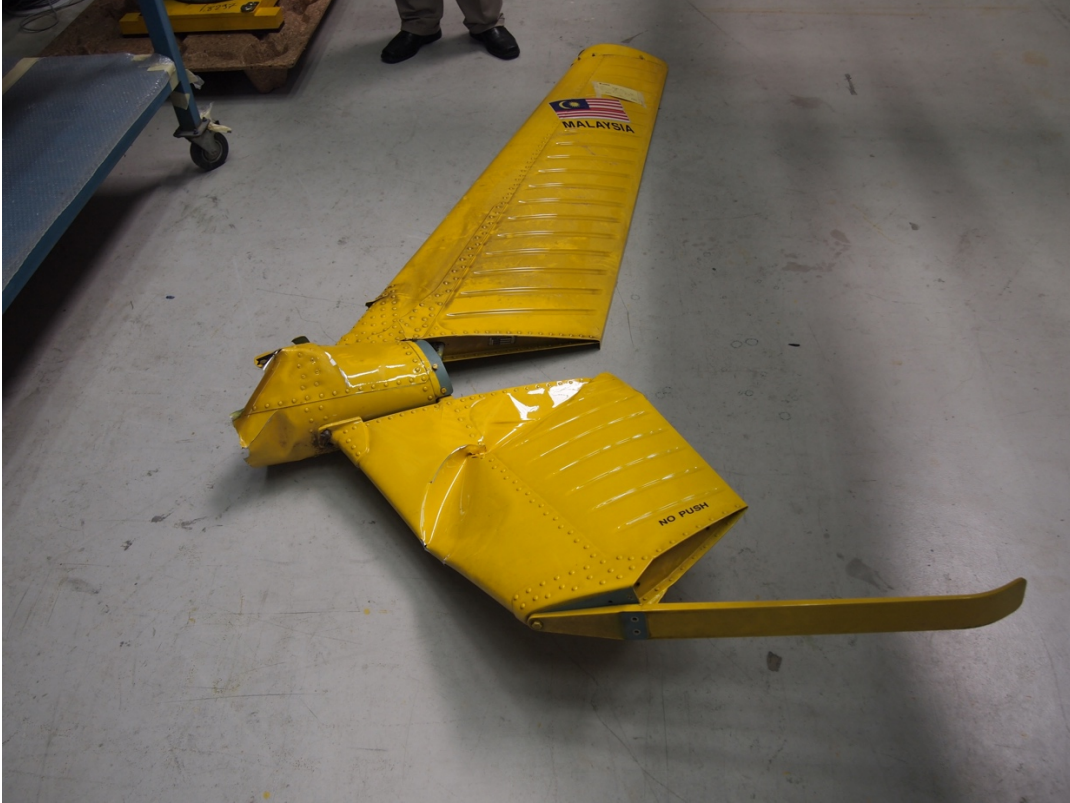
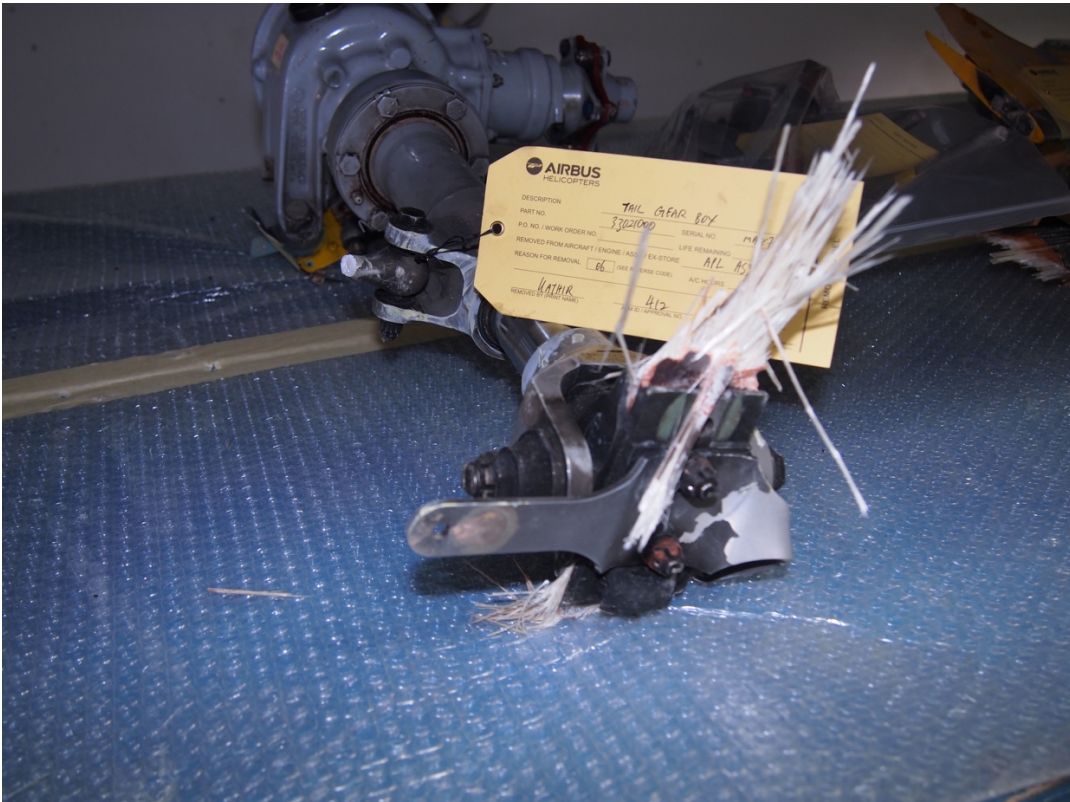
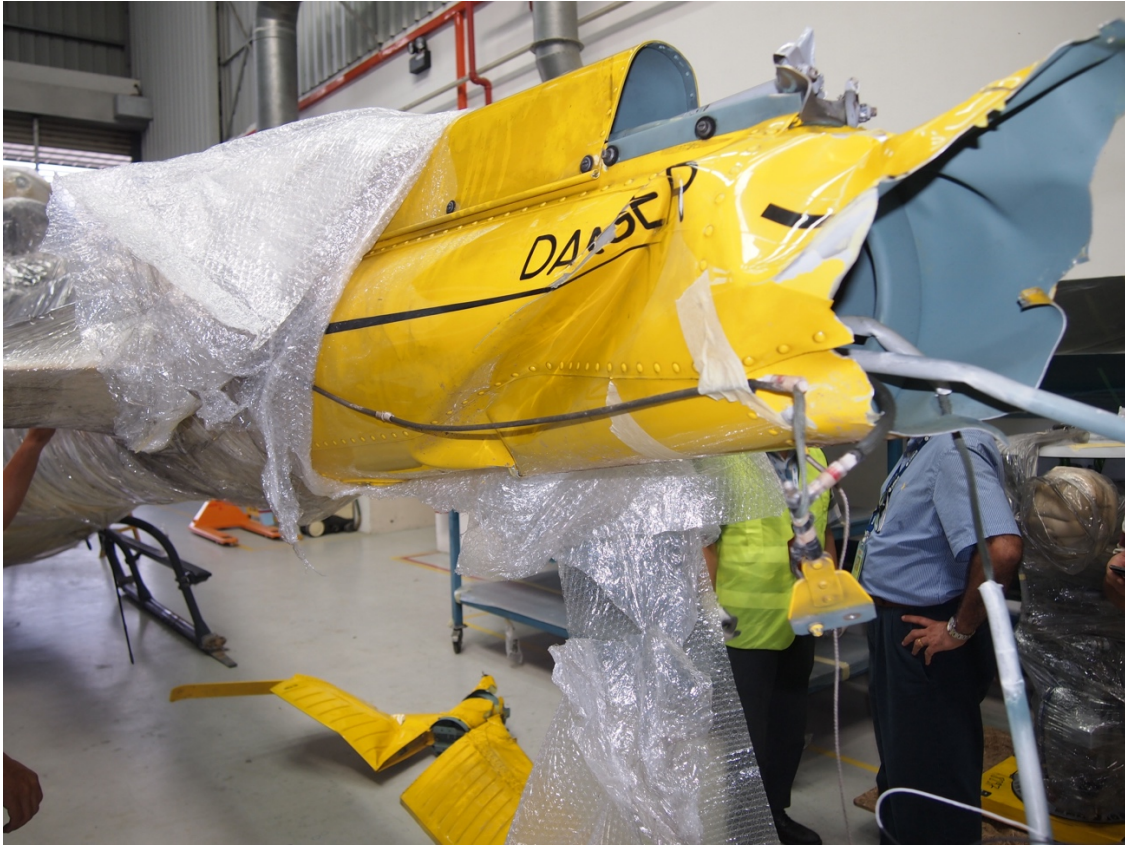
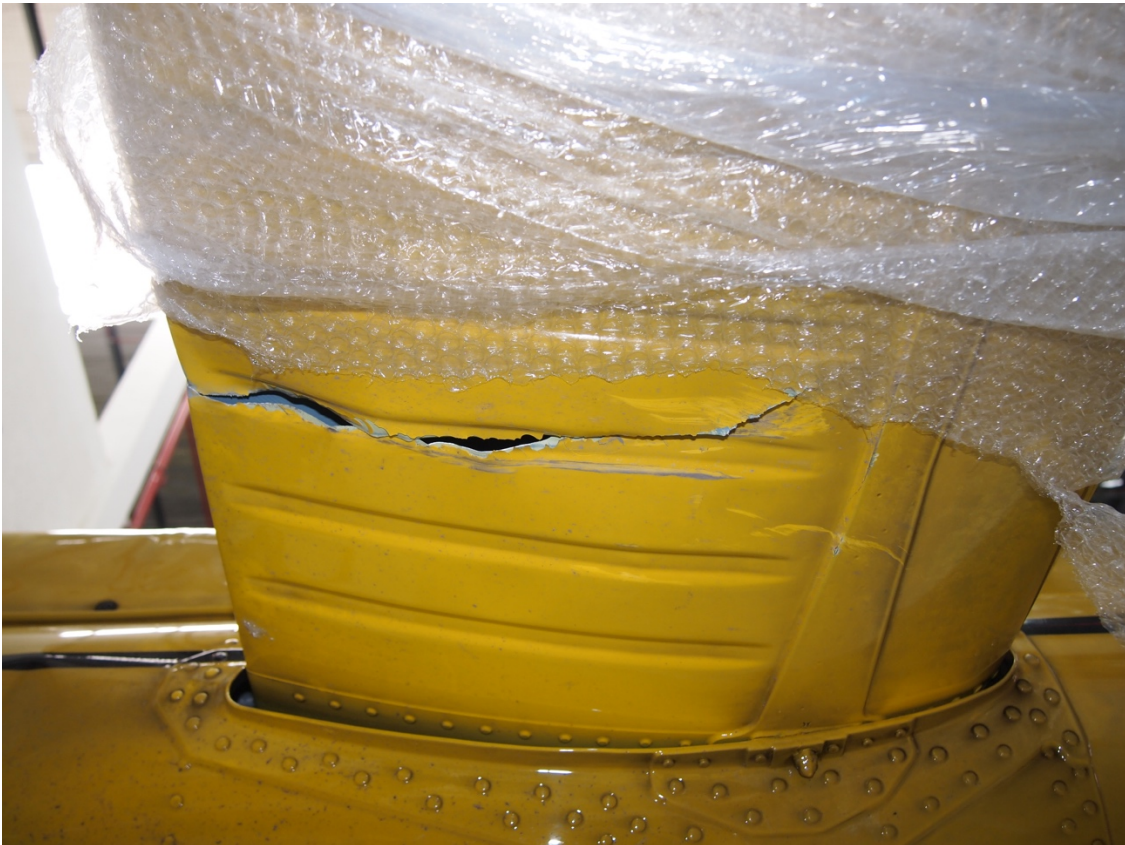
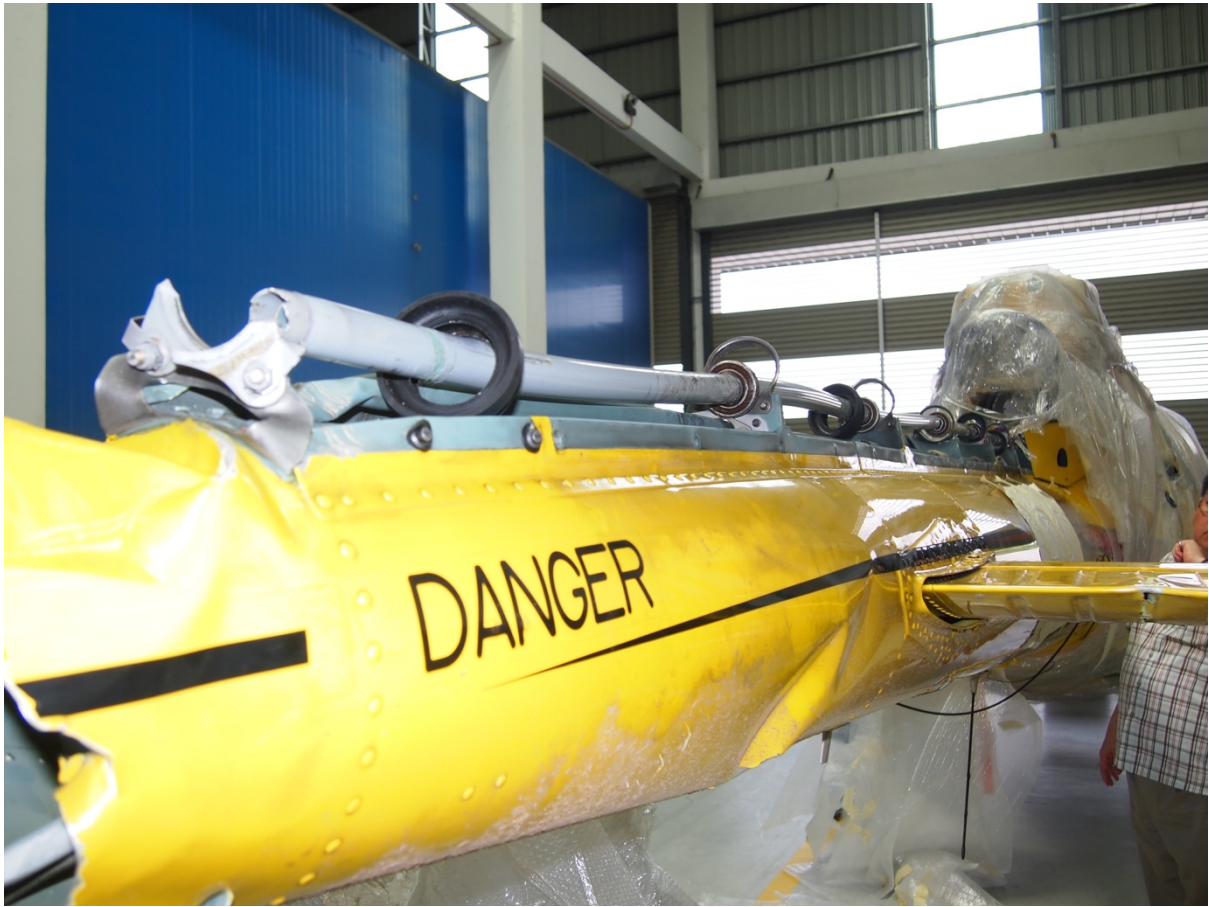
DAMAGE ASSESSMENT IMAGES

The vertical stabiliser assembly along with the tail-rotor gearbox and rotor blades were detached from the tail-boom of the aircraft. The tail-boom's skin displayed signs of buckling while the tail drive shaft was deformed. A deep cut was also found on the underside of the starboard horizontal stabiliser where it was impacted by a tail-rotor blade.
