**AIRCRAFT ACCIDENT
FINAL REPORT
SI 11/17**

**Accident Involving Airbus A320-216
Registration 9M-AHM
at Subang Airport/Sultan Abdul Aziz Shah, Kuala Lumpur
on 30th November 2017**

REPORT NO.: SI 11/17

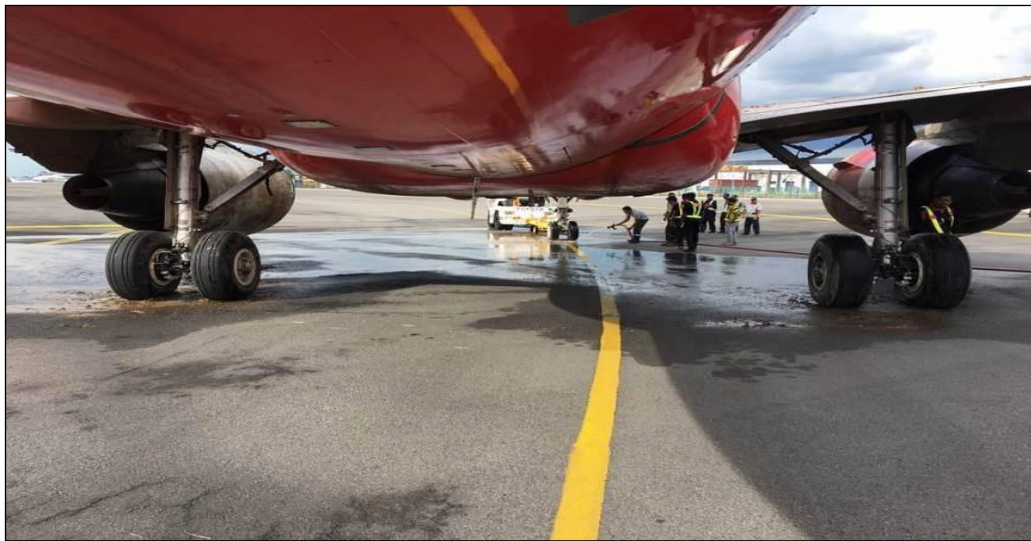
Figure 2: Damage to aircraft

Initial Aircraft Damage Assessment	
Airframe	Fuselage-sign of long cut on LH aft lower belly fairing
	Both LH landing gear mainwheel found deflated
Engine no 1	Signs of mud and soil ingestion into engine. 2 fan blades found with bent and cut respectively.
Engine no 2	Signs of mud and soil ingestion into engine

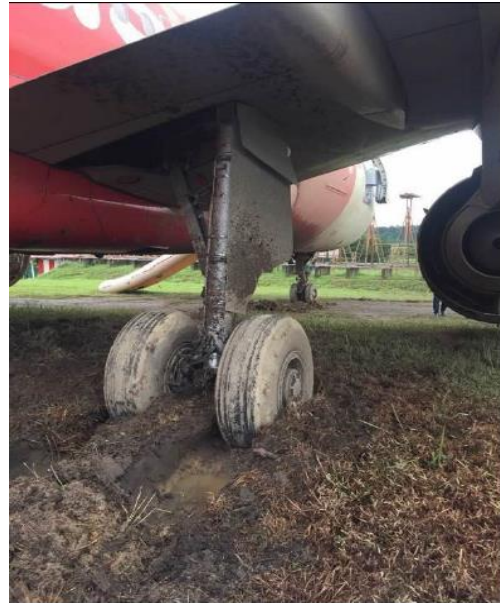
Figure 4: Left main landing gear

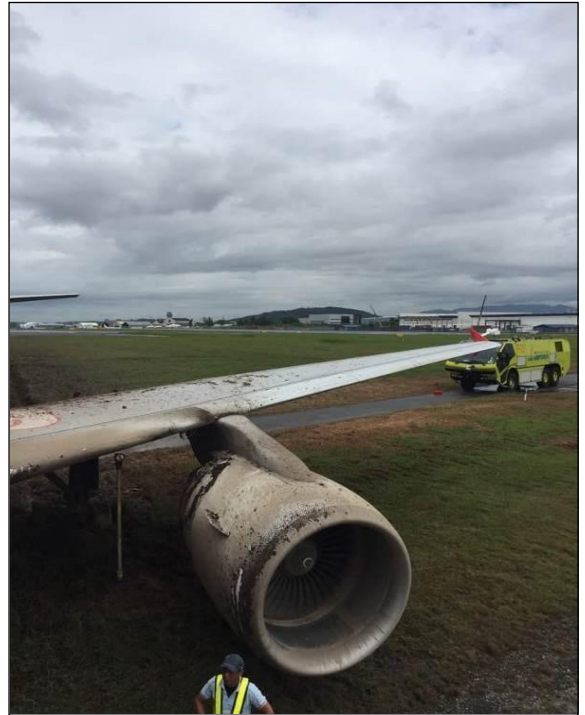
Figure 6: Engine 2

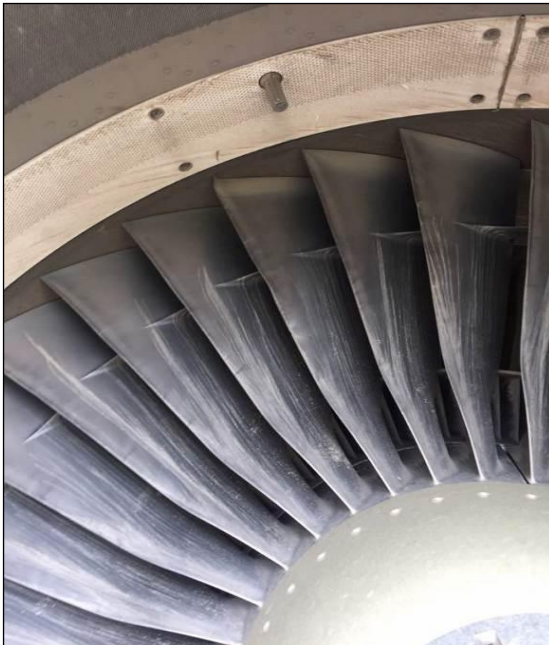
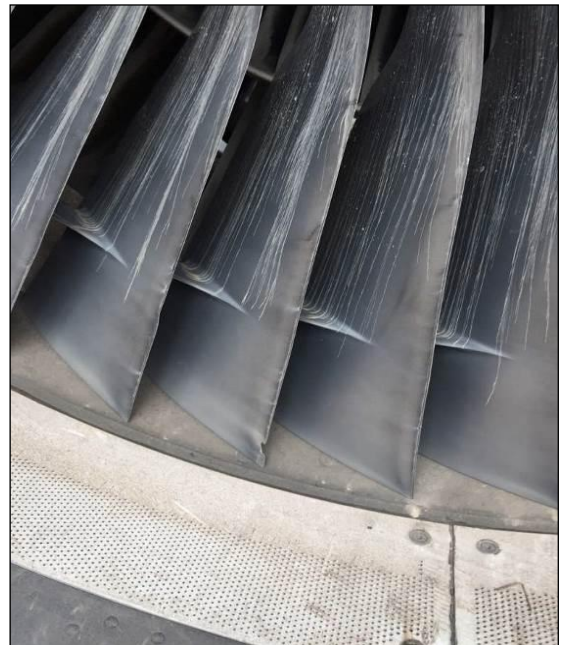
Figure 7: Engine 1

Figure 8: Engine Fan Blades

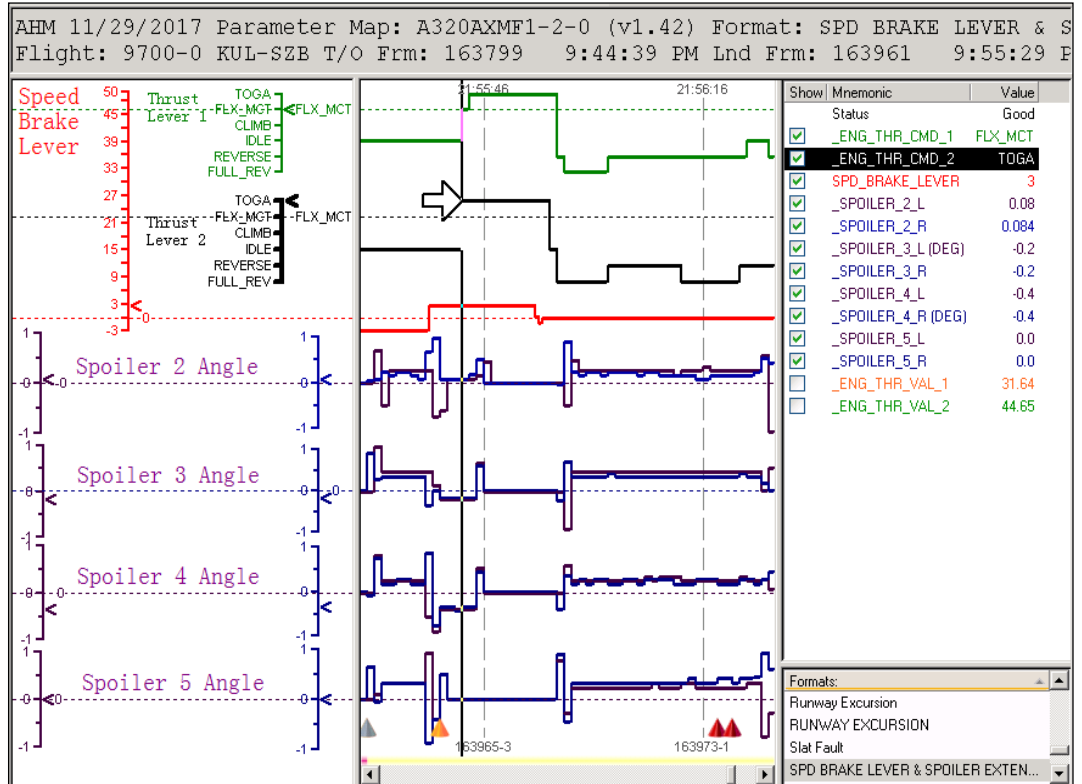
FDR data showed that on this flight, when take-off power was set, the speed brake lever was at +3° (extended) deflection instead of 0° (retracted) (see figure 33) At the same time, the actual angles of the spoiler surfaces were also showing that they were partially extended. This was found to be the cause that had triggered the TO Config warning and was not due to any faults or system failures which was corroborated with the aircraft’s Post Flight Report which did not receive any fault messages.

Figure 33: Speed brake lever and corresponding spoiler surface angle at application of take-off power (21:55:44 UTC)

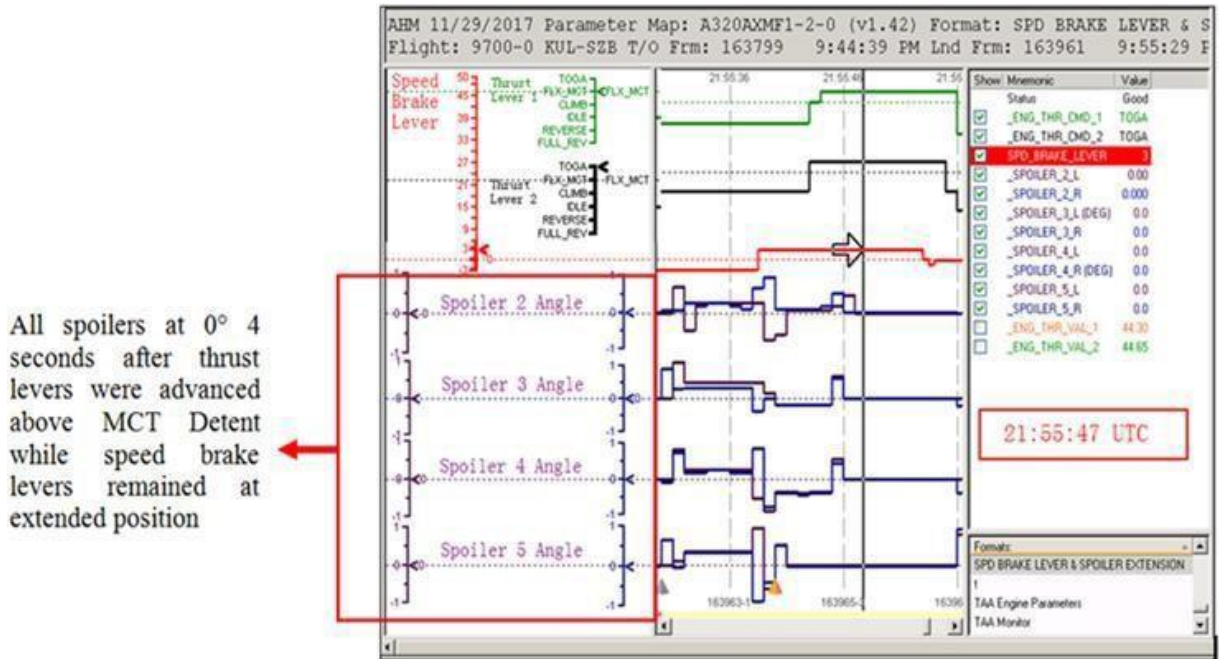
Despite the triggering of the TO Config warning, all documentations by the manufacturer indicates that the aircraft was still safe for take-off. As per Airbus, when thrust levers are advanced to take-off power setting which is above FLX/MCT detent, or more than 20° during a Touch and Go, all spoiler surfaces will automatically retract fully regardless of what the speed brake lever is set at. Flight Data confirms that this feature did not fail on this flight where 4 seconds after thrust levers were set above MCT Detent, all spoiler surfaces had fully retracted automatically at while the speed brake lever remained at extended position (see figure 34).

Figure 34: L FDR (Speed brake lever and corresponding spoiler surface angle at application of take-off power 21:55:44 UTC)

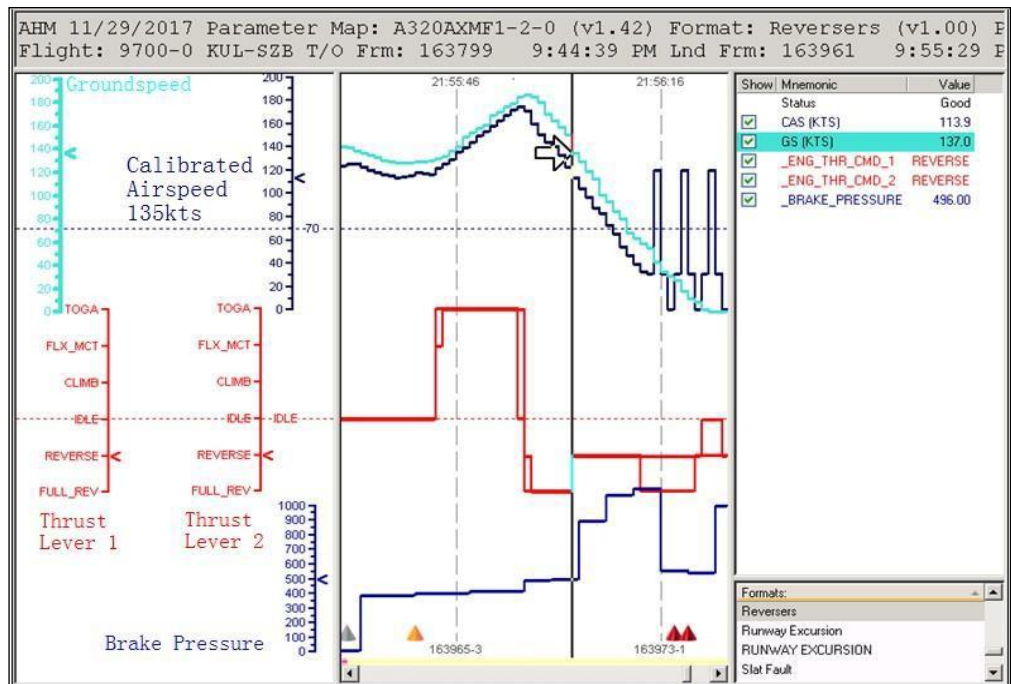
Figure 41: Flight Data showing full reversers were cancelled at 114kts

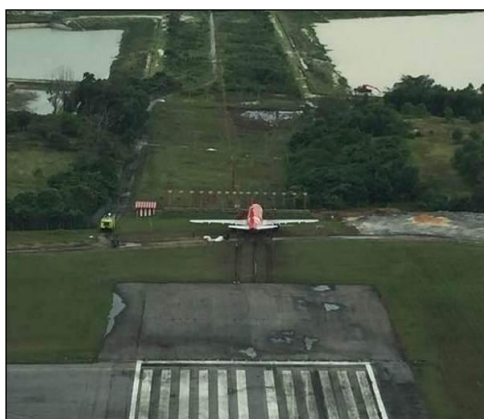
The aircraft stopped in an intact condition and no wreckage is involved. The final stopping position of the aircraft is hereby regarded as the “impact area”.

Figure 58 : Aerial Photo of Aircraft at Impact Area

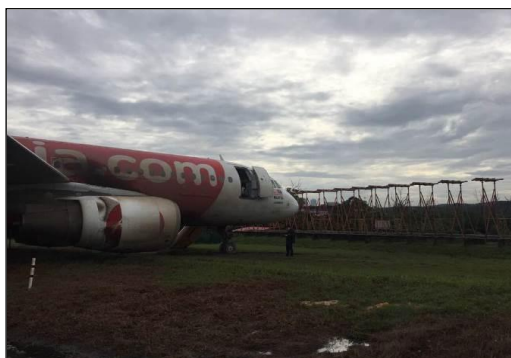
Figure 60: Aircraft Stopped 15 m from ILS Localizer Antenna Array

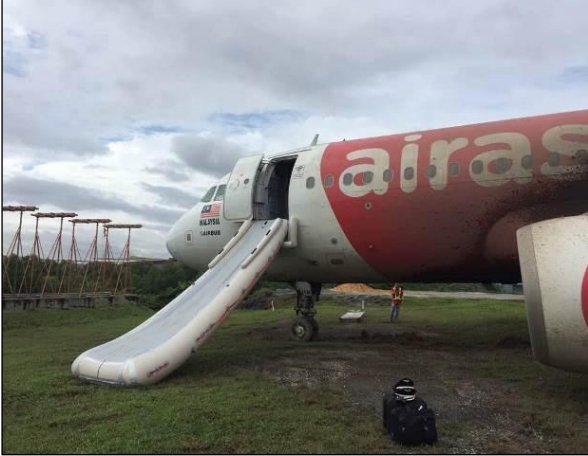
The crew deplaned the aircraft via the Escape Slide on Door 1 Left approximately after 06:10:00 LT when APU was shut down. The door was initially disarmed as the commander was satisfied that there was no urgency for an emergency evacuation. Slide was deployed successfully when the AFRS arrived and all three crew vacated the aircraft safely. Before leaving the aircraft, the crew performed the Parking and Securing the Aircraft checklists.

Figure 62: Aircraft Escape Slide Deployed from Door 1L
