AIRCRAFT ACCIDENT FINAL REPORT
A 03/17
Air Accidents Investigation Bureau (AAIB)
Ministry of Transport

Accident Involving a Piper PA-28-161
Registration 9M-DRC
at Pulau Jaya, Johor, Malaysia
on the 4 June 2017

FINAL REPORT A 03/17

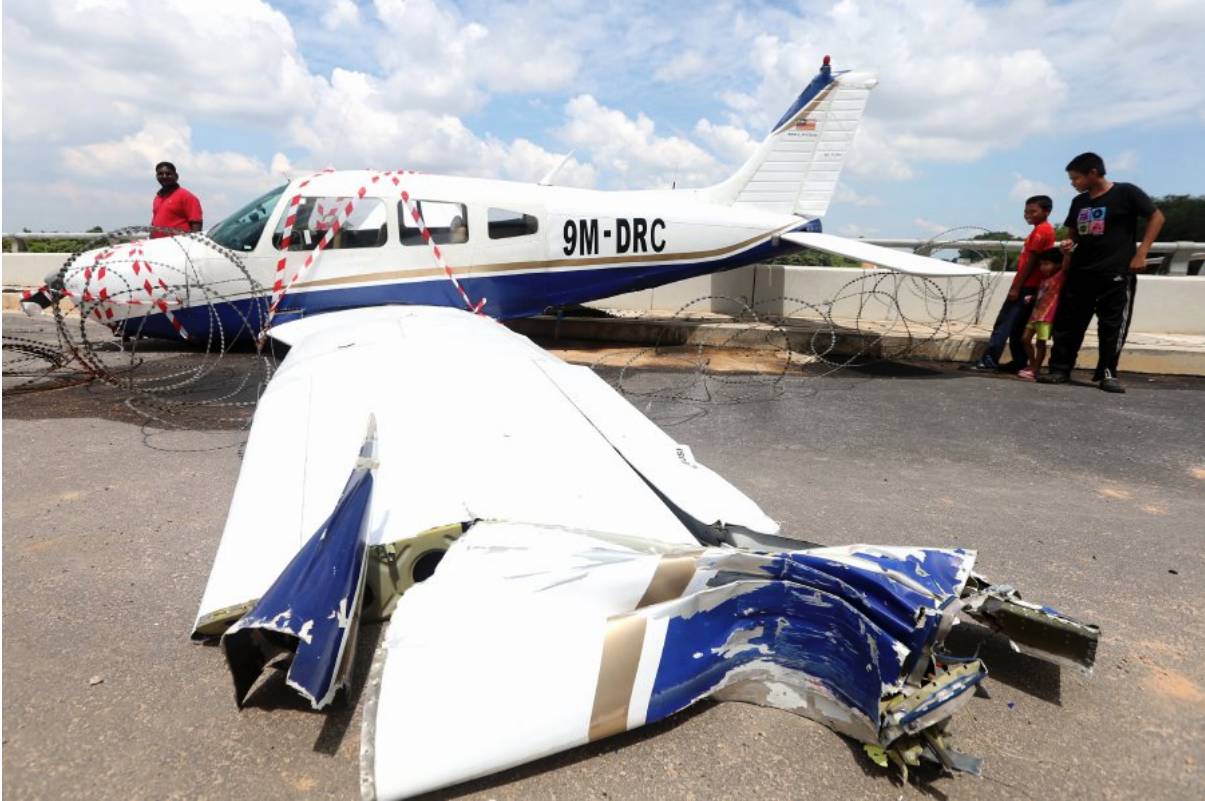
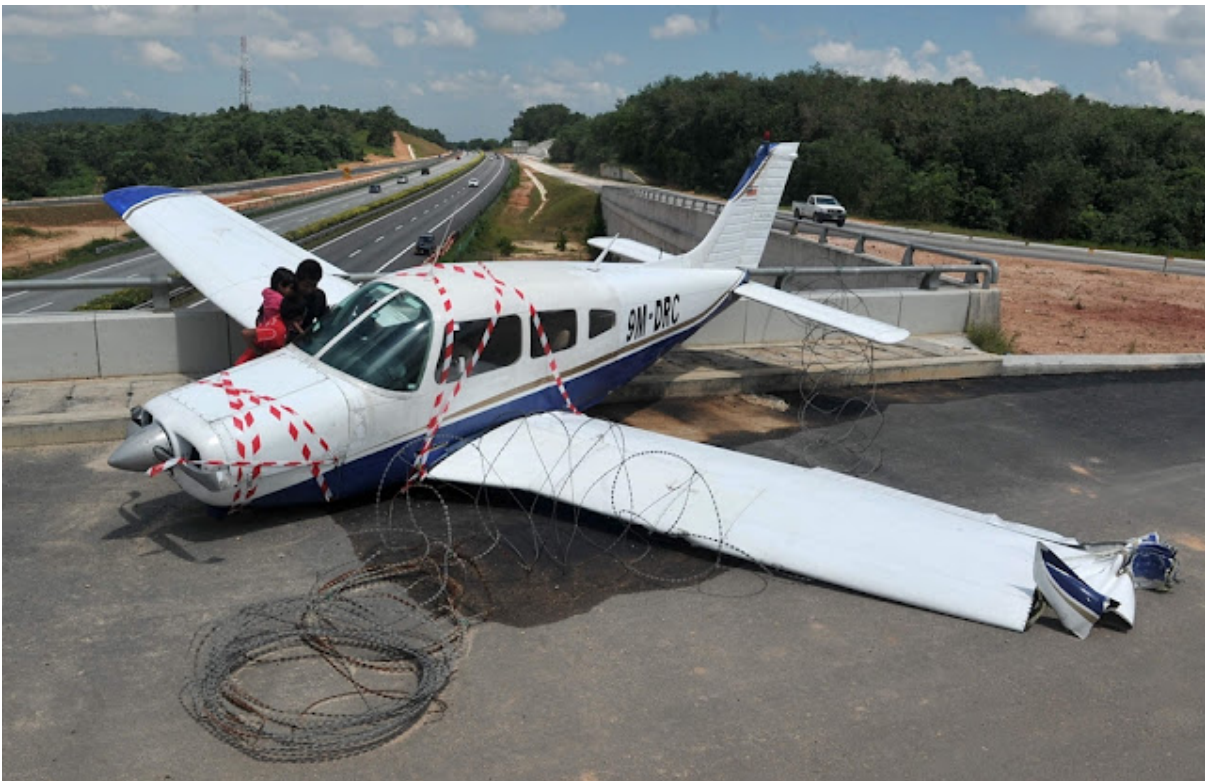
9M-DRC

The aircraft came to a rest at the edge of the flyover. Its left wingtip was heavily damaged due to it striking a lamp post just as the aircraft was about to land. All three landing gears collapsed most probably due to the impact. The cabin however was intact which perhaps is why the passengers were free from injury.

It was interesting to note that the propellers were bent backwards indicating that the aircraft impacted power-off. Overall damage to the aircraft was quite considerable and it was subsequently deemed a total write-off.

Other than scuff marks on the asphalt of the flyover, a temporary barbed wire fence placed across it was destroyed by the aircraft.
