AIRCRAFT ACCIDENT FINAL REPORT
A 07/17
Air Accidents Investigation Bureau (AAIB)
Ministry of Transport

Accident Involving a Cessna C-152
Registration 9M-FBS
at Sultan Abdul Aziz Shah Airport (WMSA), Selangor, Malaysia
on the 8 July 2017

ACCIDENT REPORT NO. : A 07/17

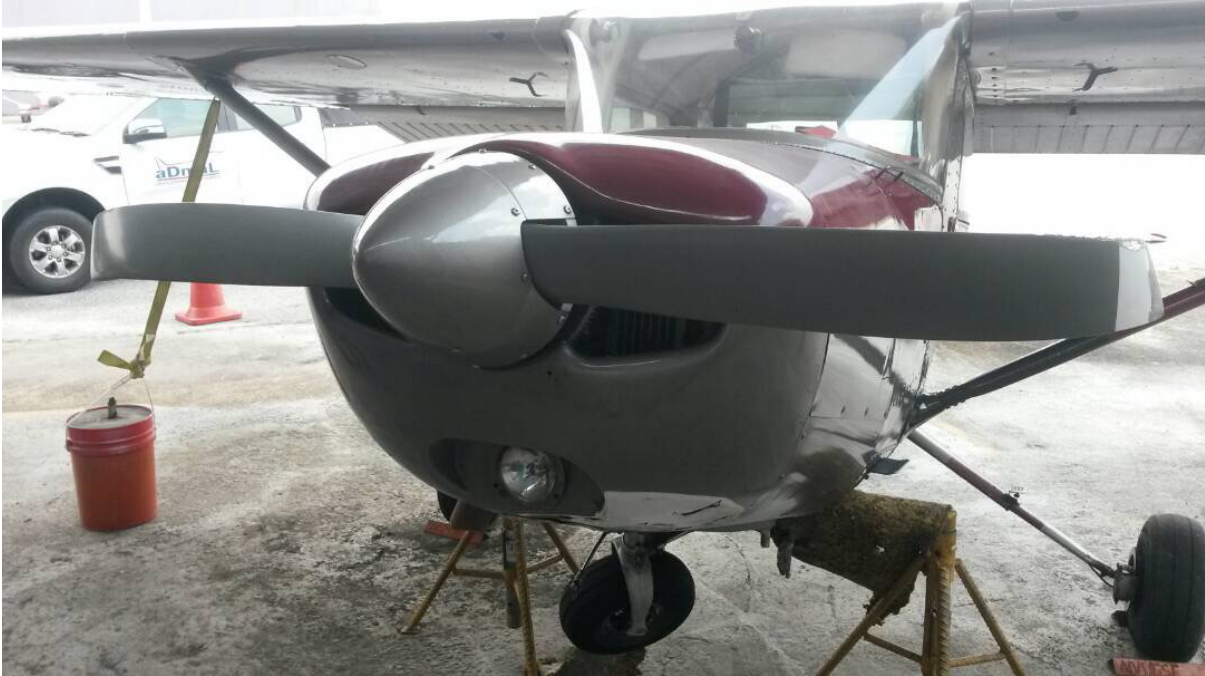
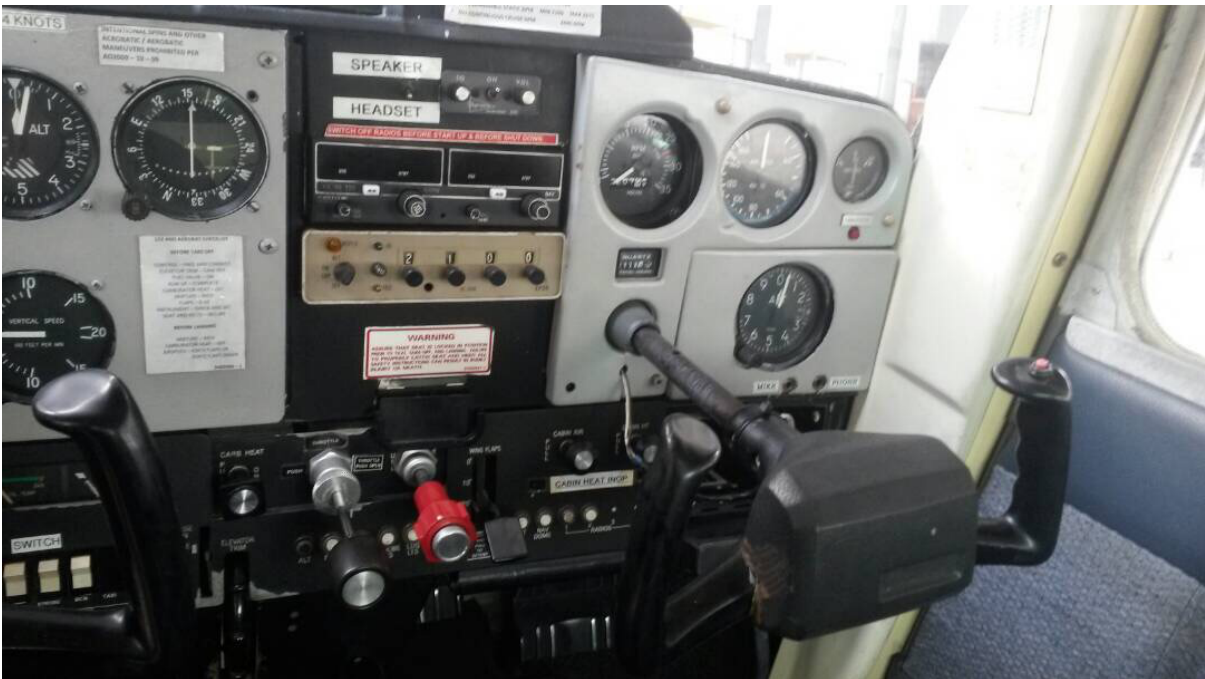
9M-FBS

An assessment of damage to the aircraft revealed that the nose-wheel gear assembly had been substantially damaged along with damages to the propeller and engine cowling.
