## **Accident Investigation Coordinating Committee**

### **Report 2018/01**

Final Report on the Serious Incident to  
Airbus, A330-300 (9M-XXC), A350-900 (A7-ALL)  
Velana International Airport, Maldives  
7 July 2018

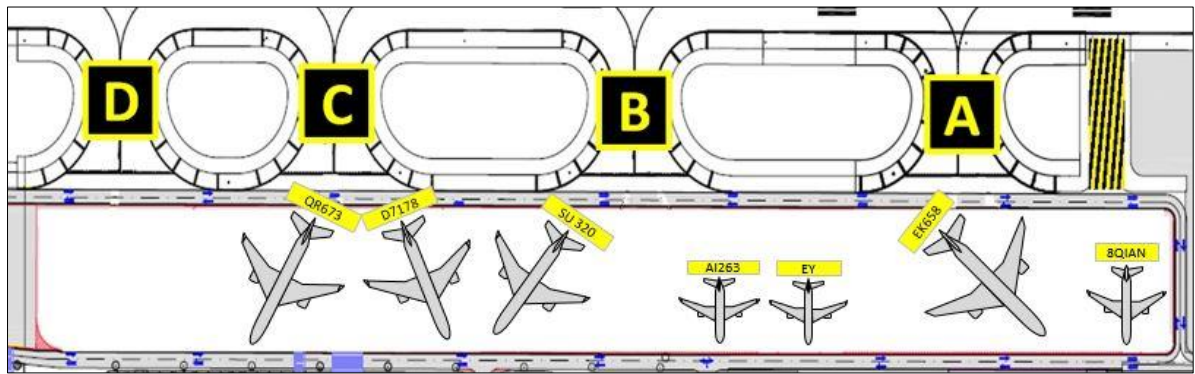
Figure 5 – Parking allocation for 9M-XXC

"Plan-4" was generated for the arrival of 9M-XXC (flight number D7178), among other aircraft. In this plan 9M-XXC was to be parked near Taxi-way C between A7-ALL (flight number QR673) and another A330 (flight number SU 320).

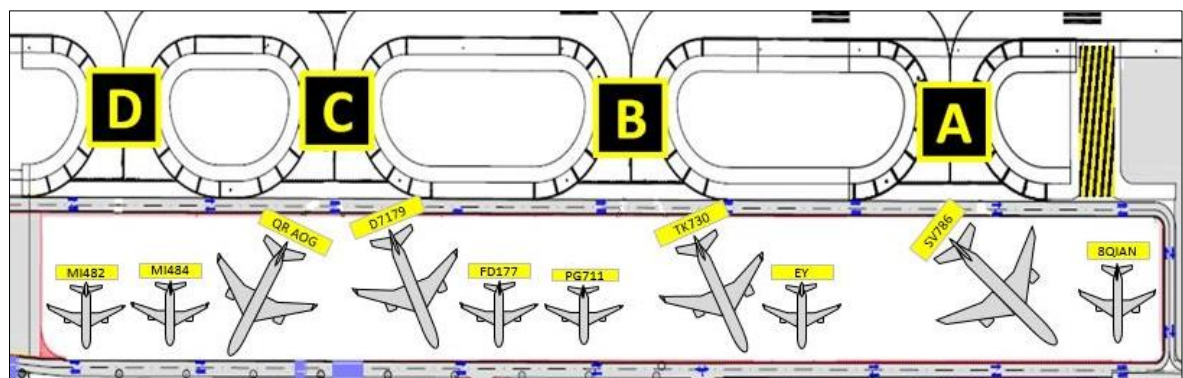
Figure 6 – Parking Allocation with the most aircraft

Given that the parking bays are not marked, the allocation (i.e. number, type and orientation) of aircraft varies depending on the traffic. For example, the parking allocation with the most number of aircraft, for the day, was “Plan-6” shown in figure 6. In this arrangement 10 aircraft are parked.

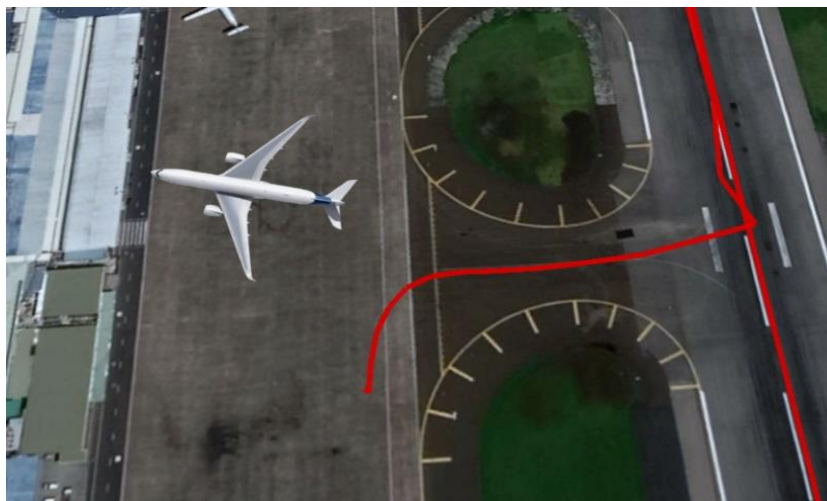
Figure 7 – The path (red line) taken Air Asia aircraft

The red line in the above figures represent the movement of the aircraft from the Flight data System. It is evident from the mapping above, the starboard (right hand) wing of the Air Asia aircraft could not have cleared the Qatar Airways aircraft horizontal stabilizer.
