AIRCRAFT ACCIDENT FINAL REPORT

A 01/18

Air Accident Investigation Bureau (AAIB)

**Final Report on the Accident involving
Fixed wing aircraft Cirrus SR20 Registration 9M-ZWR
In Pulau Tioman, Pahang, Malaysia
On the 1 February 2018**

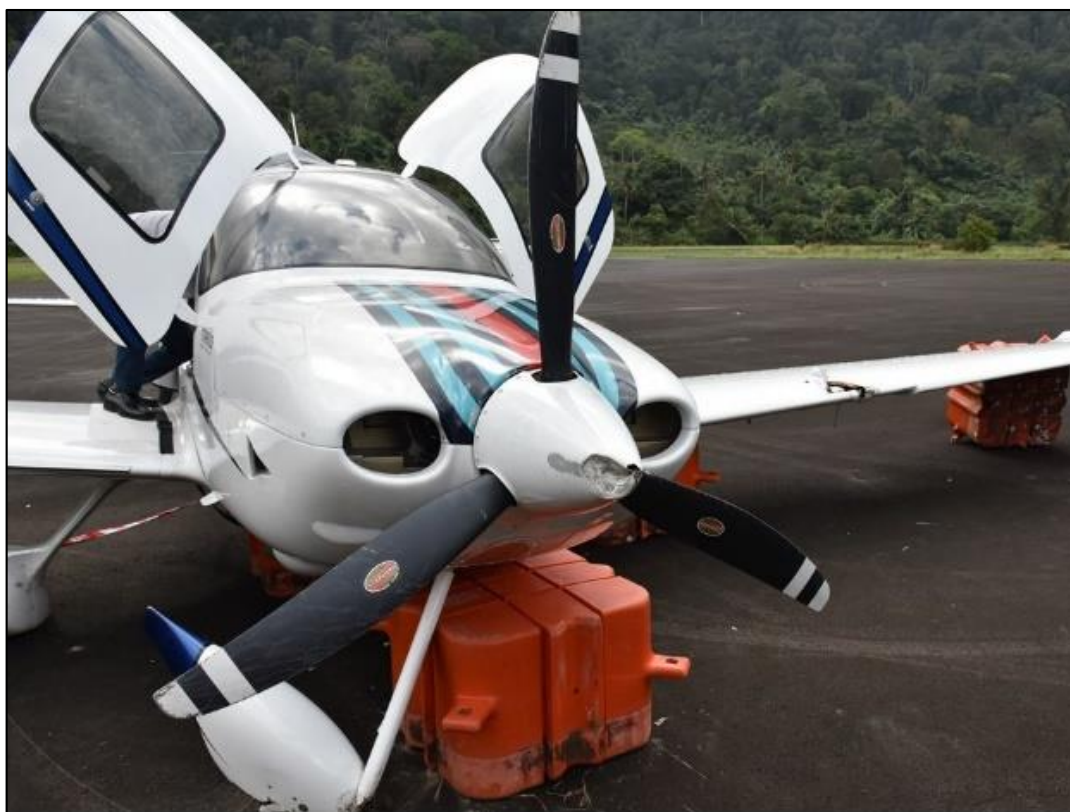
Picture 1 – Nose wheel collapsed

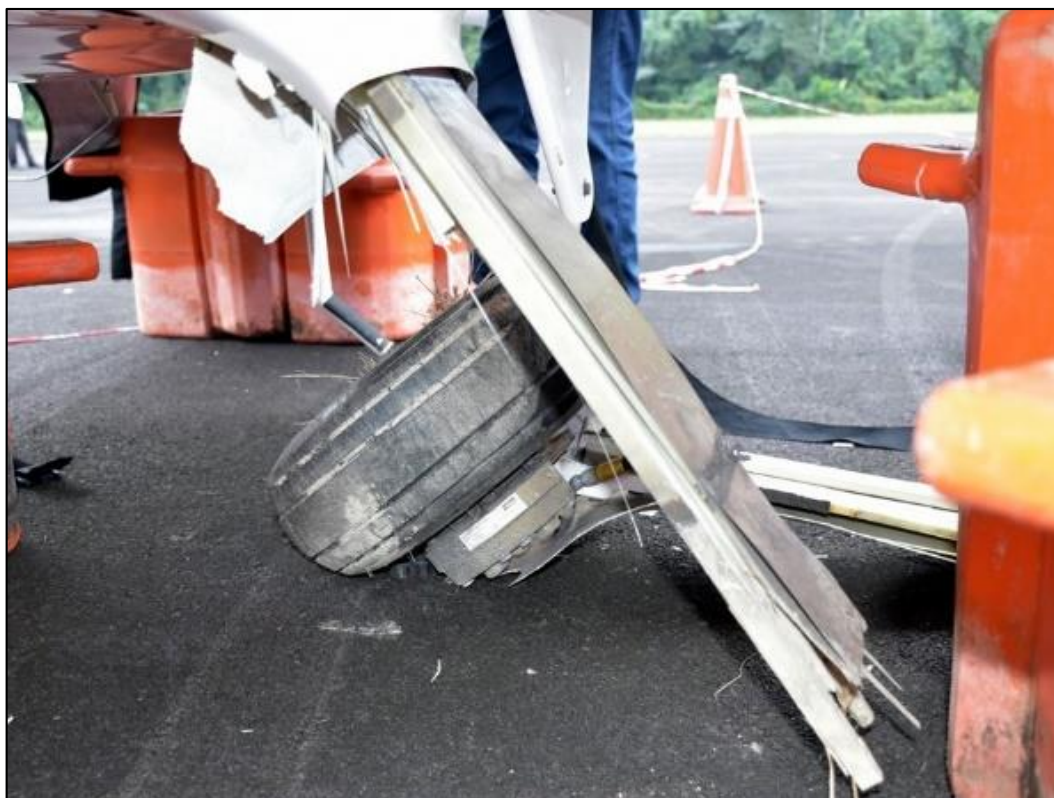
Picture 2 – Port wheel collapsed and starboard wheel damaged

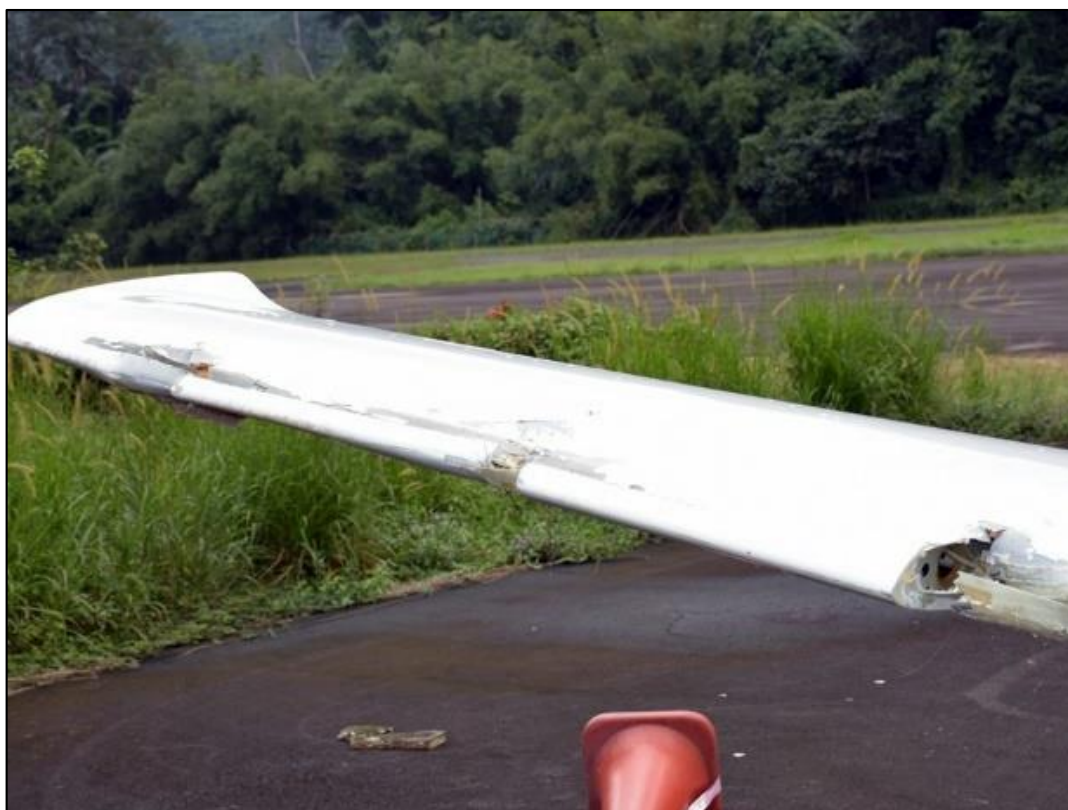
Picture 3 – Starboard side wing leading edge damaged

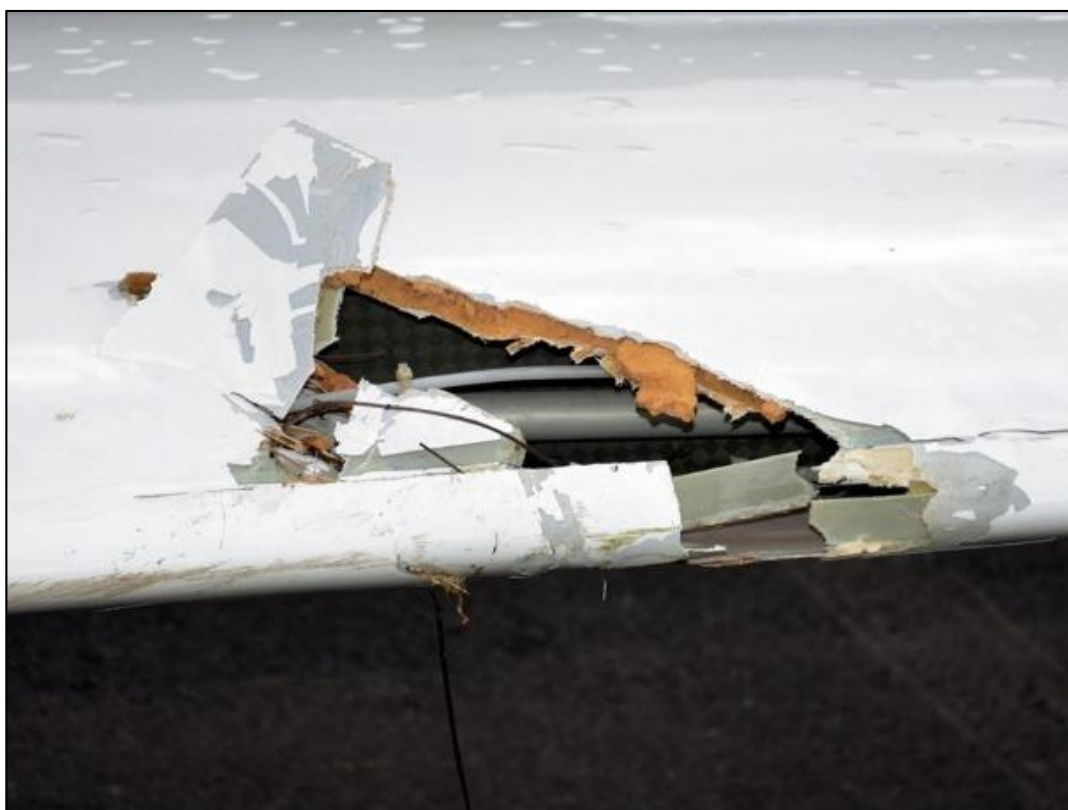
Picture 4 – Port side wing leading edge damaged

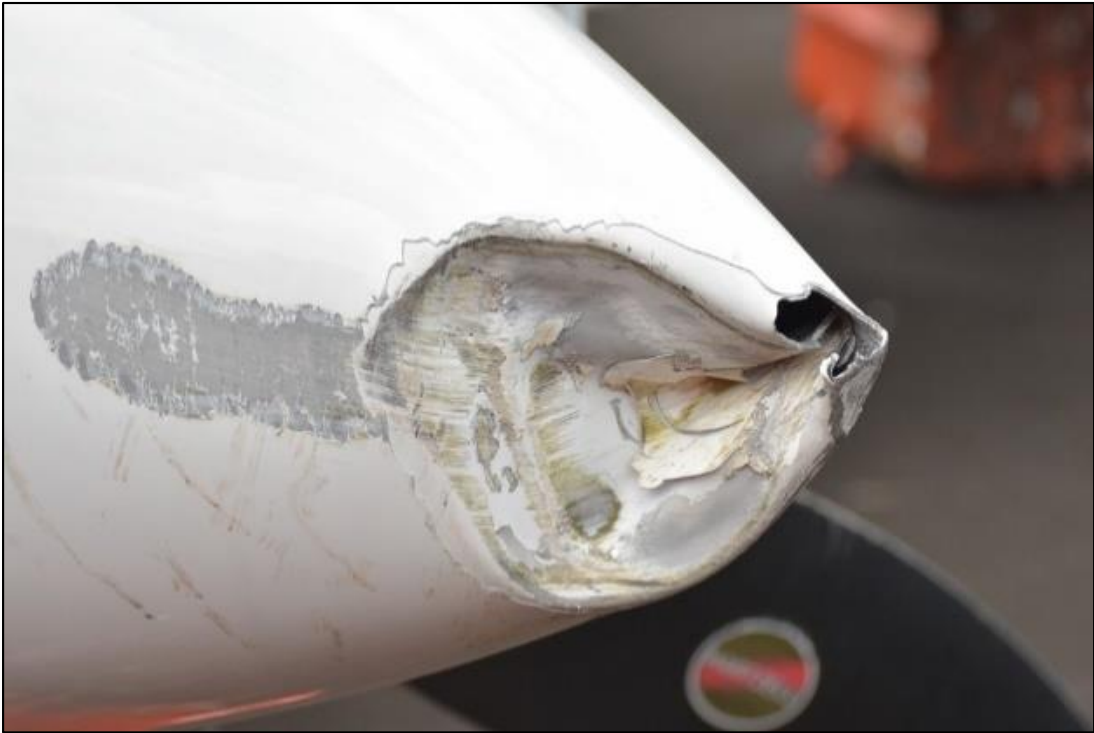
Picture 5 – Propeller spinner dented

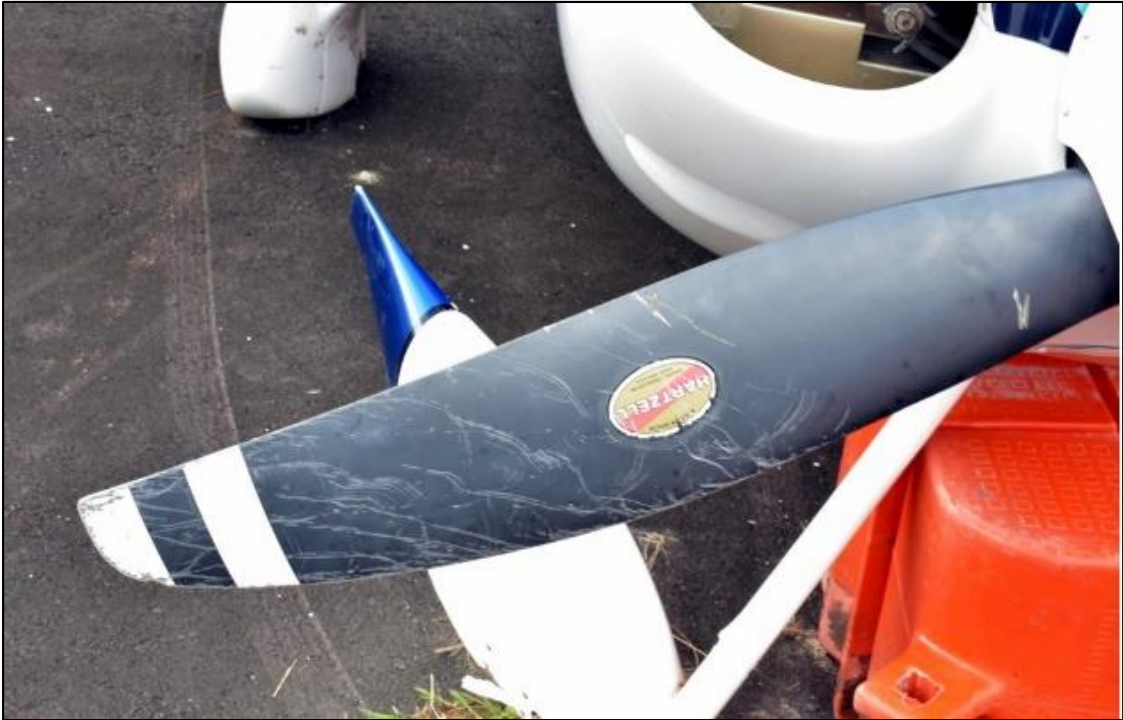
Picture 6 – Propeller Strike

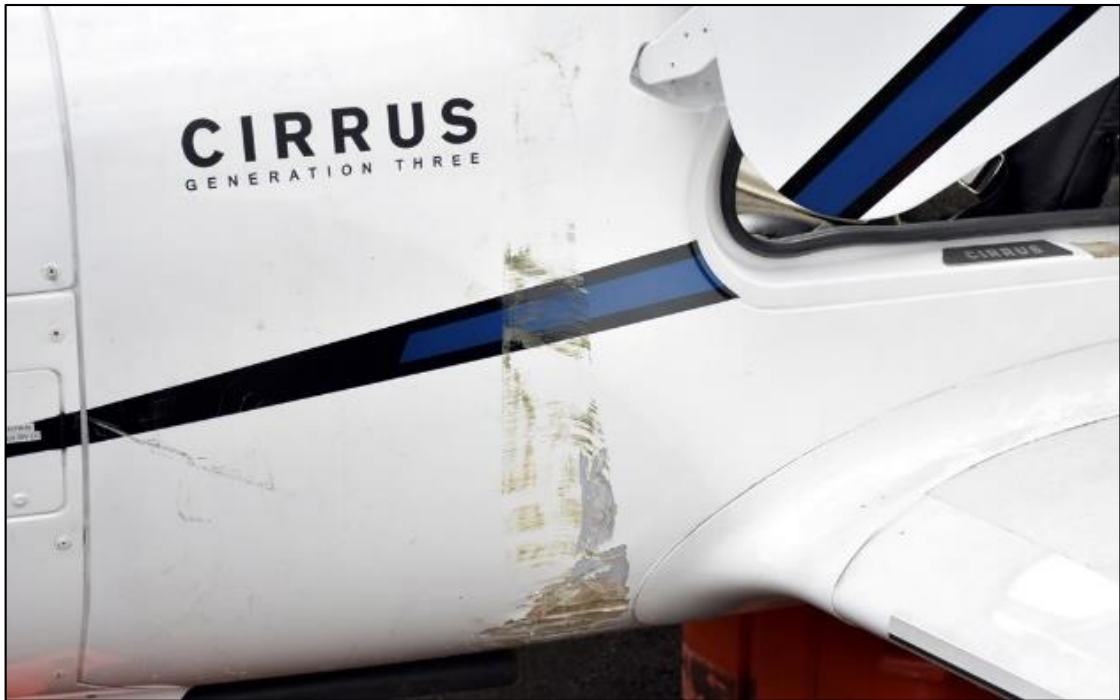
Picture 7 – Dented and minor scratches on the fuselage

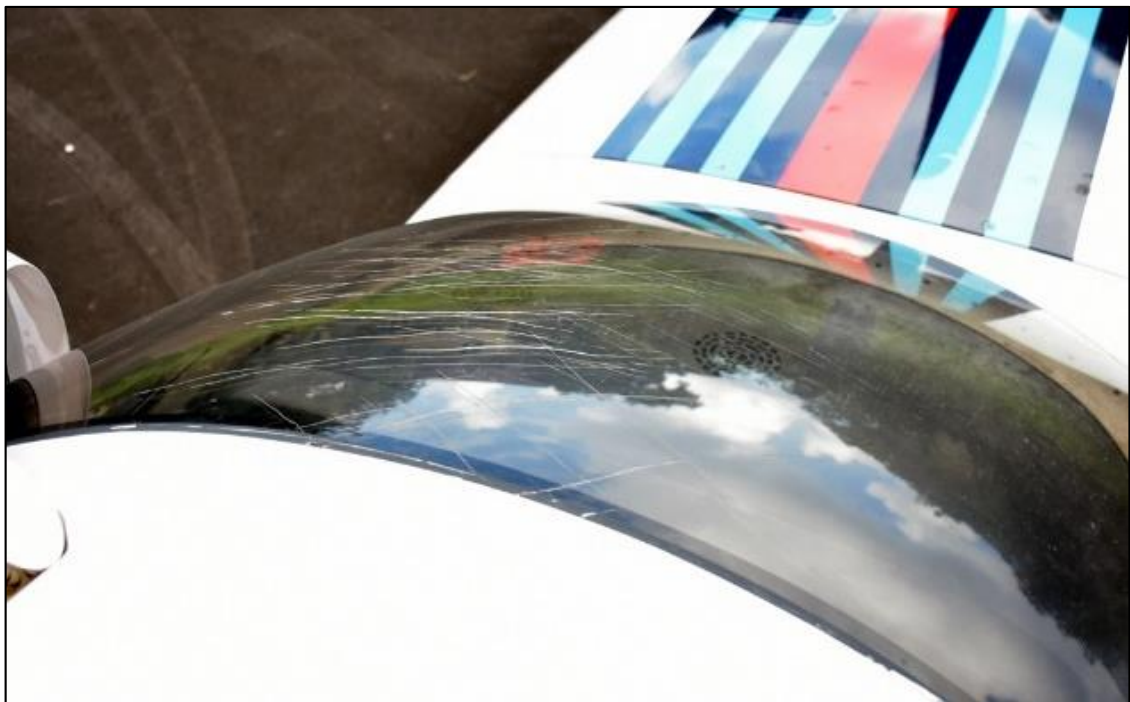
Picture 8 – Scratches on the windscreen

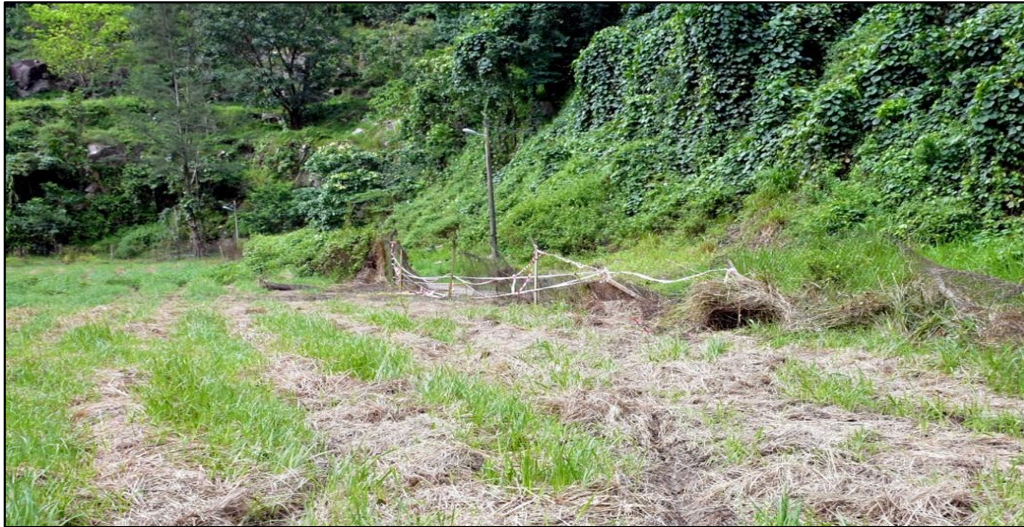
The aircraft veered off to the right of runway 20 causing it to hit the parameter fencing.

Picture 9 – Tioman Airport parameter fence

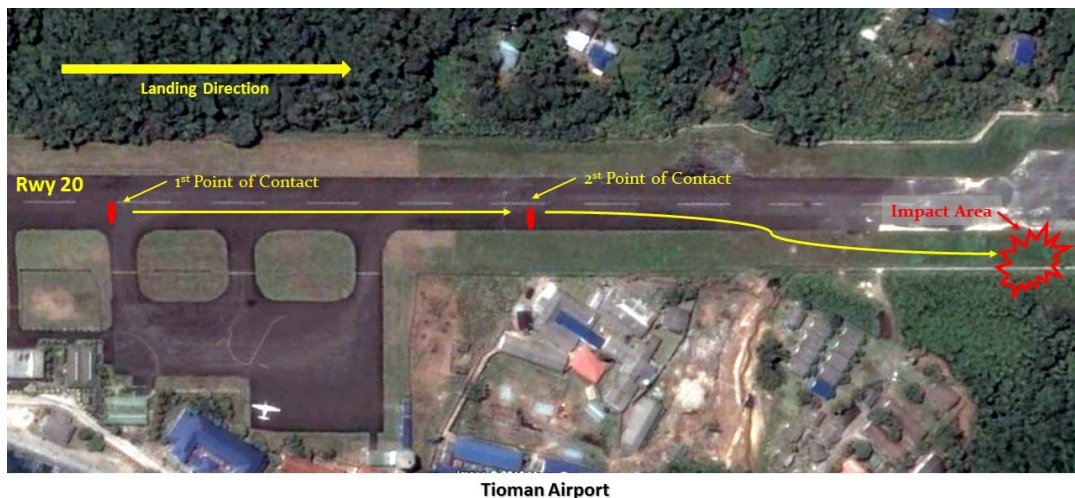
When the aircraft touched the runway for the second time as depicted in Picture 10 below, it swerved towards the grass area on the right hand side of the runway and ran through the airport parameter fence, out of the airport parameter and stopped upon hitting the drain.

Picture 10: Illustration of the aircraft path prior impact.
