**AIRCRAFT ACCIDENT FINAL REPORT**  
**A 03/21**  
**Air Accidents Investigation Bureau (AAIB)**  
**Ministry of Transport**

**Accident Involving an Airbus Helicopters H125**  
**Registration 9M-LEO**  
**at Sultan Abdul Aziz Shah Airport (WMSA), Malaysia**  
**on the 24 March 2021**

**ACCIDENT REPORT NO. : A 03/21**

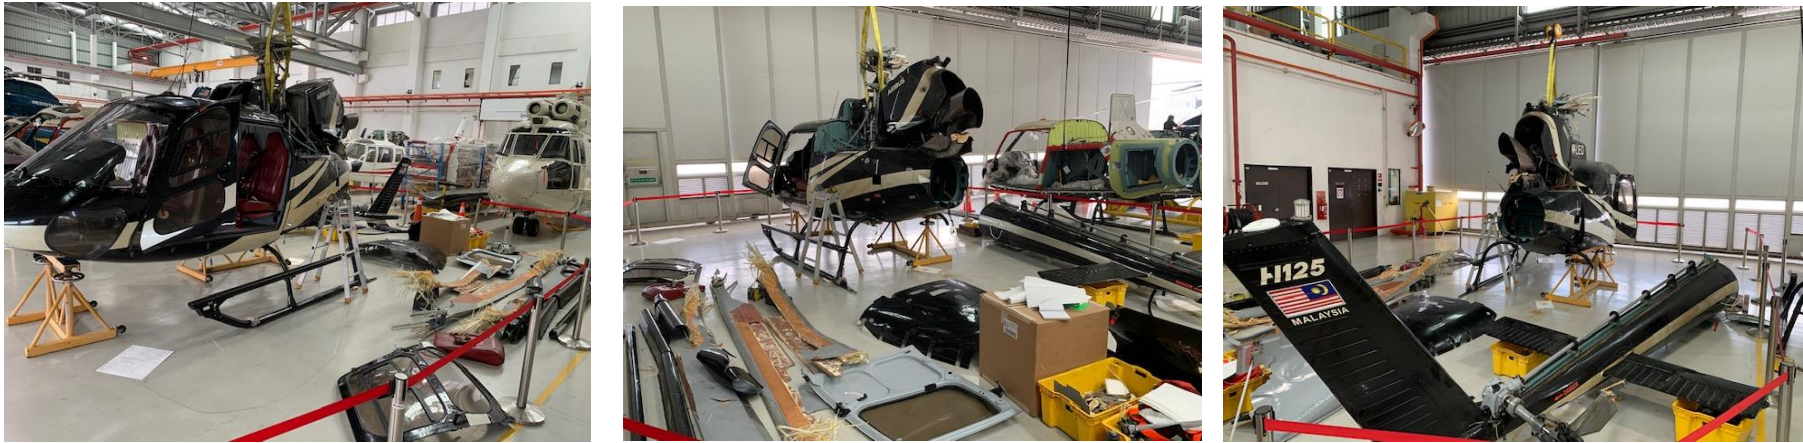
*Figure 1. Parts recovered after the accident*

Most of the parts are damaged and destroyed.

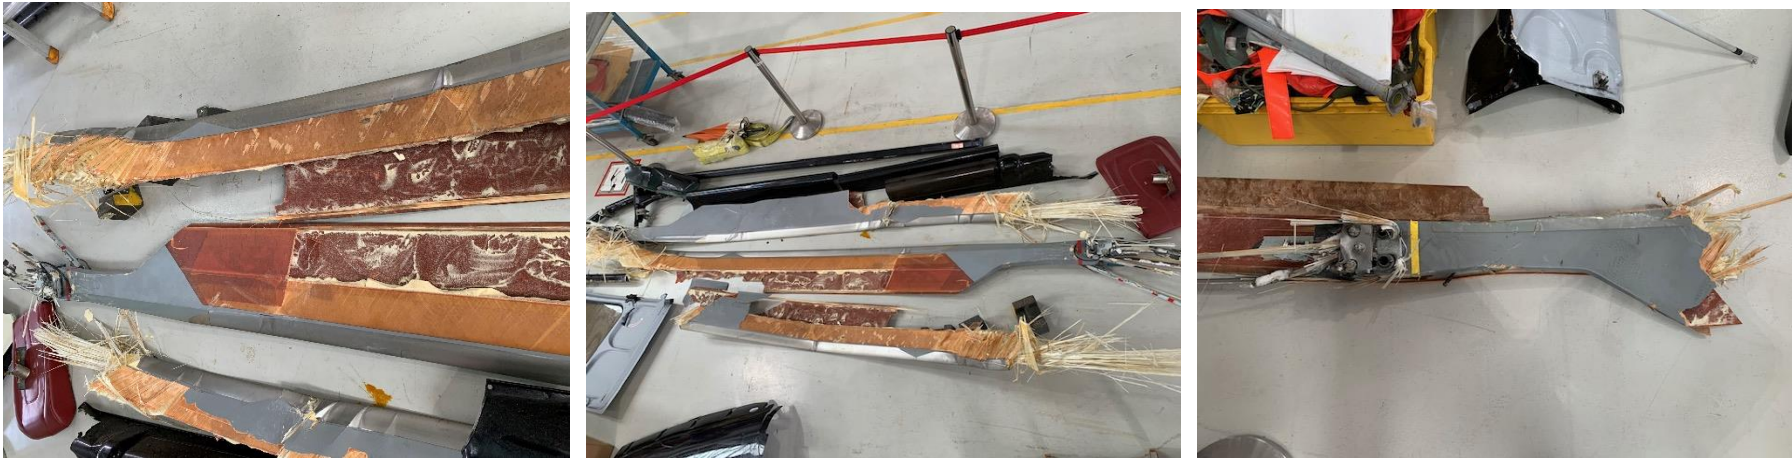
**Figure 2. Damage on all the 3 Main Rotor Blades**

The 3 Main Rotor Blades are seriously damaged (leading and trailing edges) and exhibit impact damages.

- Blade split

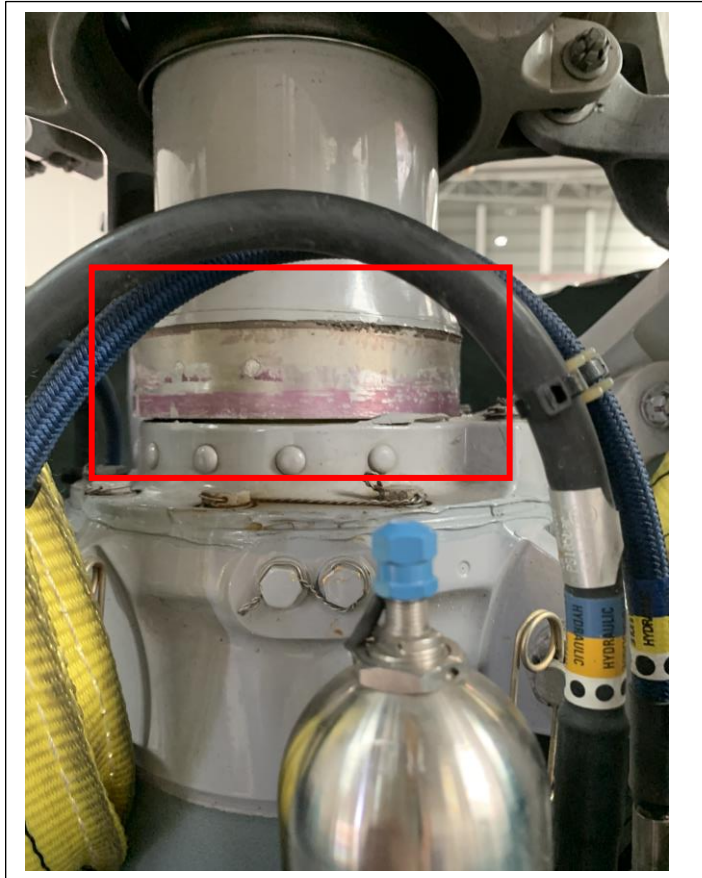
*Figure 3 - Swashplate Guide – dislocated and sheared*

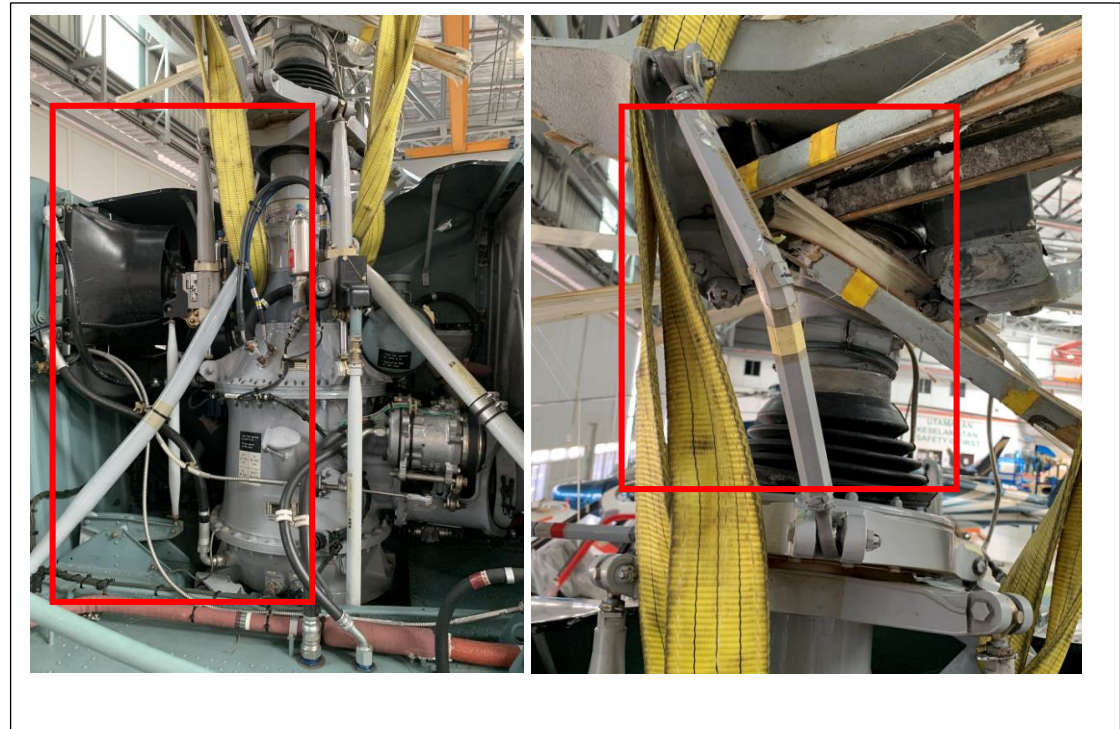
*Figure 4 – Main Rotor Assembly*

- LH forward MGB suspension bar bend
- Pitch link broken
- Starflex broken
- Sleeve Assembly missing

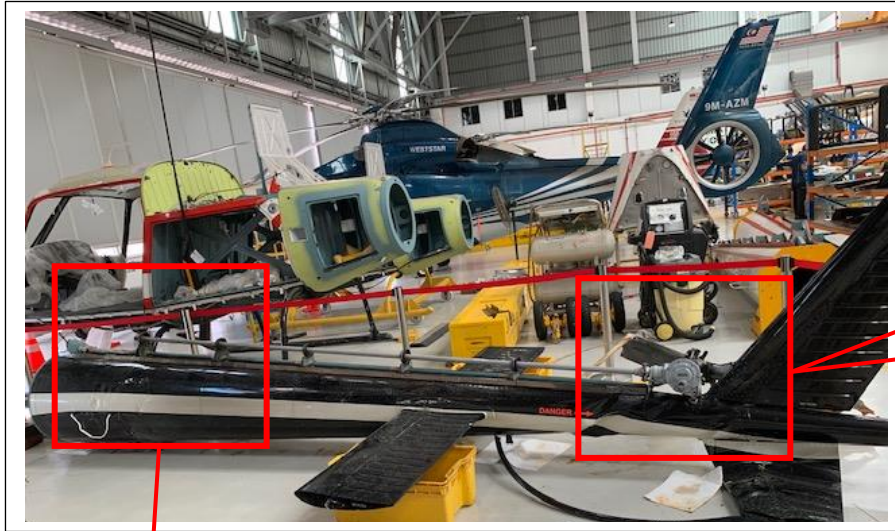
Figure 5 - Intermediate Tail Rotor Drive Shaft broken on engine side but all the attachment bolts are available

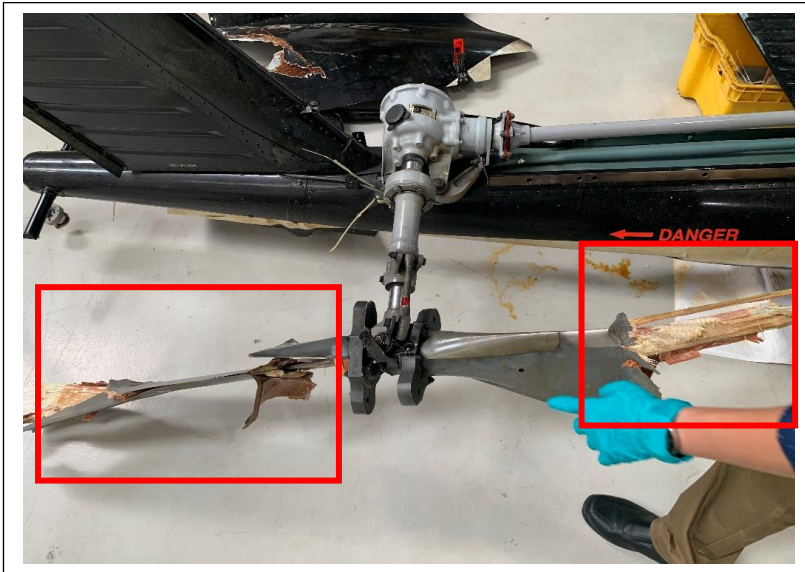
*Figure 7 - The 2 Tail Rotor Blades were broken.*

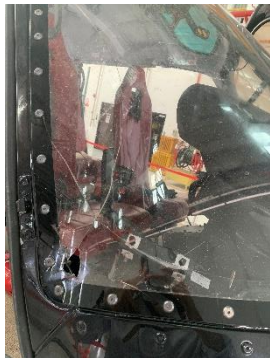
No	Damage Description	Picture
1	RH Windshield crack and punctured.

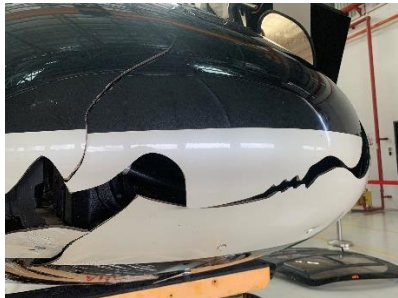
2	Nose Canopy was badly ruptured

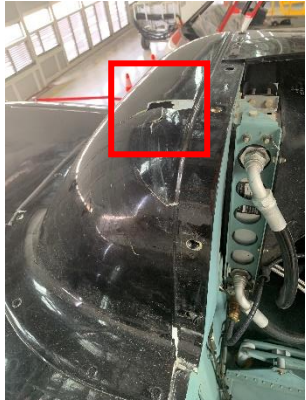
No	Damage Description	Picture
3	Air Intake cowling was punctured.

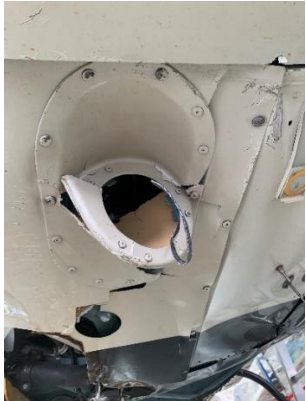
4	Landing Light missing and surrounding cowling broken

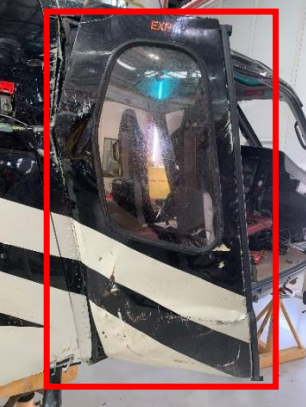
5	RH Flap Door exhibit multiple damage (scratches, bend, window pane cracked and punctured)

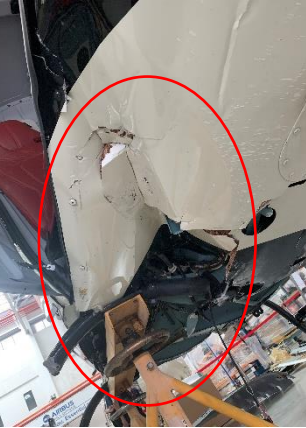
6	RH Aircraft Structure (cabin floor) bent and cowling ruptured

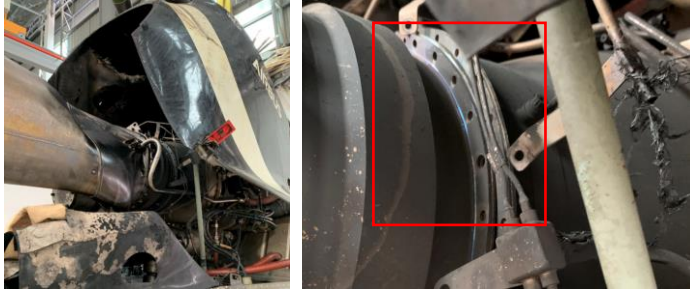
No	Damage Description	Picture
7	<ul style="list-style-type: none"> <li>Split Engine module 3 and 4 (most bolts sheared)</li> <li>Exhibit burn damage</li> <li>Engine Exhaust bent</li> </ul>

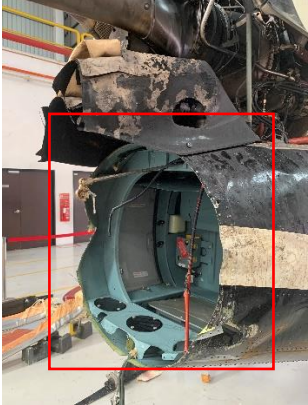
8	Tailboom Junction circumference structure badly damage and Tailboom Assembly detached.

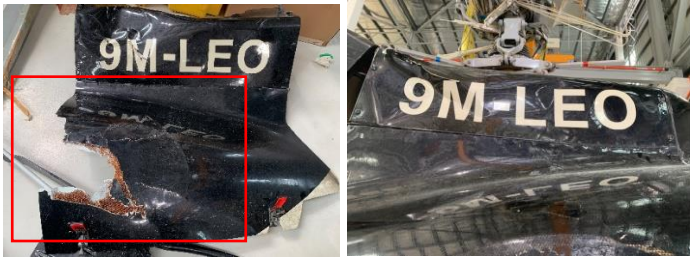
9	LH and RH Main Gear Box Cowling badly broken

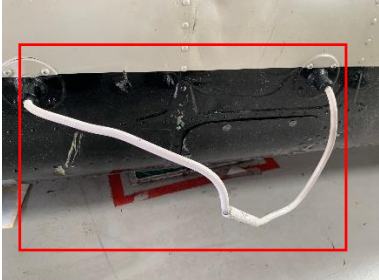
10	VOR Antenna damaged

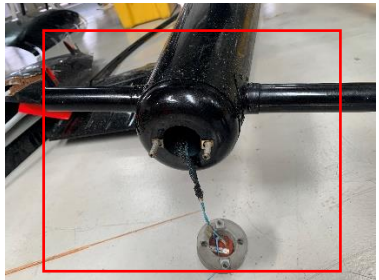
11	Tail Position Light detached

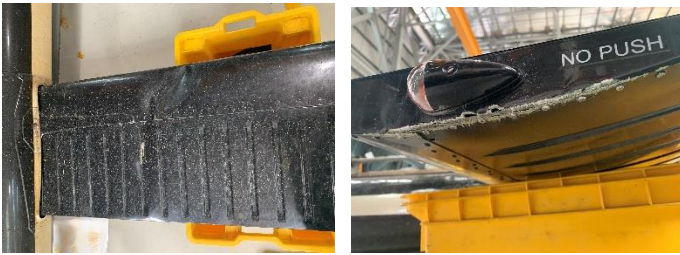
No	Damage Description	Picture	
12	Horizontal Stabilizer exhibit big dent and severe scratches.

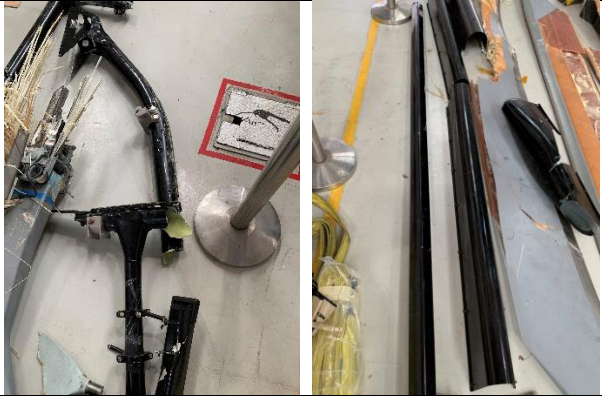
13	RH Landing gear: <ul style="list-style-type: none"> <li>• Cross Tube broken</li> <li>• Landing Skid broken</li> <li>• Side step broken</li> </ul>

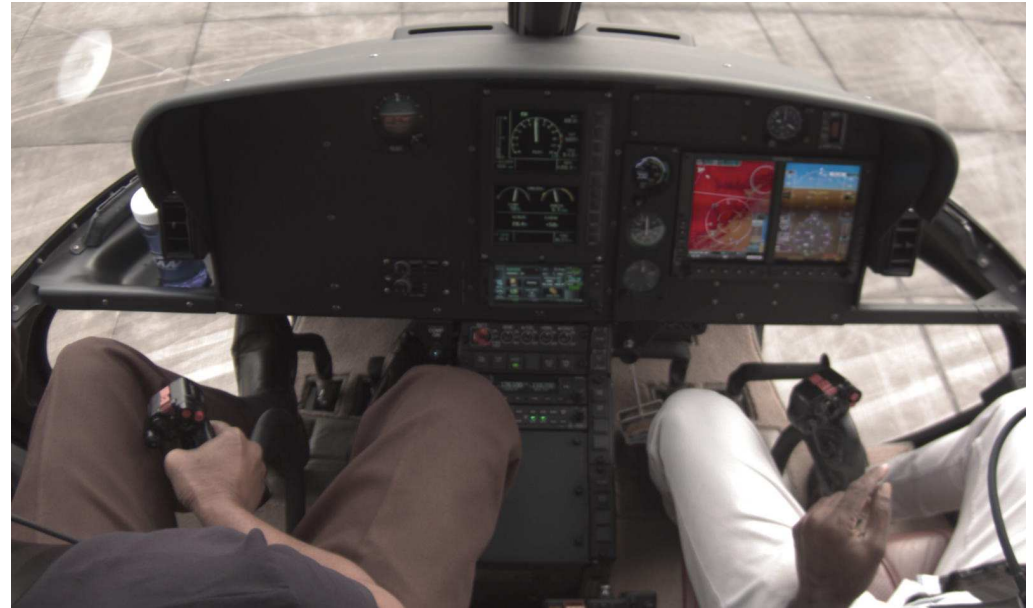
- LH turn \_ LH side pilot in control  
VIS-FHVS-01268-3635508  
→01:19:24  
→T0 + 59min48s

- LH turn +180° (U turn)
- No action on rudder pedals to stop the aircraft rotation

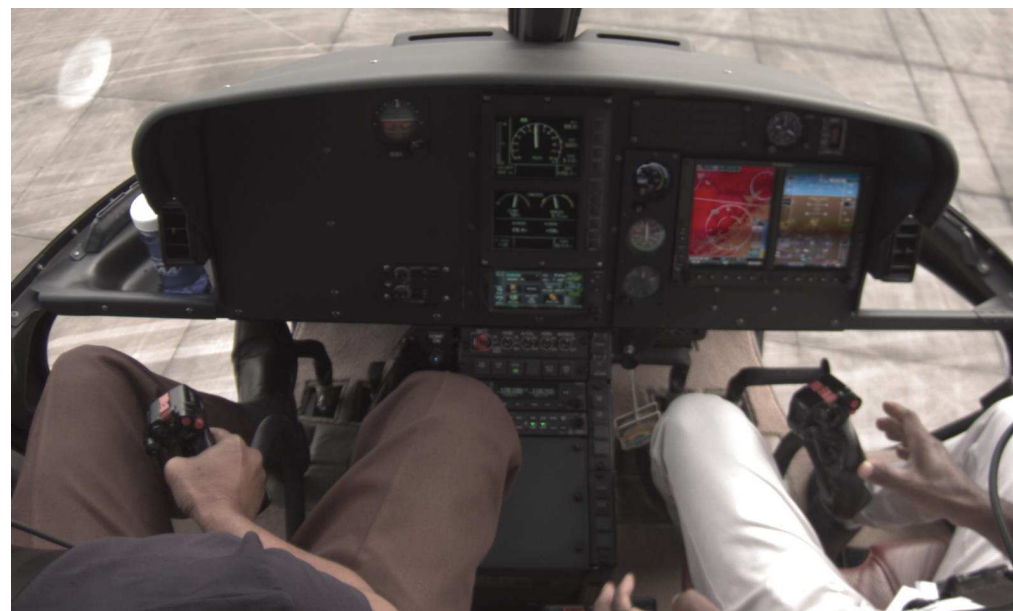
- LH turn \_ LH side pilot in control + RH pilot reaction  
VIS-FHVS-01268-3635758  
→01:19:24  
→T0 + 59min48s

- LH turn +180° (U turn)
- No action on rudder pedals to stop the aircraft rotation

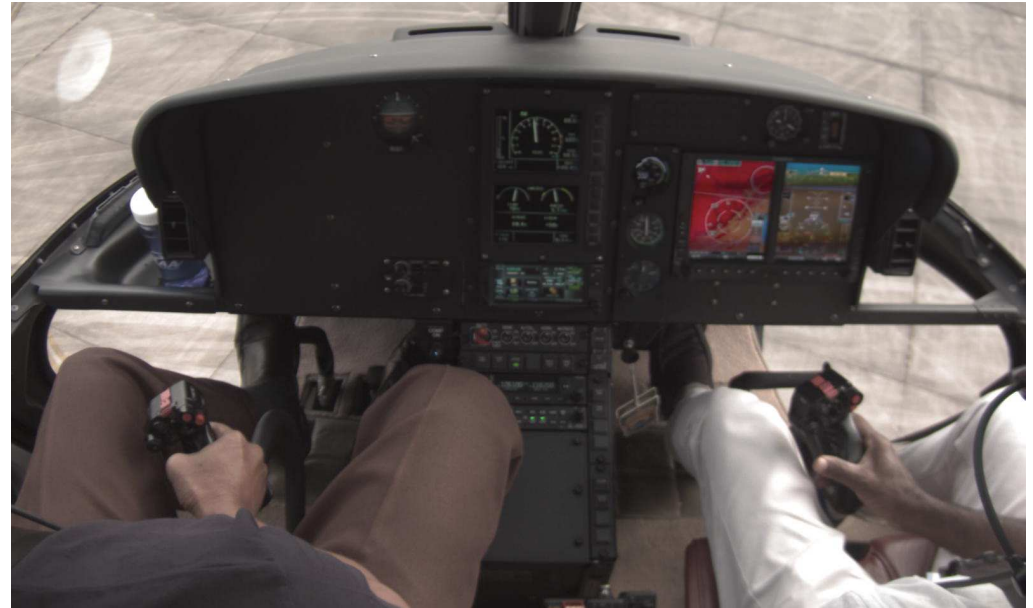
- LH turn \_ LH side pilot in control + RH pilot in control  
VIS-FHVS-01268-3636008  
→01:19:24  
→T0 + 59min48s

- LH turn +180° (U turn)
- Rudder pedal pushed in the LH side position (instead of RH to stop the aircraft left rotation)
- Aircraft rotation speed increase
- Loss of aircraft control
- No warning on CWP

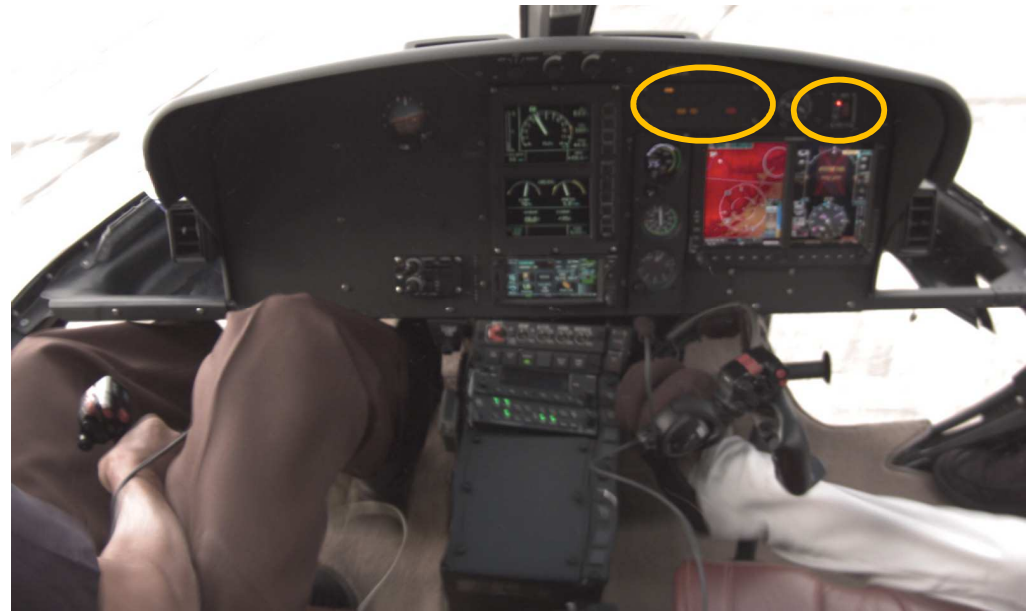
- Impact on ground \_ Crash sequence  
VIS-FHVS-01268-3640260  
→01:19:29  
→T0 + 59min53s

- RH pilot ejected
- ELT activated
- Aircraft spinning on ground
- Warnings on CWP

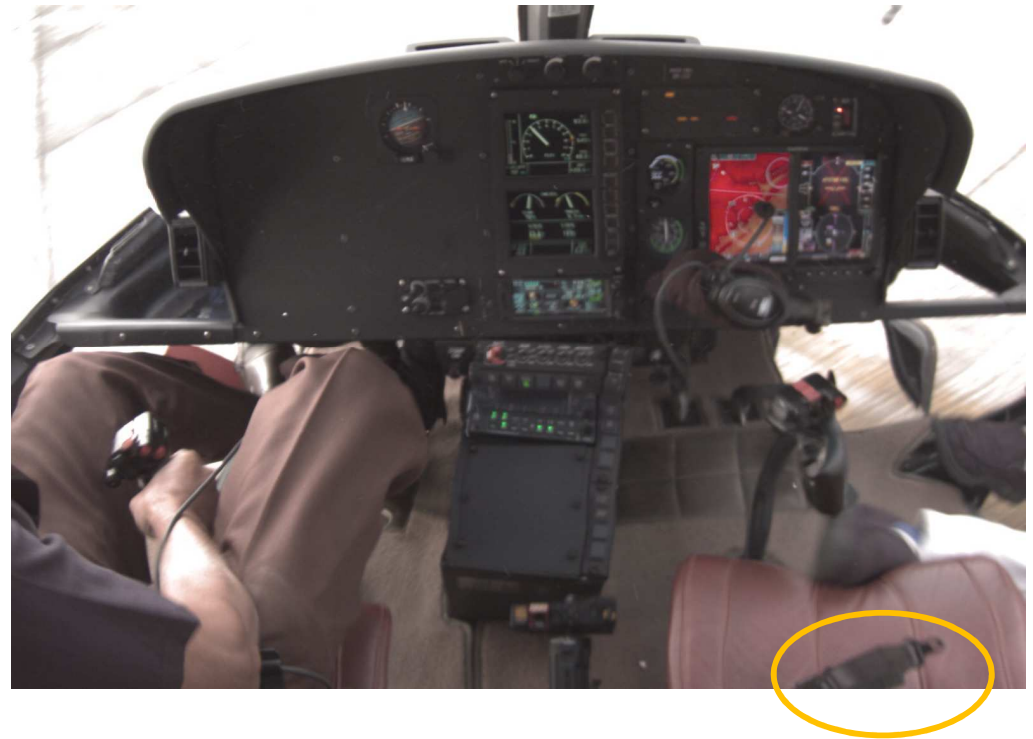
- Impact on ground \_ Crash sequence  
VIS-FHVS-01268-3640512  
→01:19:29  
T0 + 59min53s

- RH pilot ejected
- ELT activated
- Seat belt buckle visible
- Aircraft spinning on ground
- Warnings on CWP

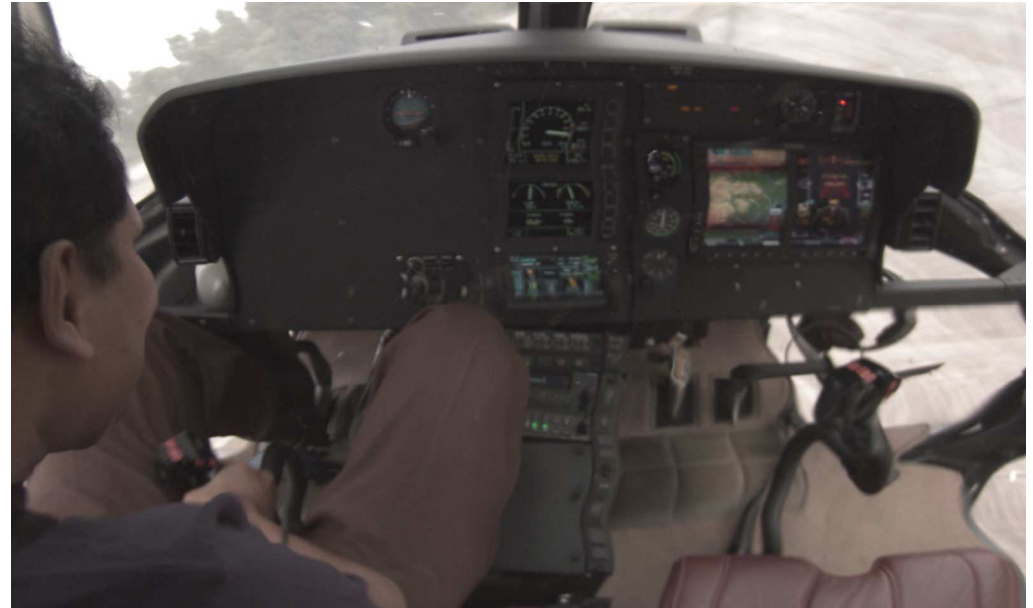
- Impact on ground \_Crash sequence  
VIS-FHVS-01268-3642510  
→01:19:31  
→T0 + 59min55s

- RH pilot ejected
- ELT activated
- Very high FLI
- Aircraft rollover on its RH side
- Aircraft spinning on ground
- Warnings on CWP

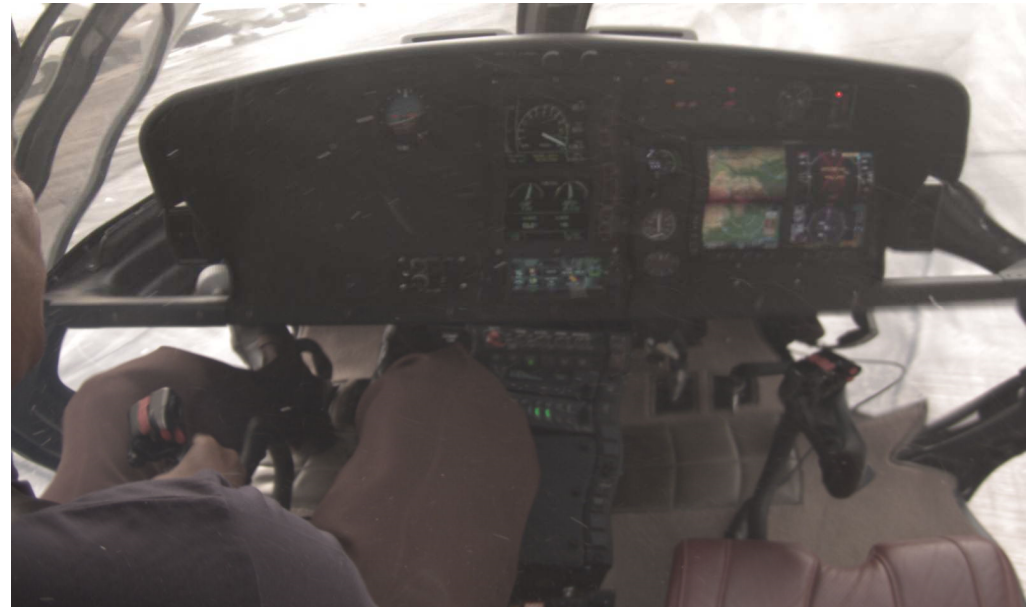
- Impact on ground \_Crash sequence  
VIS-FHVS-01268-3643759  
→01:19:32  
→T0 + 59min56s

- RH pilot ejected
- ELT activated
- FLI to the max
- Aircraft rollover on its RH side
- Aircraft spinning on ground
- Warnings on CWP

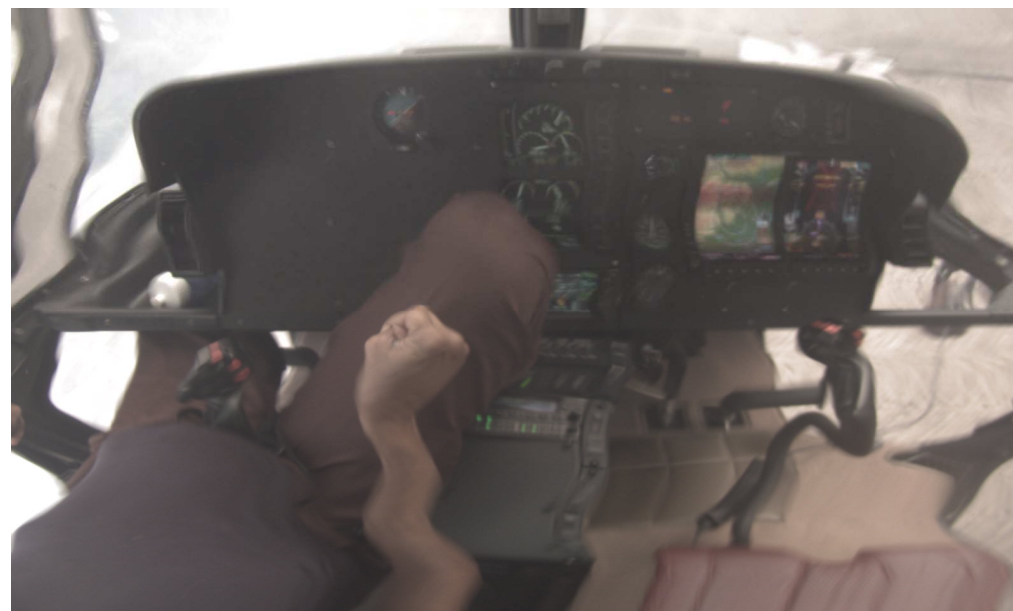
- Impact on ground \_Crash sequence  
VIS-FHVS-01268-3656511  
→01:19:45  
→T0 + 1h00min09s

- RH pilot ejected
- ELT activated
- FLI to the max → Switch to 3 info indication
- Aircraft rollover on its RH side
- Aircraft spinning on ground
- Warnings on CWP
