AIRCRAFT SERIOUS INCIDENT FINAL REPORT

SI 02/22P

Air Accident Investigation Bureau (AAIB)

Boeing B737-800, Registration 9M-MLS
En-route KUL to TWU (Kuala Lumpur to Tawau)
on 03 April 2022

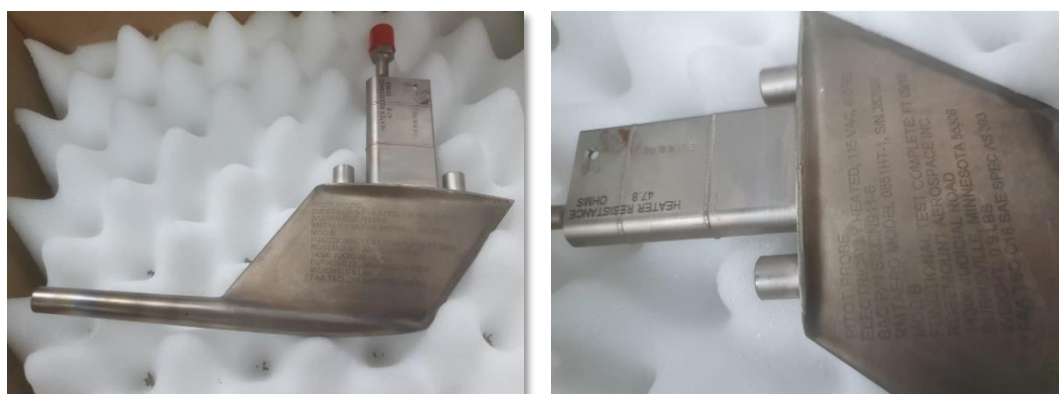
Figure 13: Captain's Probe

- a. **Captain and FO Probes.** The Captain and FO probes were removed and sent for a check at Collins Product Improvement Laboratory (PIL) to ascertain the condition of the subject parts by conducting physical, electrical, and x-ray examinations. From the test report, both probes were externally in good condition.

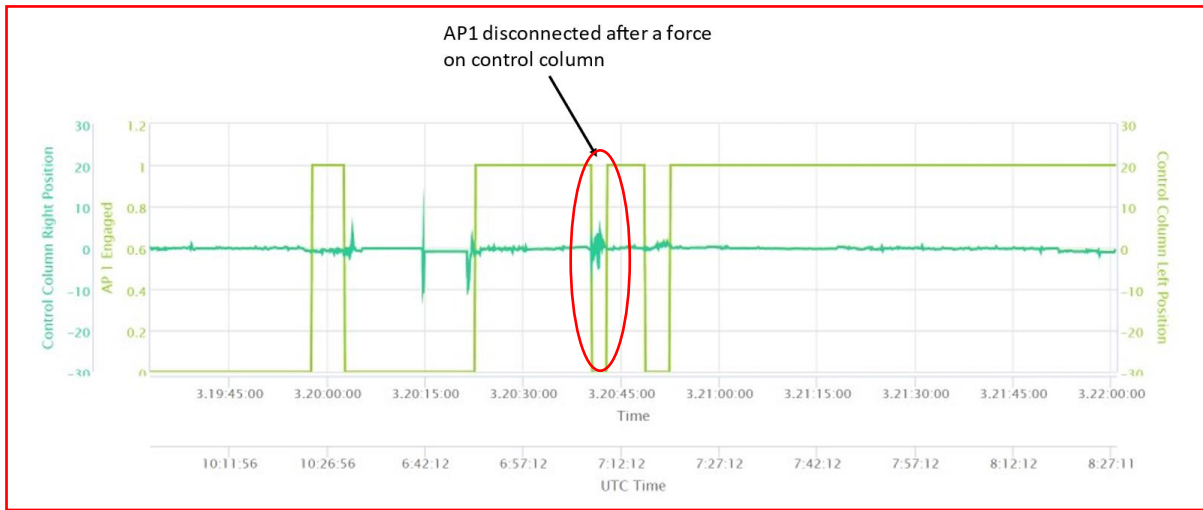
Figure 17: Autopilot disconnected - FDR data

From the FDR data, AAIB found that autopilot A was engaged at the time of the incident, and the physical input on the flight control column disconnected the autopilot, as shown in Figure 17.

However, from the interview with the flight crews, there was no input from them. AAIB Investigator have tested at the Simulator where a force has to be applied to the Control Column to turn off the autopilot. Refer to Figure 18, Master Caution light was active during the incident.

In summary, A force is needed to deactivate the Autopilot. The physical input to the flight control column disconnected the Autopilot, and it has been tested at B737-800W Flight Simulation Training Device where the autopilot system has been disconnected

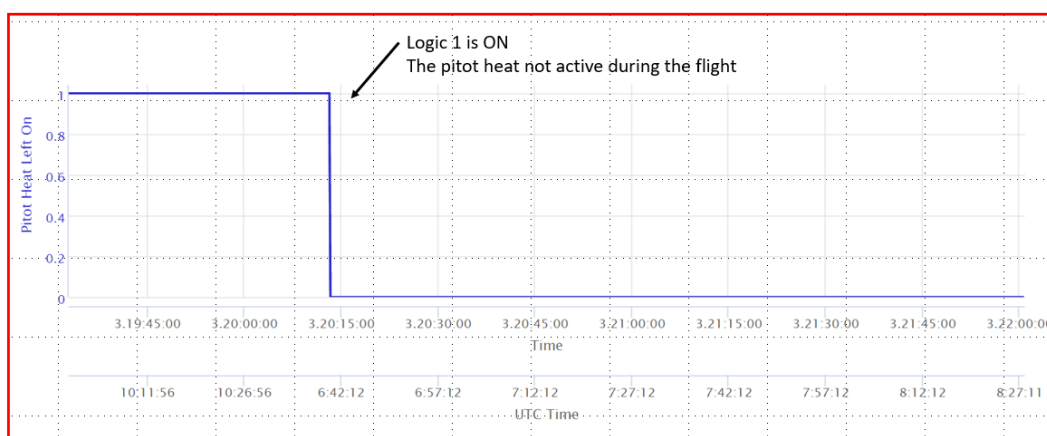
Figure 23: Capt. Pitot probe heating status

2.5 Capt. Pitot probe heating status was in OFF condition at the start of the engines and throughout the flight.

FDR data in Figure 23 shown that the Capt. Pitot probe heating status was in OFF condition at the start of the engines and throughout the flight. The heating status in OFF condition is equivalent to no heating being applied. When the aircraft flew through clouds at 25000 ft, it was possible that the ice would have gradually built up on the Capt. Pitot probe. The blockage had resulted from losing heating on the Capt. Pitot probe where the aircraft flies through an icing condition. The ice build-up on the probe would have caused the discrepancy in the Capt. IAS indication

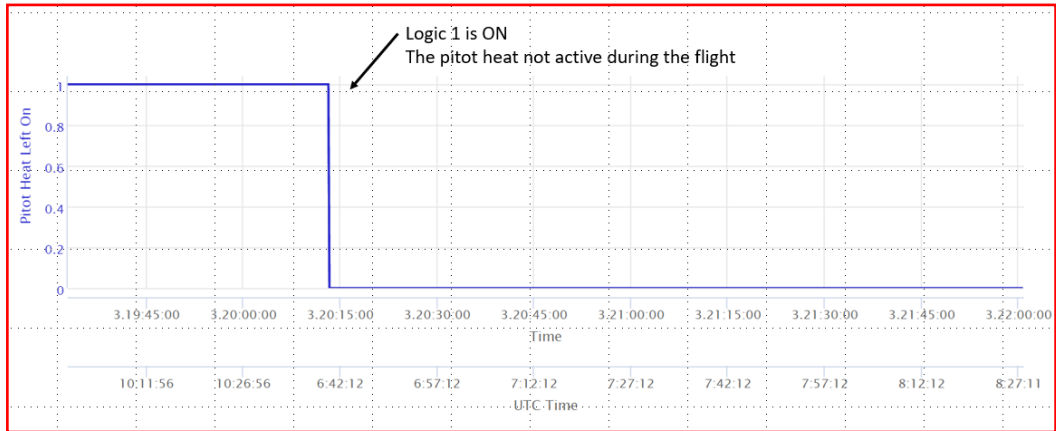
Figure 24: Pitot Heat Left was off throughout the flight FDR data

3.2.3 As mentioned by the FO, weather conditions require them to avoid the clouds during their flight enroute to Tawau. FDR data shows that Pitot Heat Left was off throughout the flight, as shown in (Figure 24), and the aircraft flew through clouds at 25000 ft. Due to that, it was possible that the ice would have gradually built up on the Capt. Pitot probe. The blockage had resulted from losing heating on the Capt. Pitot probe that flies through an icing condition. The ice build-up on the probe would have caused the discrepancy in the Capt. IAS indication.

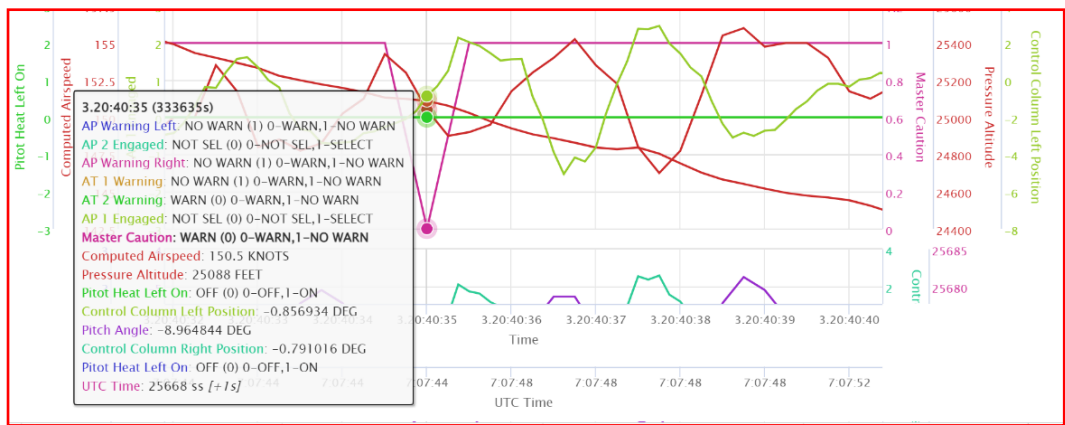
Figure 25: Master Caution warning – FDR data

The drop in the Capt. IAS indication, compared to F/O IAS, would have triggered the Master Caution warning as shown in Figure 25.

4.1.5 To be alert with Master Caution awareness

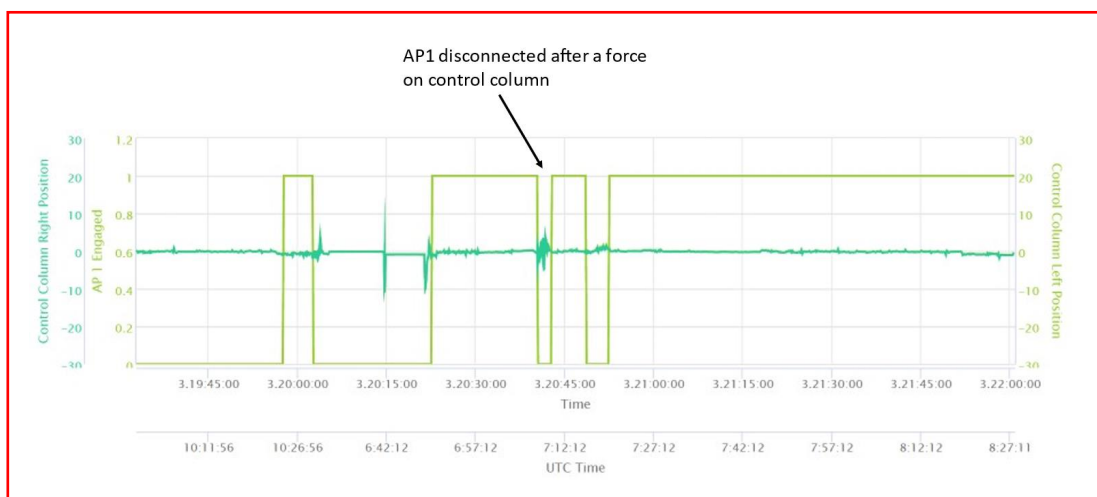
Figure 26: AP1 disconnected – FDR data

3.2.4 From the FDR data as shown in Figure 26, the flight crew's abrupt flight control movement was suspected to be present during the IAS disagreement event.
