AIRCRAFT ACCIDENT FINAL REPORT
A 08/22P
Air Accidents Investigation Bureau (AAIB)
Ministry of Transport Malaysia

Airbus Helicopter AS355 F2 Registration 9M-SSW
in Brinchang, Perak, Malaysia
on the 26 October 2022

ACCIDENT REPORT NO.: A 08/22

OPERATOR : LAYANG LAYANG AEROSPACE SDN BHD
AIRCRAFT TYPE : AIRBUS HELICOPTERS AS355 F2
NATIONALITY OF AIRCRAFT : MALAYSIA
REGISTRATION : 9M-SSW
PLACE OF OCCURRENCE : BRINCHANG, PERAK, MALAYSIA
DATE AND TIME : 26 OCTOBER 2022 AT 1303 LT

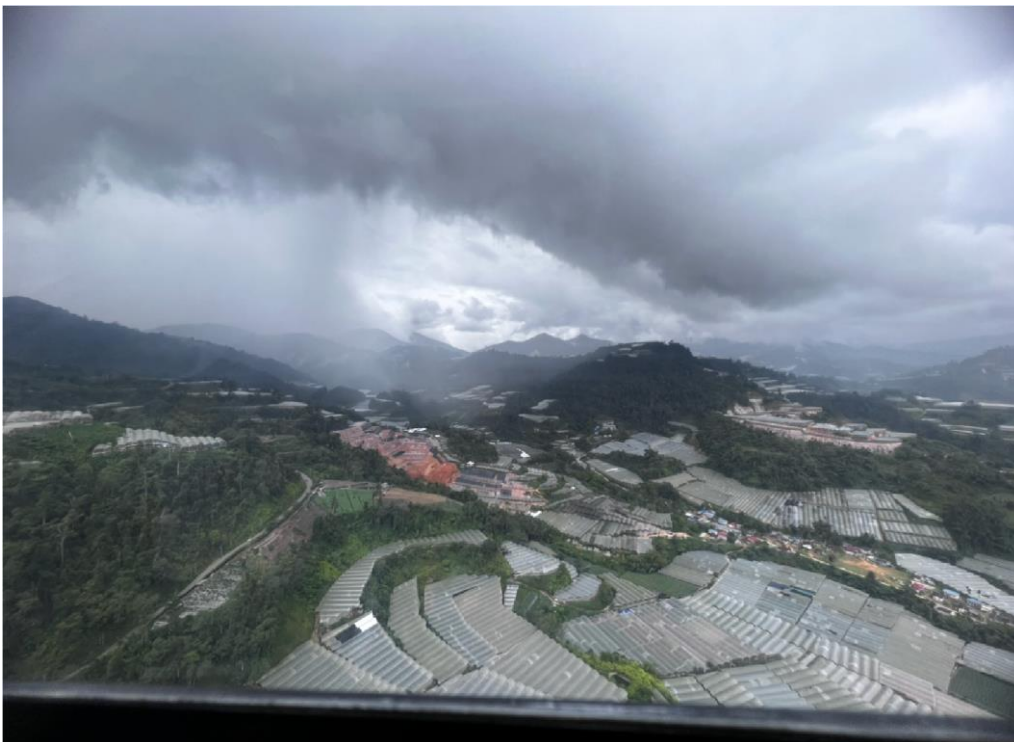
Figure 2: Photograph Taken by Passenger Just Prior the Crash

The actual weather at the time of the accident can be assessed in the photographs taken by one of the passengers just minutes prior to the accident (Figures 2 and 3). In the first photograph, a clear patch which the pilot was going for can be clearly seen. However, in this kind of situation, the weather changes very quickly and what may look like a clear area can quickly be covered up.

As can be seen from the photographs, the sky was overcast with no direct sunlight visible. The helicopter was flying in a valley with most of the mountain ridges covered by CB cloud with heavy rain in certain areas.

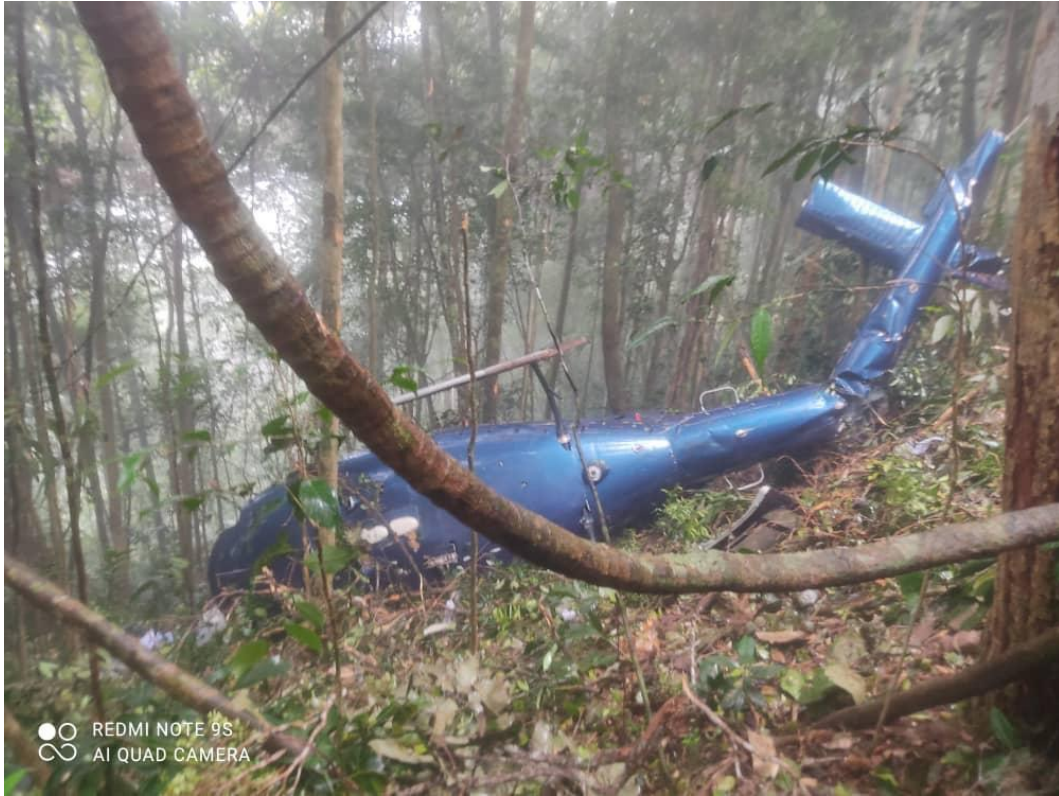
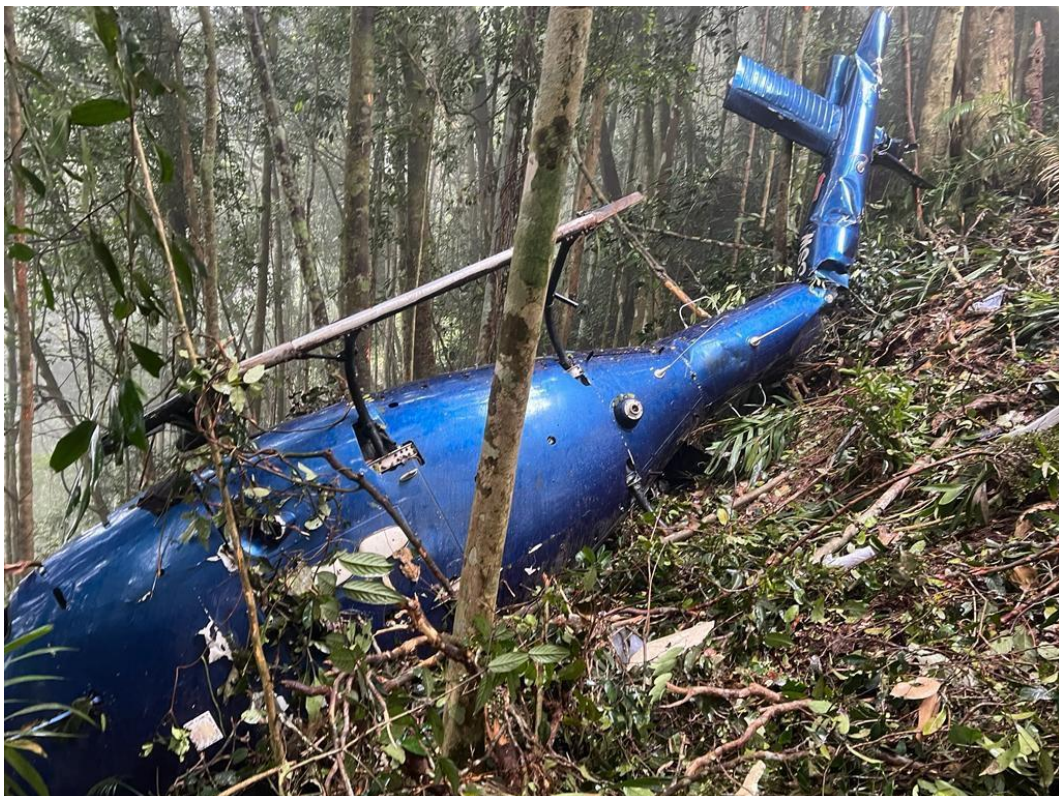
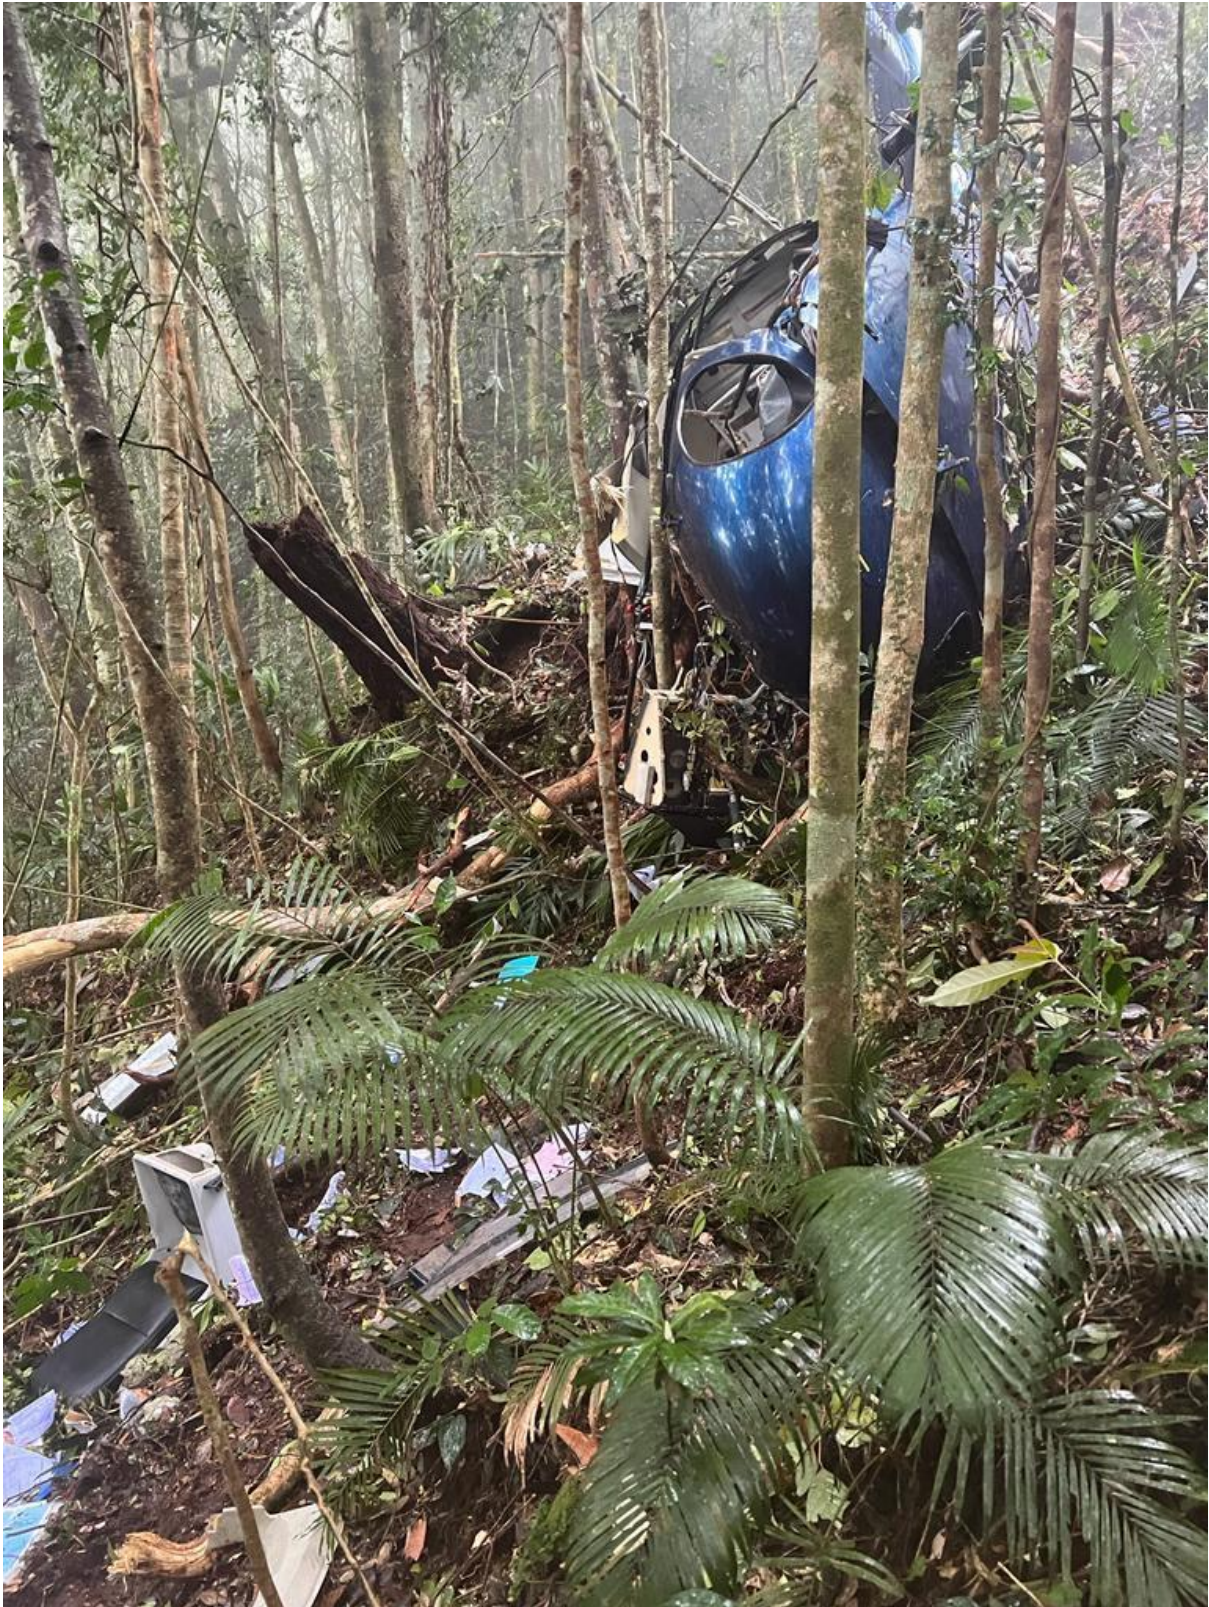
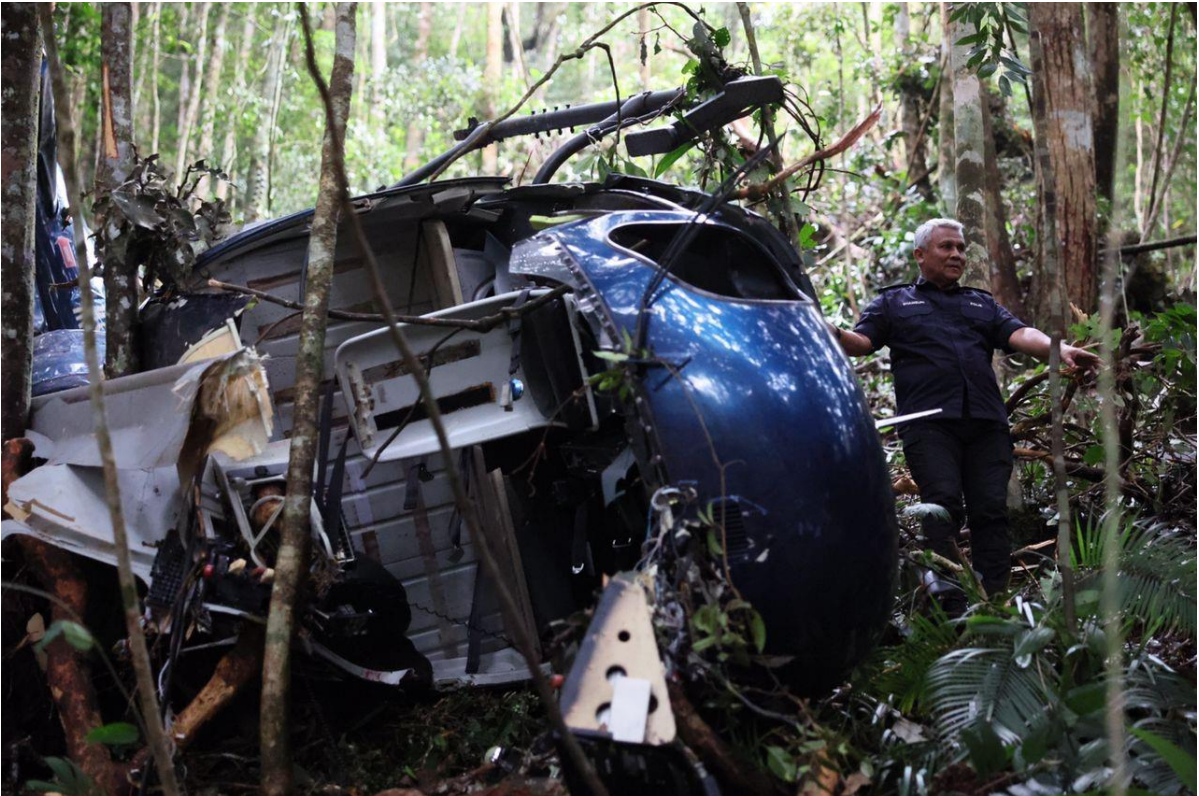
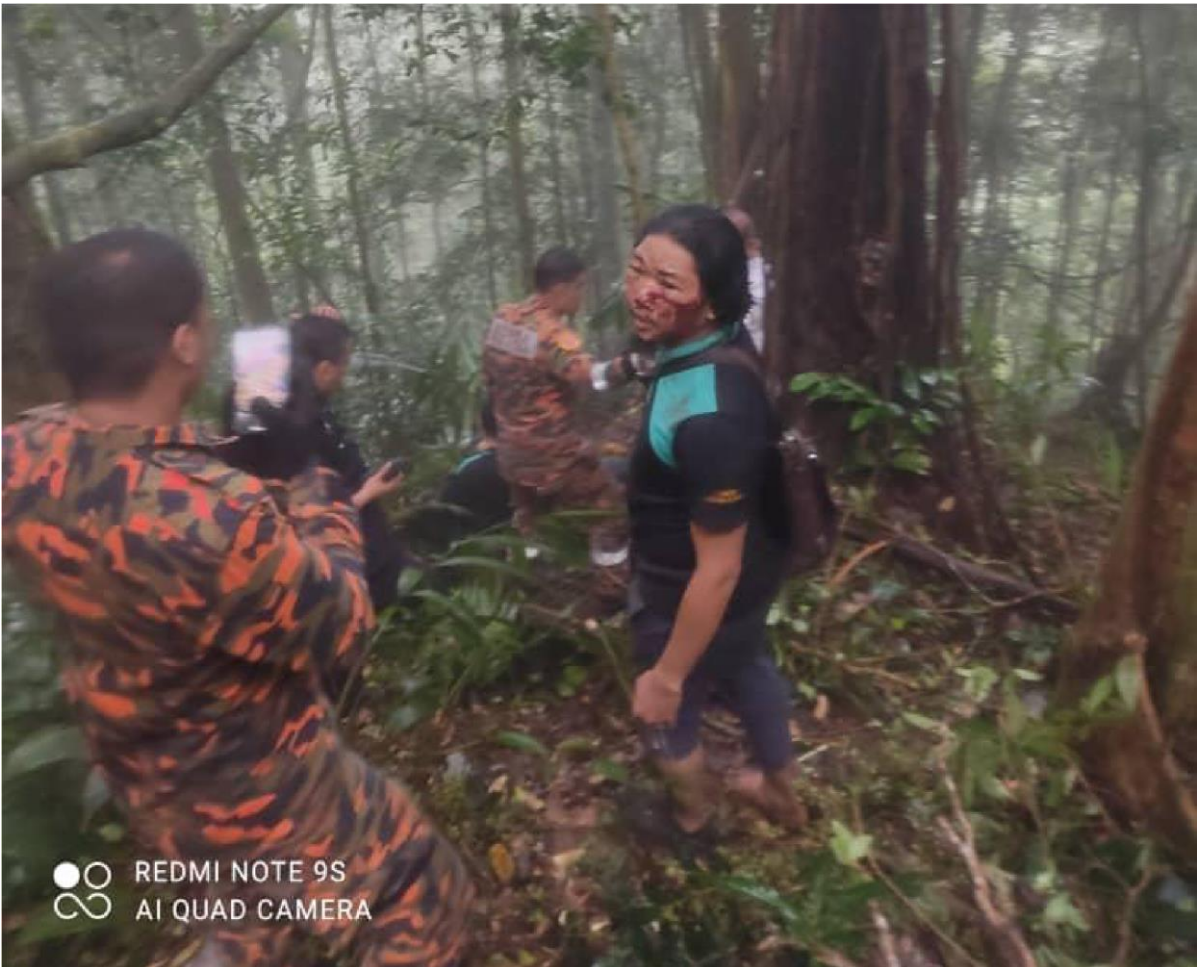
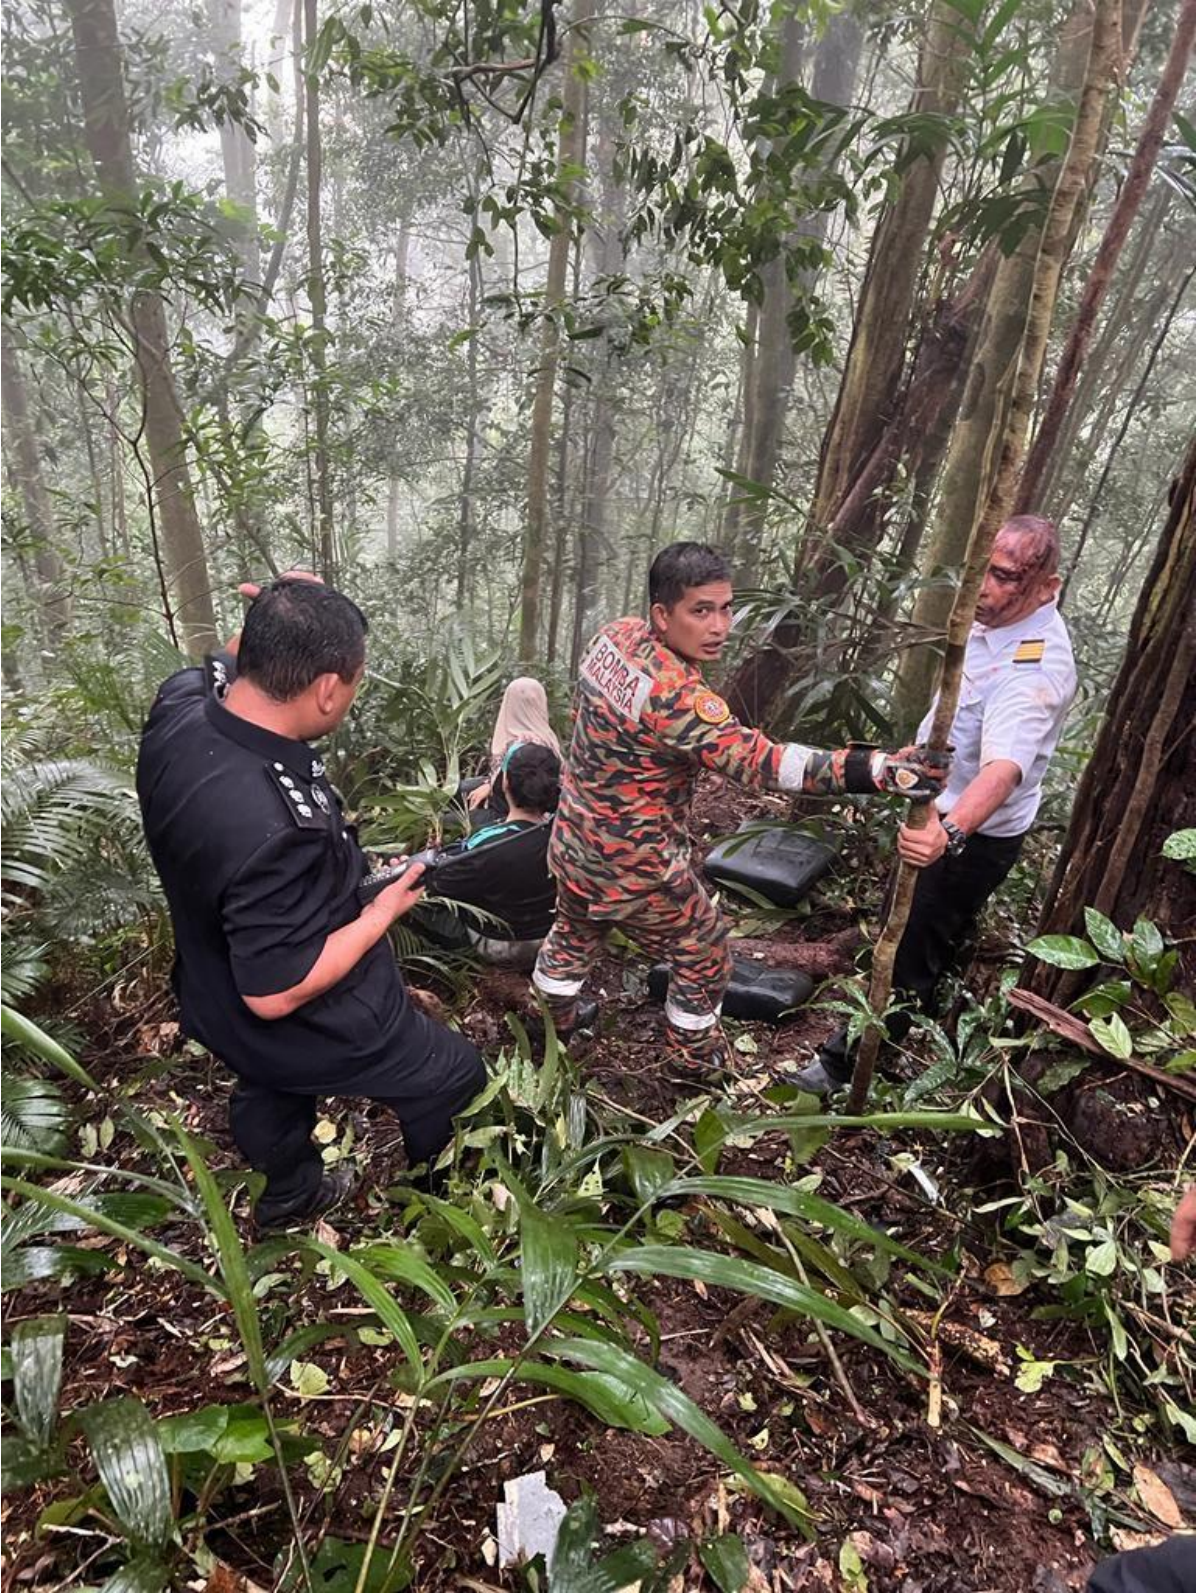
DAMAGE ASSESSMENT AND INJURIES (IMAGES ON-SITE)

Refer to **Appendix A** for images of damage to the aircraft on-site. There was no detailed Damage Assessment Report from the relevant MRO due to difficulty in accessing the crash site. The site is on a mountainous steep slope covered in primary jungle and the only access from the nearest road is an hour's hike through mountainous terrain.

A visual assessment at the crash site revealed that 9M-SSW descended nearly vertically through the jungle canopy. This was ascertained by its descent through and damage to nearby trees.

After the aircraft impacted the steep jungle slope it rolled over a few times before coming to a rest against some trees which prevented it from going further downhill **(Appendix A)**.
