FINAL REPORT

A 03/22

Accident Involving Fixed Wing Aircraft

Piper Warrior II PA28-161, Registration 9M-BAA

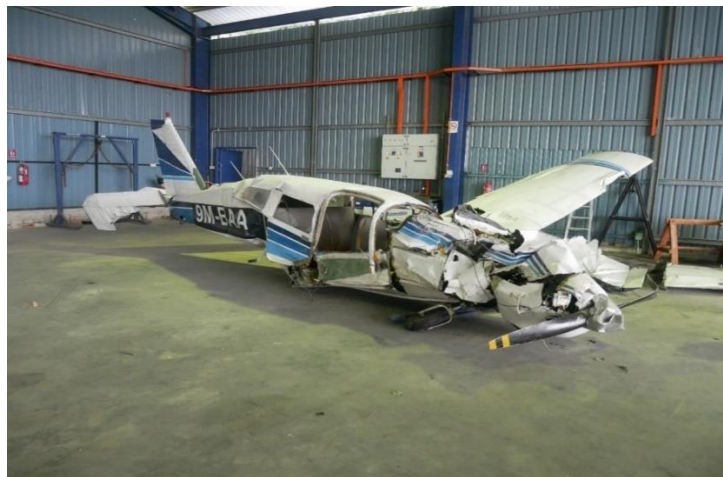
Figure 2: Aircraft condition at the hanger after salvage activities from the crash site

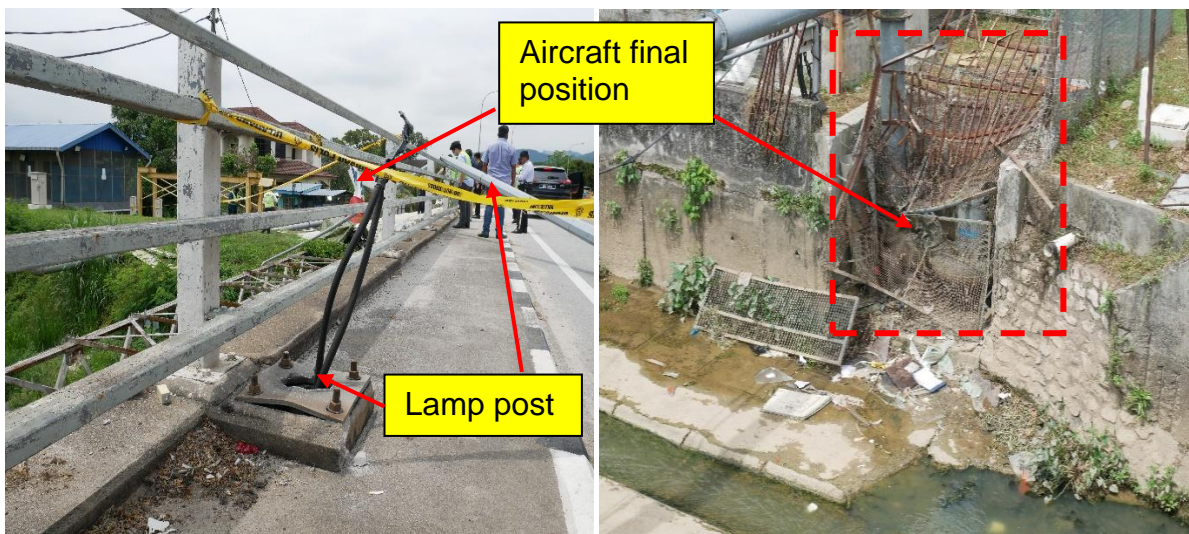
One lamp post on the main road bridge over Sungai Pinji broken off at the base and collapsed due to the impact from the aircraft propeller blade and right wing. The impact also caused some damages to the protective metal rail that surrounds the water pump house main pipe located at the water diversion culvert. No other damages were observed.

Left - collapsed lamp post at the road bridge over Sungai Pinji.

Right - damaged to the protective metal rail at the water diversion culvert.

Figure 3: Other damages due to aircraft impact

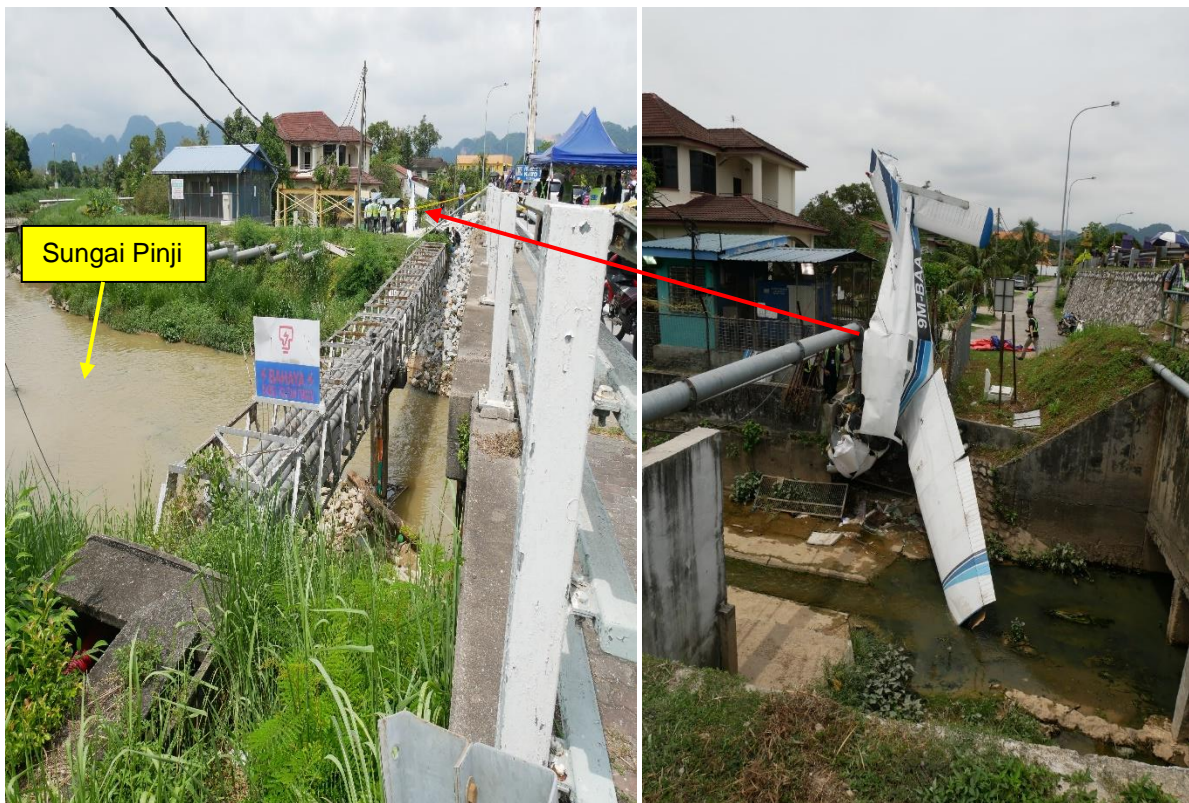
Figure 17: Final position of aircraft at the water diversion culvert beside Sungai Pinji.

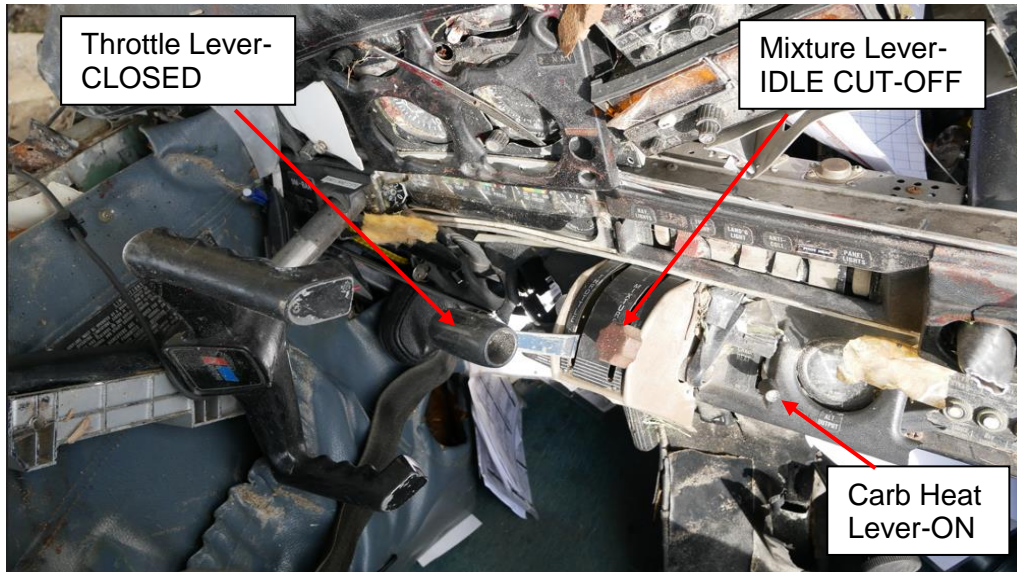
Evidence at the aircraft wreckage shows that the Magneto Switch was at 'L' (Left) position and the Carburettor Heat Lever at 'ON' position. The Fuel Selector was selected to Left Tank. The Throttle Lever was at 'CLOSED' and Mixture Lever was at 'IDLE CUT-OFF' position. One propeller had bend inwards after impacting the lamp post while the other blade was in normal condition with some scratch marks. Flaps were observed to be at UP position (Figure 18 to 23).

Figure 18: Throttle, Mixture and Carburettor Heat Position on the Aircraft Wreckage

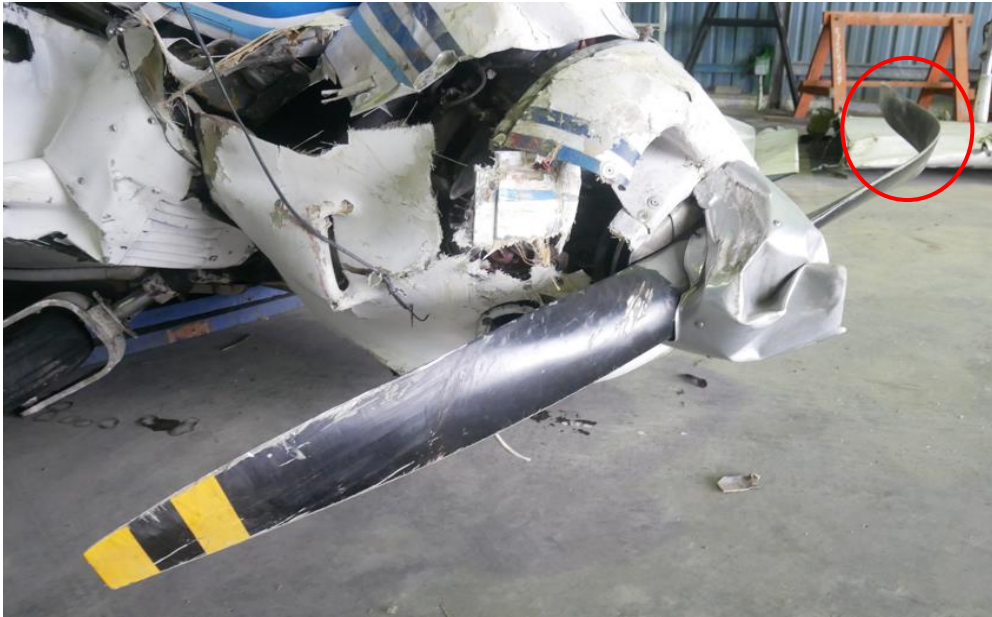
Figure 20: One propeller blade bend inwards and the other blade was in normal condition with some scratch marks

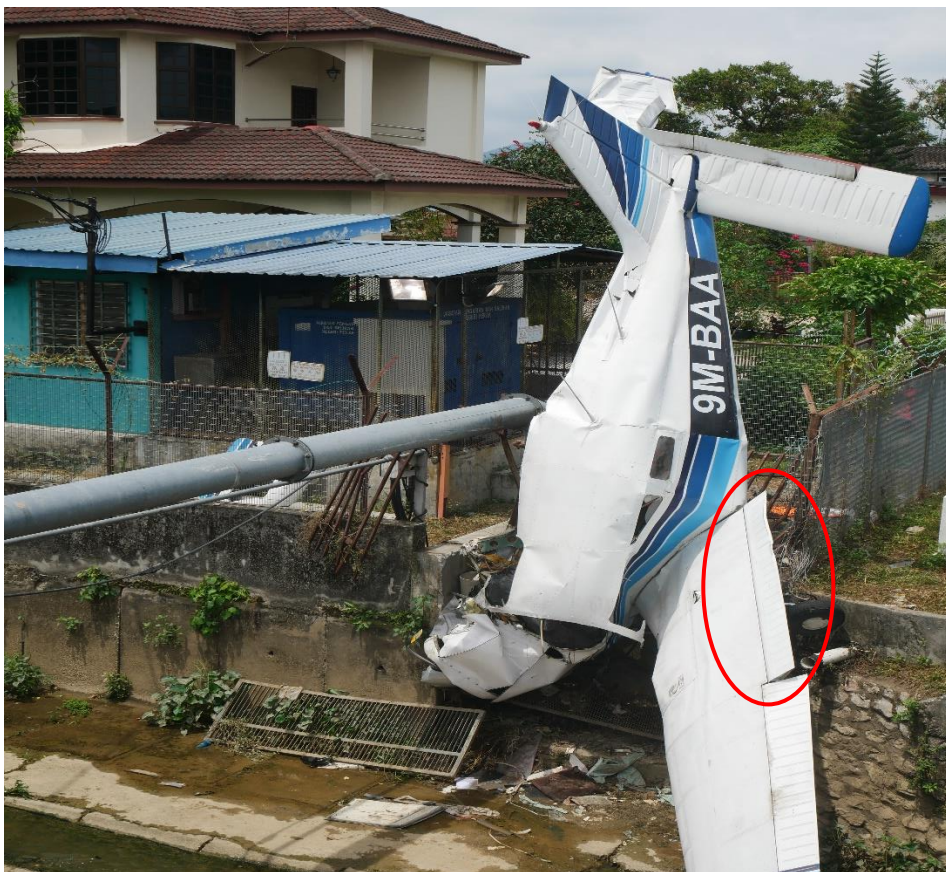
Figure 21: Flaps at UP position

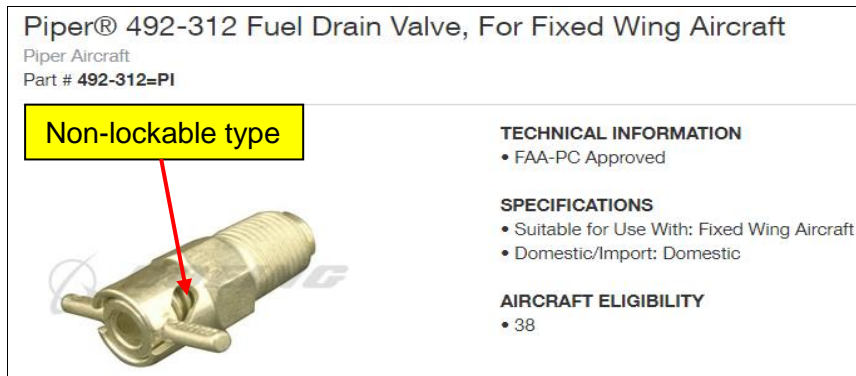
iv. **Gascolator Fuel Drain Valve** - The gascolator fuel drain valve fitted to the aircraft is of the non-lockable type part number 492-312² as per Piper Aircraft PA28-151/161 Warrior Airplane Parts Catalogue (Figure 24). The gascolator sustained impact damage and its functionality cannot be verified. The cup holding the filter had broken off missing together with the fuel drain valve.

Figure 24: Gascolator Fuel Drain Valve fitted on the aircraft

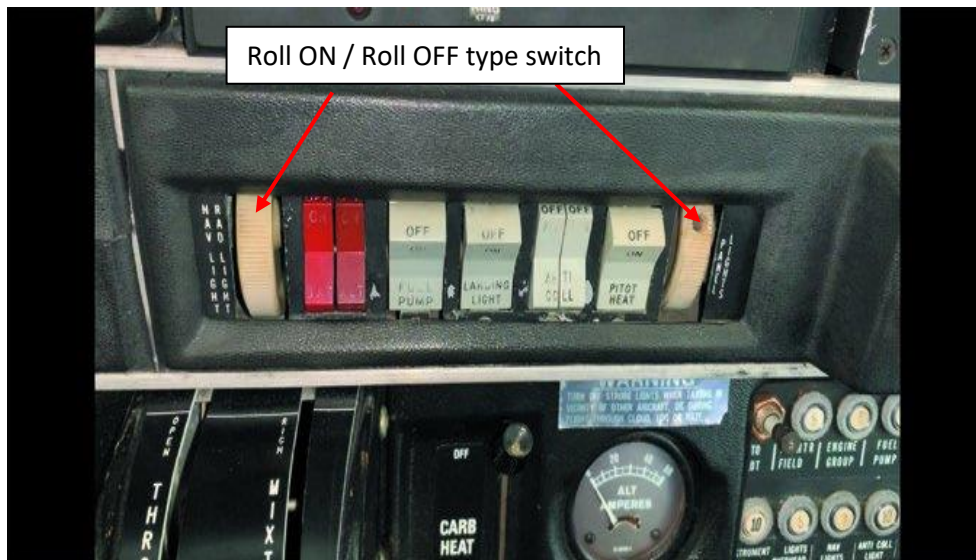
Pilot 2 and Pilot 5 interview statement revealed that the aircraft (9M-BAA – Warrior II) instrument lights were dimmer than normal as compared to another similar aircraft. There was no evidence on any defect raised on the instrument's lights by any pilots. The Warrior II aircraft does not have a variable instrument lighting intensity control switch like in the Warrior III aircraft which allows the pilot to control the brightness for instrument reading clarity. The light switch in the Warrior II aircraft is a roll ON and roll OFF type switch as in Figure 32.

Figure 32: Instrument Light Switch

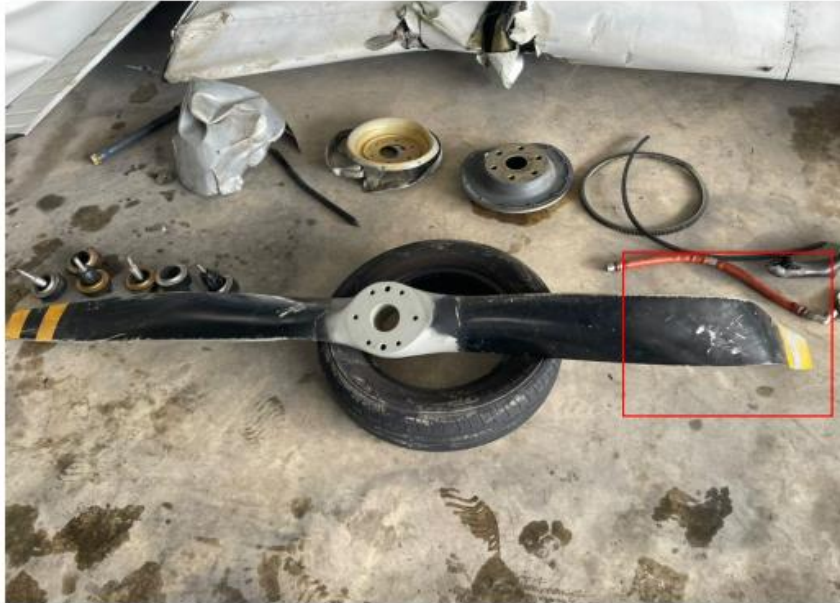
2.2.1 Propeller blade bent inward, another blade scratches

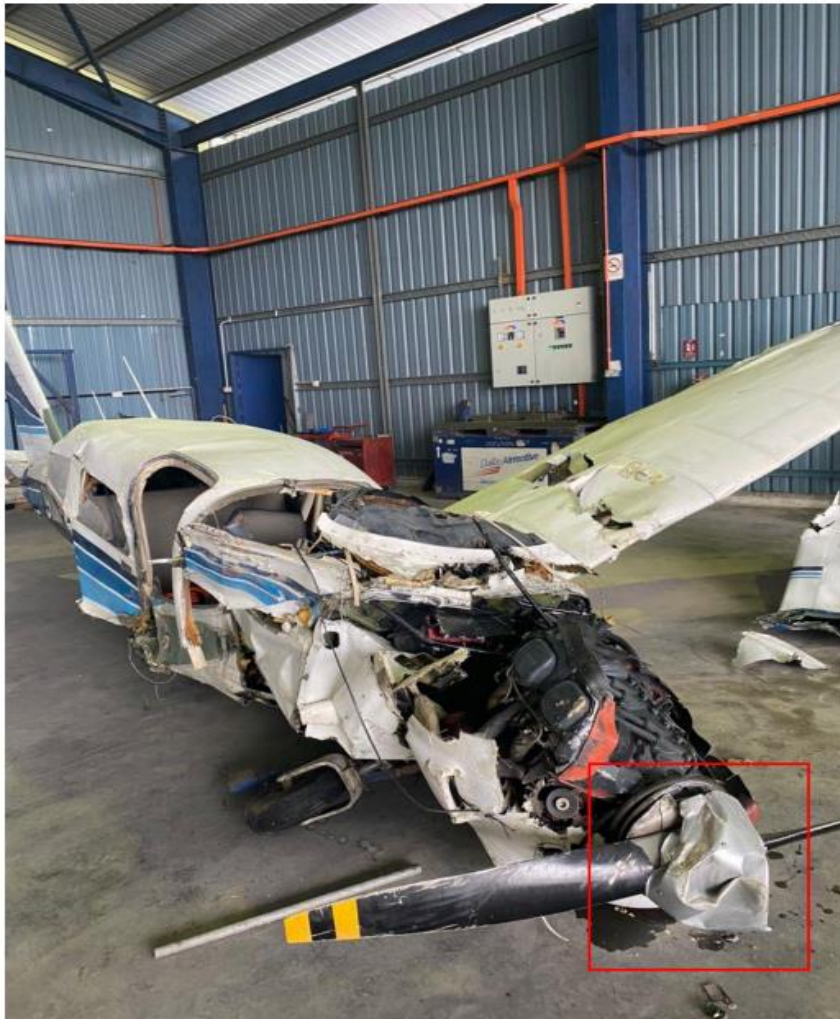
2.2.2 Nose spinner damaged

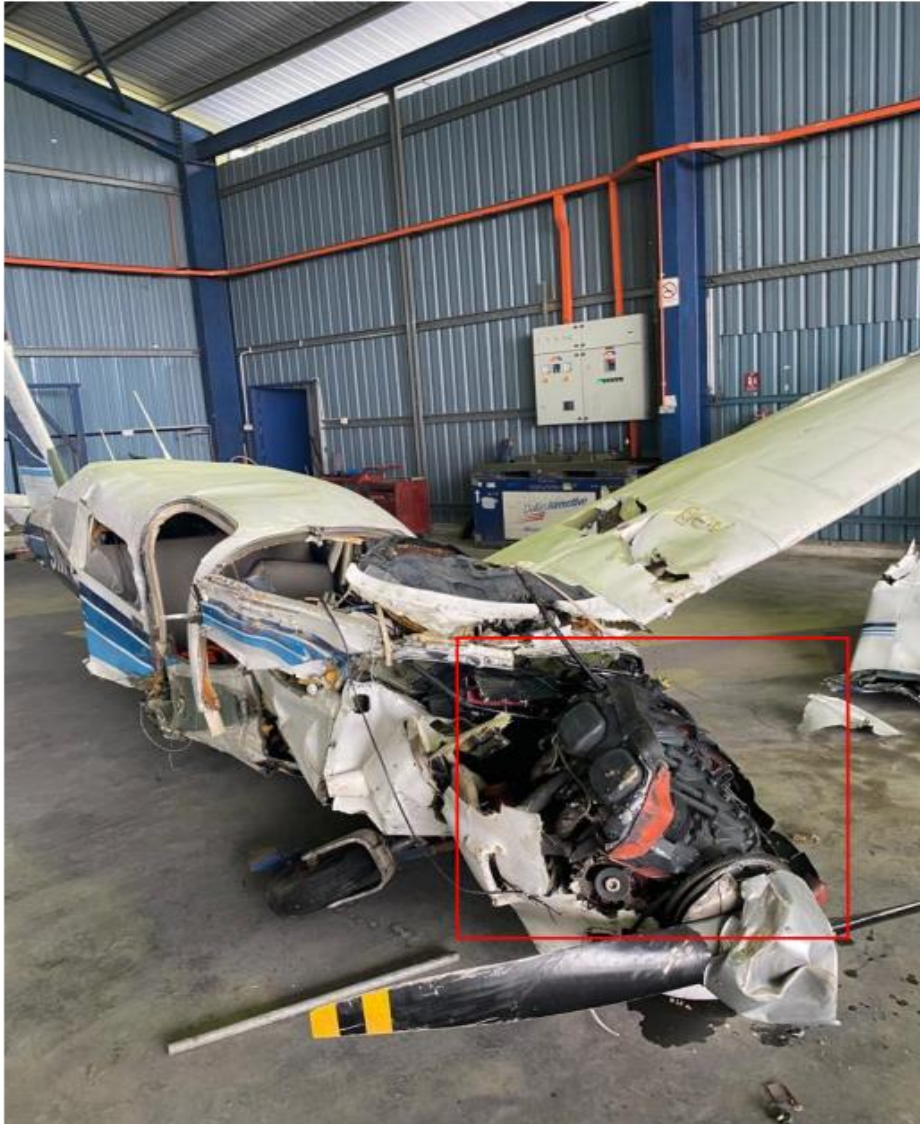
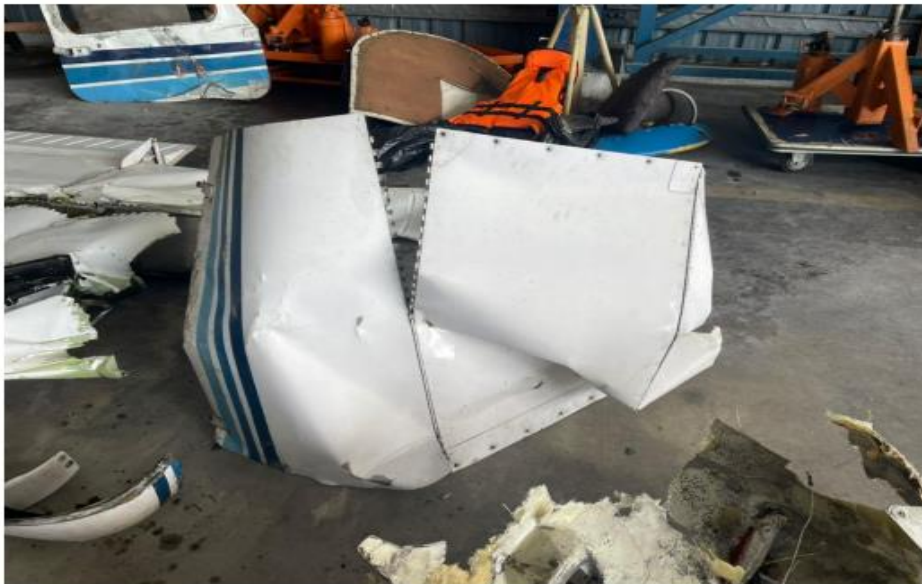
2.2.3 The upper engine cowl detached

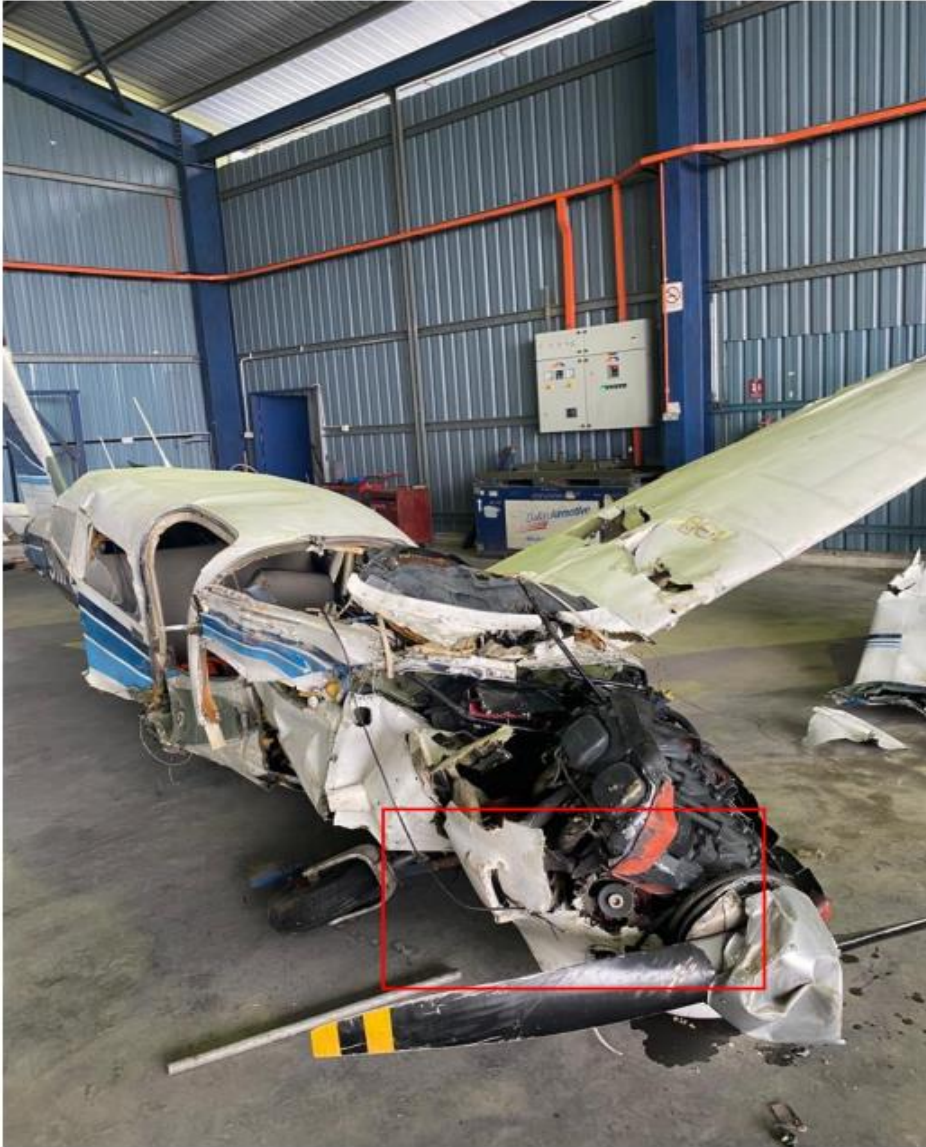
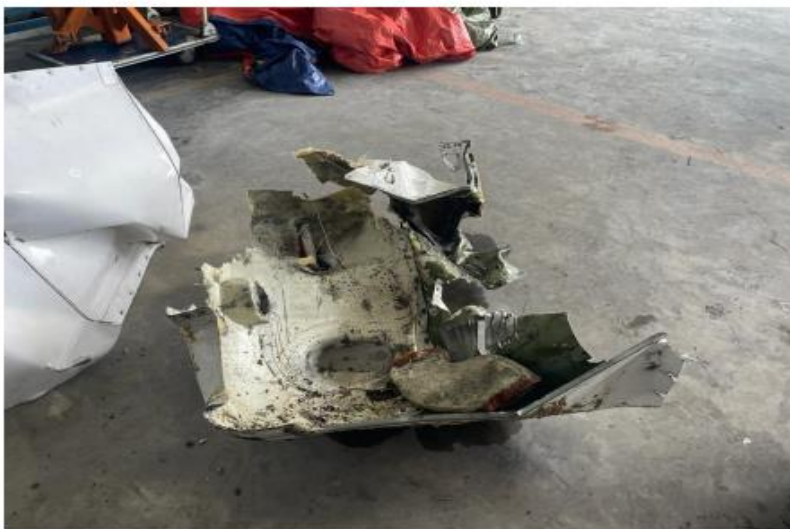
2.2.4 The lower engine cowl damaged (crushed) but still attached

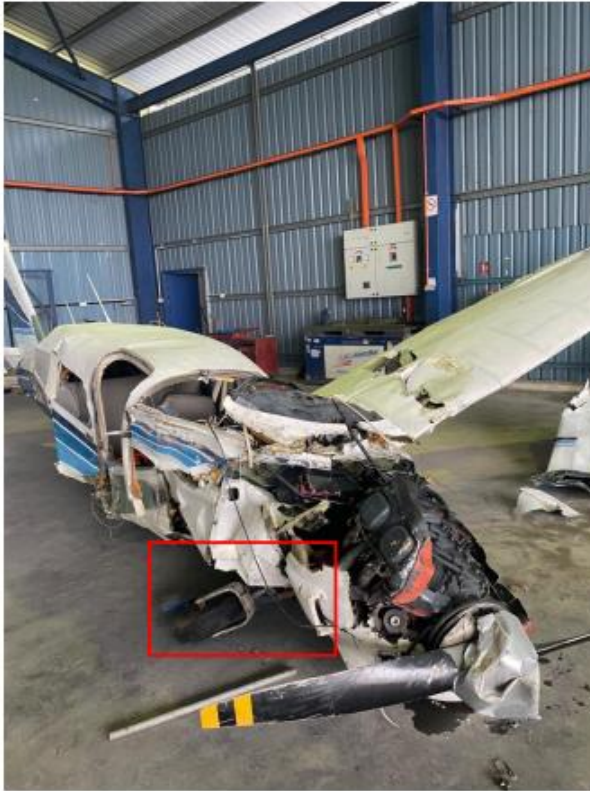
2.2.5 Nose landing gear damaged

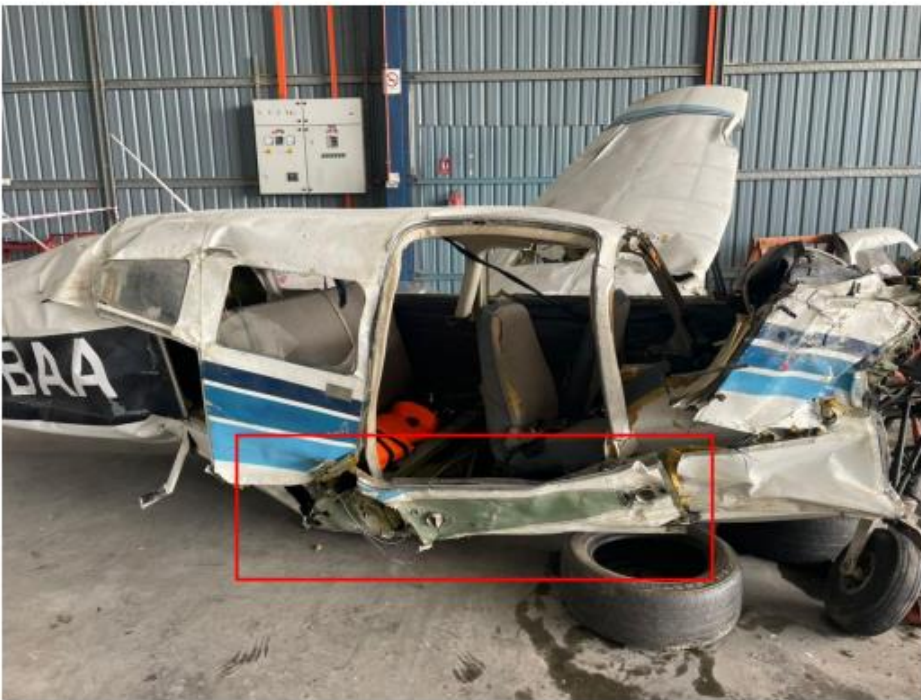
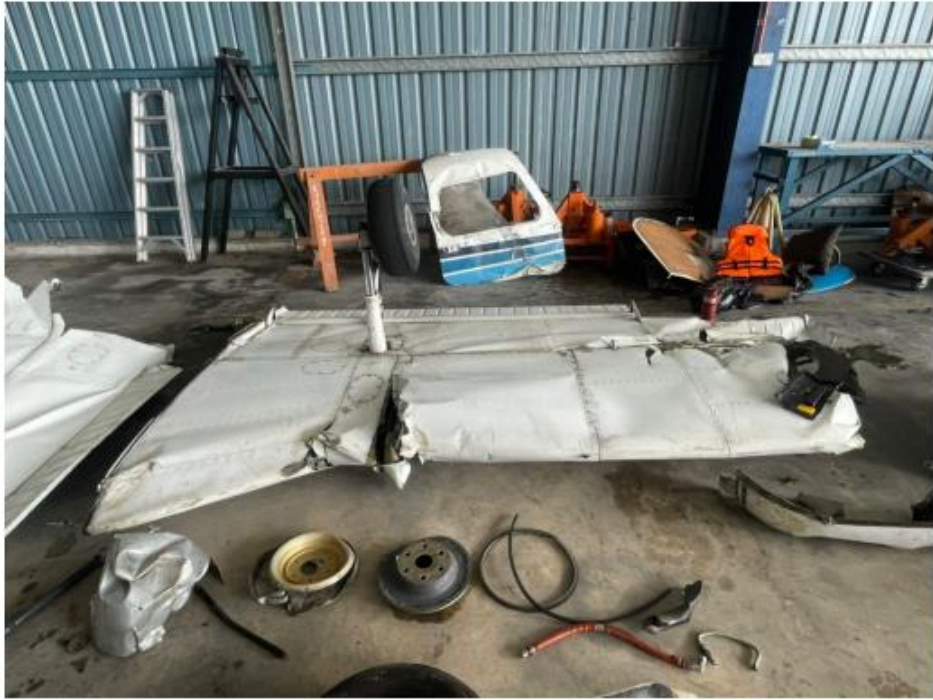
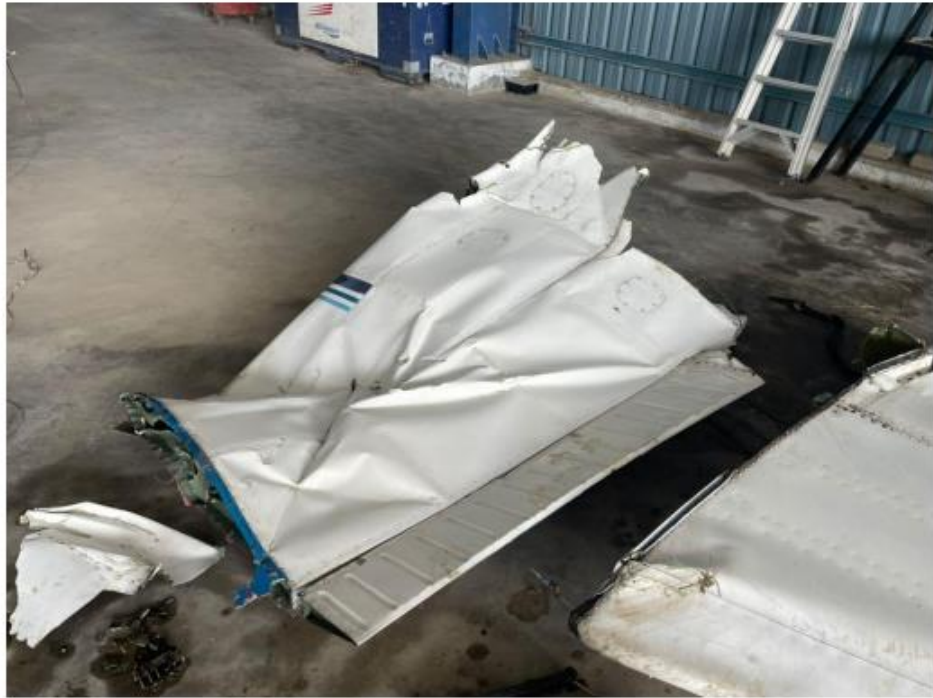
2.2.6 Starboard wing detached, broken into two

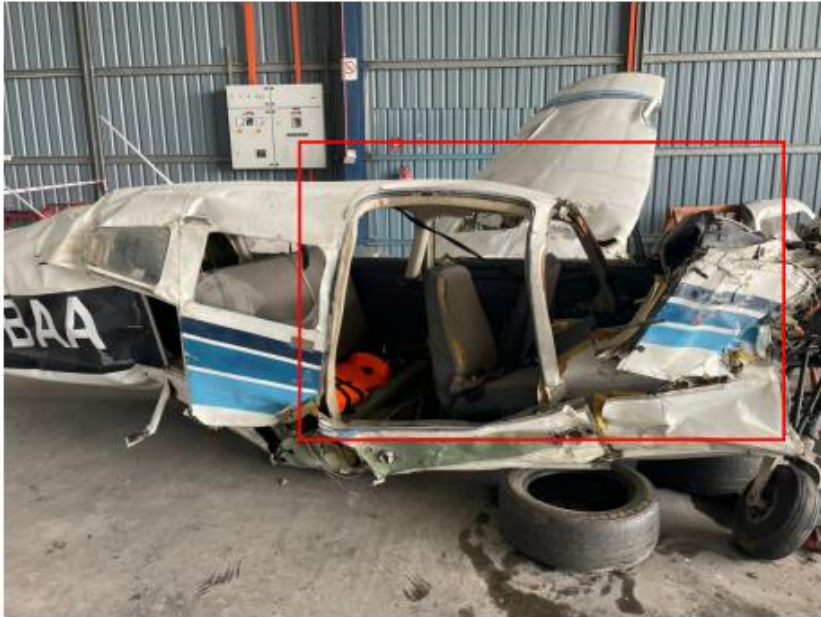
2.2.7 Starboard fuselage cockpit area damage

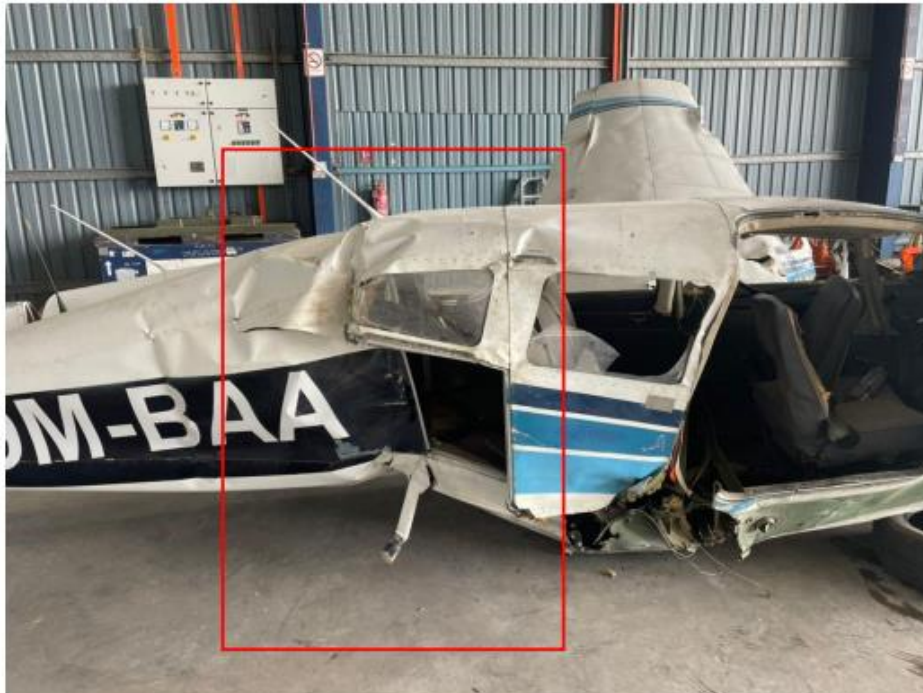
2.2.8 Baggage door detached, fuselage hogging

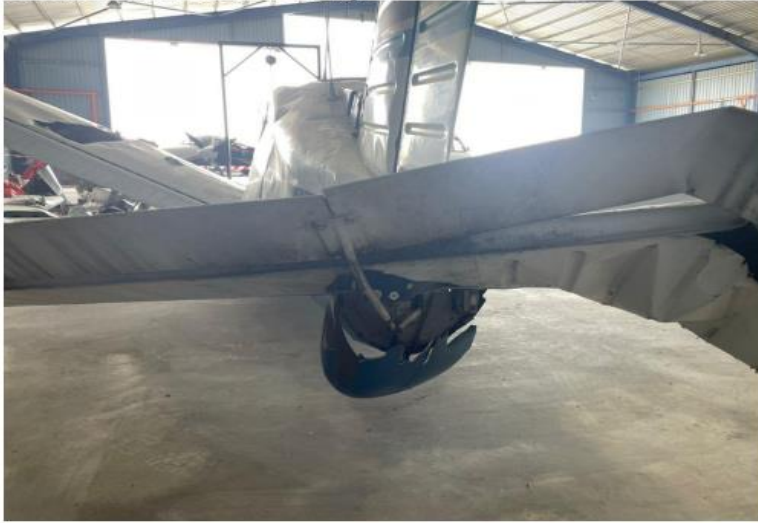
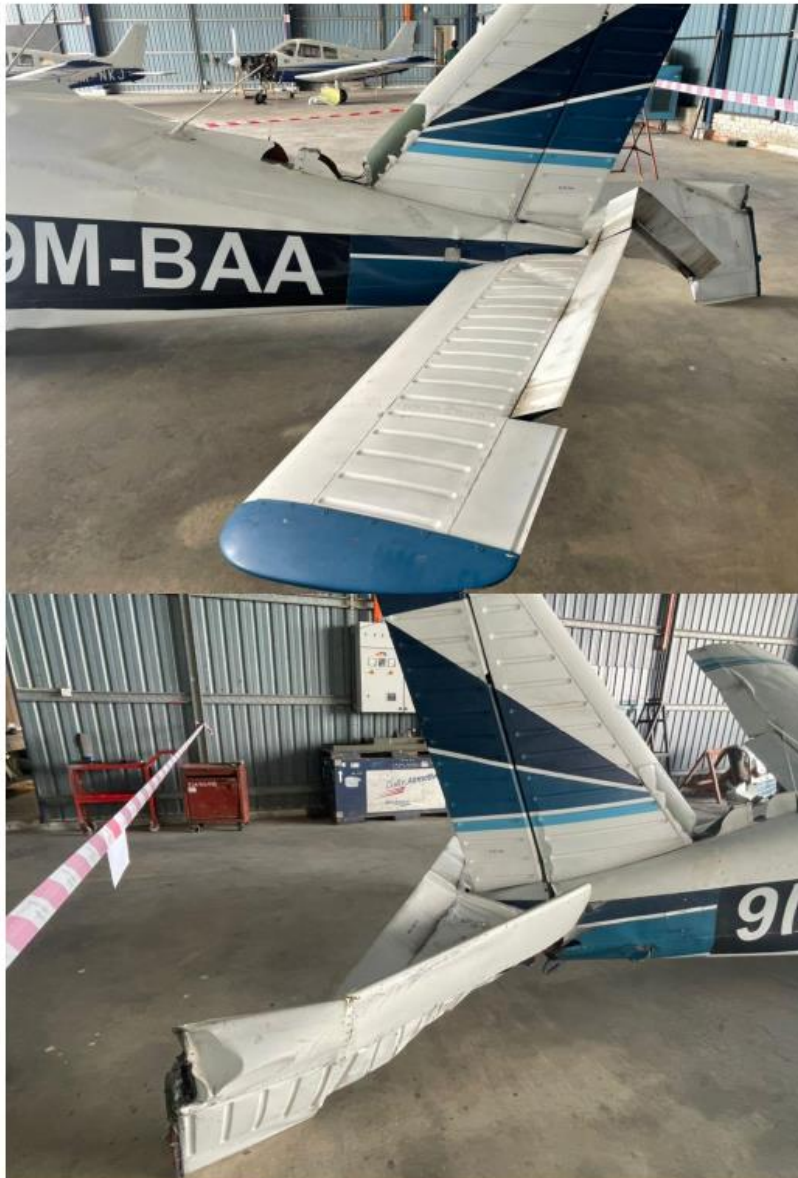
2.2.9 Horizontal stabilizer damaged

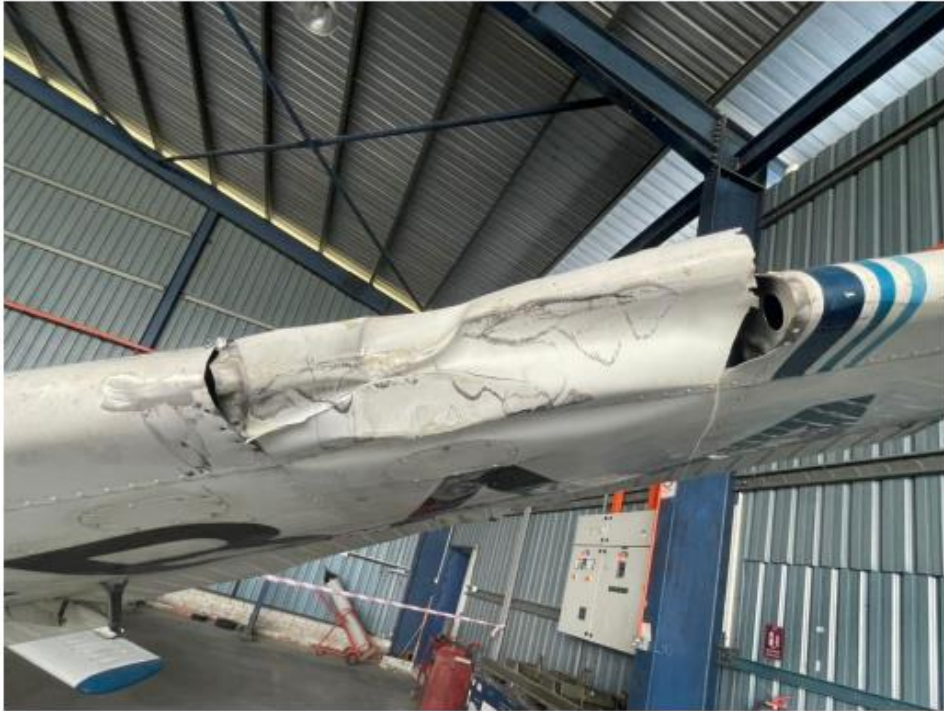
2.2.10 Port wing leading edge dented

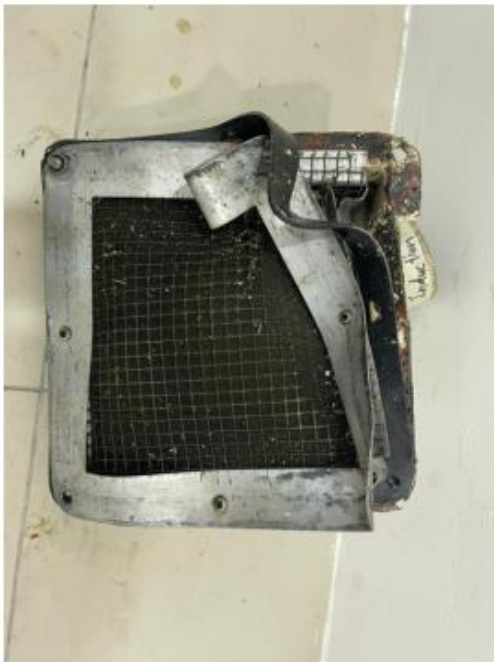
2.2.11 Induction air box damaged

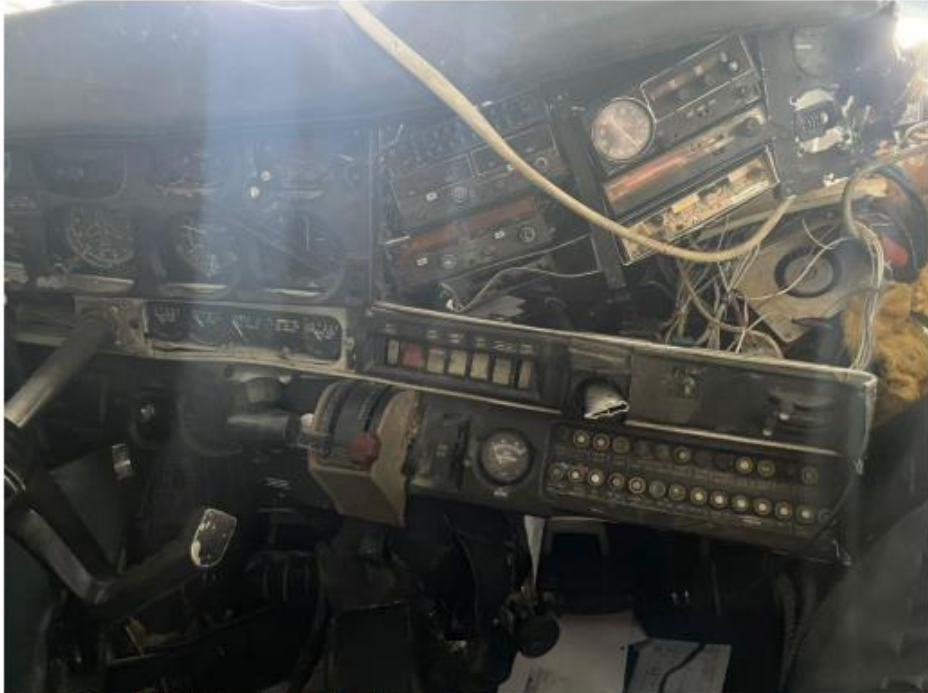
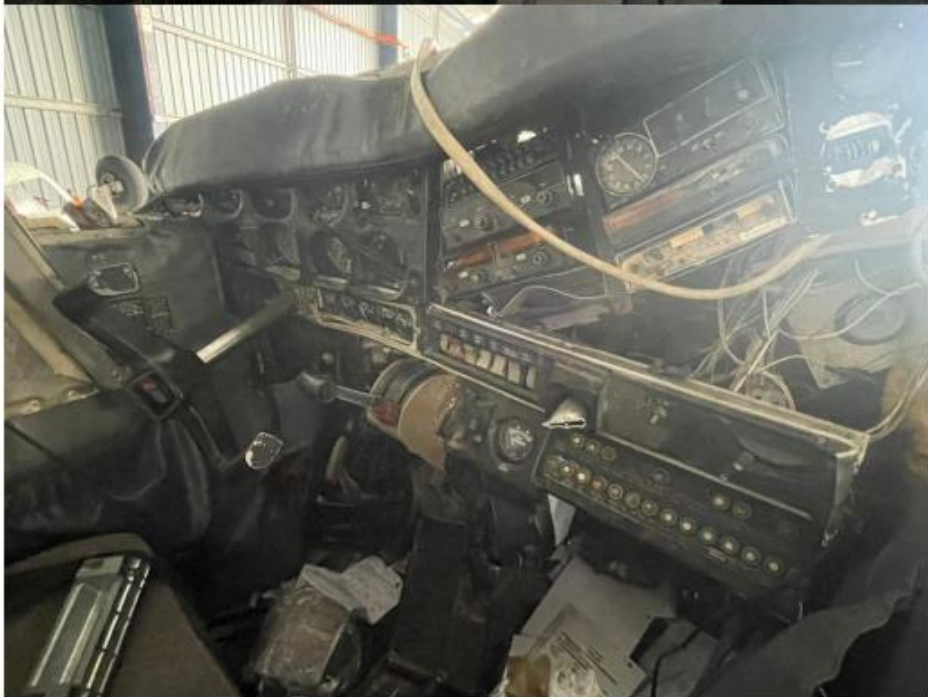
2.2.12 All aircraft instrumentation in the cockpit damaged due to impact

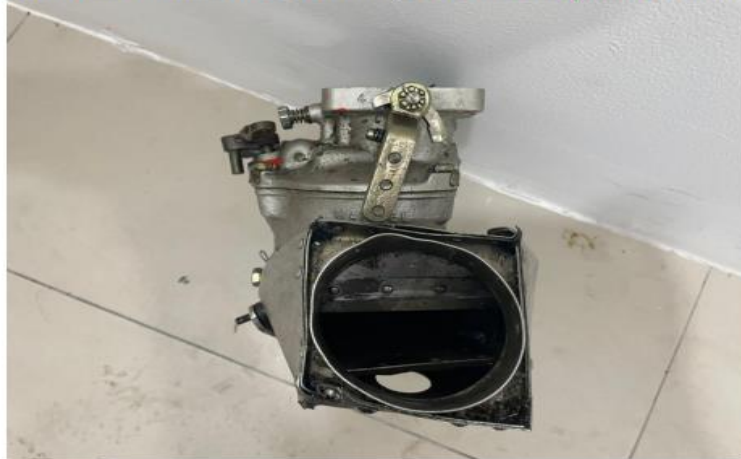
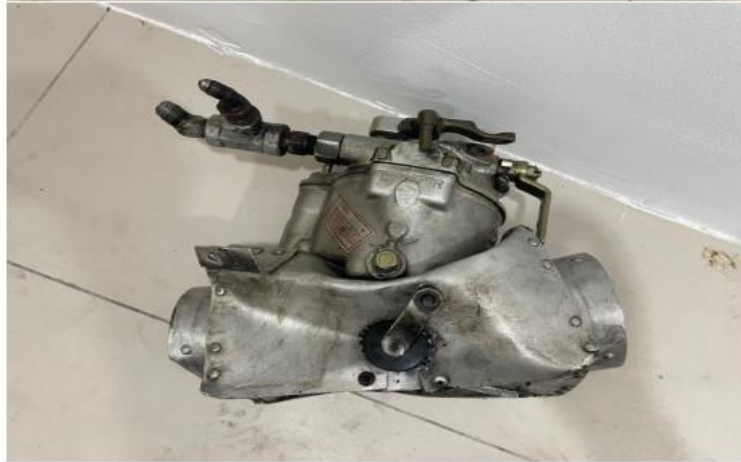
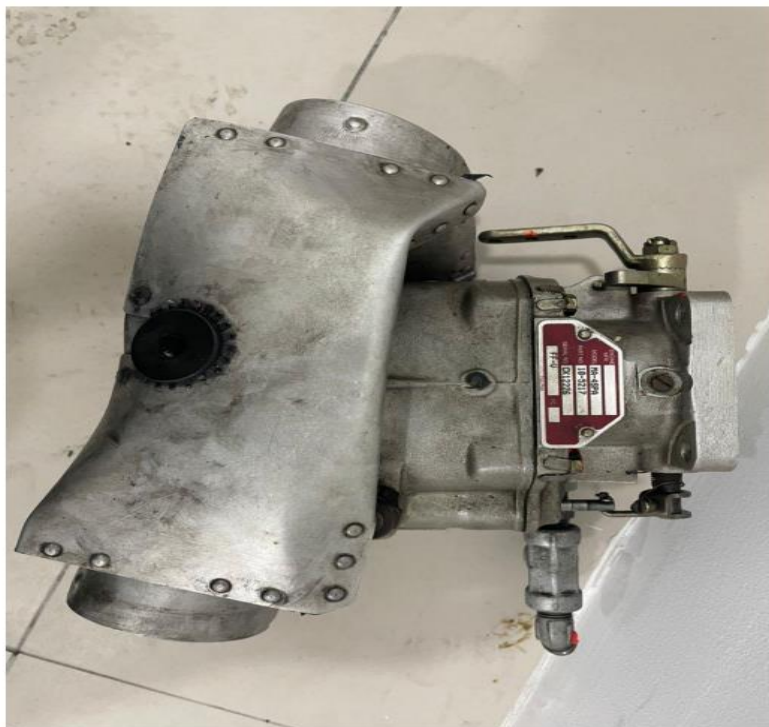
i. **Carburettor** – Sustained impact damage on the induction box. No damage found on the carburettor body. There was fuel contained in the carburettor. Fuel sprayed from the injector nozzle when the throttle arm was operated. This indicates that fuel was supplied to the engine and not starved. The carburettor filter screen was also inspected and found no evidence of blockage. Overall condition of the carburettor found no abnormalities.

2.3.1 Carburetor induction box crushed; carburetor body not affected

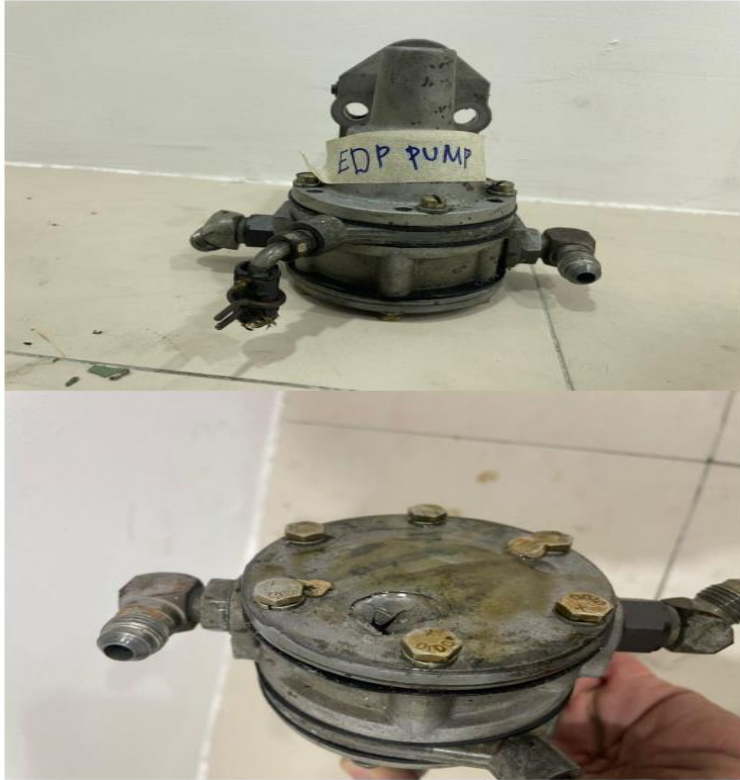
ii. **Fuel Engine Driven Pump** - Sustained impact damage on the bottom of the pump (punctured by the broken linkage). Unable to verify the functionality of the pump due to the damage. Overall condition of the pump found no abnormalities.

2.3.2 Engine driven fuel pump punctured by broken engine mount

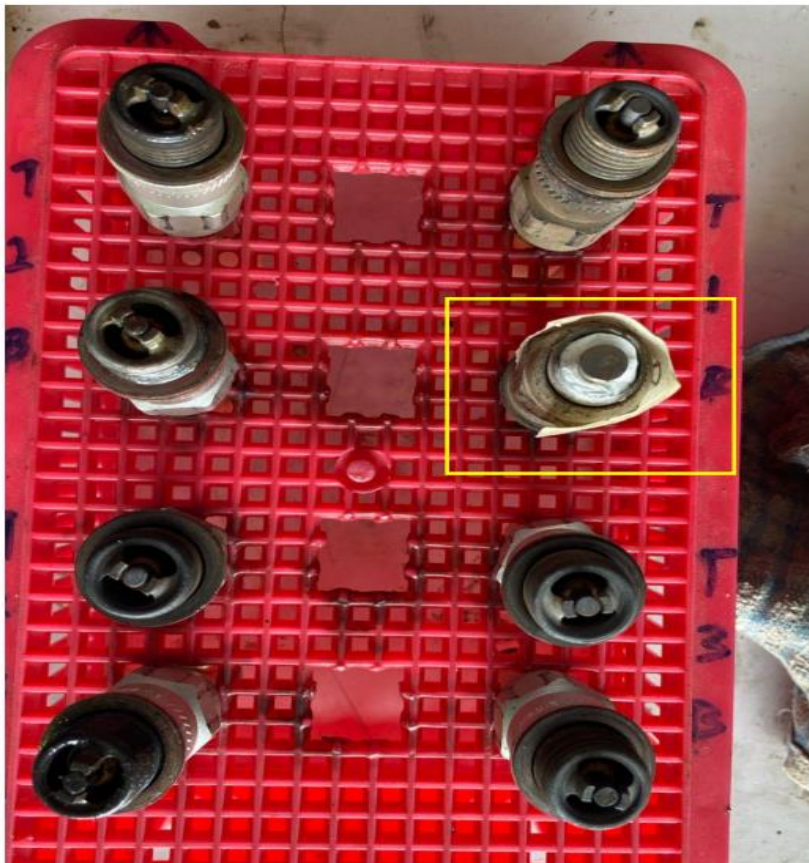
ii. **Ignition Harness and Spark Plug** – One of the spark plugs at No 1 cylinder found broken due to impact. All other spark plugs and ignition harnesses were in normal condition.

2.3.3 One spark plug broken

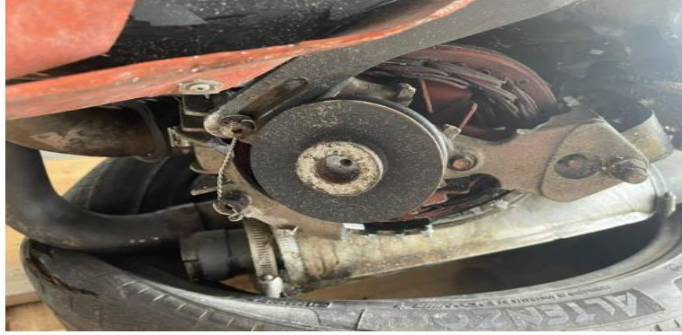
2.3.4 Alternator broken

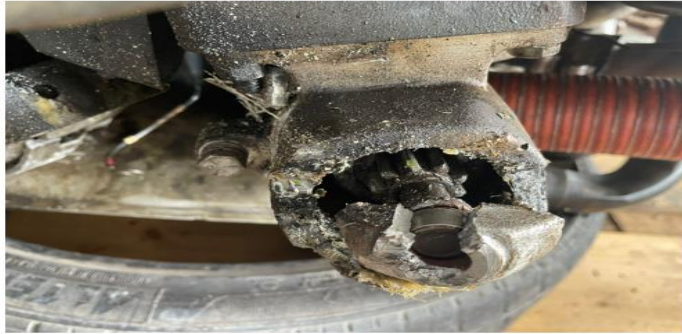
2.3.5 Starter broken

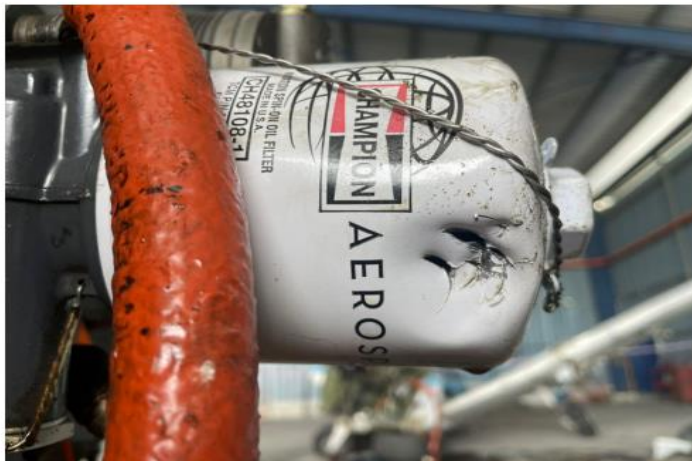
2.3.6 Oil filter punctured by broken engine mount

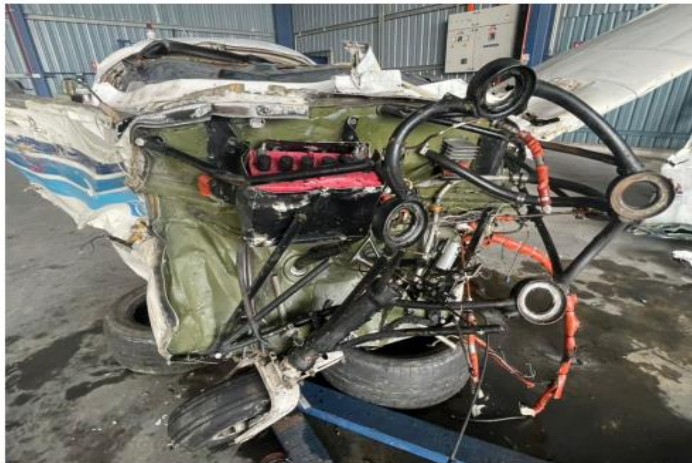
2.3.7 Engine mount broken few places

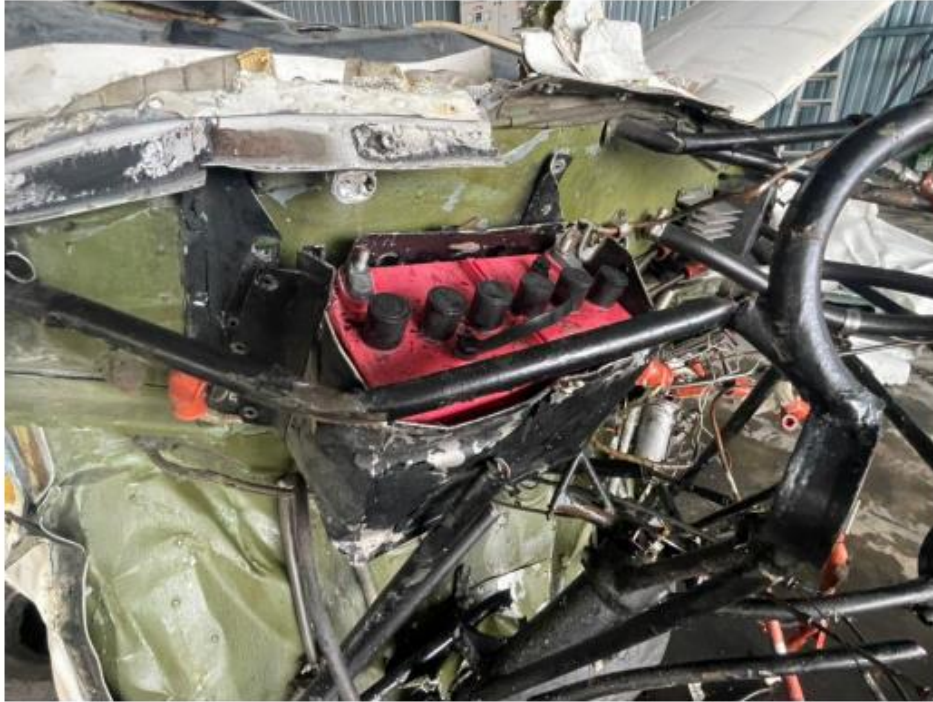
2.3.8 Battery box crushed

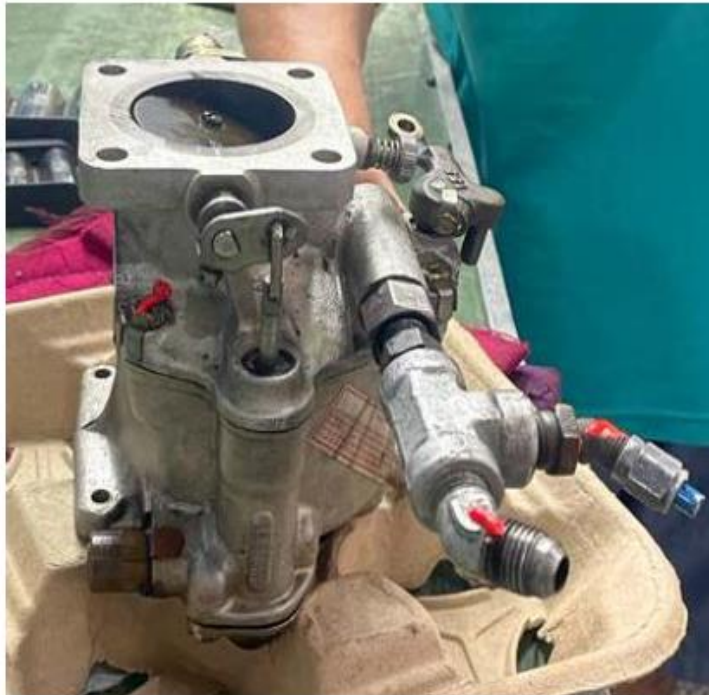
No physical damage found; carburettor looks good.

Note: Air box damaged due to impact during the accident.

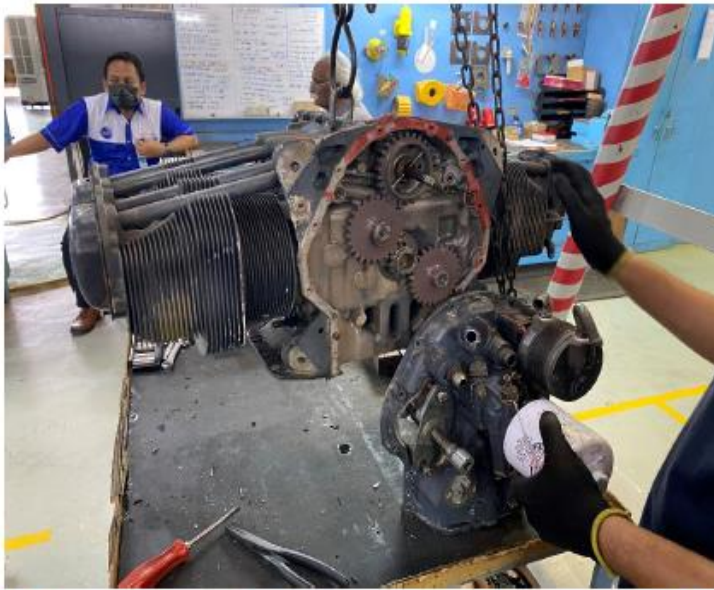
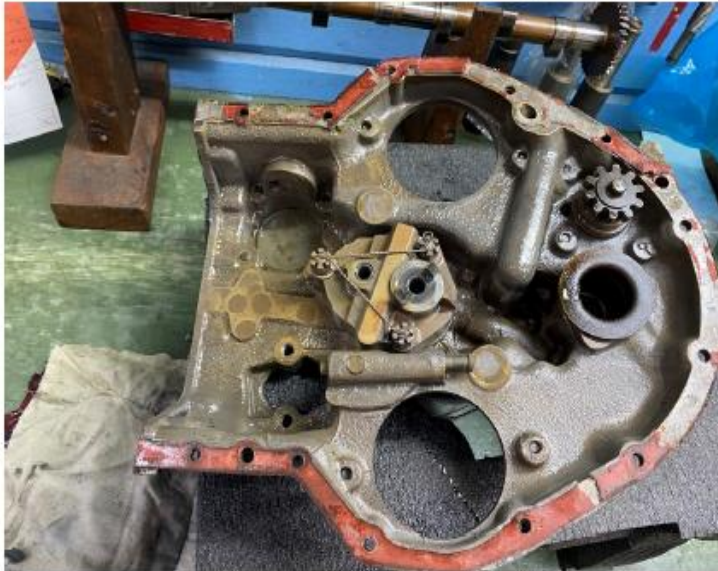
- iii. Accessories case removed and checked for condition.
FOUND SATISFACTORY
