FINAL REPORT

A 03/22

Accident Involving Fixed Wing Aircraft

Piper Warrior II PA28-161, Registration 9M-BAA

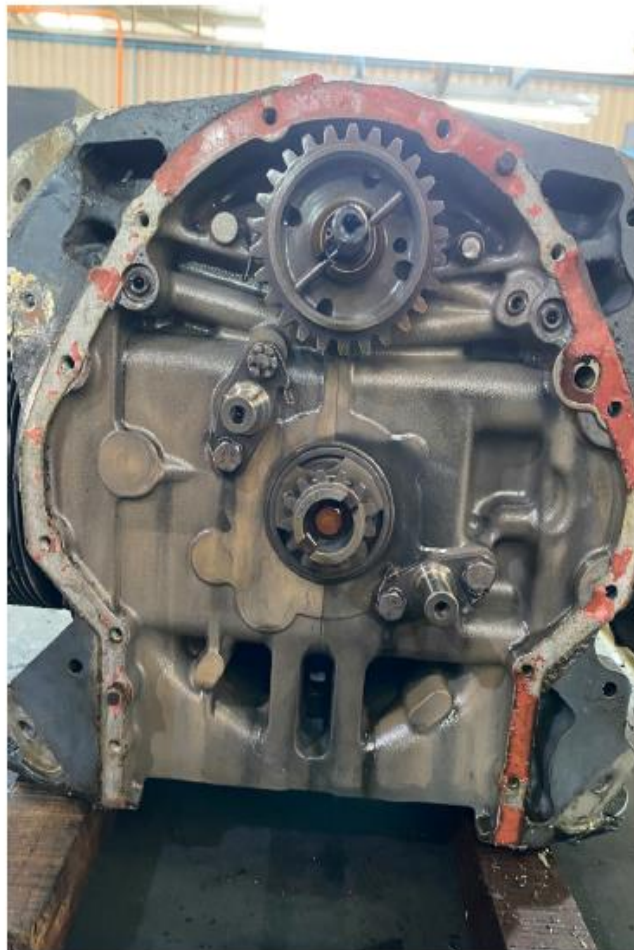
- vi. Removing crankshaft-accessories driven gear and checked for condition. FOUND SATISFACTORY.

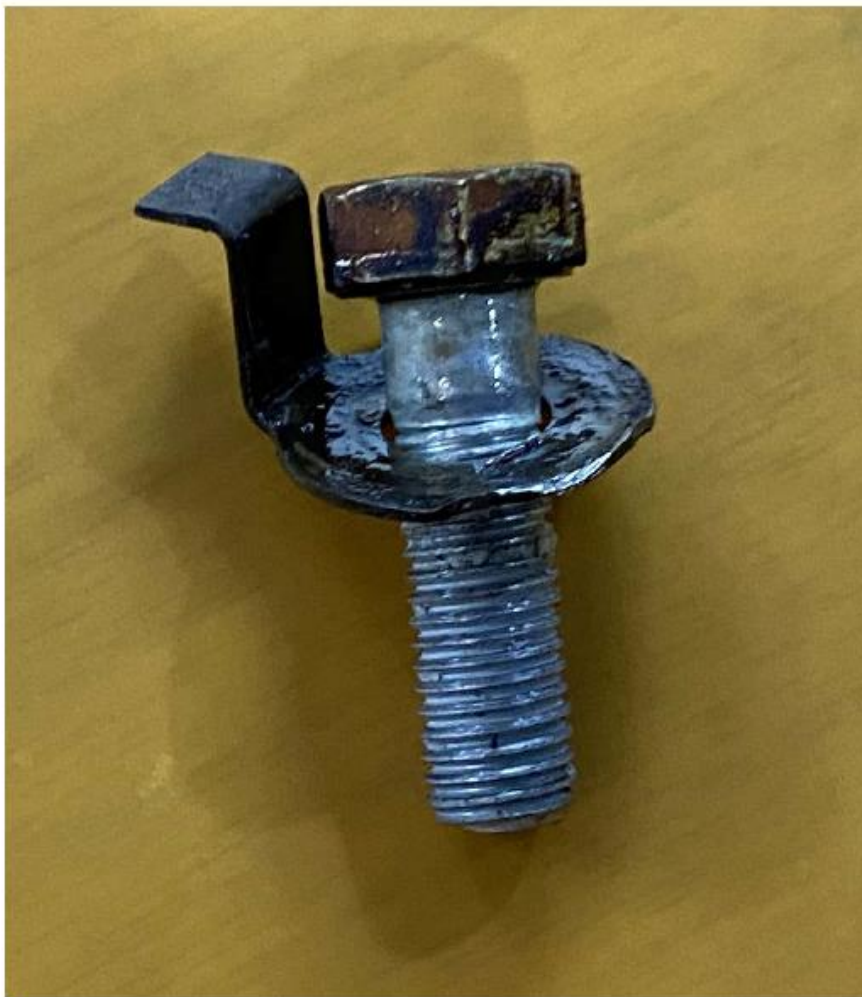
- vii. Inspecting the crankshaft-accessories driven gear's bolt. FOUND SATISFACTORY.

Note: Bolt's locking tab still intact.

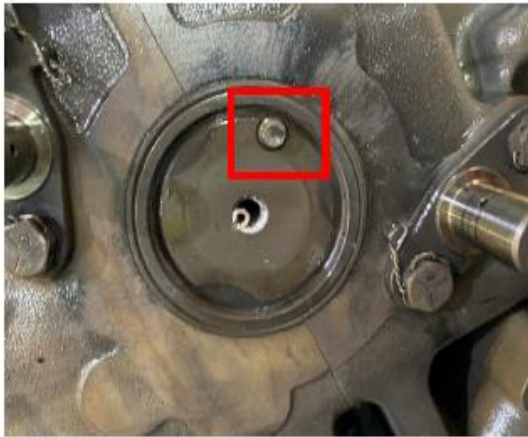
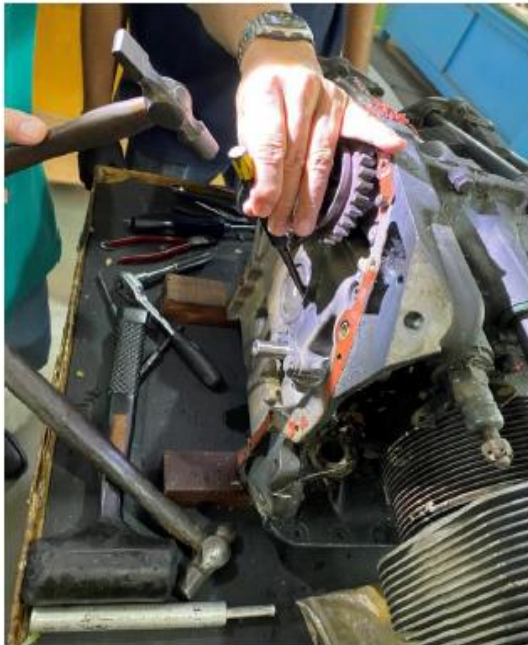
- viii. Inspecting the dowel pin the condition especially for looseness and crack. Knocking the dowel pin with punch to hear the sound. Sound of the dowel pin is solid. FOUND SATISFACTORY.

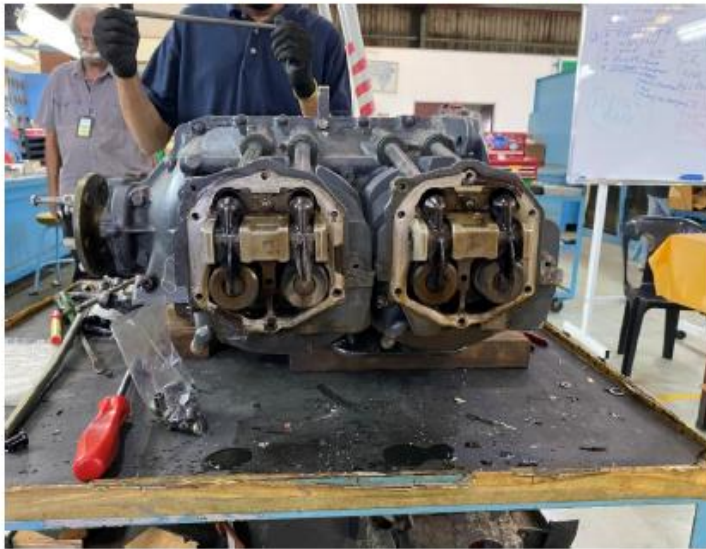
- ix. All cylinder's rocker box, rocker arms, and push-rod.
Condition inspected. FOUND SATISFACTORY.

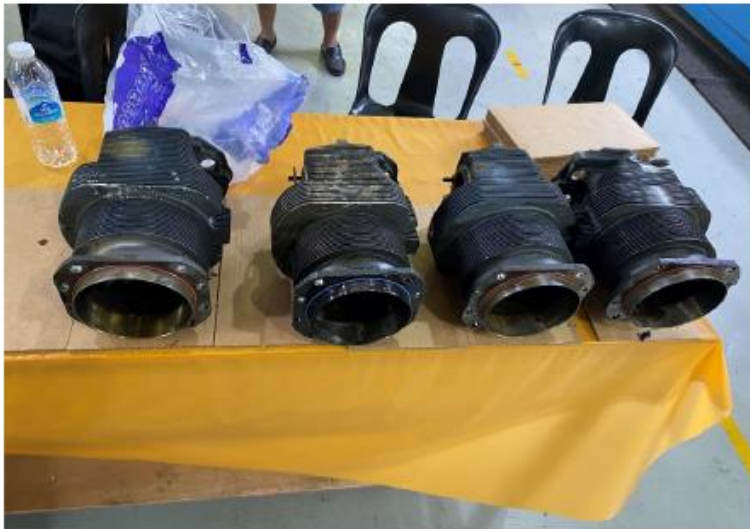
- x. Removing cylinder barrel and inspected for condition. No damaged found except for cylinder No. 1 cooling fin (damage due to impact). FOUND SATISFACTORY.

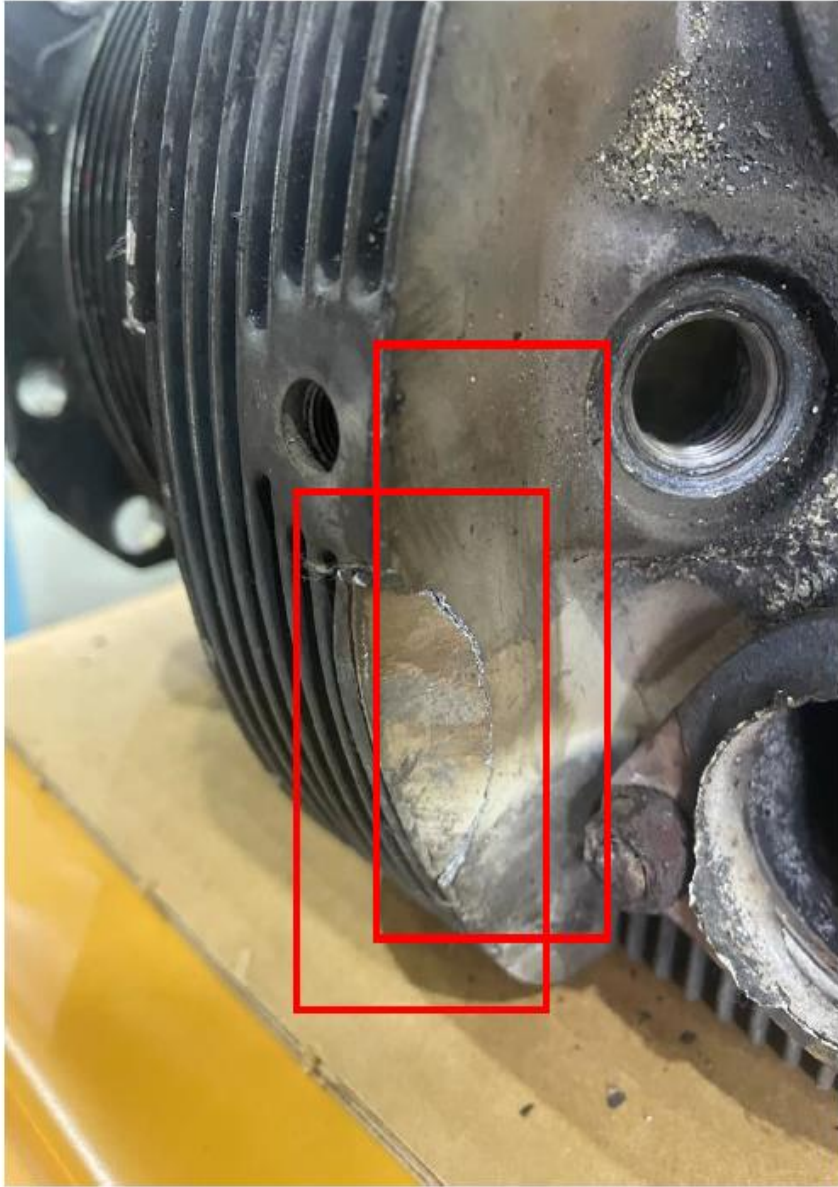
Note: Cylinder No. 1 cooling fin damage due to impact.

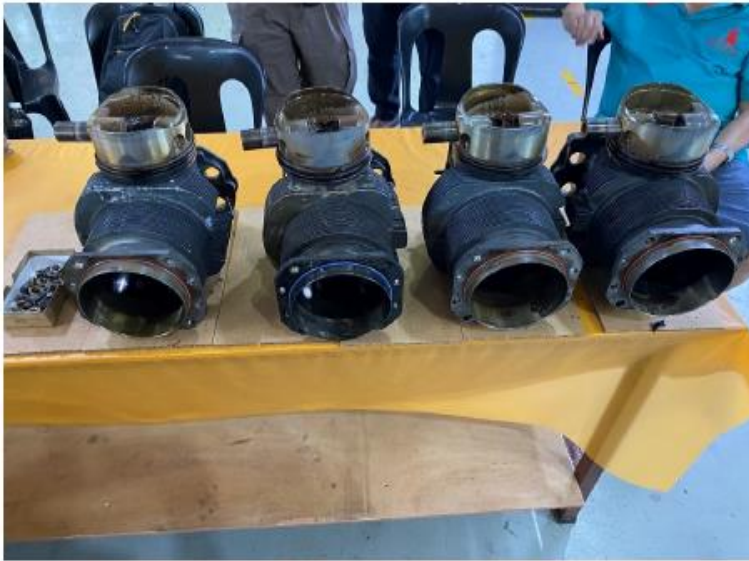
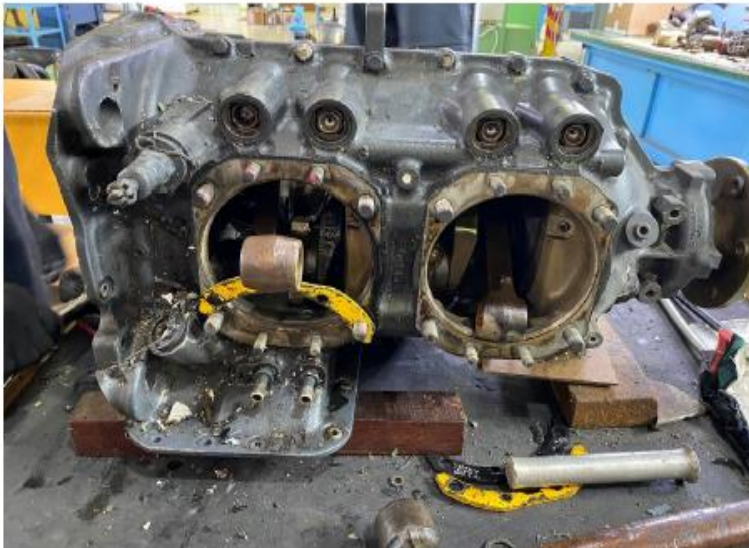
- xi. Piston removed from the piston rod. Piston, piston ring and piston rod checked for condition. FOUND SATISFACTORY.

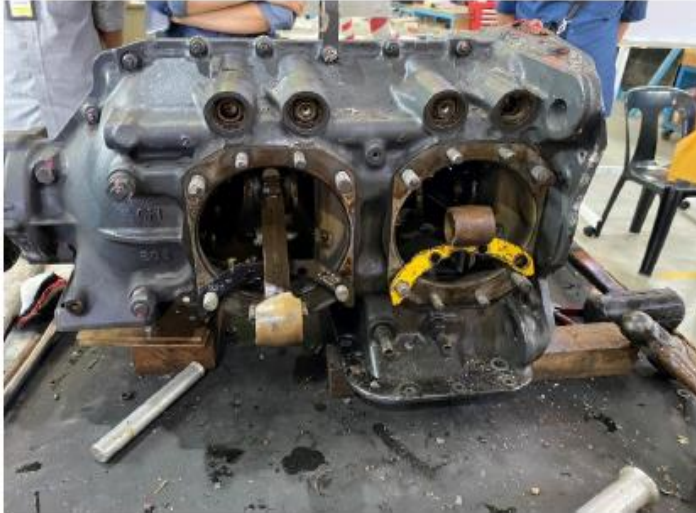
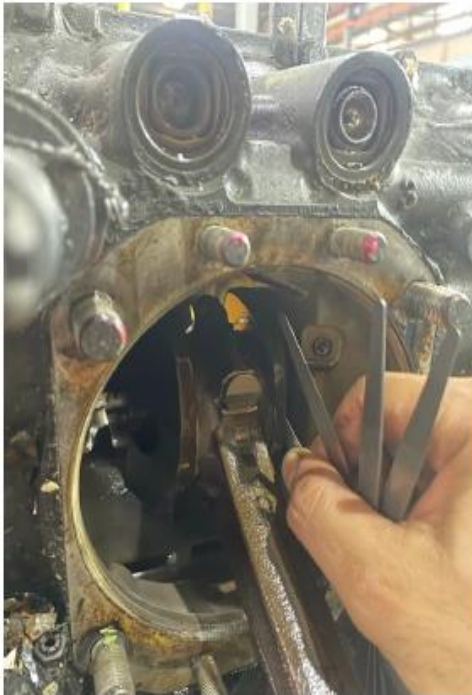
Note: Piston rod checked for gap. Found satisfactory.

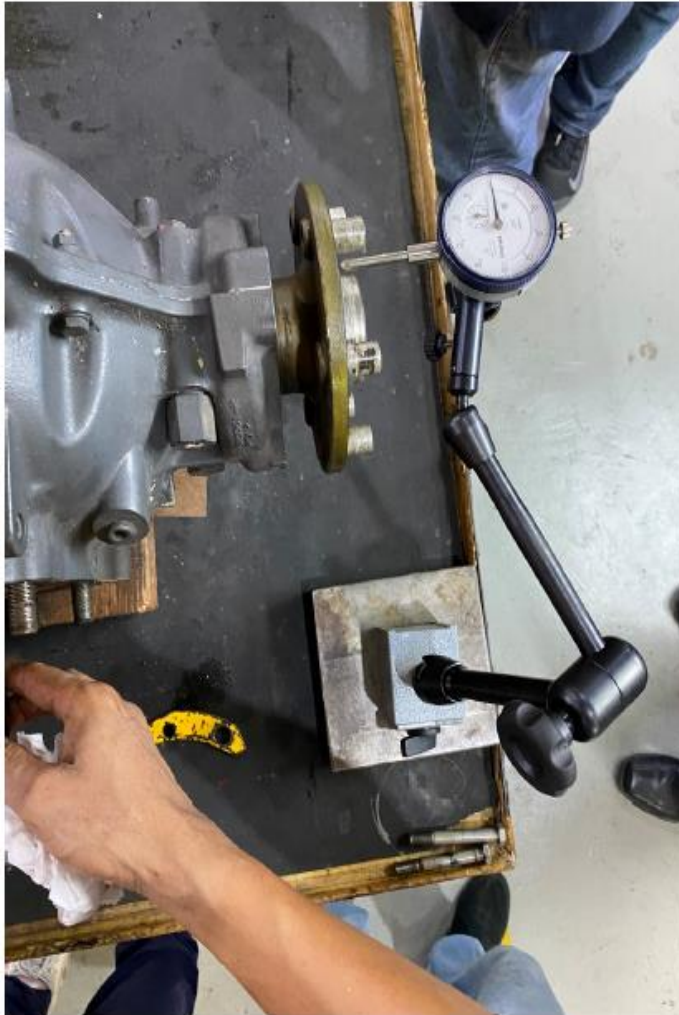
- xii. Carried out DTI (Dial test indicator) for crankshaft run out. Tolerance is within limit. FOUND SATISFACTORY.
