# AIRCRAFT SERIOUS INCIDENT FINAL REPORT

SI 01/23P

**Piper Archer III PA28-181, Registration 9M-SKJ  
at an Open Construction Area in Jasin, Malacca  
on the 14 February 2023**

**ACCIDENT REPORT NO.: SI 01/23**

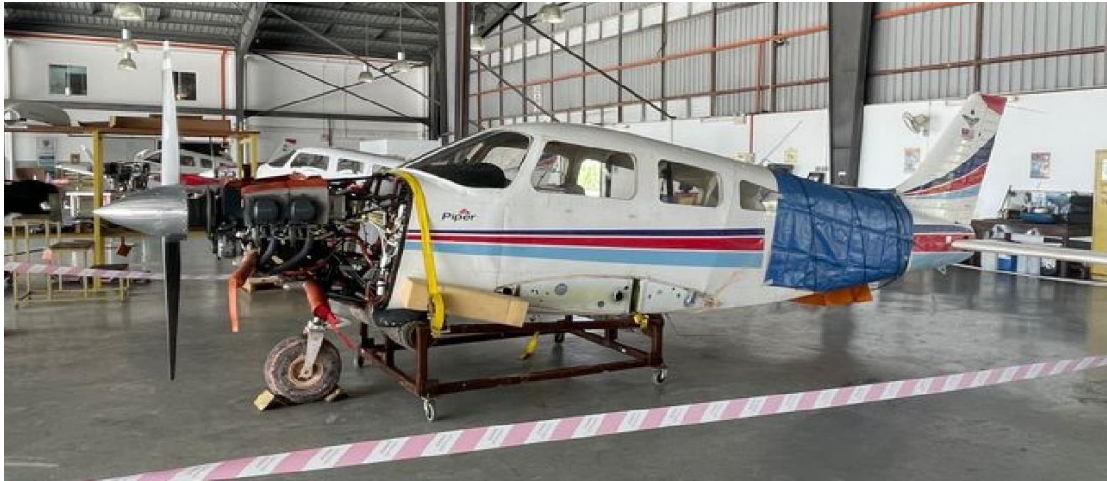
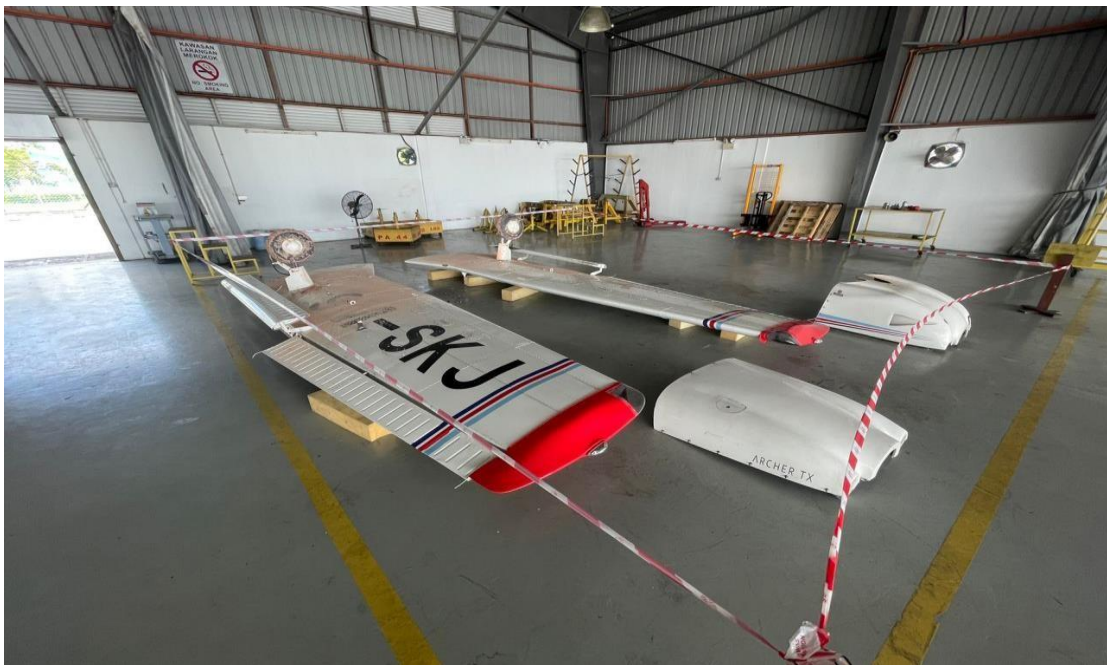
Post-incident inspection revealed no damages to the aircraft. Both the aircraft wings were disassembled at the incident site and the aircraft was transported back by road to the aircraft operator's hangar at Batu Berendam, Malacca.

Figure 2: Aircraft condition at the hangar after salvage activities from the crash site

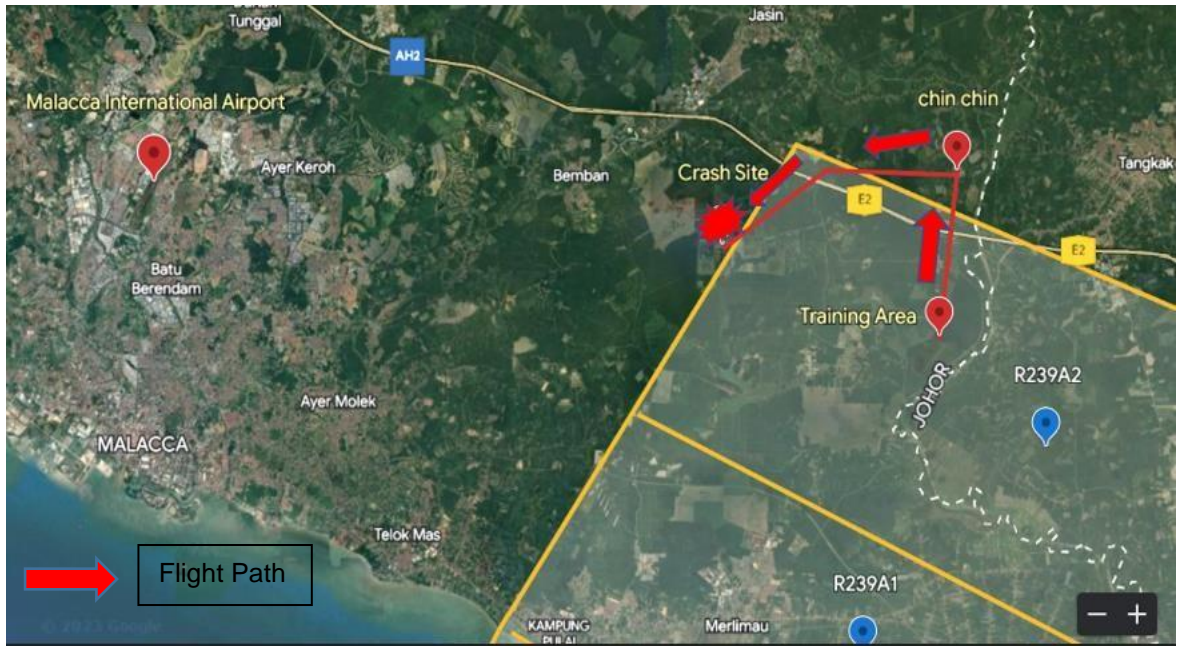
Figure 11: Flight path and final position of aircraft (Diagram not to scale)

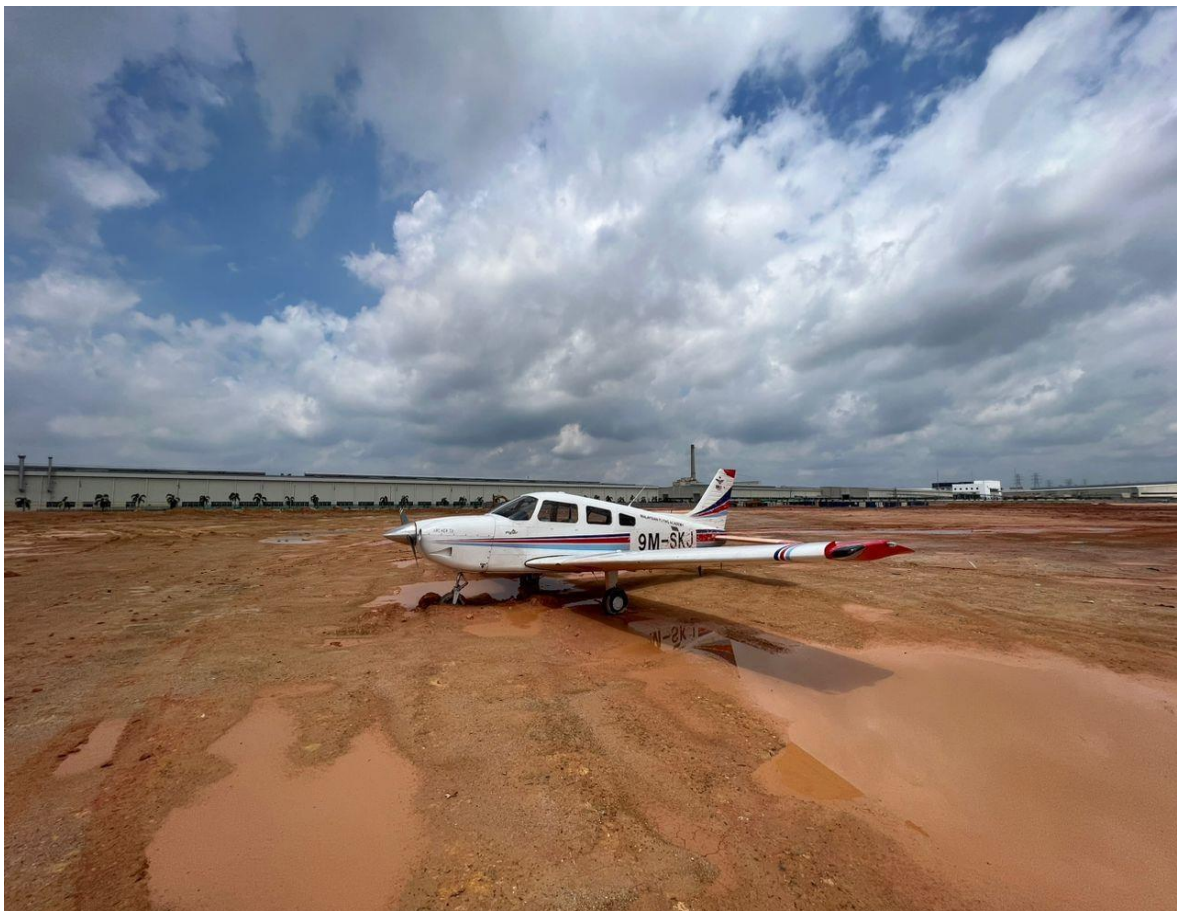
Figure 12: Final position of aircraft at the open construction area in Jasin.
