# AIRCRAFT ACCIDENT REPORT 03/15

## Air Accident Investigation Bureau

Report on the accident to Helicopter Dauphine,  
AS 365 N3 Registration 9M-IGB near Subang Airport,  
40 Nautical Miles Sout East of Subang Airport,  
MALAYSIA  
(N 03 00.64 E101 51.19)

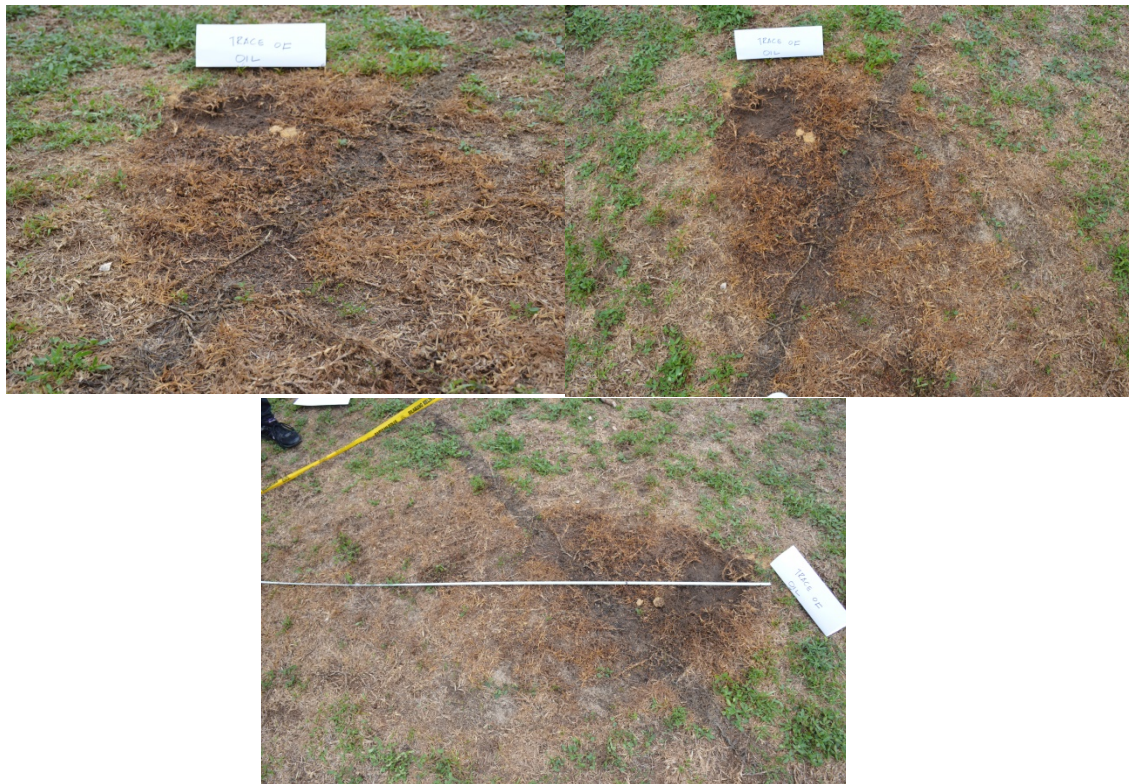
Fig. 10

The photos below show the oil traces on the field at Sekolah Kebangsaan Ladang Kota Bahagia.

The hydraulic fluid may indicate evidence of some leakage from the helicopter hydraulic system at the field where the aircraft landed.

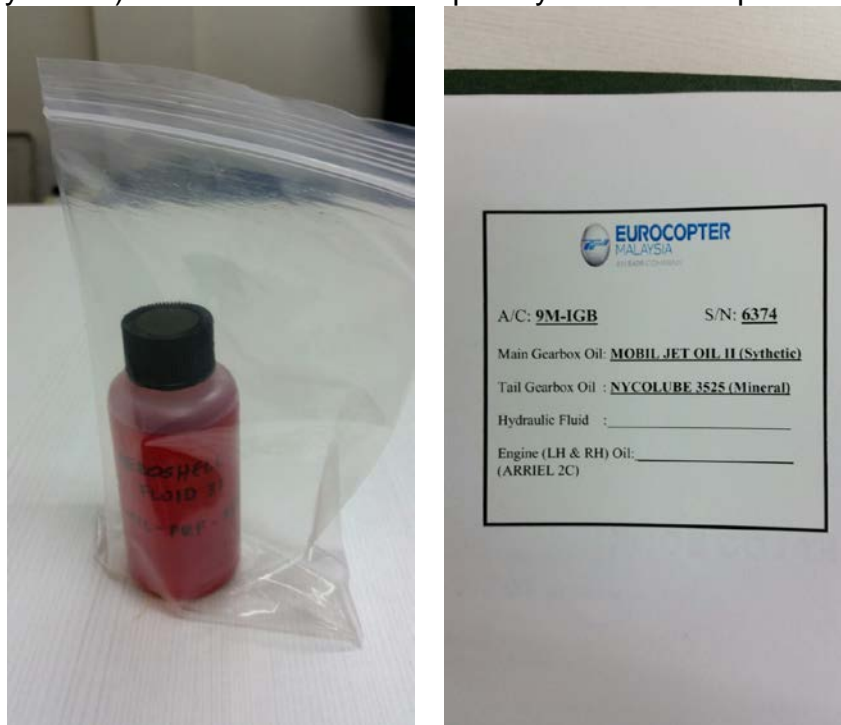
Fig. 12

Test result from the Chemistry Department of Malaysia shows that the sample taken at the SK Ladang Kota Bahagia is consistent with the Mobil Jet Oil II (Synthetic) of the AS365N3 helicopter hydraulic fluid specification.

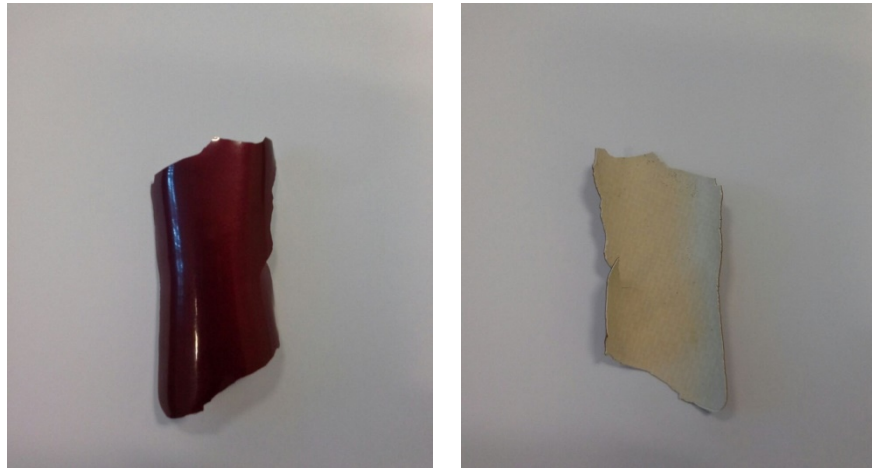
Fig. 13

During subsequent visit to at SKLKB, the investigator found a piece of chipped-off paint which is similar to the colour of the helicopter leading edge of the horizontal stabiliser. ( Fig 13)

The above photo shows the piece of chipped-off paint was sent to Chemist Department for analysis. There was no conclusive result obtained on the analysis of the piece of sample. Further test was carried out by matching the paint contents and feature from the chipped off part and the paint from the helicopter. The Left Hand Horizontal Stabilizer was missing; however, the RH Horizontal Stabiliser was found together with the wreckage and the piece of chipped-off paint matched the colour and countour of the aerodynamic profile of the horizontal stabiliser leading edge.

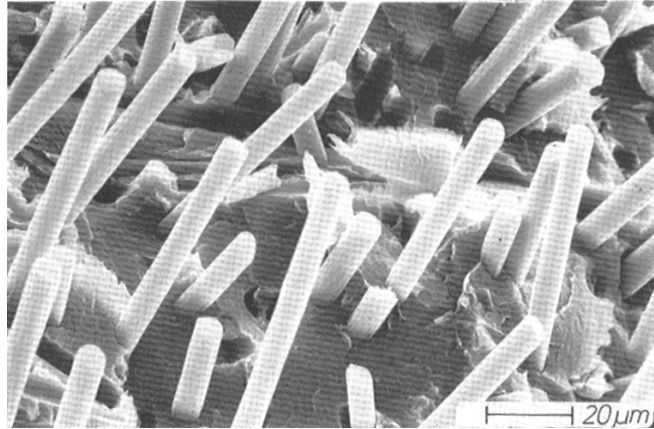
Fig 14

The following photo shows the fiber pullout resulted from tensile load on the structure.

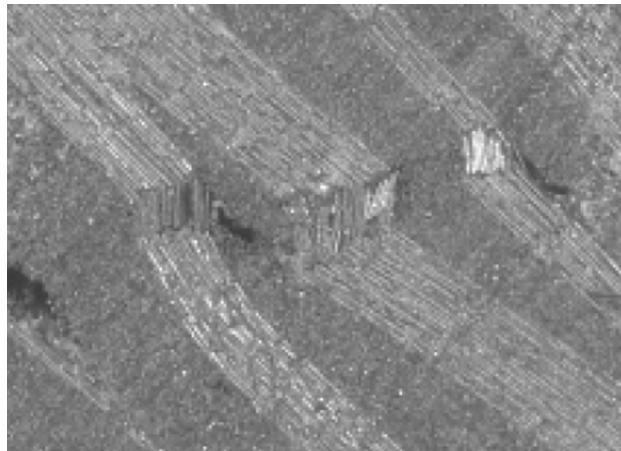
Fig 15

The kinking of fibers shown in FIG 15 indicate results of compressive loads on the structure, with some applied load translated into all the fibers. It also shows the kinking of fibers in the direction of compressive load.

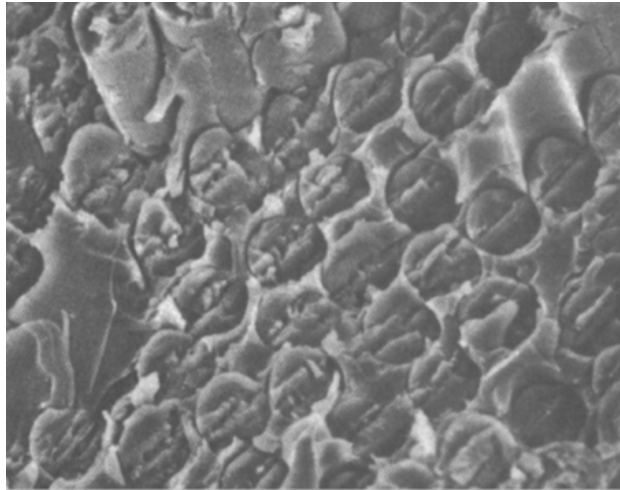
Fig 16

The following photo shows there was evidence of chop marks on the ends of broken structure which indicate that the fibers had buckled and failed under compressive load as well.

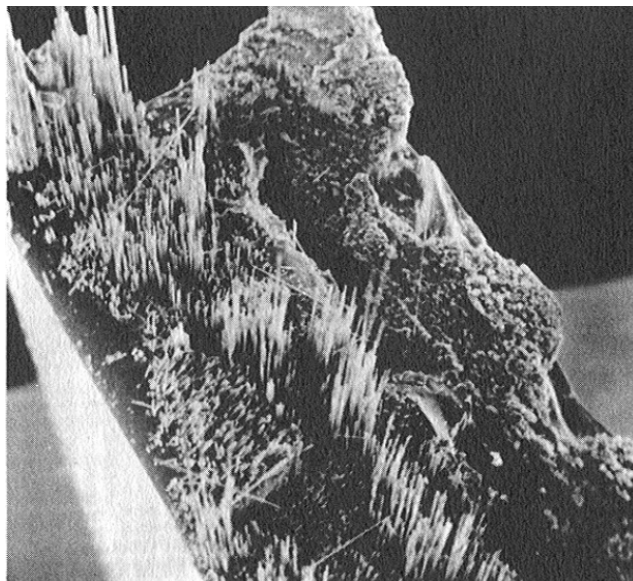
Fig 17

The following photo provides evidence of failure on the composite structure due to bending forces. See Fig. 16 – The relative rough area, visible strands of fibers and tension area and the smooth region as shown in photos indicate failure by compression.

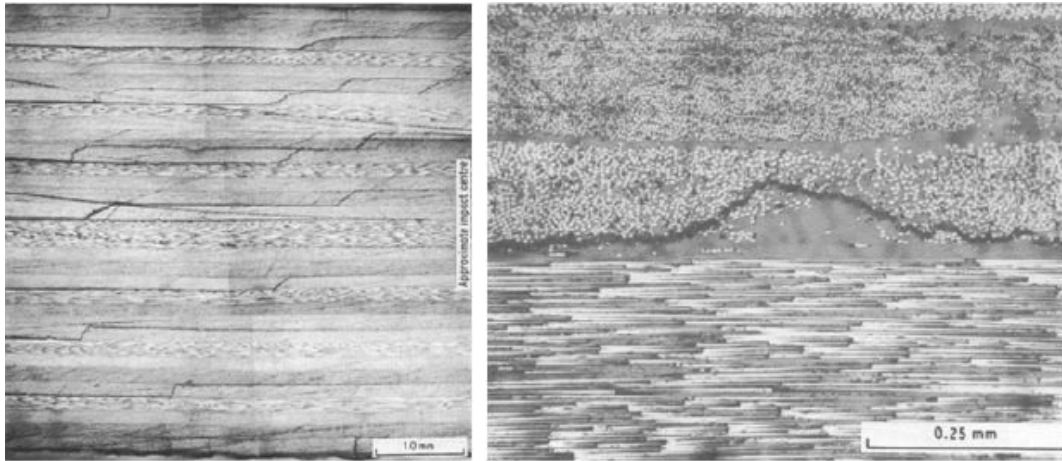
Fig 18

The following photos show the delamination between the composite plies which could attribute to pre or post impact.

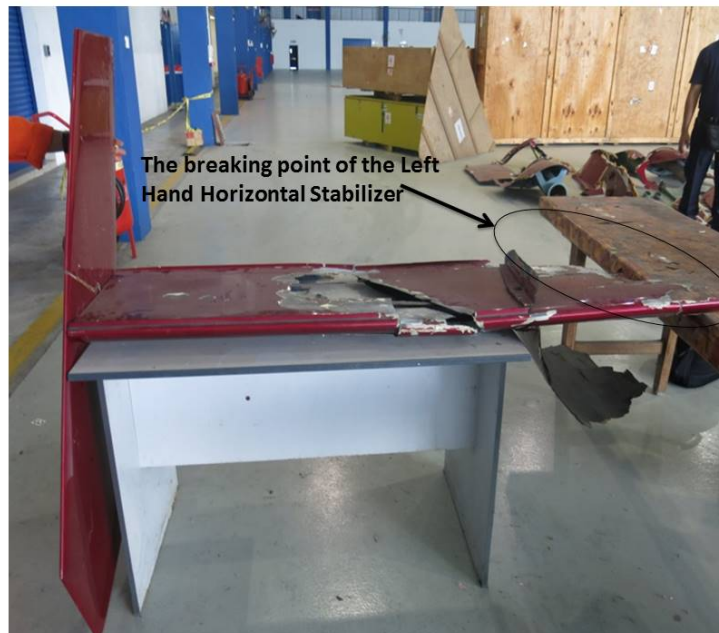
Fig 19

The above photo shows the reconstruction of the horizontal stabilizer assembly. The Left Hand Horizontal Stabilizer was missing.

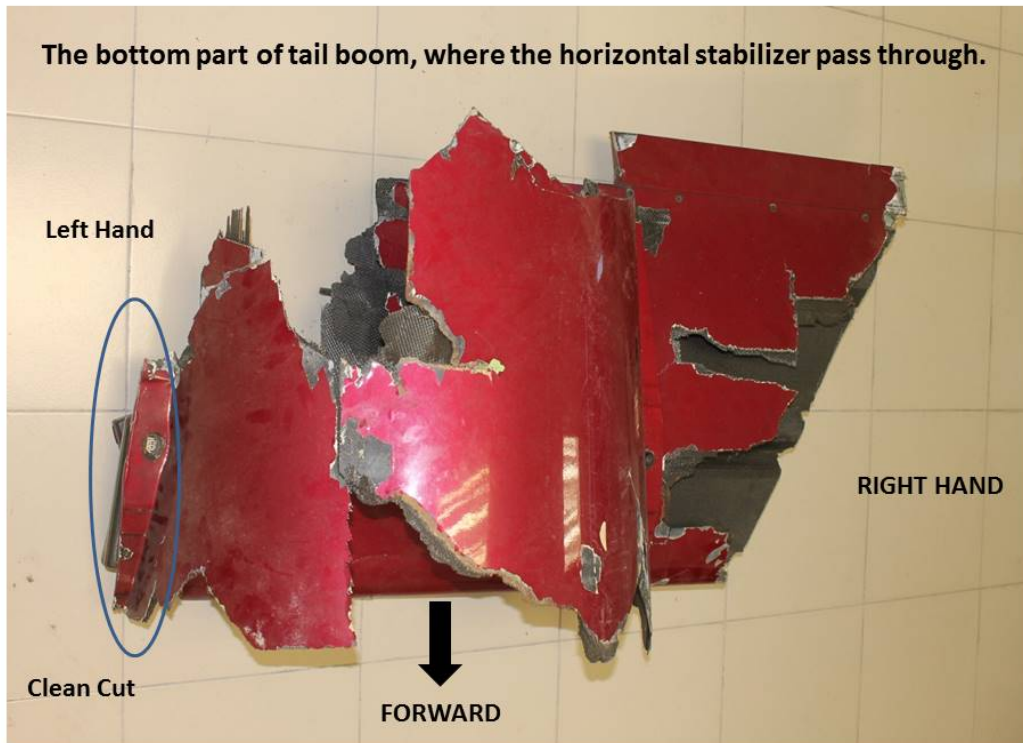
The tail boom section was reconstructed and each failure point was examined. The above photo shows the failure of the tail boom and part of the horizontal stabilizer were reconstructed.

The tail boom section was examined in detailed and the failure points show a clear cut on the tail boom skin parallel to the helicopter longitudinal axis, as shown. (See Fig 20 and Fig 21)

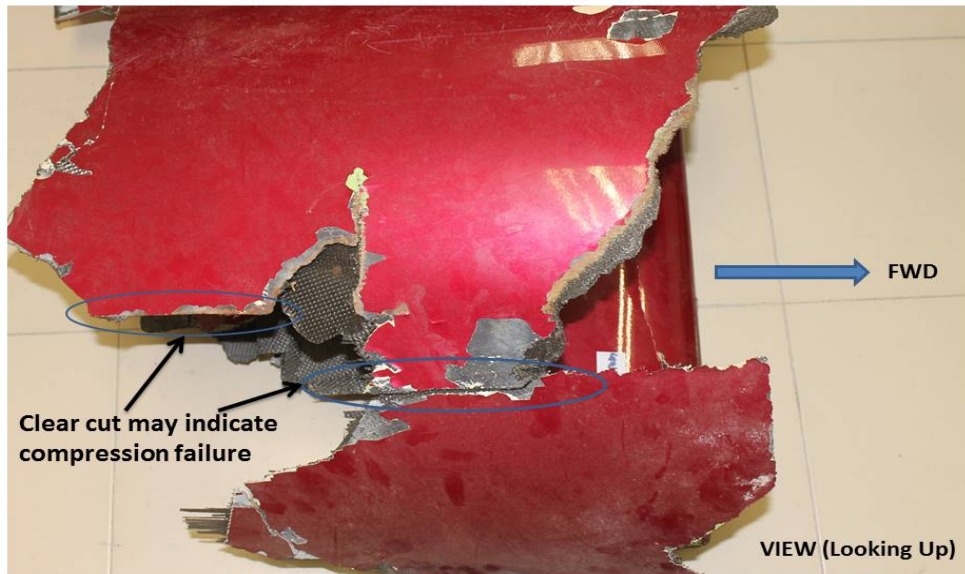
Fig 22

A straight line failure may indicate failure due to compression load. A detailed closed up examination had shown a clean cut failure in a straight line direction (See Fig 22).

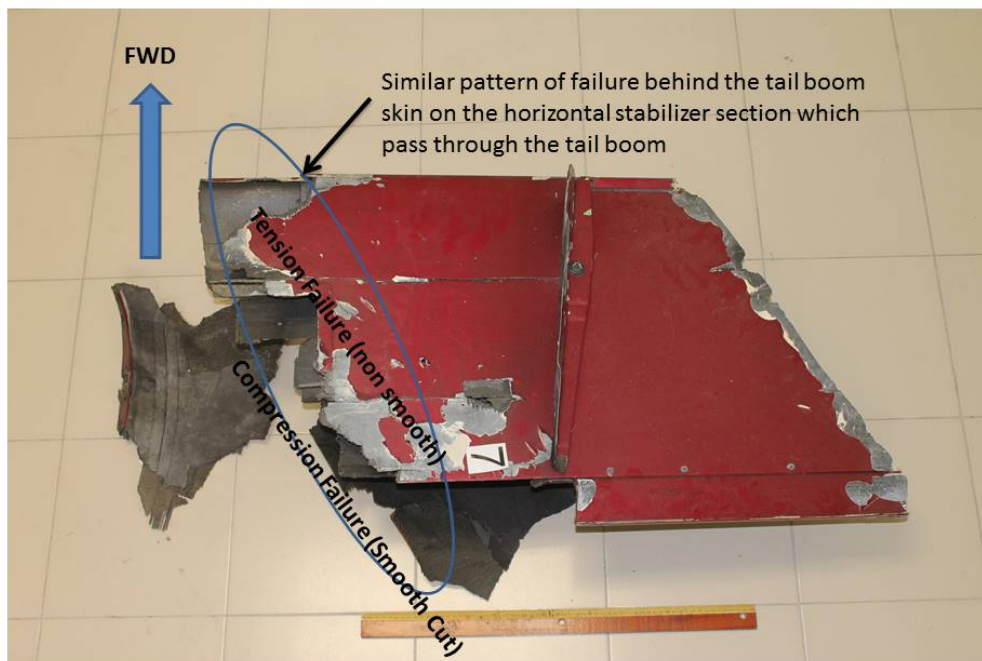
Fig 23

The examination continued with the section of the horizontal stabilizer. As the tail boom section is removed, the horizontal stabilizer section at the breaking point is visible as shown in Fig 23.

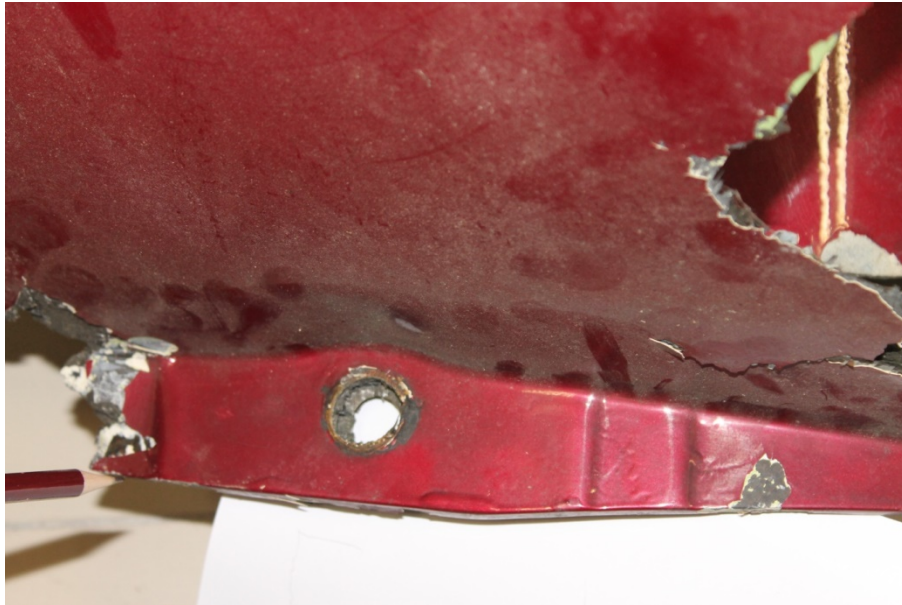
Fig 24

The top skin of the horizontal stabilizer had smooth cut which indicates it had failed under compression load whilst the bottom skin of the horizontal stabilizer had jagged edges failed under tension load. (See Fig 24)

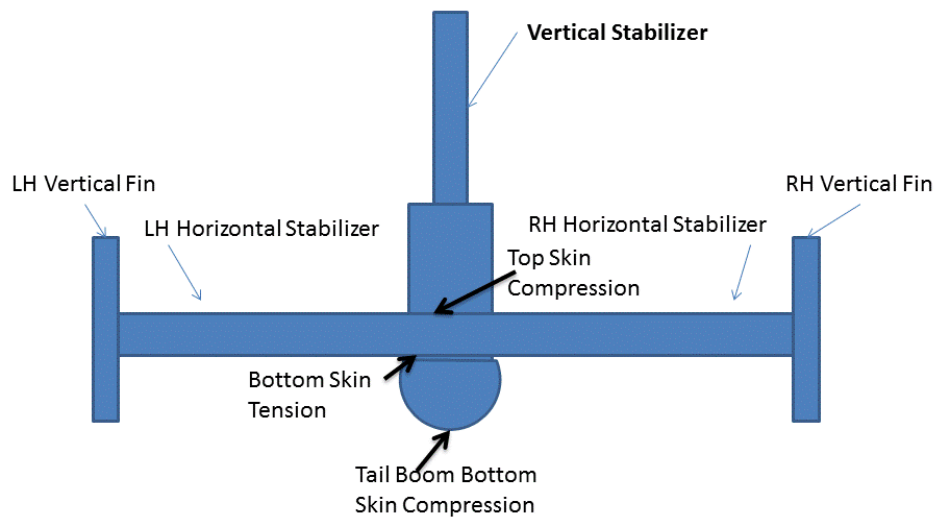
Fig. 25

The tail boom attachment to the horizontal stabilizer indicates a pulled through failure. A review the structure failure lines is shown in the following diagram (See Fig 25).

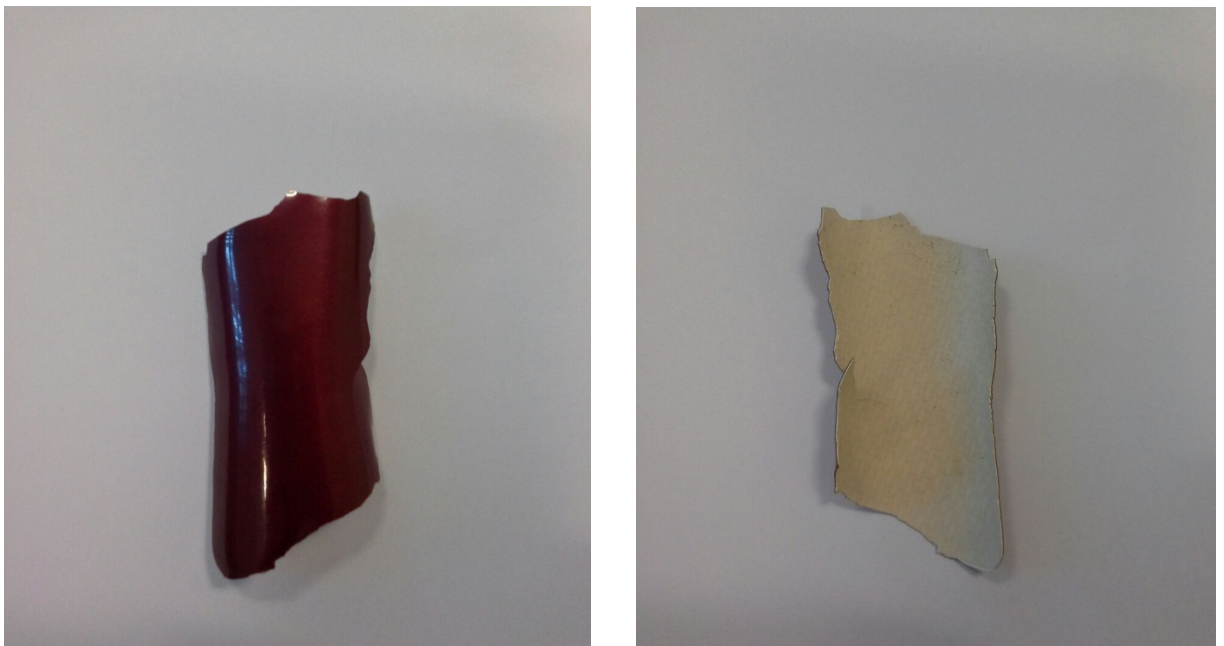
As the LH Landing Gear sunk into the ground, the vertical fin of the LH Horizontal Stabilizer had contacted the ground and may have caused premature structural damage to the LH Horizontal Stabiliser. The piece of chipped-off paint found on the field provides the evidence that LH Horizontal Stabiliser and helicopter structures has been badly distorted causing the dislodgement of the piece of paint.

A small chip of paint was found at the last landing field on the second visit by the investigation team. The chip was curved in nature and having the colour of the horizontal stabiliser on the outer and white colour with cross grain in the inside. This paint chip most probably came from the missing left horizontal stabiliser because the right stabiliser was found intact. When the critical area of the leading edge was subjected to bending, and when the outboard fin contacted the ground, the critical area experienced compressive stress to buckling. In these conditions, delamination and failure of fibres on one of several plies can occur causing it to buckle. The paint could have chipped off from the left stabiliser which had been weakened by the bending stress. (See Fig 28 and Fig 30)

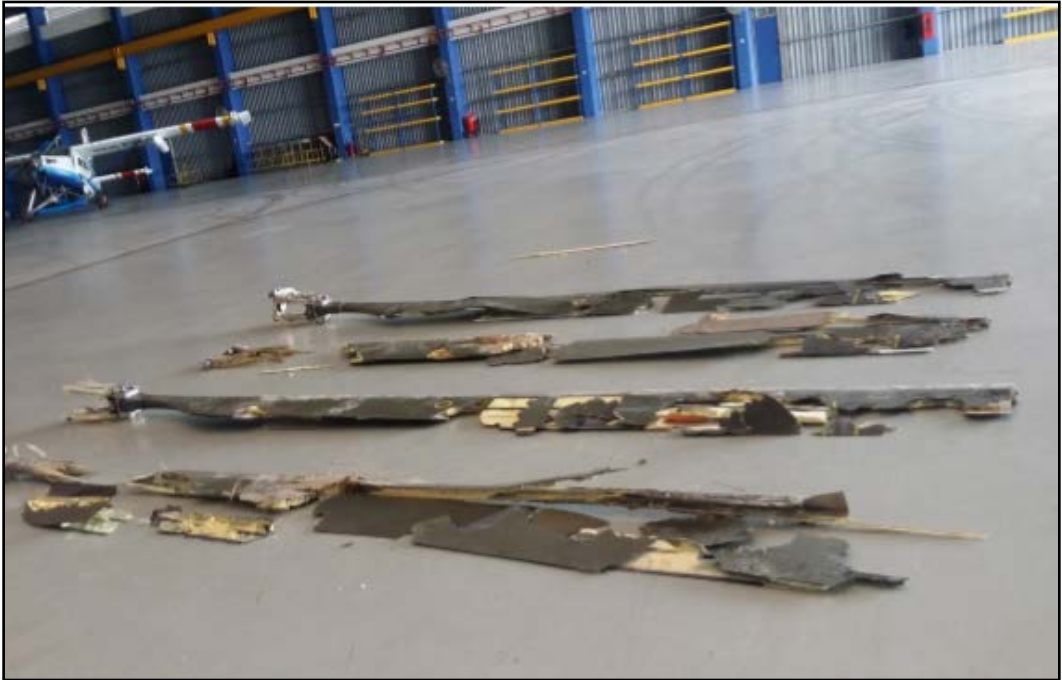
**Appendix 5, Figure 1**

All four main rotor blades had separated from the attachment of the main rotor head. One of the main rotor blades had evidence of severe damage on the main rotor tip. This would suggest that it could have struck the fenestron leading edge.

**EXTENSIVE DAMAGE TO MAIN ROTOR BLADES**

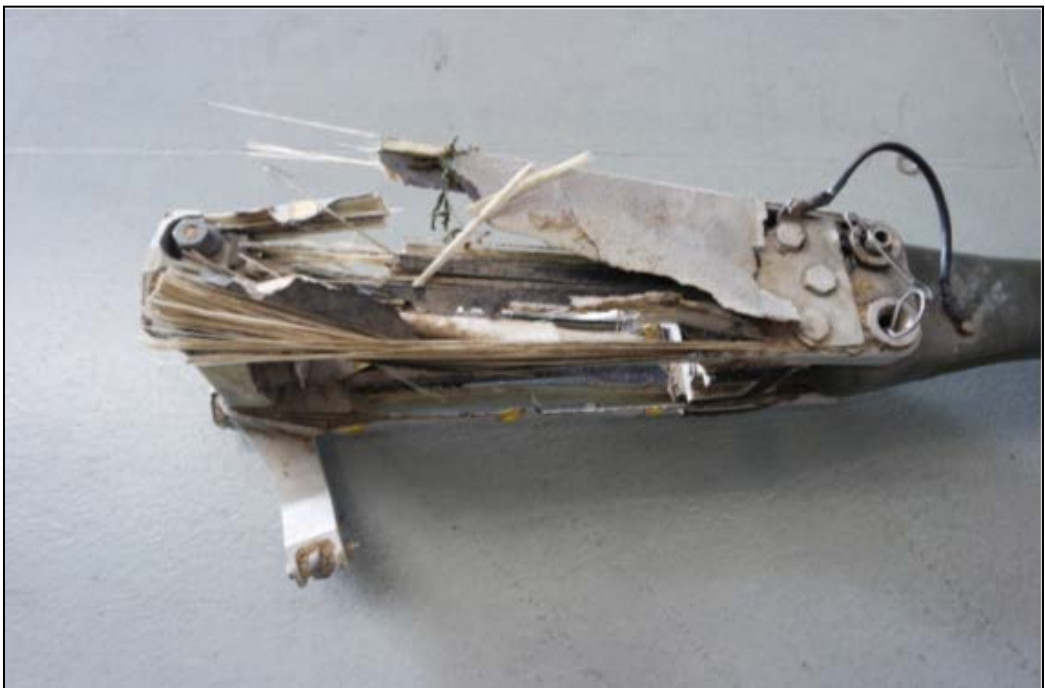
**Appendix 5, Figure 2**

Two of the main rotor blades had evidence of red paint marks on the leading edges of the centre section of the main rotor blades. The fragments on the main rotor blades suggest that the damage could be attributed to high impact force with the tail boom structure and subsequent post impact damage after separation from the main rotor head. (See Appendix 5, Fig 12)

**EXTENSIVE DAMAGE TO MAIN ROTOR BLADE ROOT**

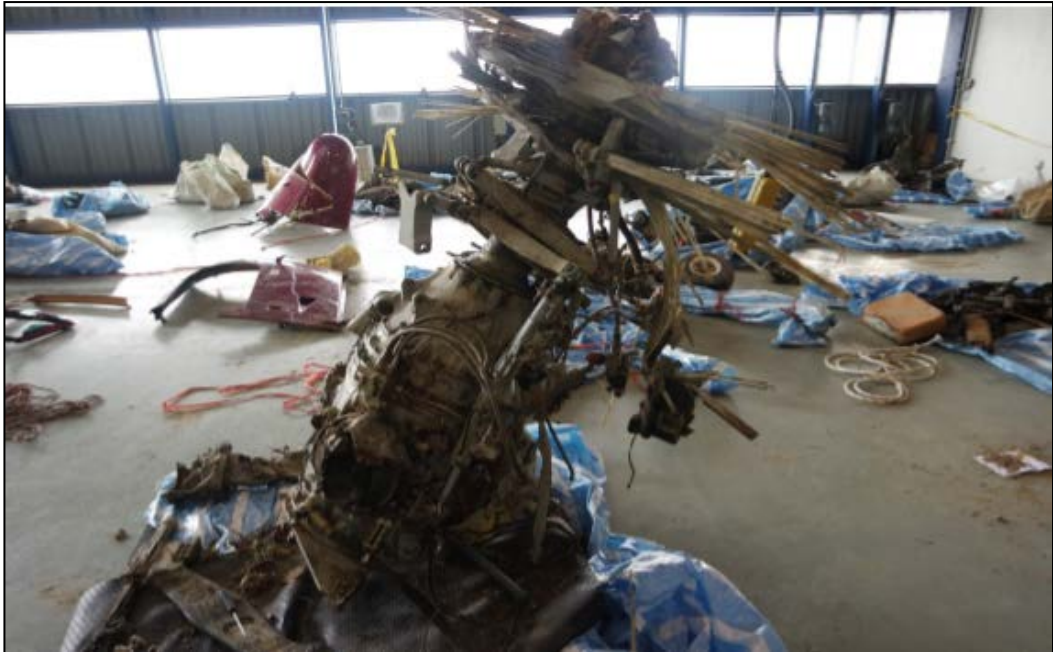
**SEPERATION OF THE MAIN ROTOR BLADES UNDER HIGH  
ROTATIONAL SPEED**

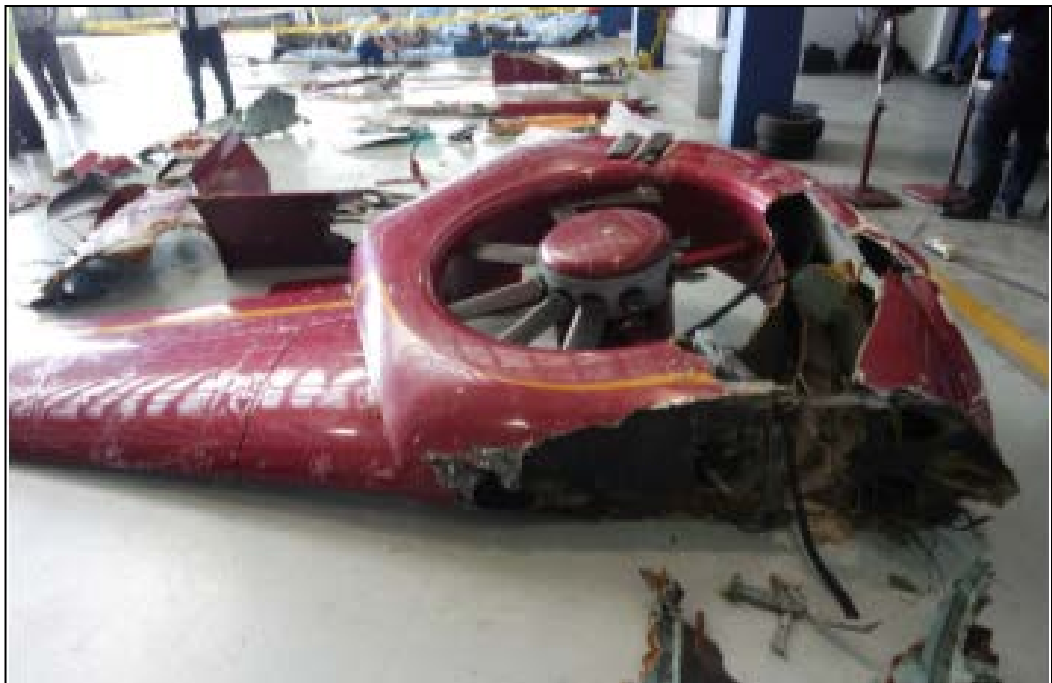
The examination on the fenestron revealed that extensive damage was caused by high impact force which caused it to separate from the tail boom structure.

**SEVERE DAMAGE ON THE LOWER PART OF THE  
FENESTRON**

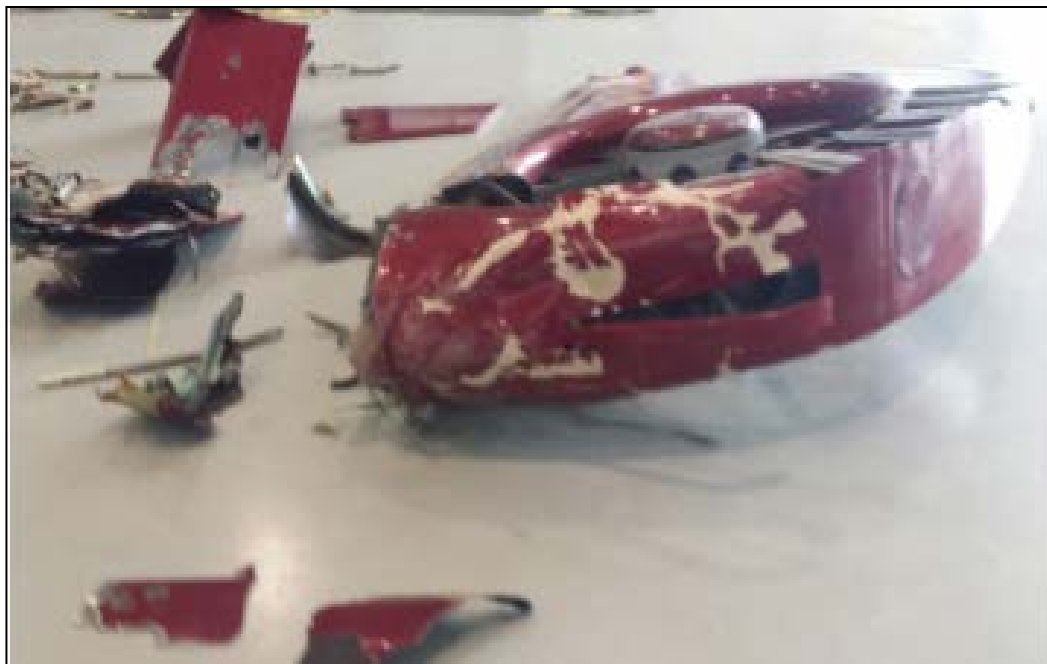
BROKEN TAIL ROTOR BLADES UNDER HIGH ROTATIONAL SPEED

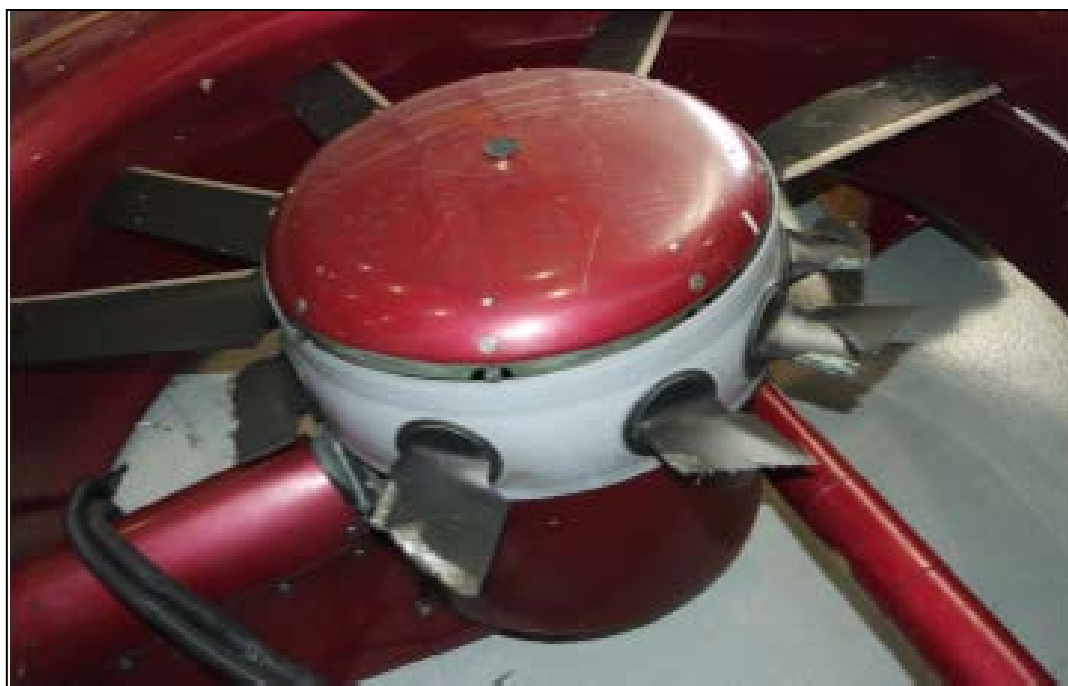
BROKEN BLADES DUE TO SUDDEN IMPACT WITH THE FENESTRON CASING

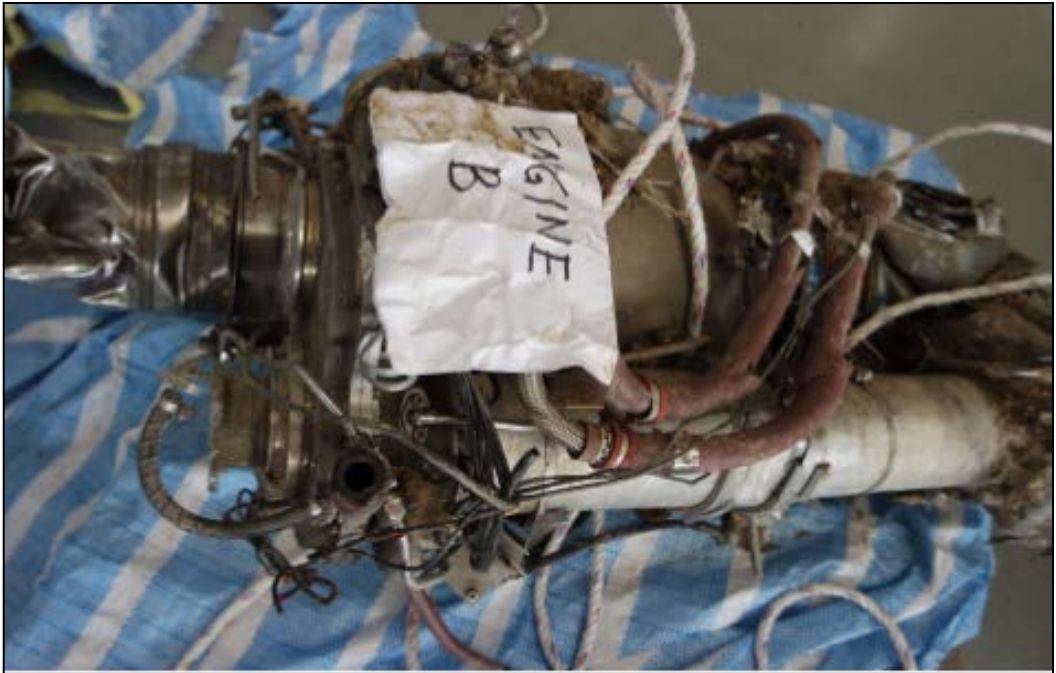
ENGINE CONDITION, SERIAL NUMBER 4270

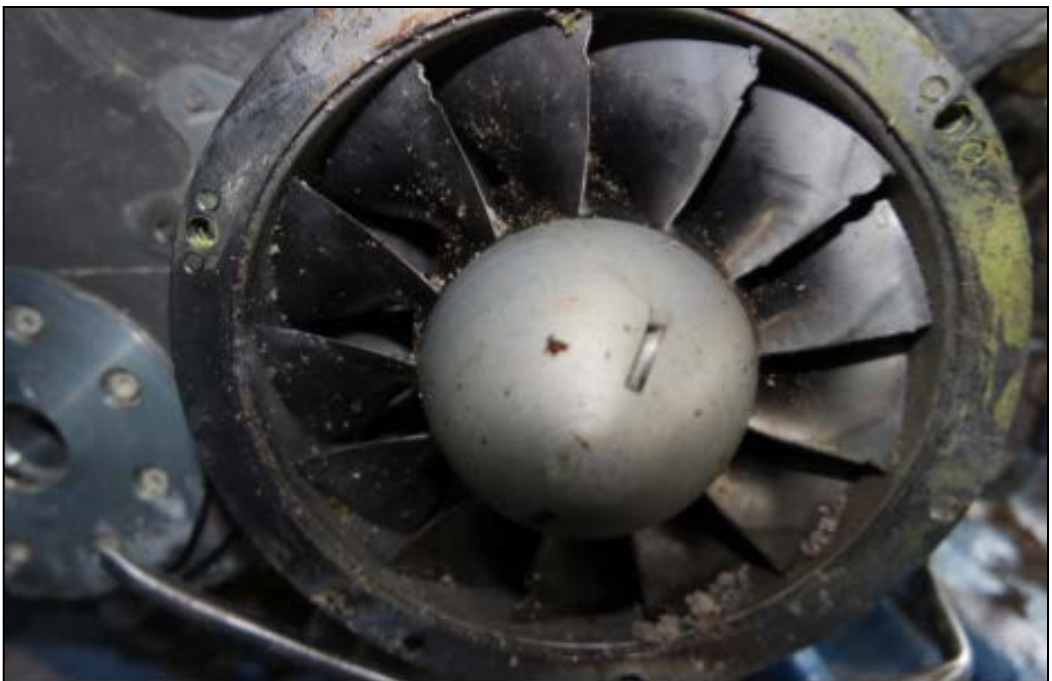
SEVERAL NICKS ON THE COMPRESSOR BLADES

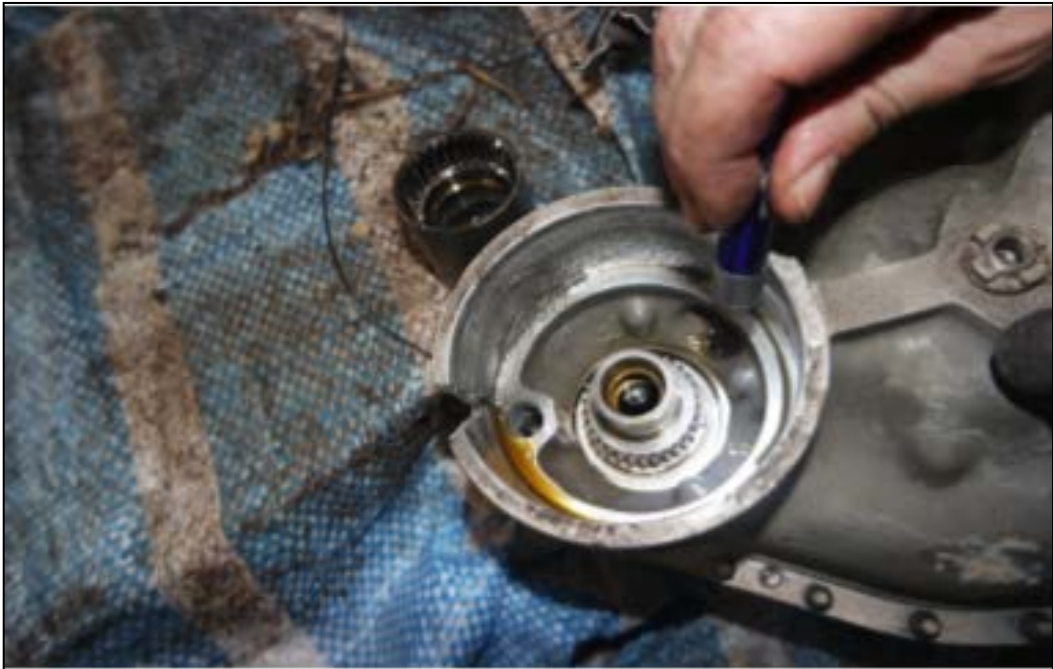
MANUFACTURER'S ALIGNMENT MARKS ON THE SPLINE  
AND BASE MOUNT

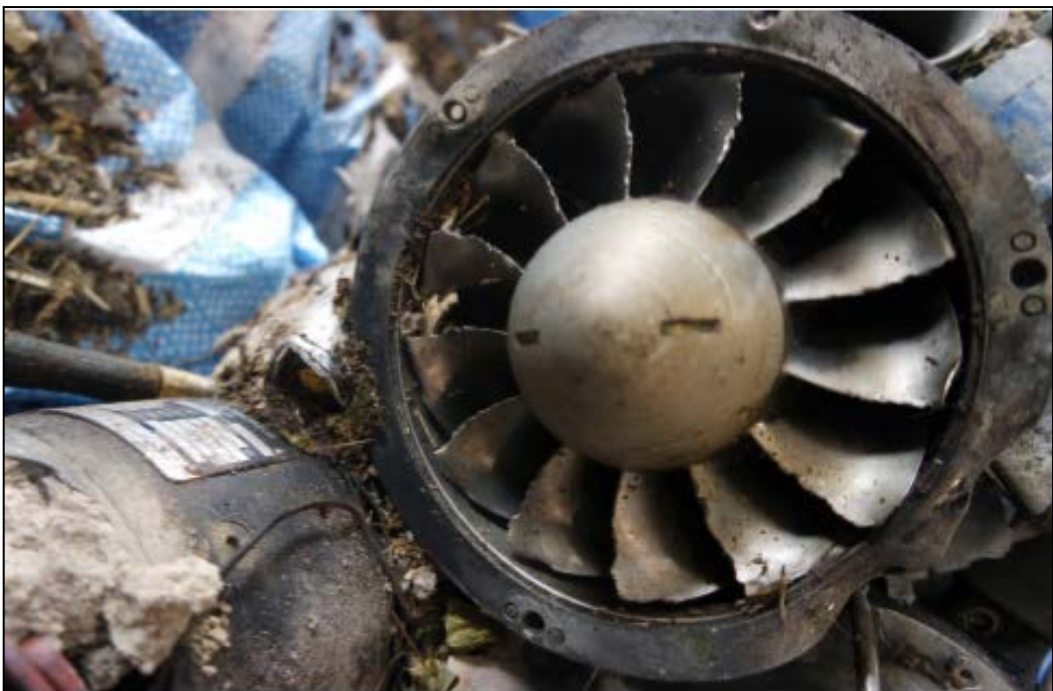
The compressor blades were found jagged and severely bent due to foreign objects damage (FOD) from ingress of wooden branches. Boroscope inspections around the impeller section revealed traces of solidified aluminium deposits due to sudden scrapping under impact load and intense heat. The compressors were totally seized and there was evidence of post impact fire on the engine.(See Appendix 5, Fig 12)

SEVELY BENT AND JAGGED COMPRESSOR BLADES DUE TO  
INGRESS OF FODs.

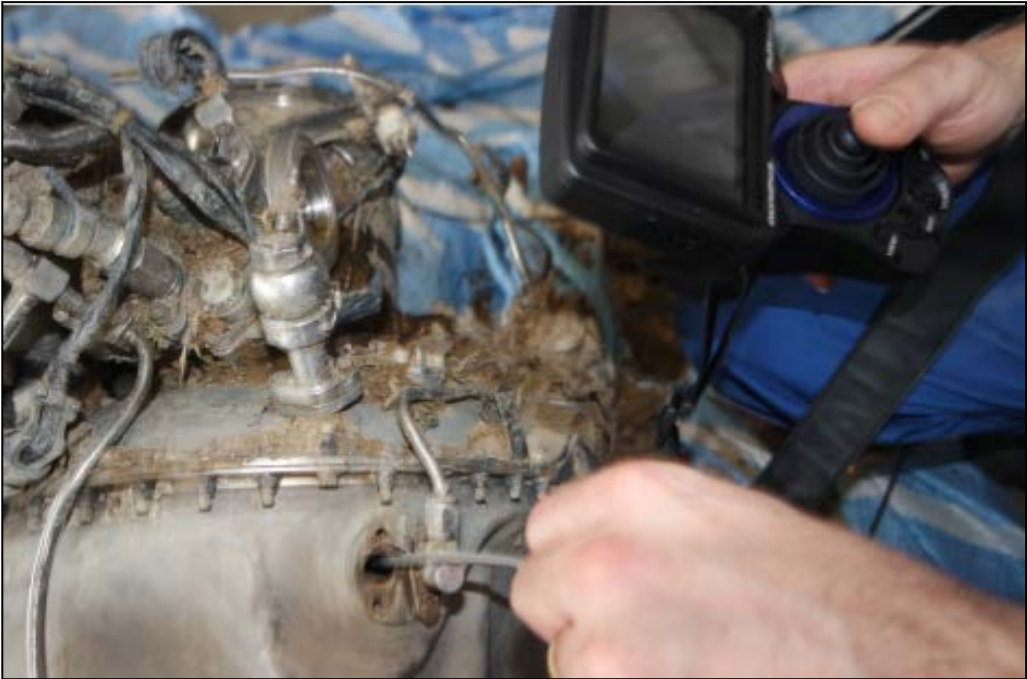
**Appendix 5, Figure 11**

deposits of an abrupt engine failure. The oil filter appears normal and clean. The manufacturer's alignment marks which coupled the power transfer shaft to the spline at the reduction gearbox - Module 5 did not indicate of any signs of excessive engine over-torqued. Boroscope inspections around the impeller section revealed slight traces of aluminium deposits due to sudden scrapping under impact load. There was evidence of slight nicks on the compressor blades due to ingestion of debris. The compressor blades had totally seized. (See Appendix 5 Fig 11)

**BOROSCOPE INSPECTION AROUND THE IMPELLER SECTION**

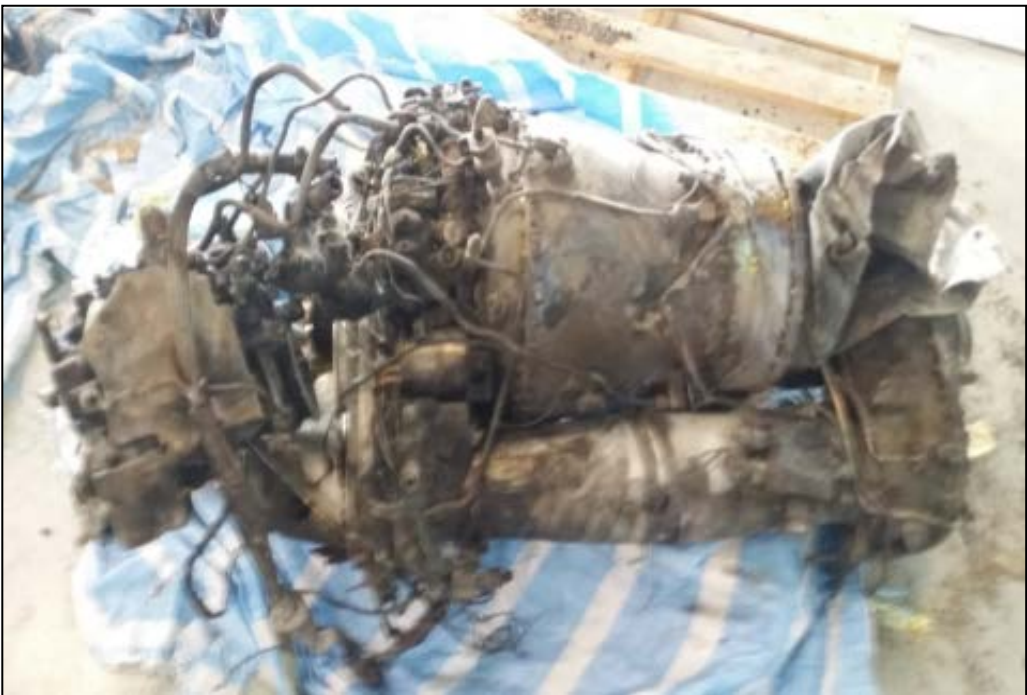
**Appendix 5, Figure 12**

**POST IMPACT FIRE ON THE ENGINE**

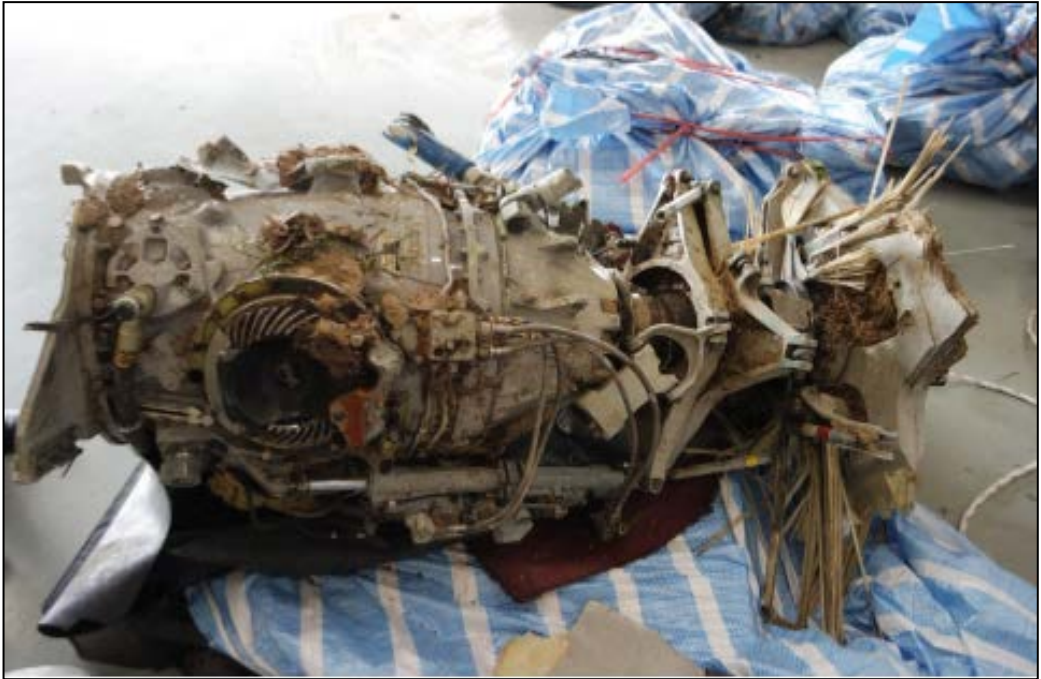
**Appendix 5, Figure 13**

**CONDITION OF MAIN ROTOR HEAD ASSEMBLY**

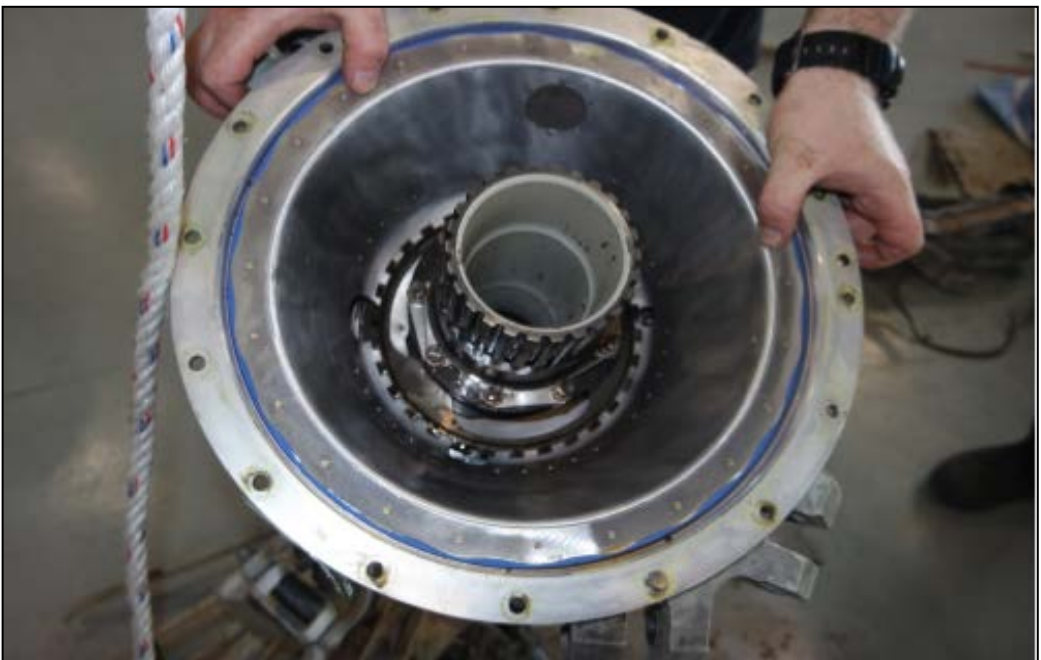
**Appendix 5, Figure 14**

**CONDITION OF MAIN ROTOR GEARBOX**

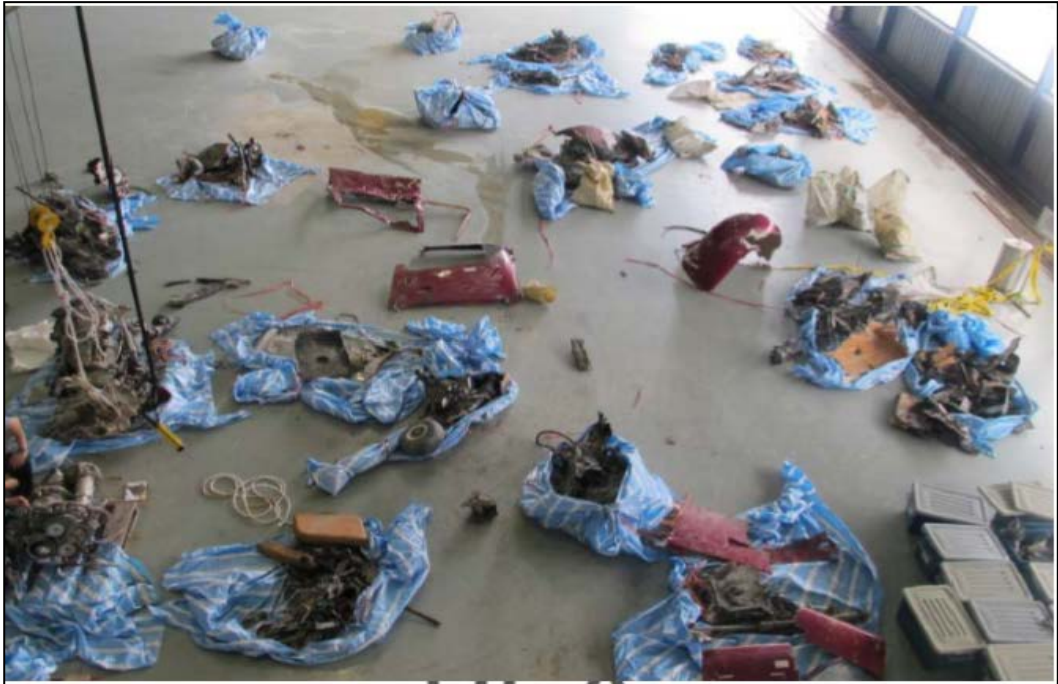
CONDITION OF THE COVERED PARTS

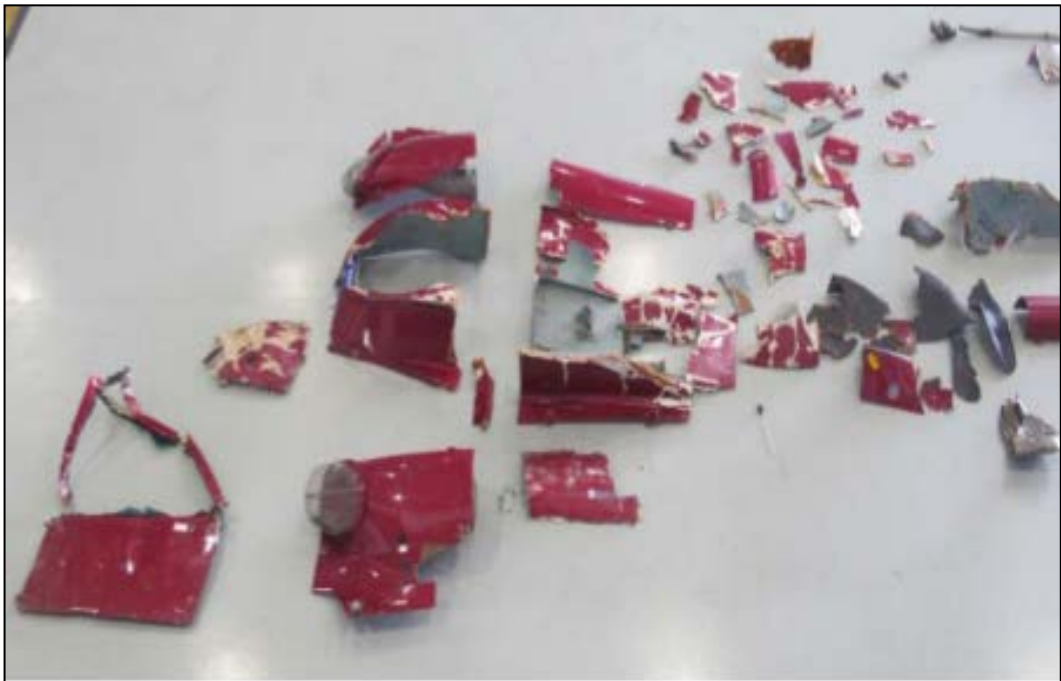
PARTS RECOVERED ALONG THE HELICOPTER TRAJECTORY

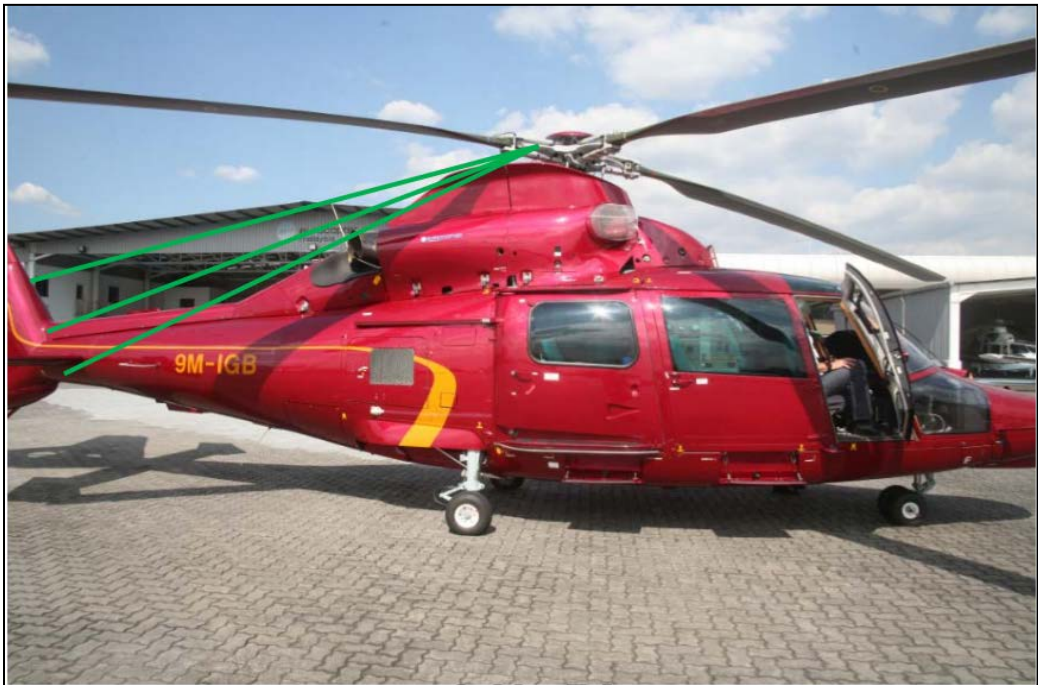
**Appendix 6, Figure 1**

**3 IMPACTS EVIDENCE ON THE REAR PART OF THE AIRFRAME**

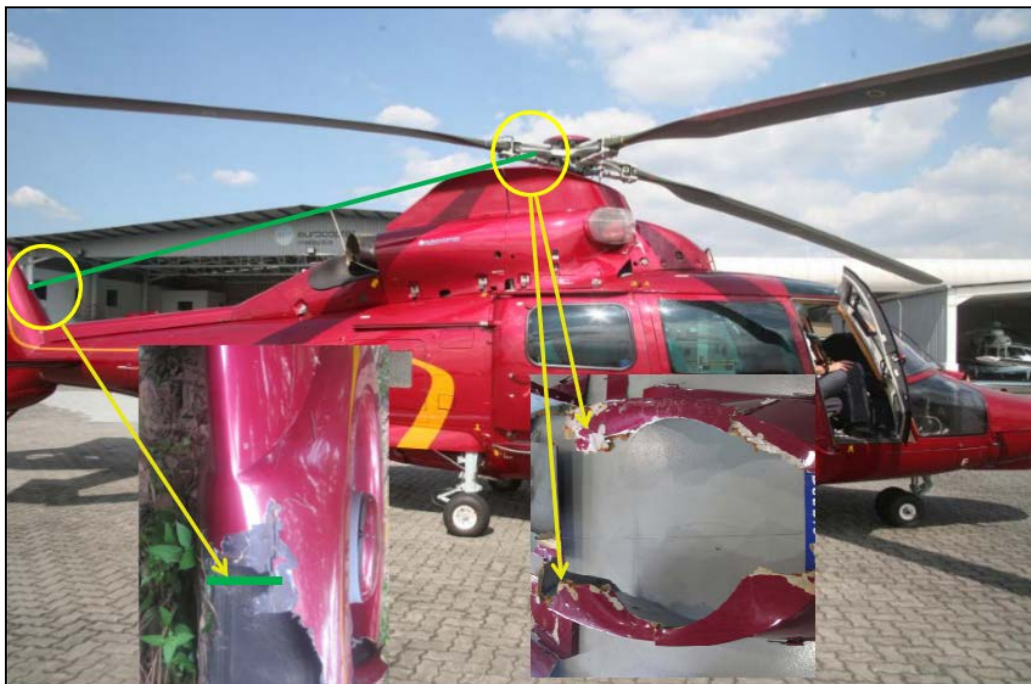
**Appendix 6, Figure 2**

**3 IMPACTS EVIDENCE ON THE REAR PART OF THE AIRFRAME**
