# AIRCRAFT ACCIDENT REPORT 03/15

## Air Accident Investigation Bureau

Report on the accident to Helicopter Dauphine,  
AS 365 N3 Registration 9M-IGB near Subang Airport,  
40 Nautical Miles Sout East of Subang Airport,  
MALAYSIA  
(N 03 00.64 E101 51.19)

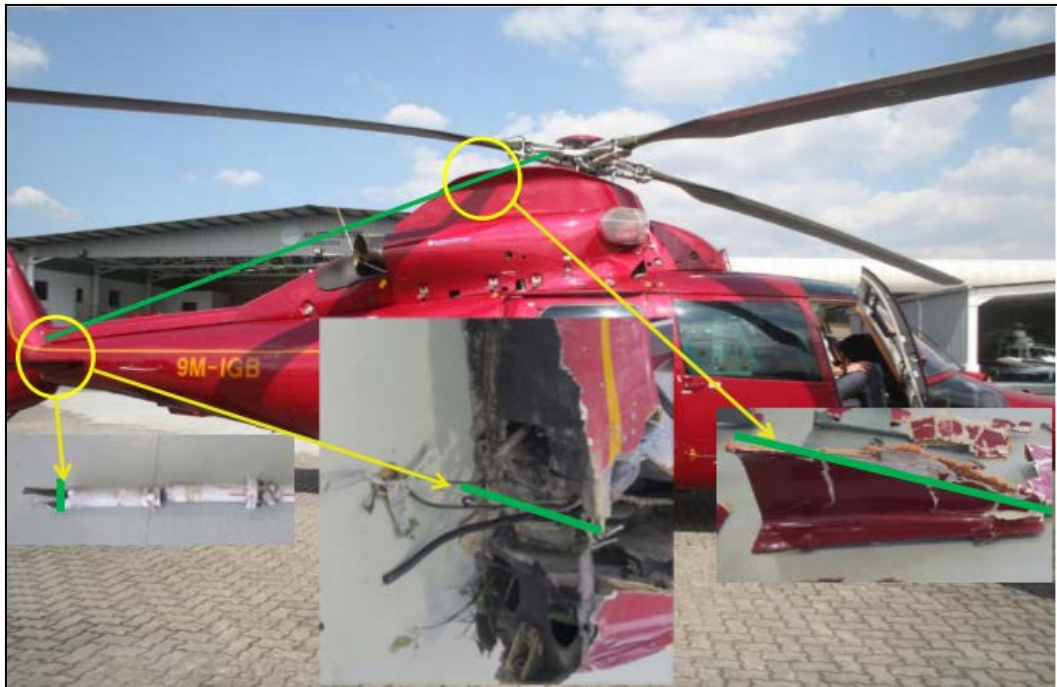
1 IMPACT ON THE FENESTRON FRAME (+ TAIL DRIVE SHAFT AND ON ENGINE COWLING)

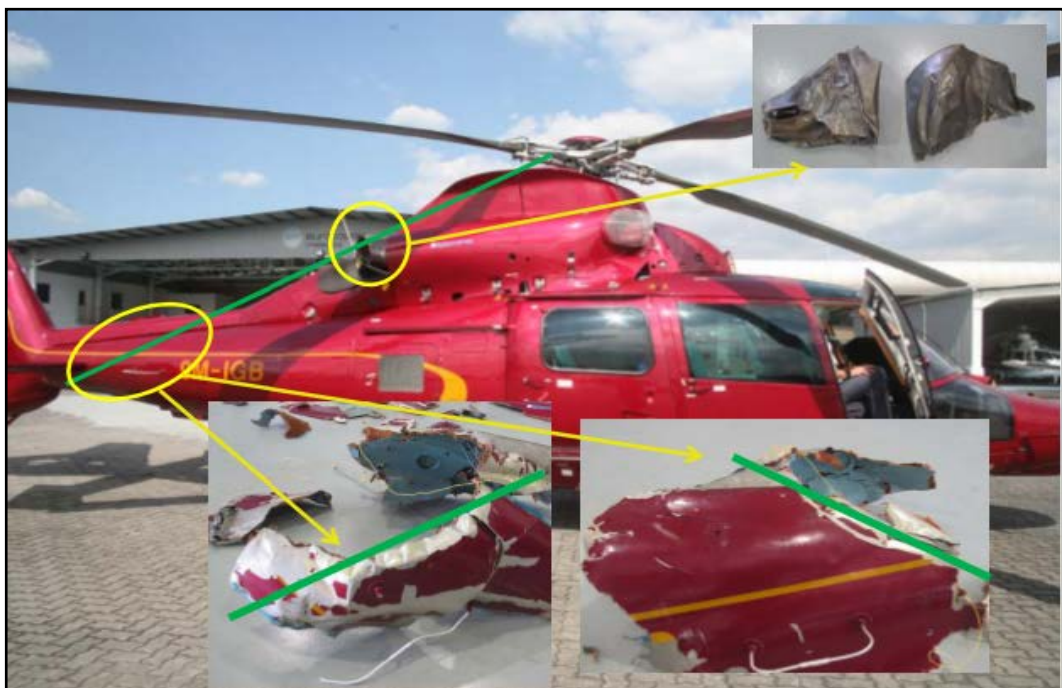
1 IMPACT EVIDENCE ON THE TAIL BOOM(+ TAIL DRIVE SHAFT, ENGINE COWLING AND EXHAUST PIPES)

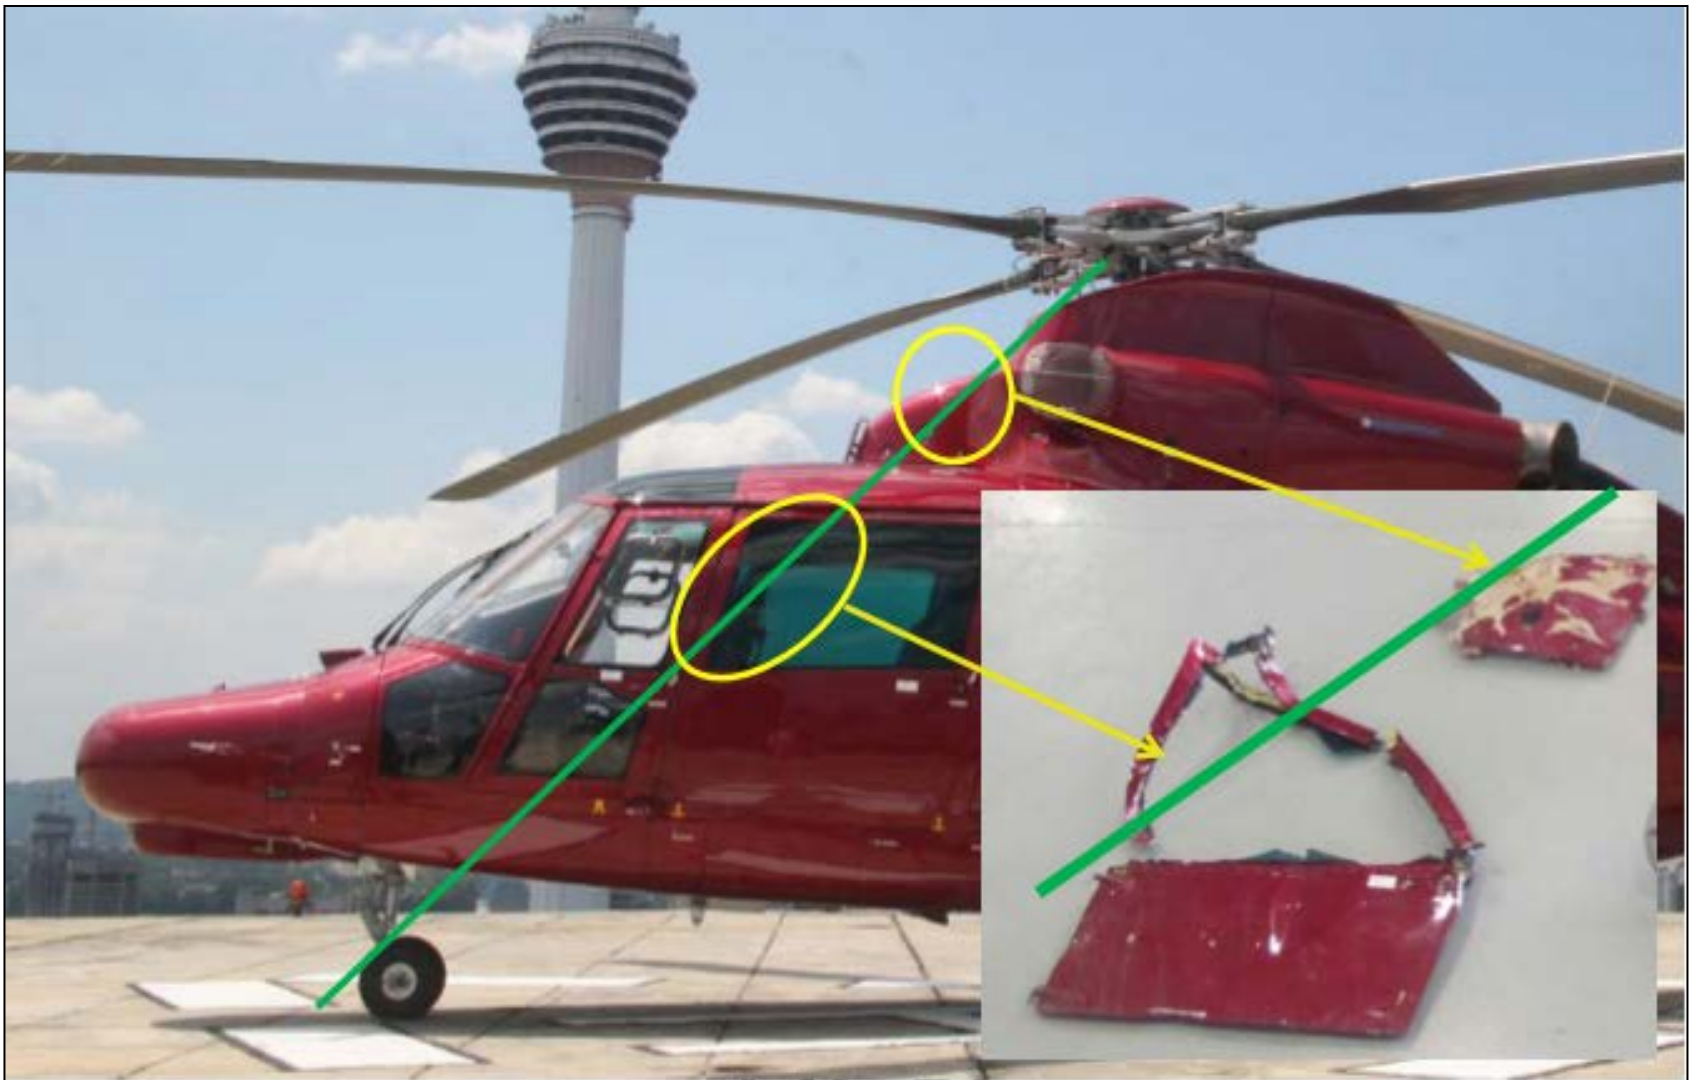
1 IMPACT EVIDENCE ON THE LEFT SIDE OF CABIN DOOR AND FORWARD COWLING
