**PRELIMINARY
AIRCRAFT ACCIDENT REPORT
30 APRIL 2015**

**EUROCOPTER DAUPHINE AS365 N3, REGISTRATION 9M-IGB
CRASH AT KG. SUNGAI PENING-PENING, SEMENYIH, SELANGOR
MALAYSIA
04 APRIL 2015**

**AIR ACCIDENT INVESTIGATION BUREAU OF MALAYSIA
MINISTRY OF TRANSPORT
MALAYSIA**

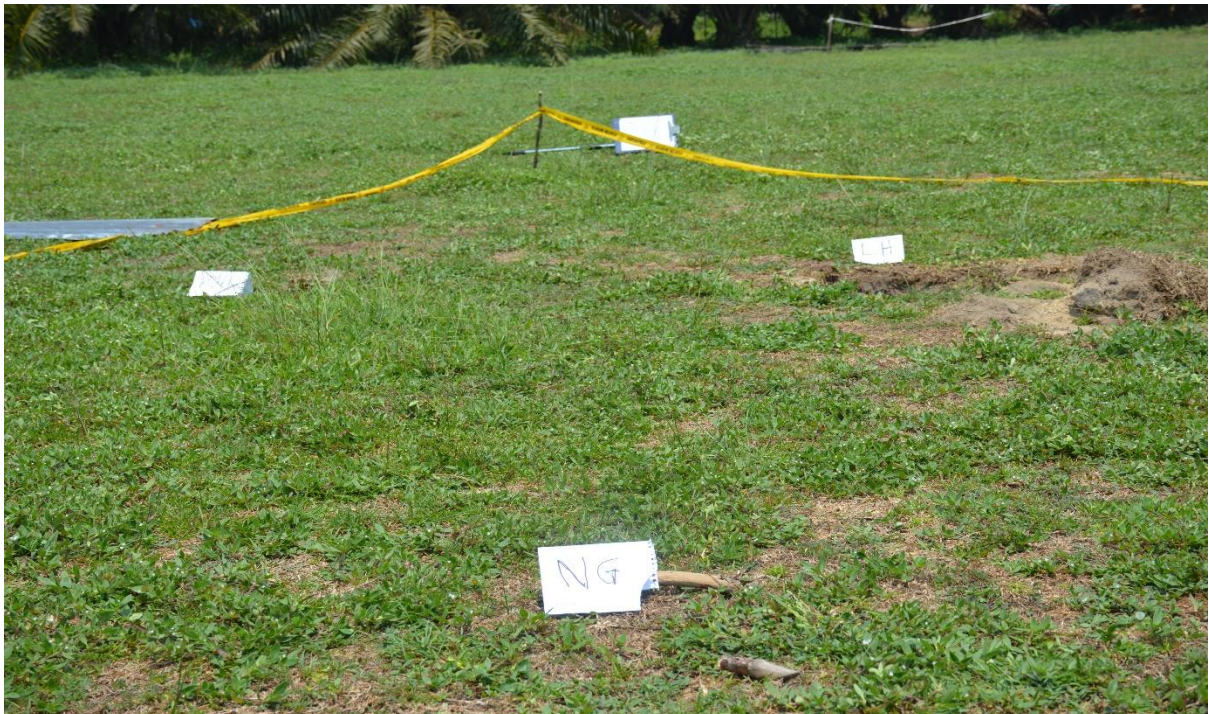
First landing area

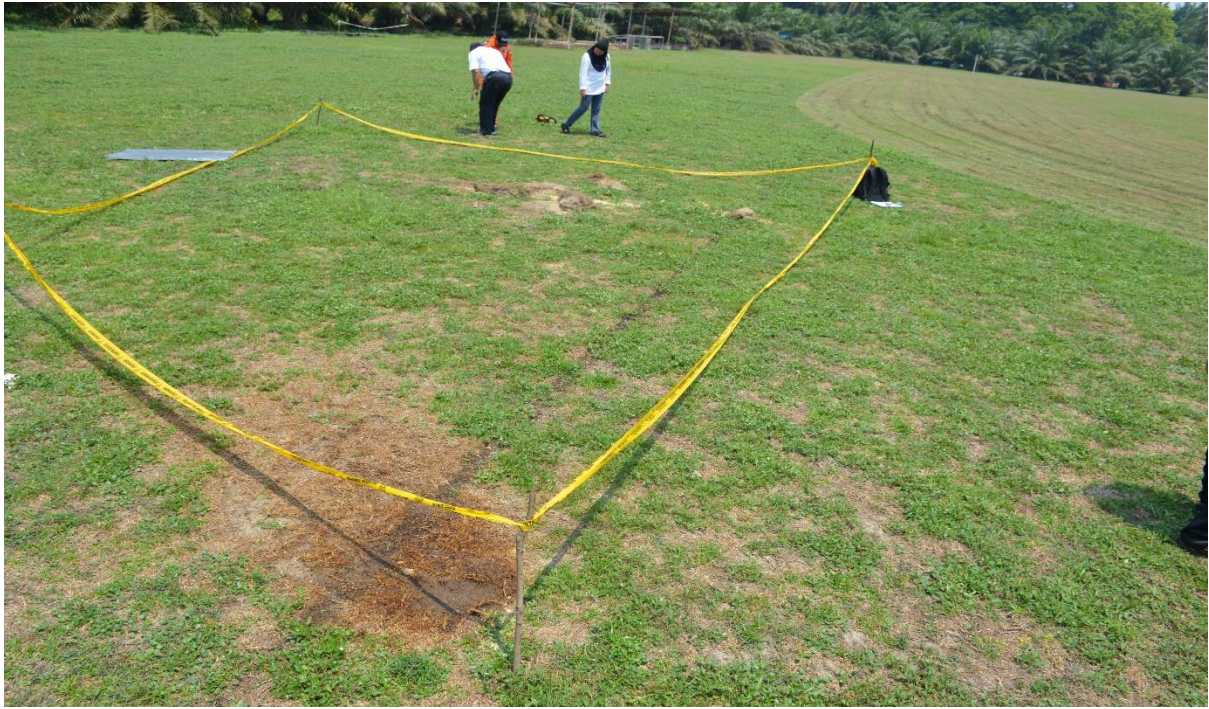
- 2.2 There was also evident of excessive fluid leak in the sink hole as well as on the grass about 10 meters forward of the landing point. Further investigation is being carried out to determine the fluid type and its specification.

First landing area with suspected hydraulic oil spot

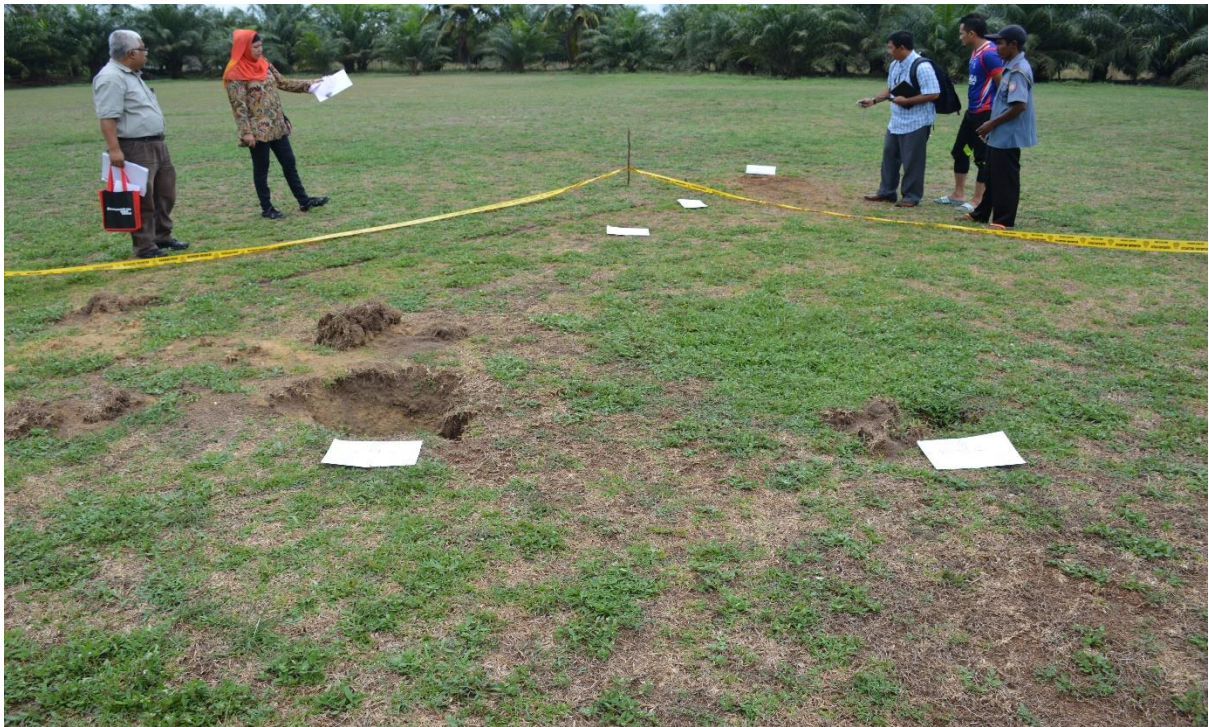
Picture of port holes

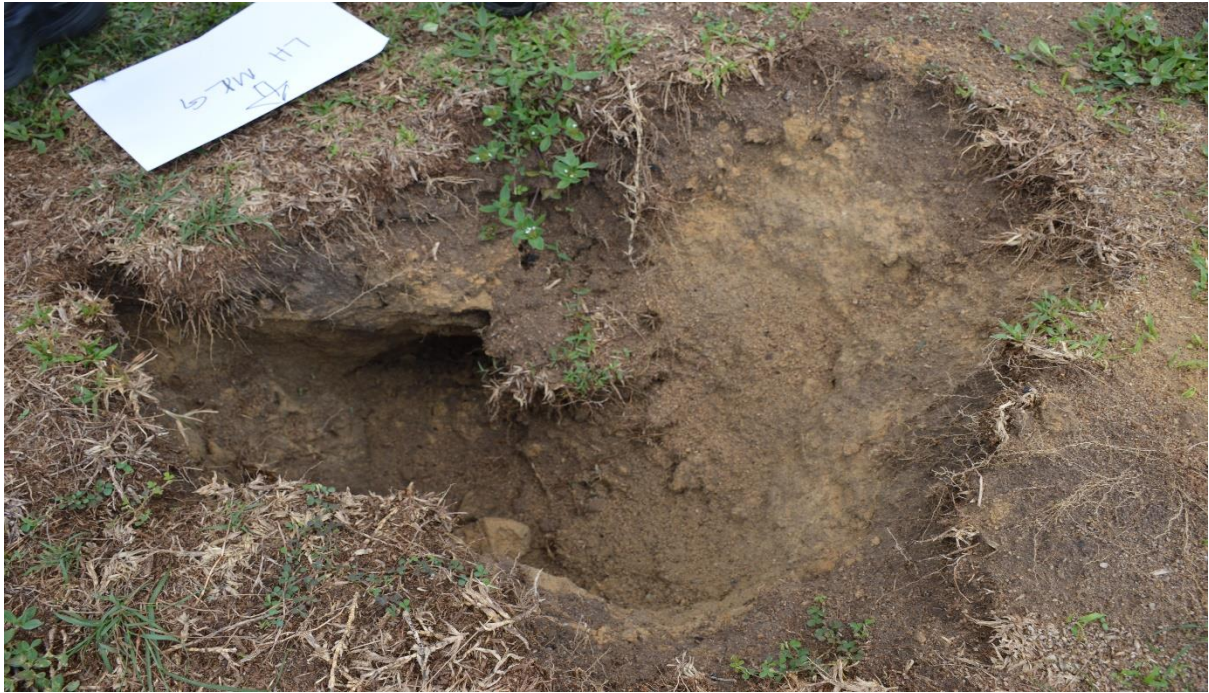
- 2.1 SSCVFDR information and inspection of the last landing area before the accident revealed that the helicopter had its left landing gear sunk into soft ground while attempting a landing at a football field of Sekolah Rendah Ladang Kota Bahagia. The left landing gear had sunk to approximately 20 inches deep into the soft ground causing the helicopter to tilt more than 13 degrees to the left. The left main landing gear and the tail section below the tail rotor fenestron was suspected to have impacted the ground.

The port hole of the LH landing gear

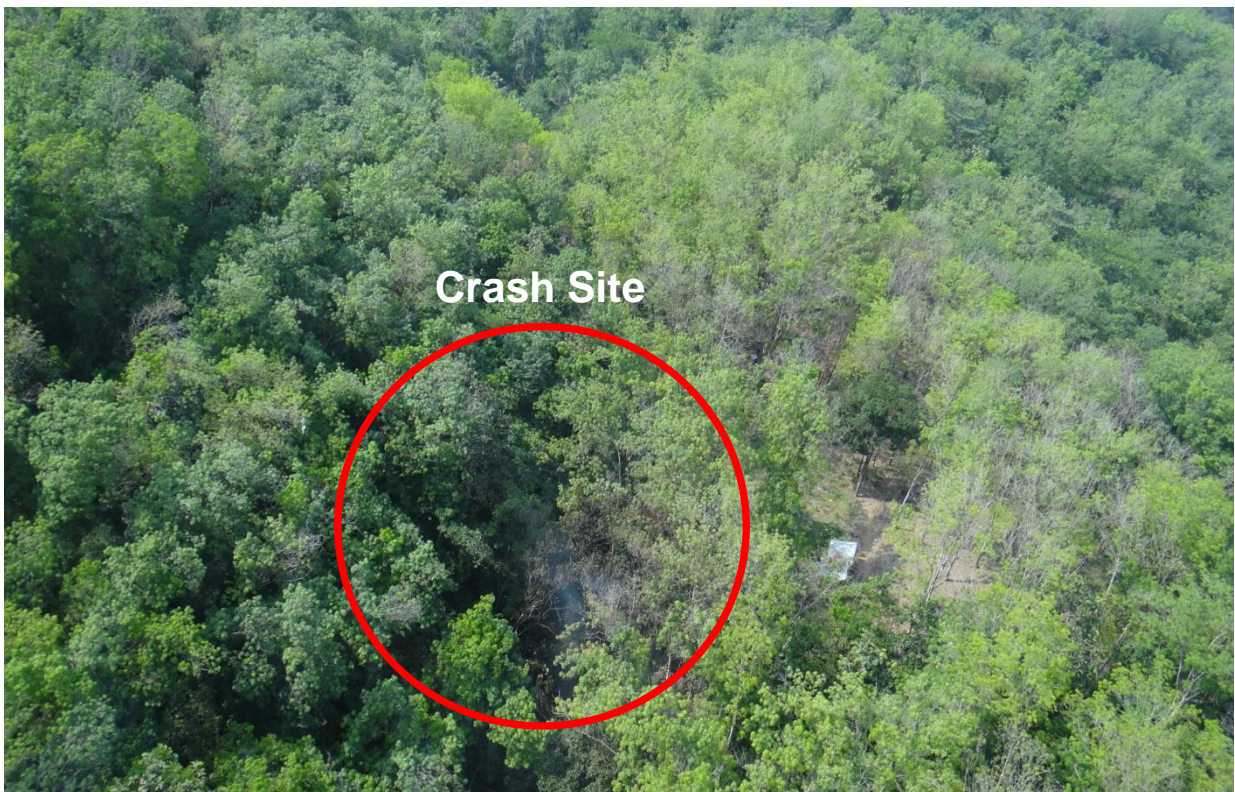
- 2.4 The main wreckage was concentrated at one area in a ravine. The 4 main rotor blades were found at different places from the main wreckage. The tail rotor and the right horizontal stabiliser was found about 200 meters away from the main wreckage.

Crash site from the air

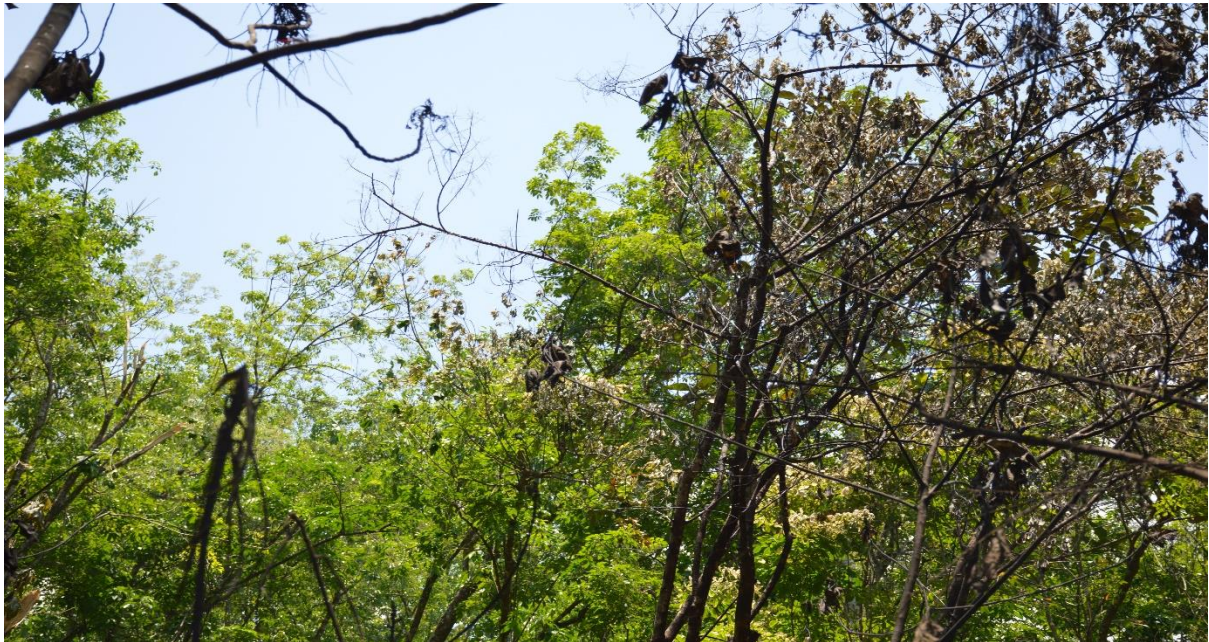
Broken/ burnt trees

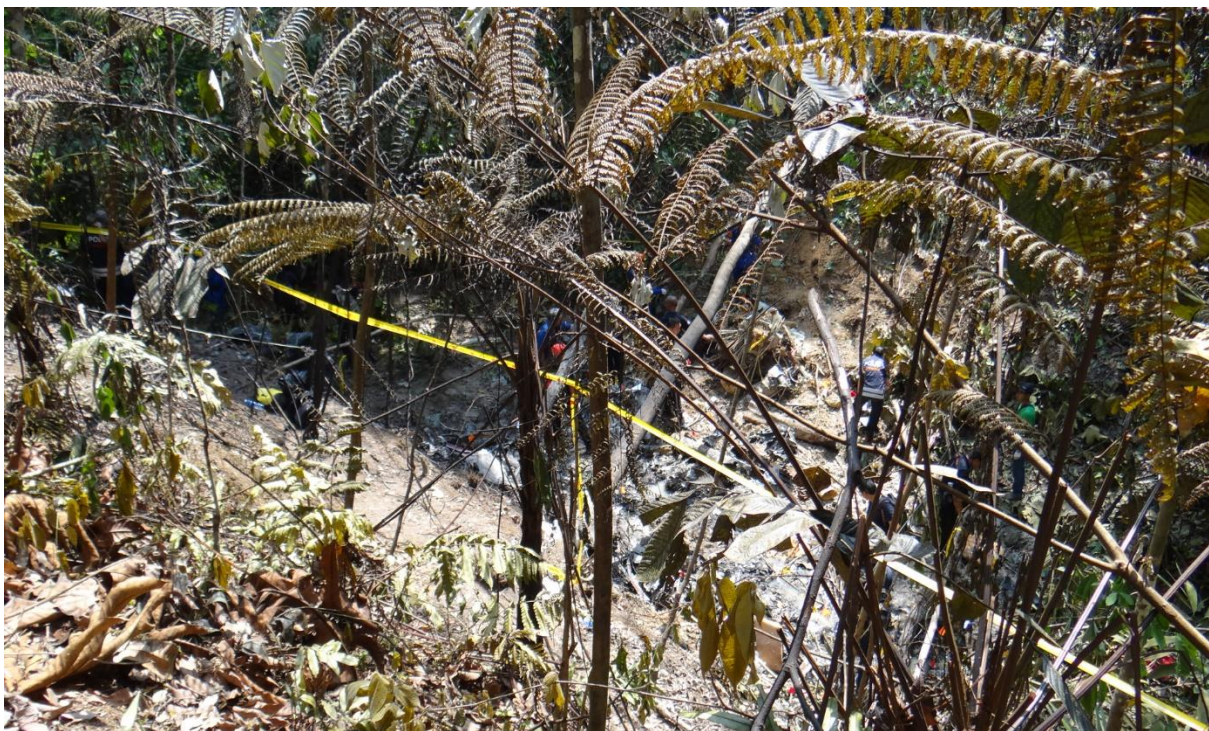
Crash site
