AIRCRAFT ACCIDENT FINAL REPORT
A 03/22P
Air Accident Investigation Bureau (AAIB)
Ministry of Transport Malaysia

Piper Warrior II PA28-161, Registration 9M-BAA
beside Sungai Pinji, near Medan Gopeng, Ipoh, Perak
on the 01 August 2022

ACCIDENT REPORT NO.: A 03/22

OPERATOR : BATS AVIATION SDN BHD
AIRCRAFT TYPE : PIPER WARRIOR II PA28-161
NATIONALITY OF AIRCRAFT : MALAYSIA
REGISTRATION : 9M-BAA
**PLACE OF OCCURRENCE : BESIDE SUNGAI PINJI, NEAR MEDAN
GOPENG, IPOH, PERAK**
DATE AND TIME : 01 AUGUST 2022 AT 2007 LT

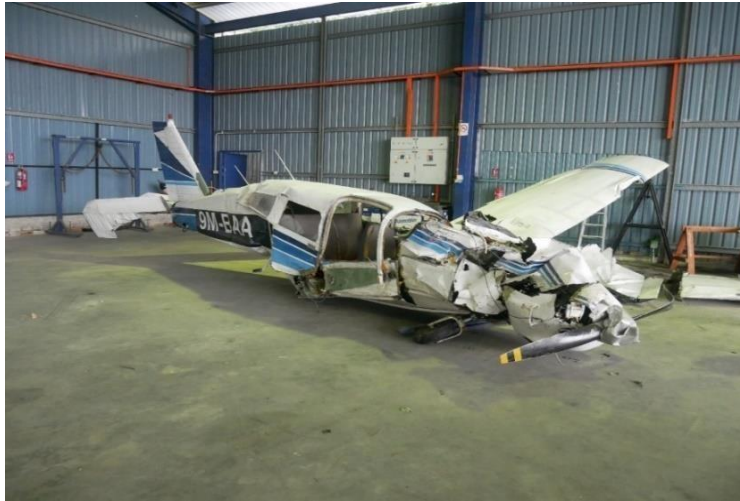
- a. Engine – No extensive damage on the cylinder, oil sump and crankcase. Magnetos - No extensive damage on both magnetos.
- b. Carburettor - No extensive damage on the carburettor and only carburettor induction box crushed.
- c. Engine Accessory – Most of the engine accessory are badly damaged beyond repair.
- d. Propeller – Damaged beyond repair.
- e. Fuselage – Cockpit area is badly damaged. All the avionics equipment is beyond repair. Aircraft main frame badly distorted and beyond repair. Wings – Starboard wing broken into two. Both wing main spar distorted beyond repair.
- f. Empennage – Tail section of the aircraft is badly damaged and beyond repair.
- g. Landing Gear – Nose landing gear bent. Both main landing gear still attached to the wing.

Figure 2: Aircraft condition at the hanger after salvage activities from the crash site

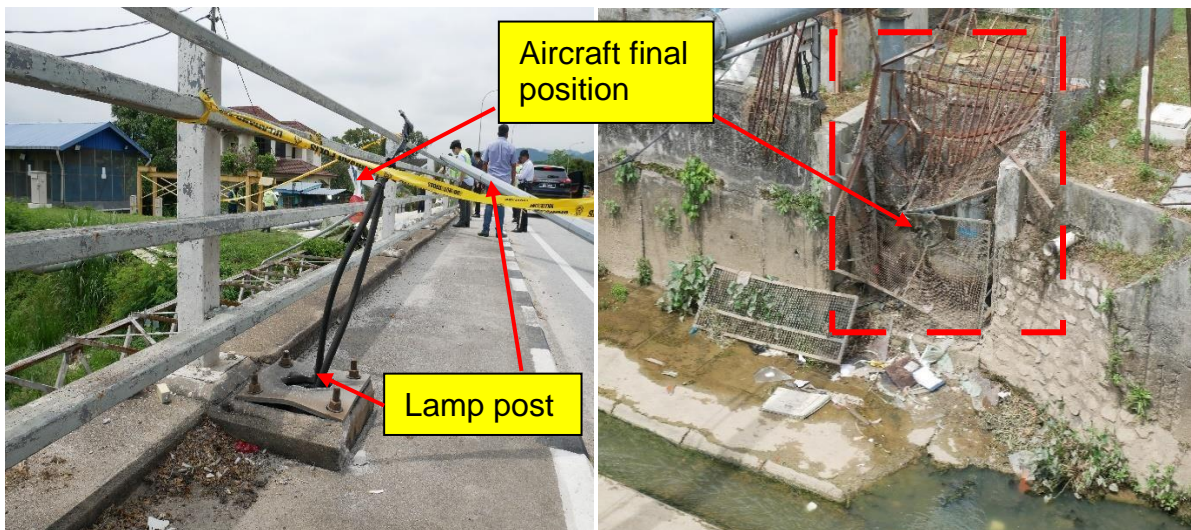
One lamp post on the main road bridge over Sungai Pinji broken off at the base and collapsed due to the impact from the aircraft propeller blade and right wing. The impact also caused some damages to the protective metal rail that surrounds the water pump house main pipe located at the water diversion culvert. No other damages were observed.

Left – collapsed lamp post at the road bridge over Sungai Pinji.

Right – damaged to the protective metal rail at the water diversion culvert.

Figure 3: Other damages due to aircraft impact

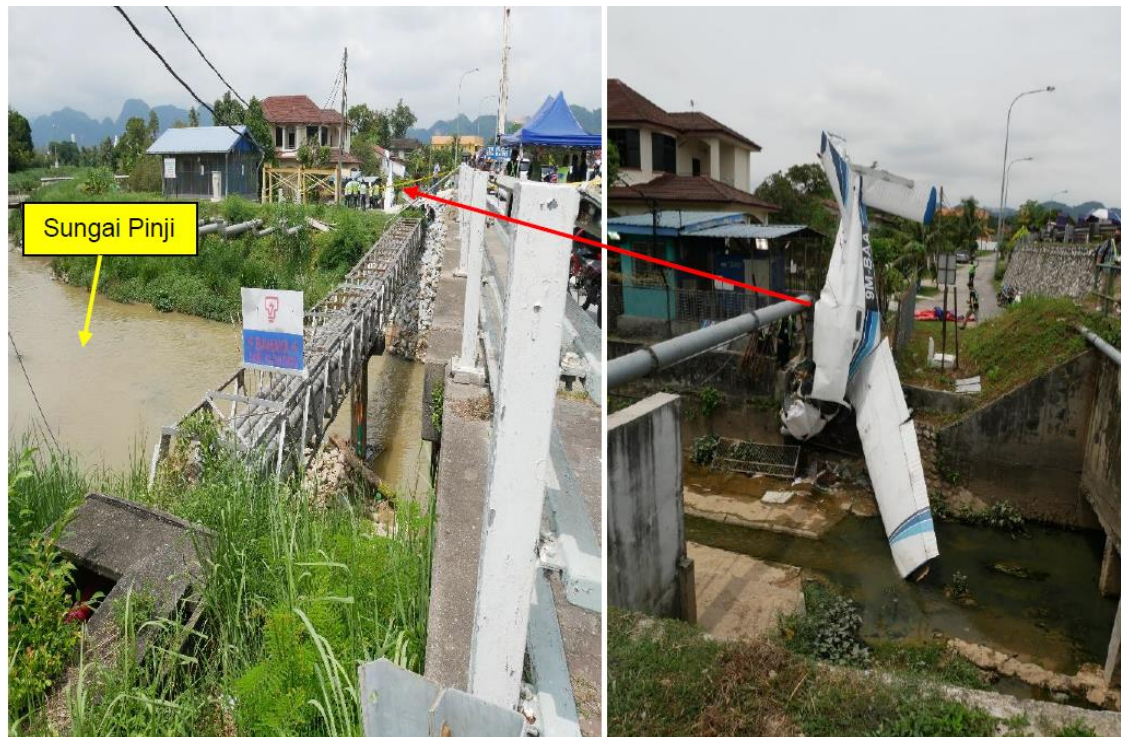
Figure 17: Final position of aircraft at the water diversion culvert beside Sungai Pinji.

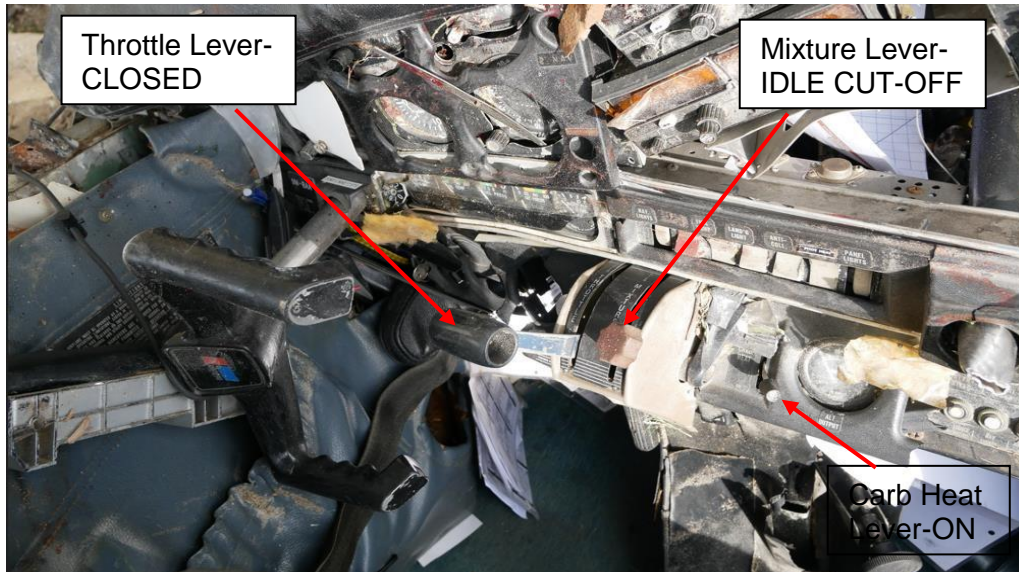
Evidence at the aircraft wreckage shows that the Magneto Switch was at 'L' (Left) position and the Carburettor Heat Lever at 'ON' position. The Fuel Selector was selected to Left Tank. The Throttle Lever was at 'CLOSED' and Mixture Lever was at 'IDLE CUT-OFF' position. One propeller had bend inwards after impacting the lamp post while the other blade was in normal condition with some scratch marks. Flaps were observed to be at UP position (Figure 18 to 23).

Figure 18: Throttle, Mixture and Carburettor Heat Position on the Aircraft Wreckage

Evidence observed at the aircraft wreckage found the throttle at CLOSE, mixture at IDLE CUT-OFF, ignition switch at 'L' position, Carb Heat at 'ON', fuel selector was at LEFT tank and flaps were at UP position. This shows that Pilot 1 most probably took over controls and did the 'Power Off Landing' checks before the aircraft crash landed after Pilot 2 had passed out.

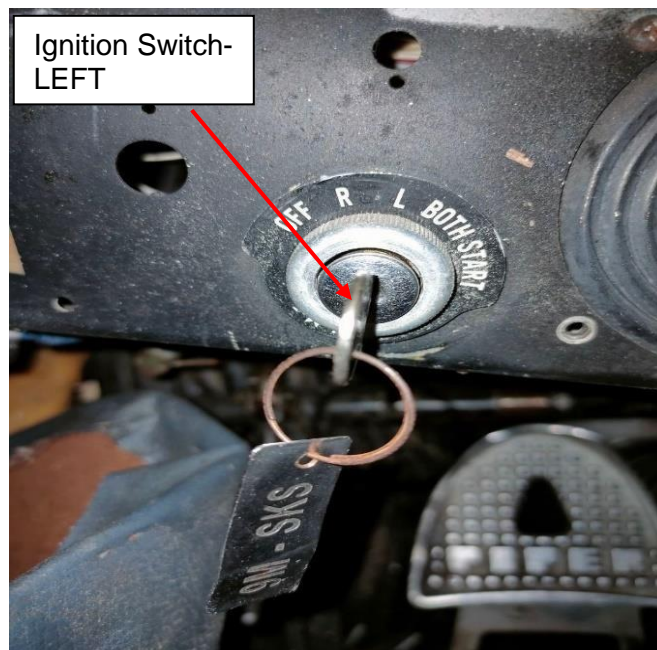
Figure 19: Ignition Switch Position on the Aircraft Wreckage

Observation in the cockpit after the accident found the ignition switch was in 'L' (Left) position. The ignition switch must be in 'BOTH' position for all phases of normal flight.

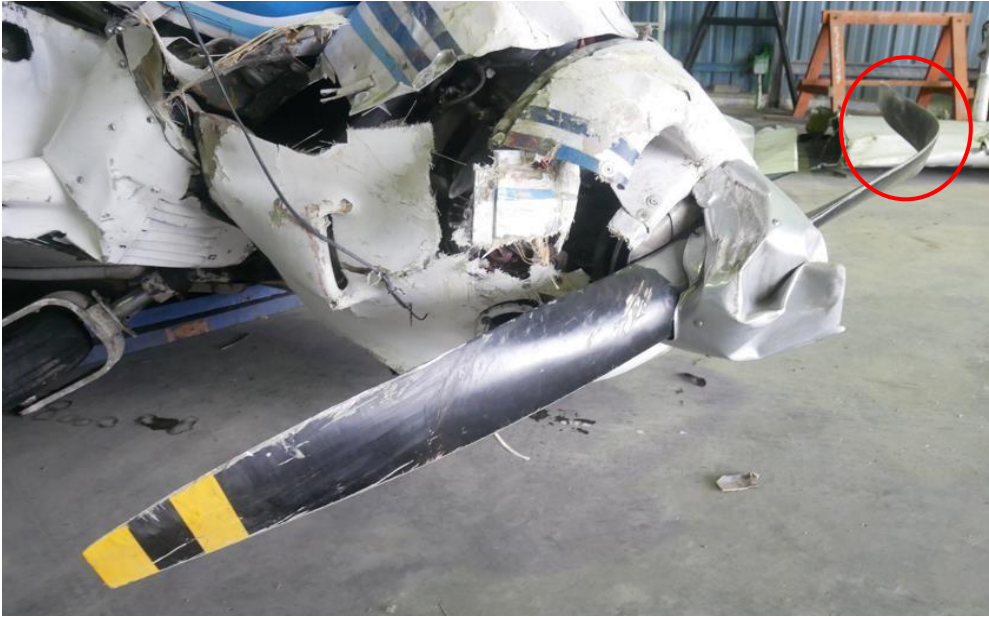
Figure 20: One propeller blade bend inwards and the other blade was in normal condition with some scratch marks

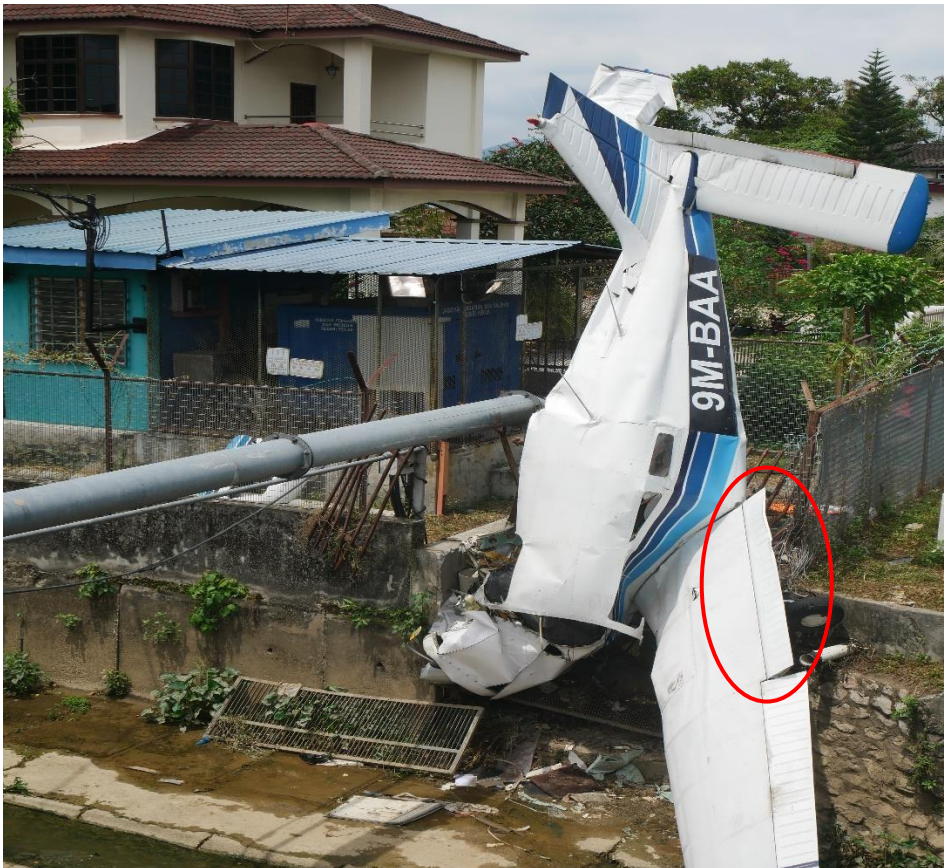
Figure 21: Flaps at UP position

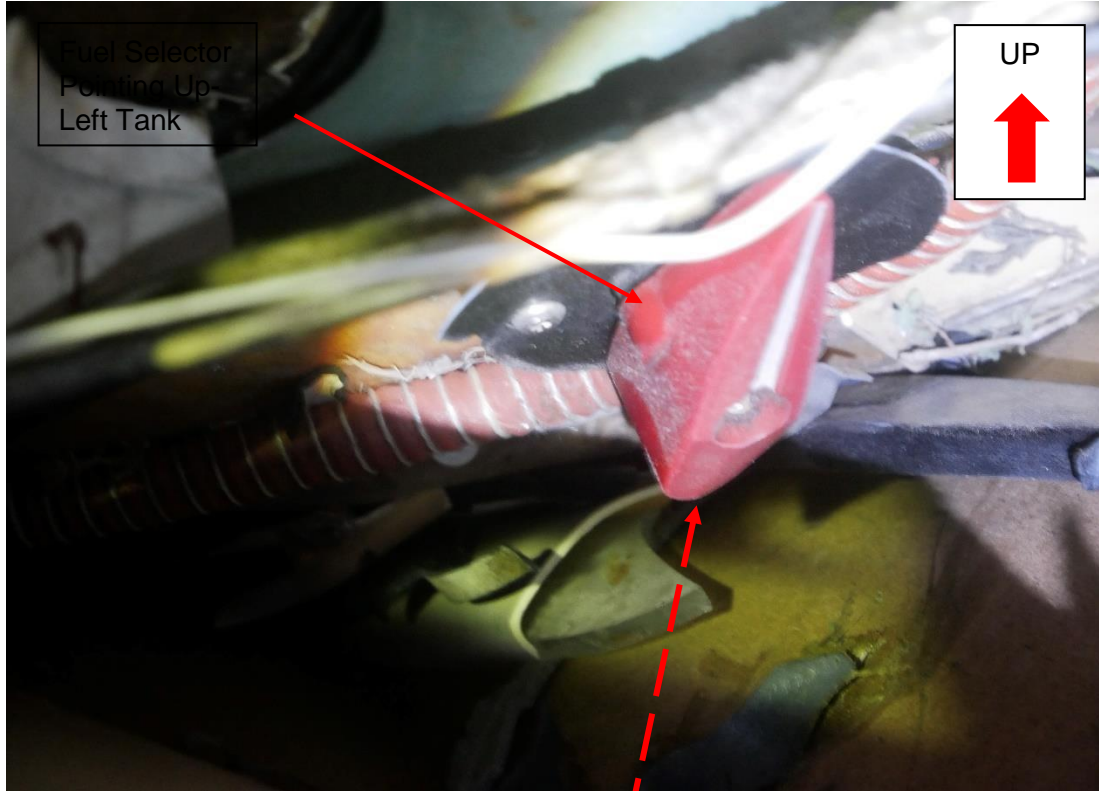
Figure 22: Fuel Selector Position on the Aircraft Wreckage

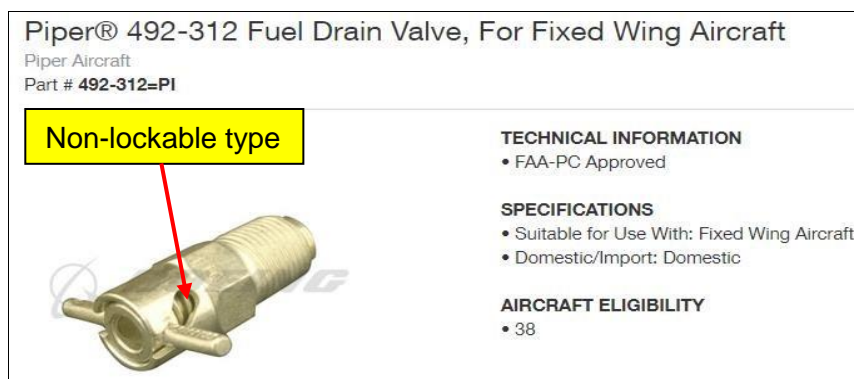
- iv. **Gascolator Fuel Drain Valve** – The gascolator fuel drain valve fitted to the aircraft is of the non-lockable type part number 492-312² as per Piper Aircraft PA28-151/161 Warrior Airplane Parts Catalogue (Figure 24). The gascolator sustained impact damage and its functionality cannot be verified. The cup holding the filter had broken off missing together with the fuel drain valve.

Figure 24: Gascolator Fuel Drain Valve fitted on the aircraft

Although the gascolator sustained impact damage with the cup holding the filter broken off missing together with the fuel drain valve, there were no evidence of blockage at the carburettor filter screen. There was fuel contained in the carburettor indicating the engine did not malfunction due to fuel starvation.

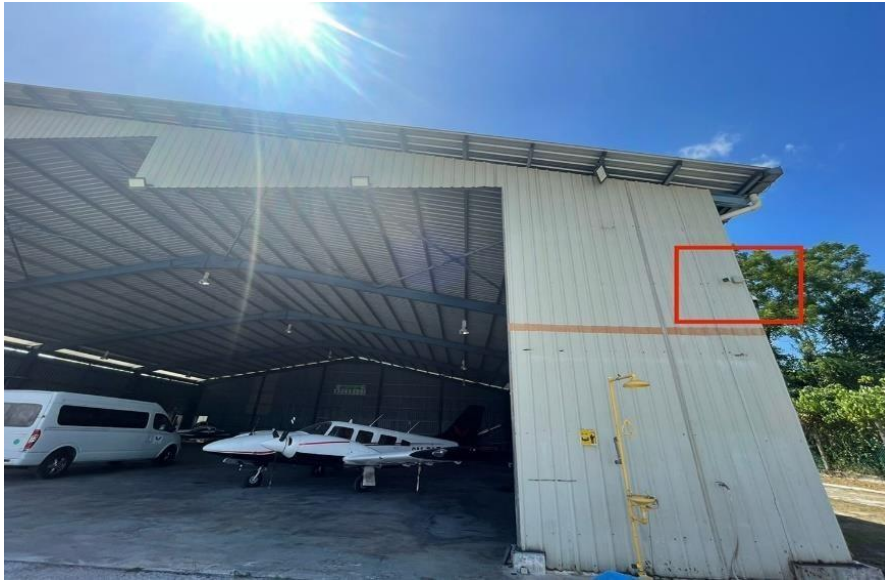
There is a CCTV camera located at the left side of the FTO Hangar view towards the direction of the dispersal area and runway (Figure 33).

Figure 33: CCTV Camera location

The Aircraft Operator should consider to place at a suitable location a 180° or 360° view CCTV camera with continuous recording for safety and security reasons. There is also a need to ensure the CCTV system is operating normally. It will assist in any incident or accident investigation and provide evidence if there is a breached of safety or security.

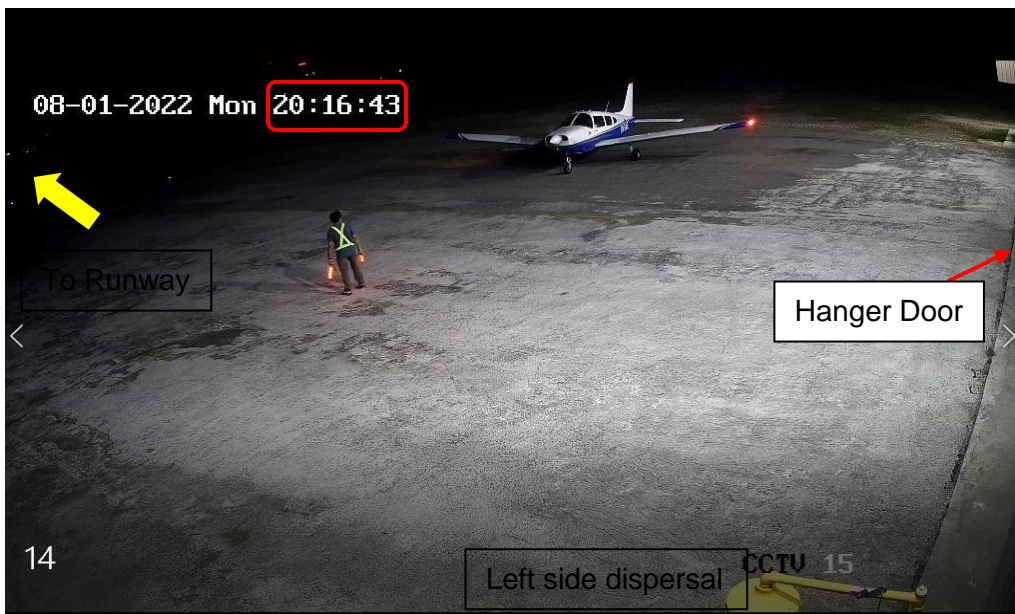
Observation revealed that this camera is 'motion activated' type and focus mainly on the right side of the dispersal area (Figure 34). It is also observed that the recording time is not synchronised to the actual real time as it indicates about 15 minutes ahead compared to actual real time.

The location of the CCTV camera resulted in no recording of activities on the left side of the dispersal. The aircraft 9M-BAA which was park on the left side of the dispersal was not seen in the CCTV recording. There was no continuous recording which would have provided critical information on events taking place on the runway, taxiway and dispersal area. The inaccurate time of recording also does not give real time information when an event which is time critical happens.

Figure 34: CCTV Camera limited view and inaccurate time of recording

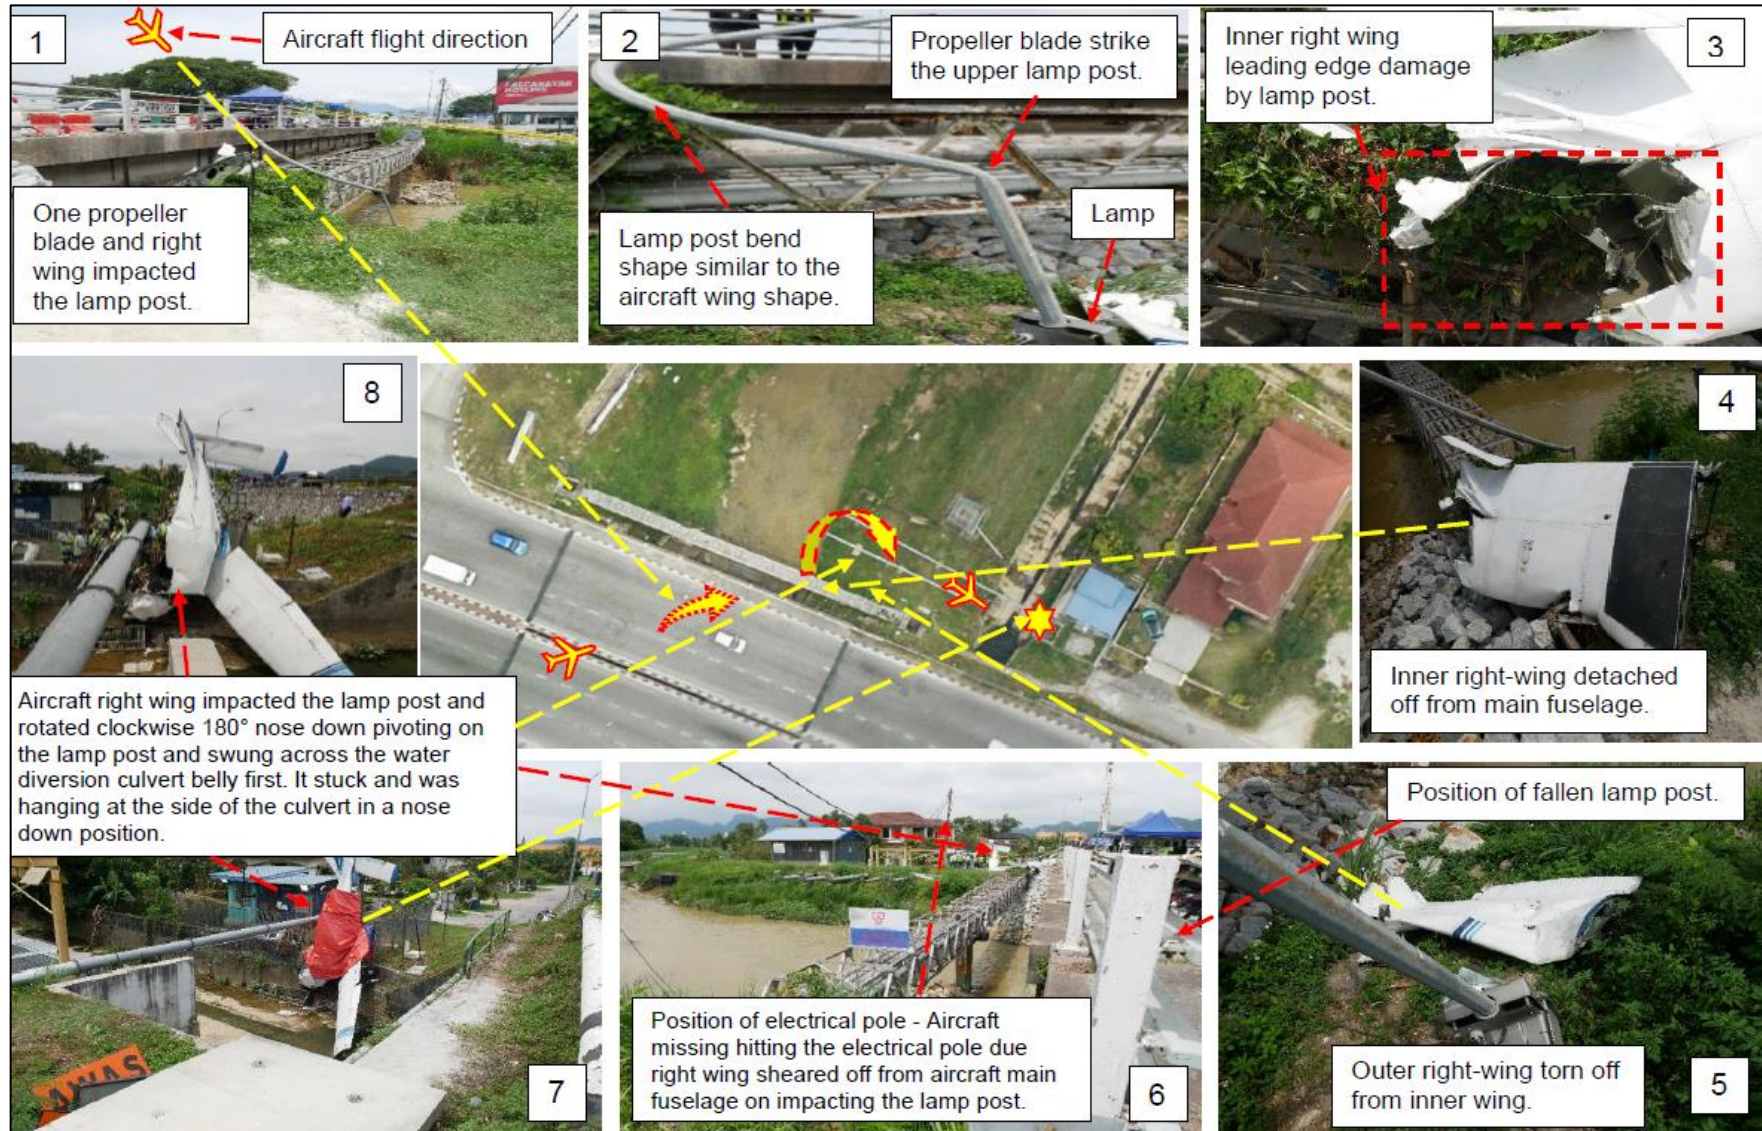
Photo 8 – The wreckage stuck and was hanging at the side of the water diversion culvert in a nose down position.

Figure 39: On-site investigation sequence of event
