FINAL REPORT

PIPER PA34-220T SENECA III, REGISTRATION 9M-RBI LANDING ACCIDENT IN SELETAR AIRPORT 1 JANUARY 2016

AIB/AAI/CAS.120

**Transport Safety Investigation Bureau
Ministry of Transport
Singapore**

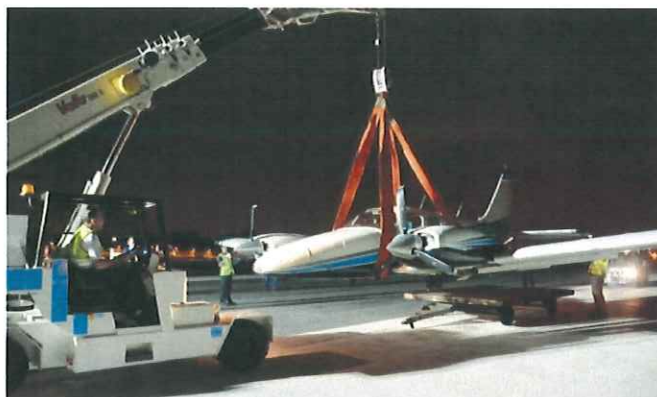
Figure 2. Recovery of disabled aircraft

- 1.1.11 The disabled aircraft was subsequently recovered and moved to a hangar facility on a dolly (**Figure 2**).
