AIRCRAFT ACCIDENT REPORT 02/15

AIR ACCIDENT INVESTIGATION BUREAU MINISTRY OF TRANSPORT, MALAYSIA

Report on the accident to Helicopter Bell 206BIII Registration 9M-LLM,
On the grass near helipad 'H' at Kota Kinabalu International Airport

AIRCRAFT ACCIDENT FINAL REPORT 02/15

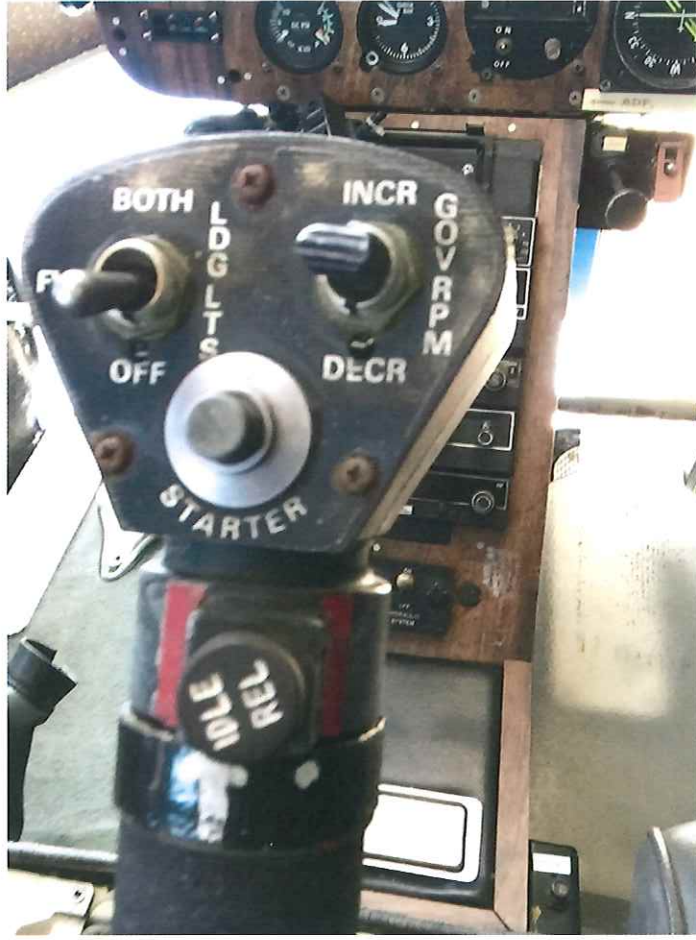
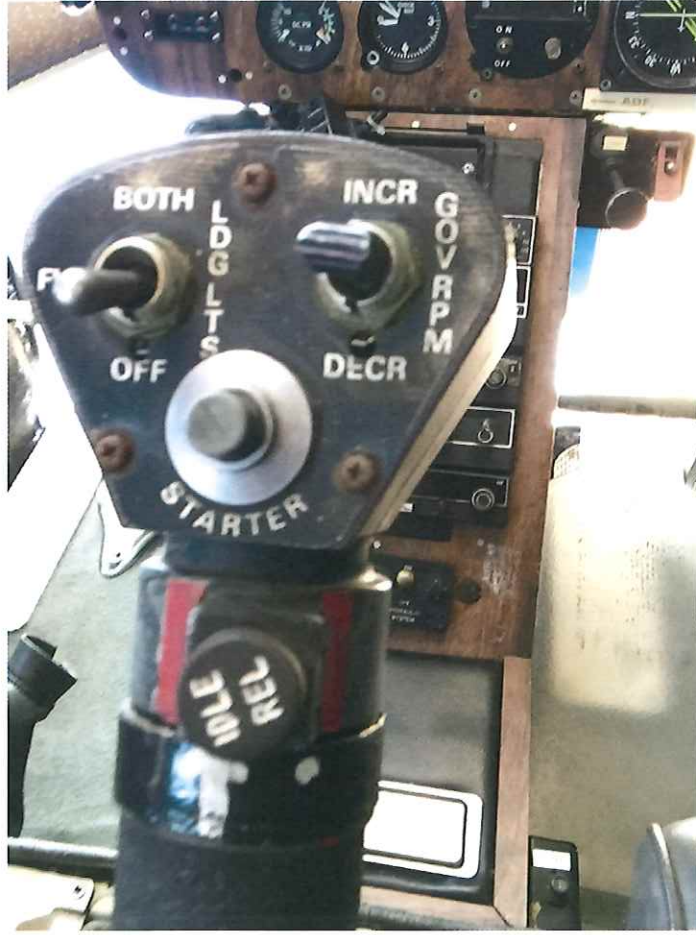
APPENDIX B Fig 1
Collective lever and throttle position

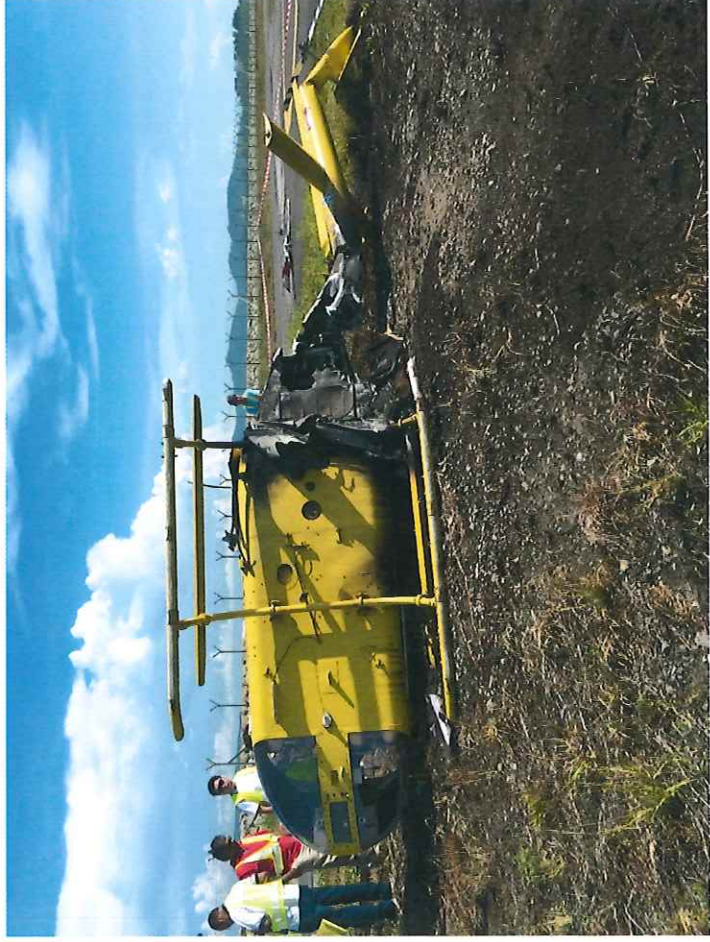
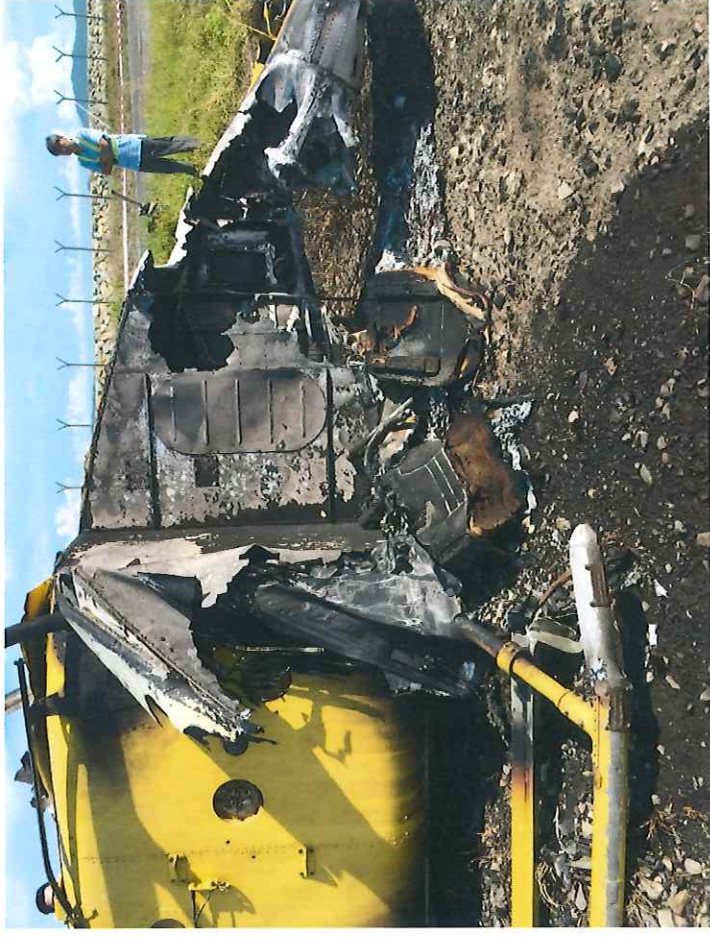
APPENDIX B, Fig. 2

Fuselage rested on its right side

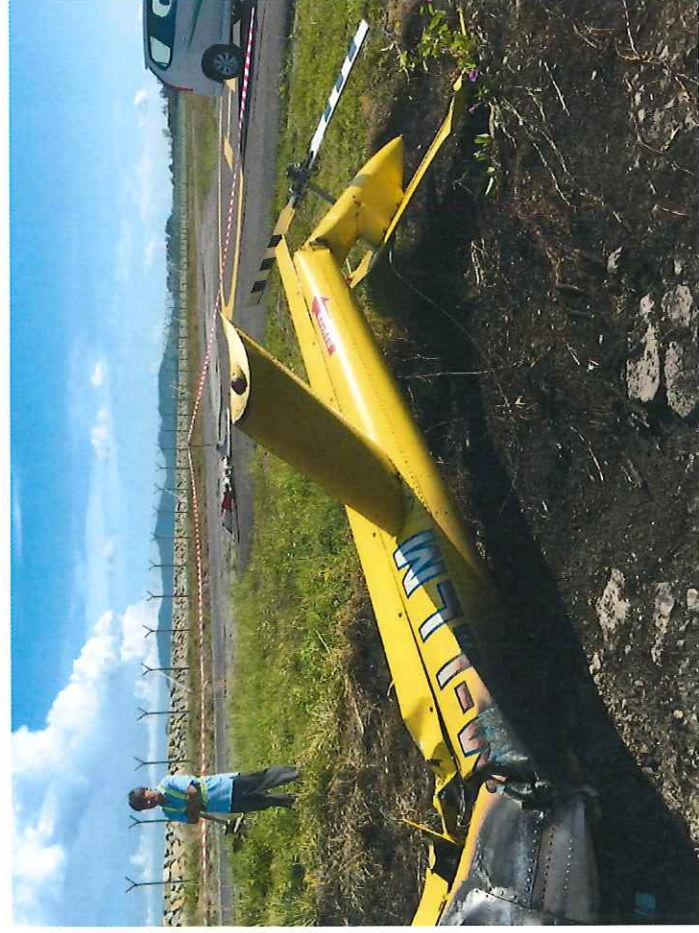
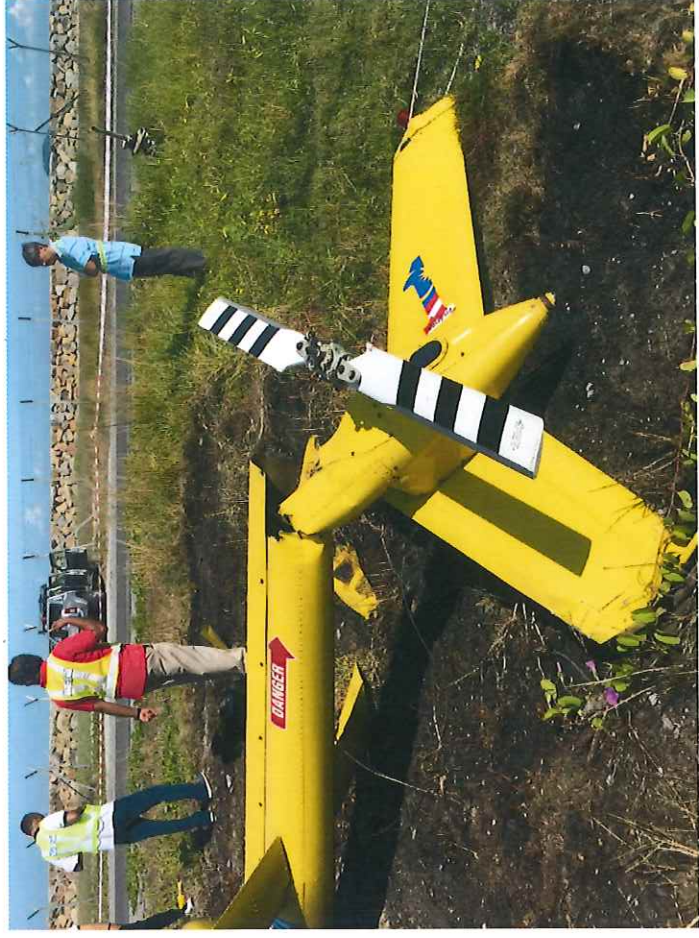
APPENDIX B, Fig.3 Tail rotor and tail boom condition

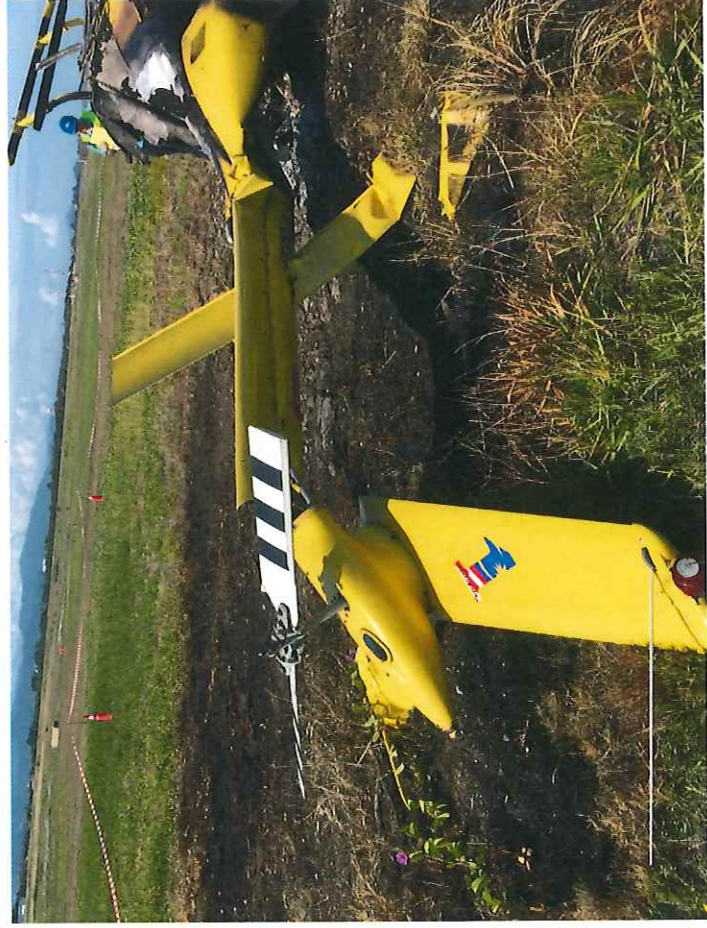
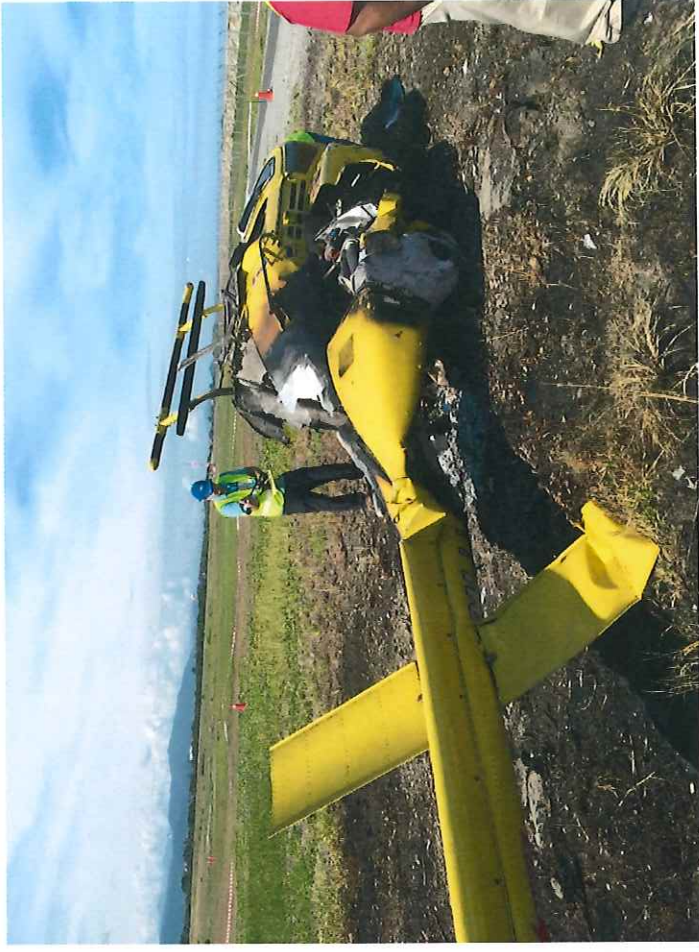
APPENDIX B, Fig. 4
Wreckage from the tail

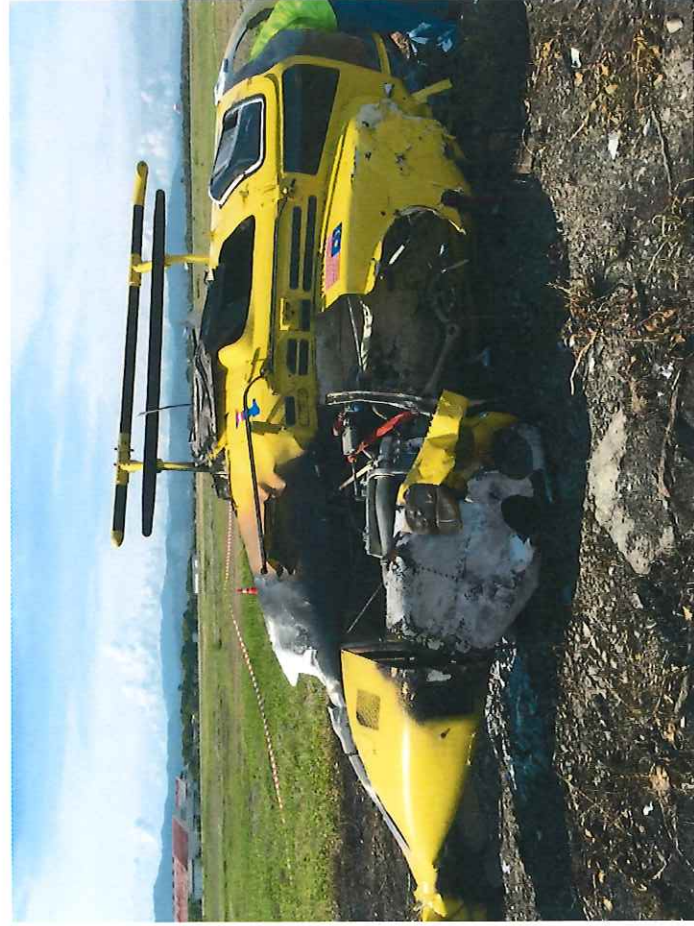
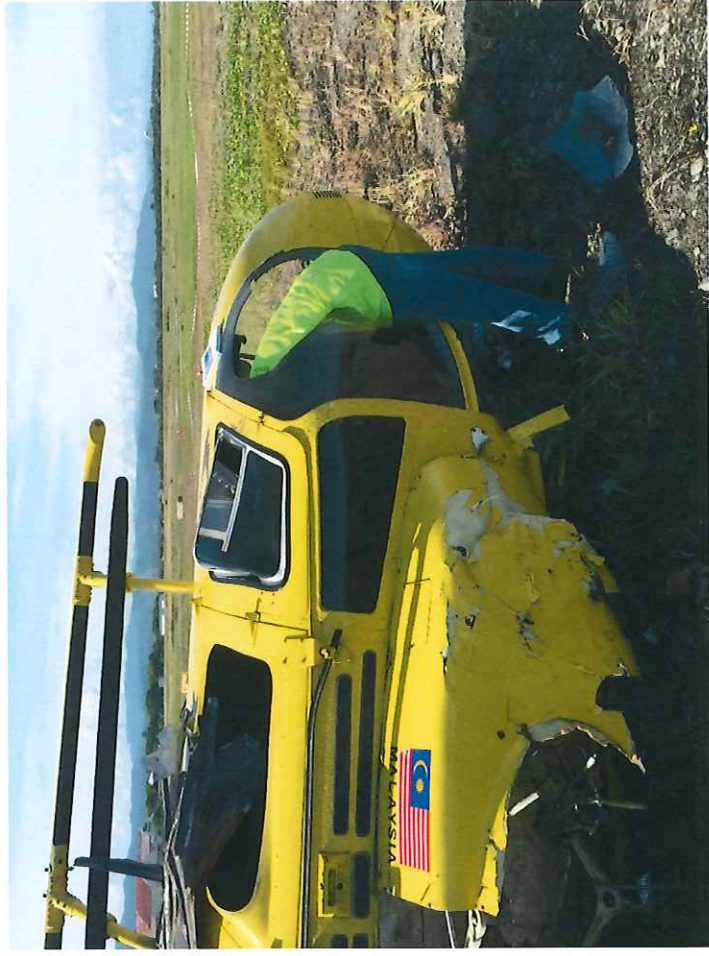
There was fire after the impact which started from the baggage compartment.

APPENDIX B, Fig 5
Fire started from the baggage compartment

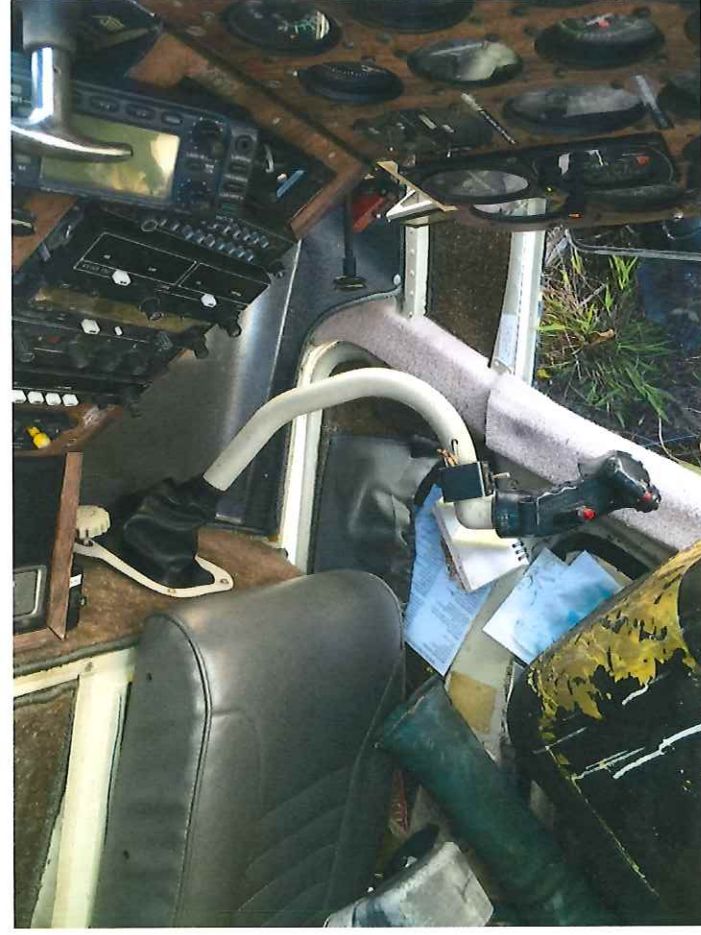
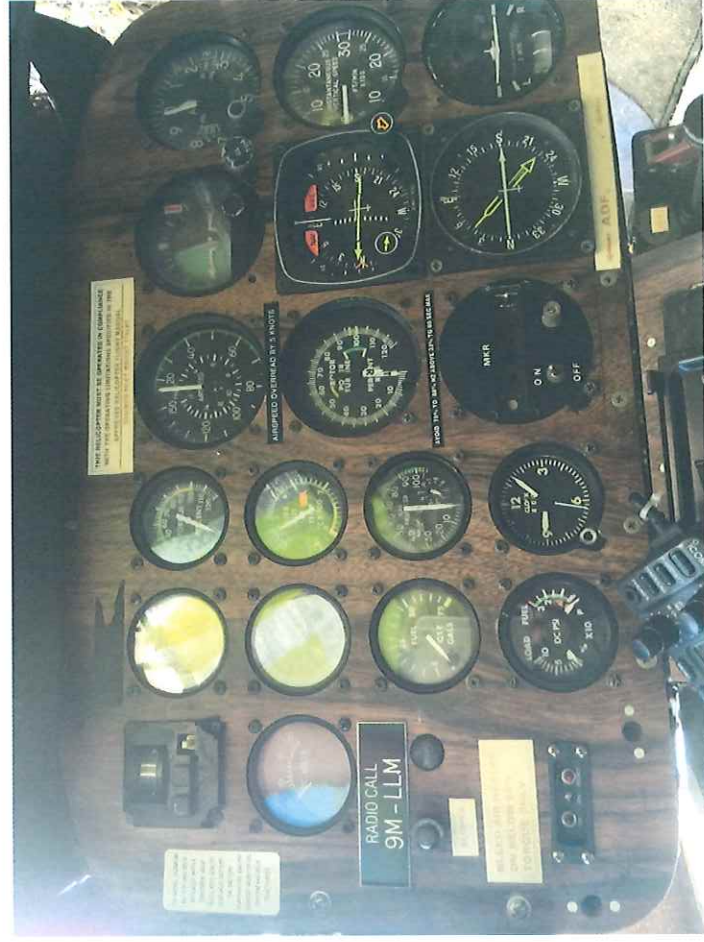
APPENDIX B, Fig.6

Helicopter instrumentations

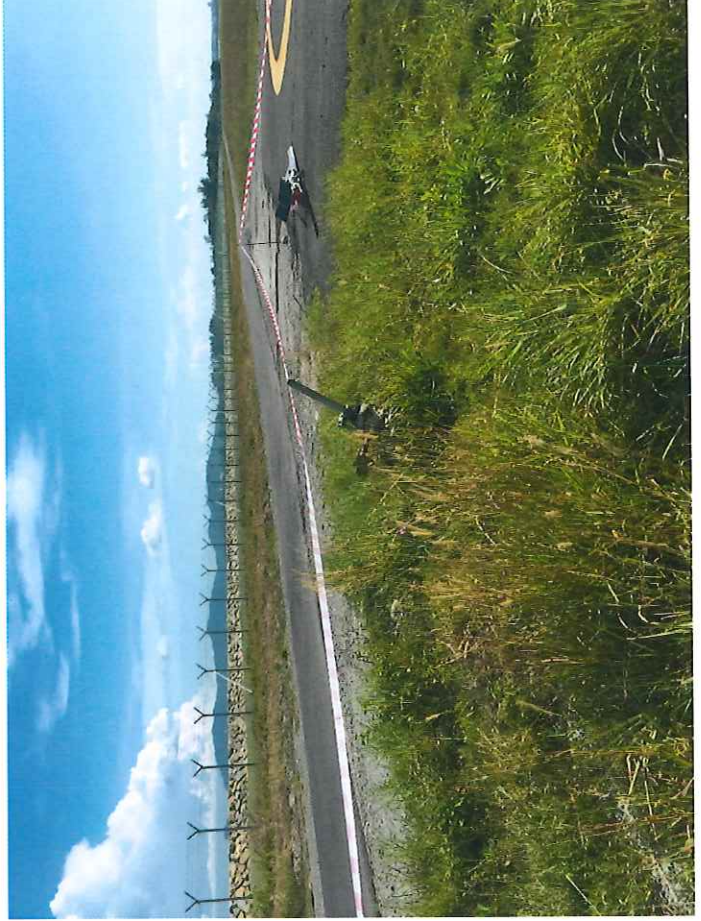
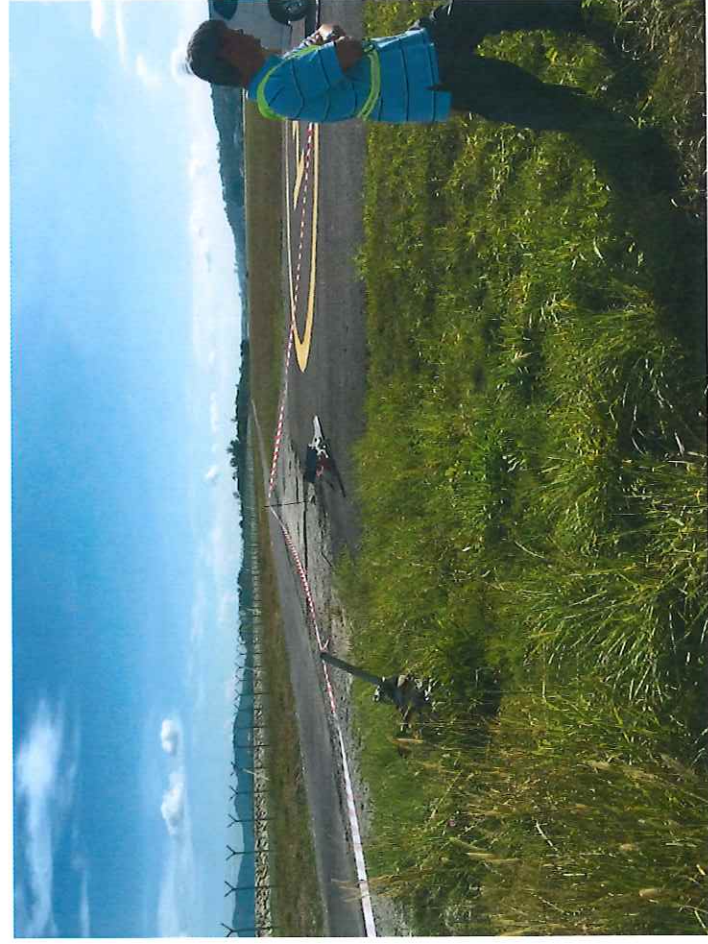
APPENDIX B, Fig.7
The main gearbox detached from the fuselage

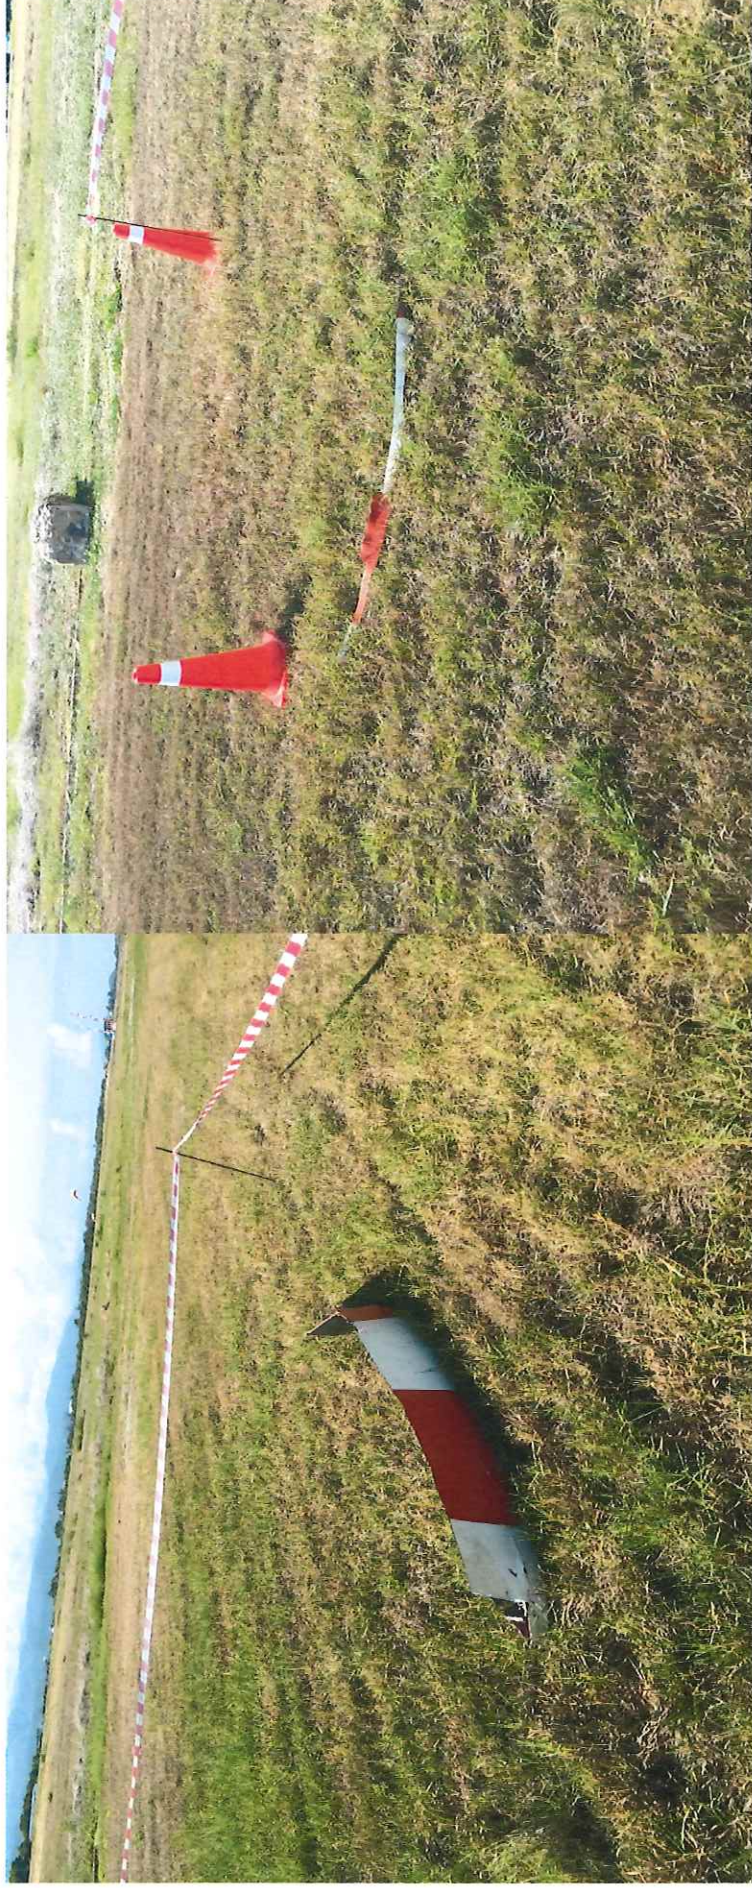
APPENDIX B, Fig. 8
Main rotor broken off due to high rotor energy

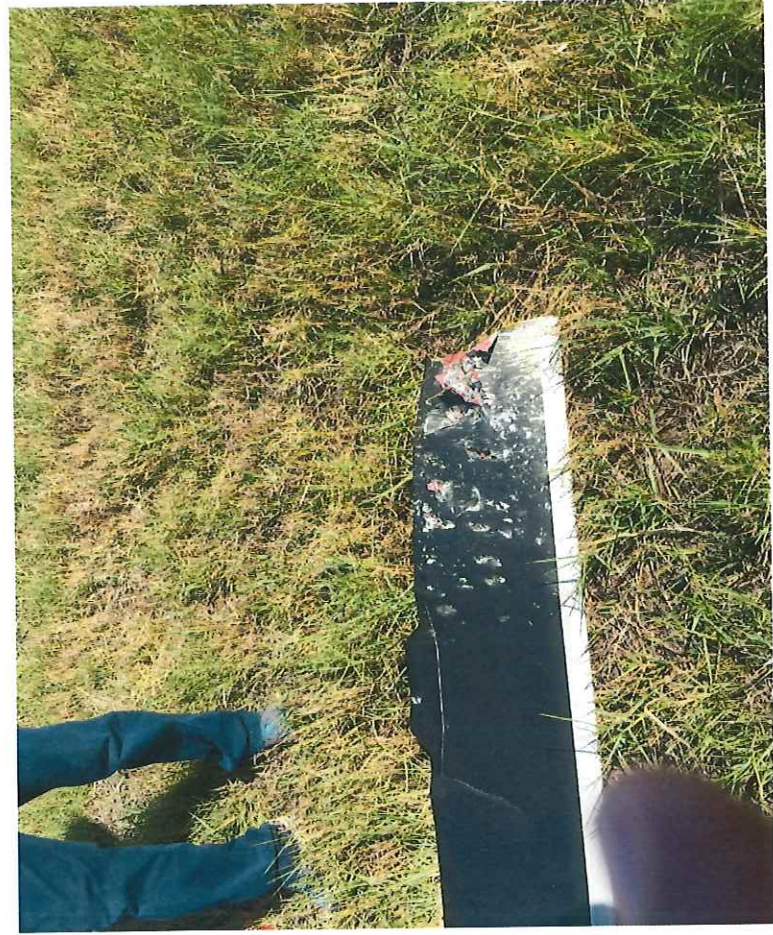
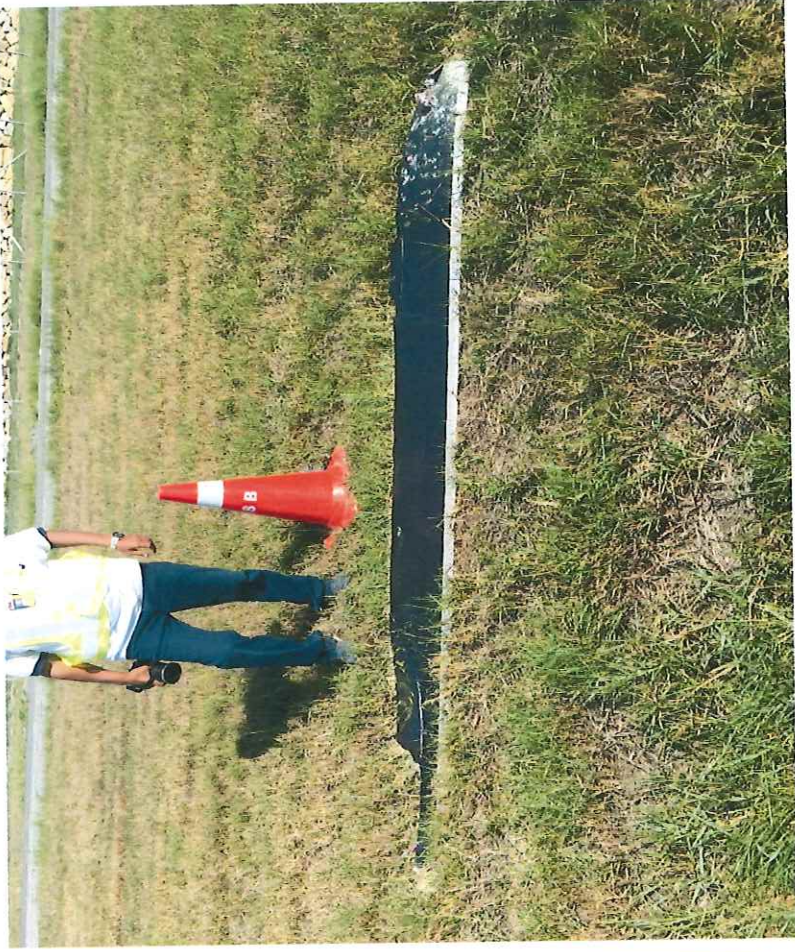
APPENDIX B, Fig. 9
Main rotor blades damage

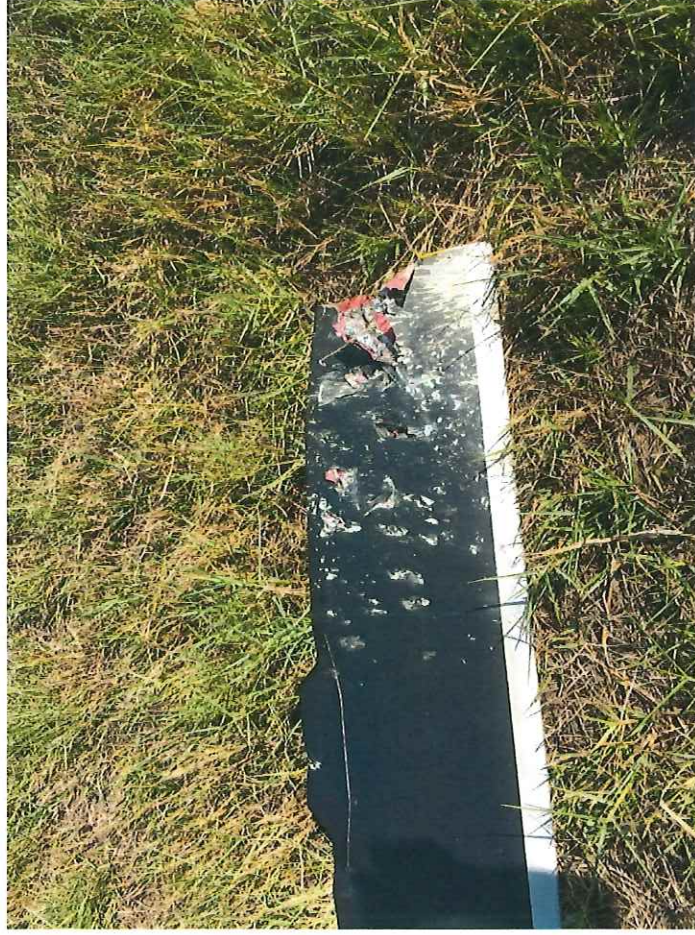
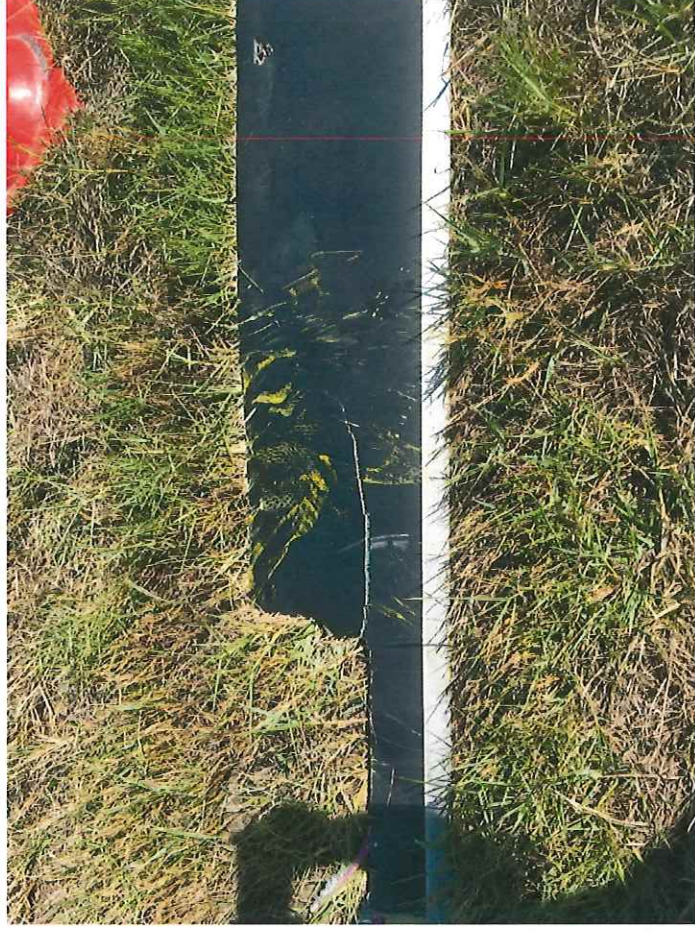
APPENDIX B, Fig 10
Close look at the main rotor blade tips

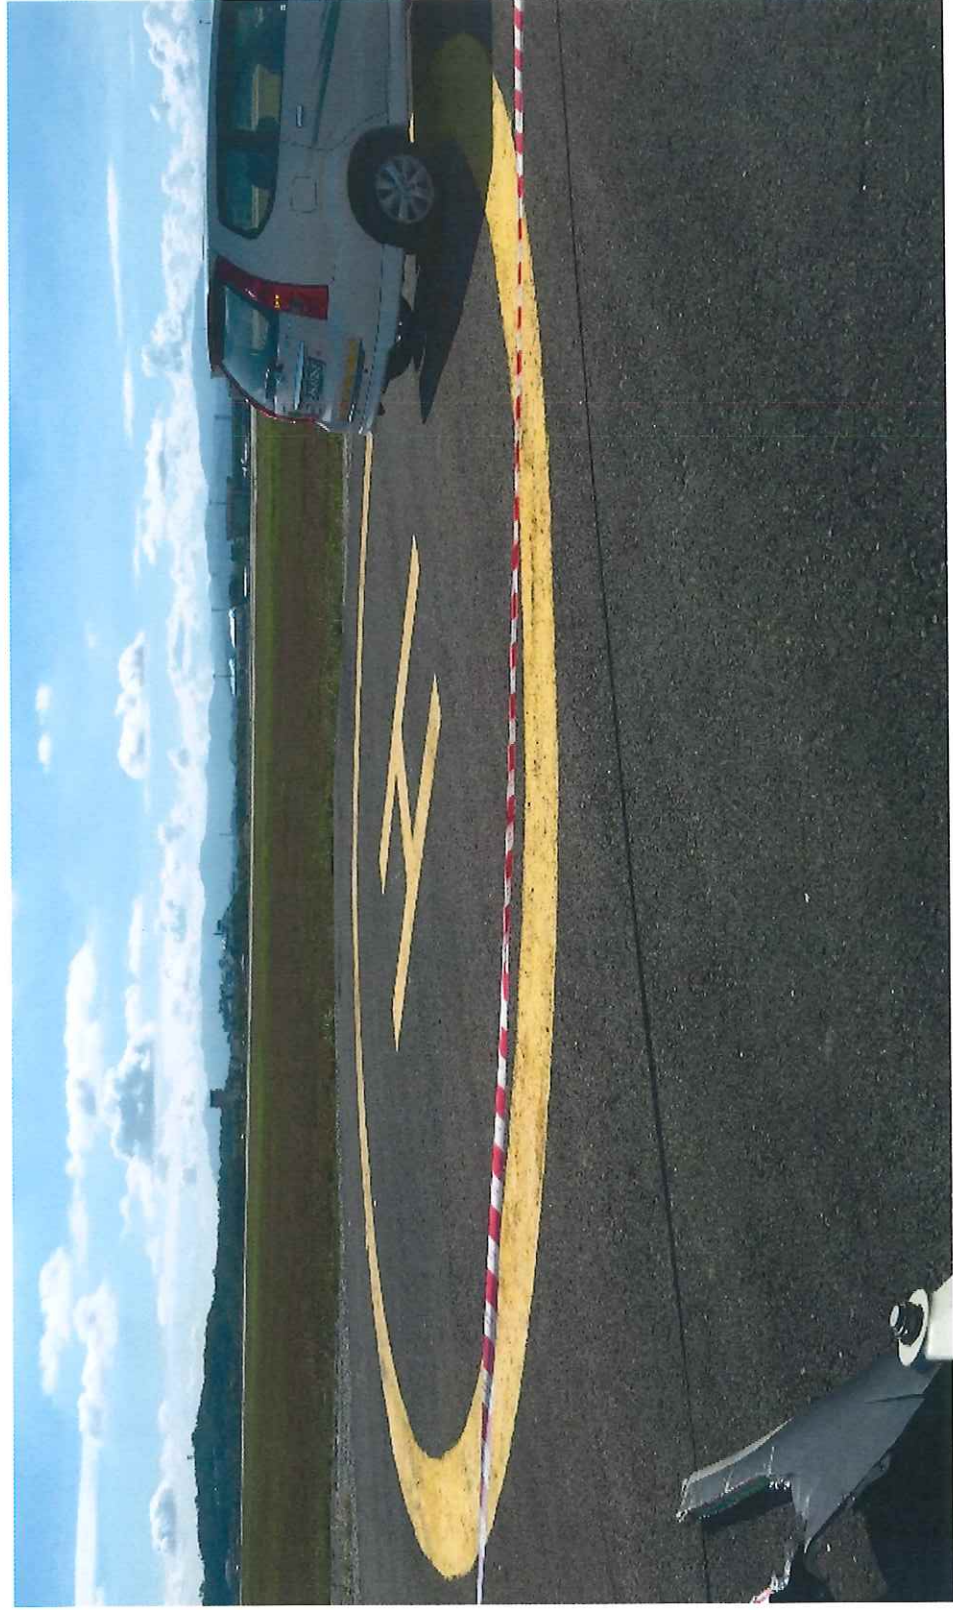
APPENDIX B, Fig 11
Helipad

The helipad is measured 40 feet by 40 feet with a layer of hard tarmac. It has a yellow circle for the helicopter to land. It has been in operation for several years.

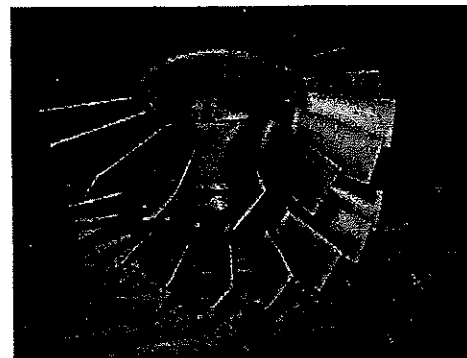
2st / 3rd Stage Compressor Wheel

Damaged vanes due to the FOD

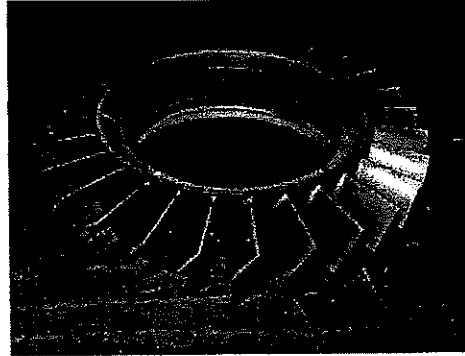
5th Stage Compressor Wheel
Part No. 23057115
S/N: E60099

Damaged vanes due to the FOD

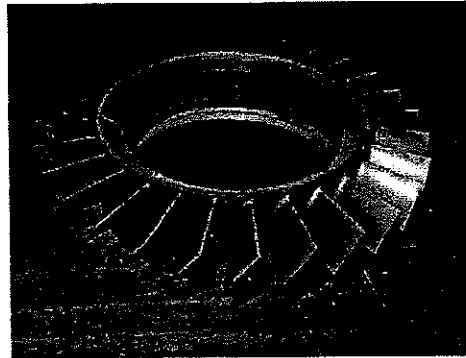
6st Stage Compressor Wheel
Part No. 23057116
S/N: KR58292

Damaged vanes due to the FOD

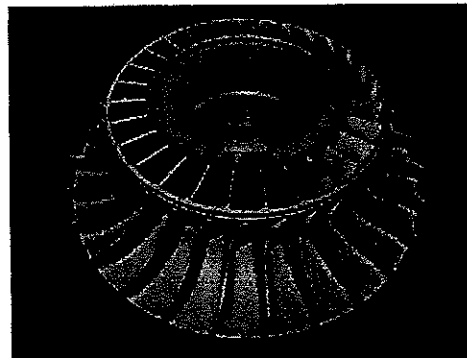
Impeller Assy
Part No. 23058147
S/N: KR96571

Damaged due to the FOD

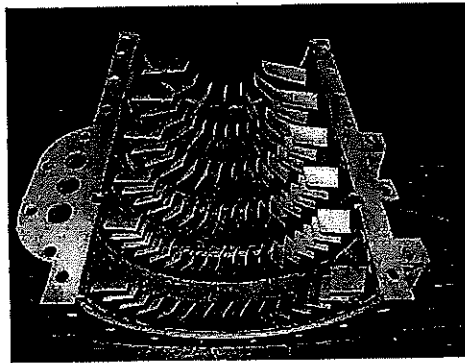
Half cases
Part No. 23057142
Set 25003

Damaged coating due to the FOD

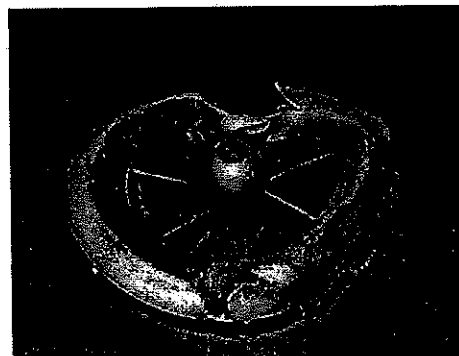
Compressor Front Support

Damaged due to the FOD.

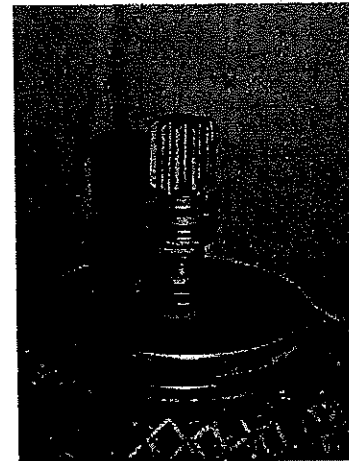
Starter Generator

Shaft not broken, so no seizure.

No cause for failure.
