**AIRCRAFT ACCIDENT FINAL REPORT NUMBER A05/2016**

**ACCIDENT INVOLVING EUROCOPTER AS350 B3e REGISTRATION RP-C6828  
AT BATANG LUPAR, SARAWAK  
05 MAY 2016**

**ACCIDENT REPORT NO.: A05/2016**

**REGISTRATION : RP-C6828**

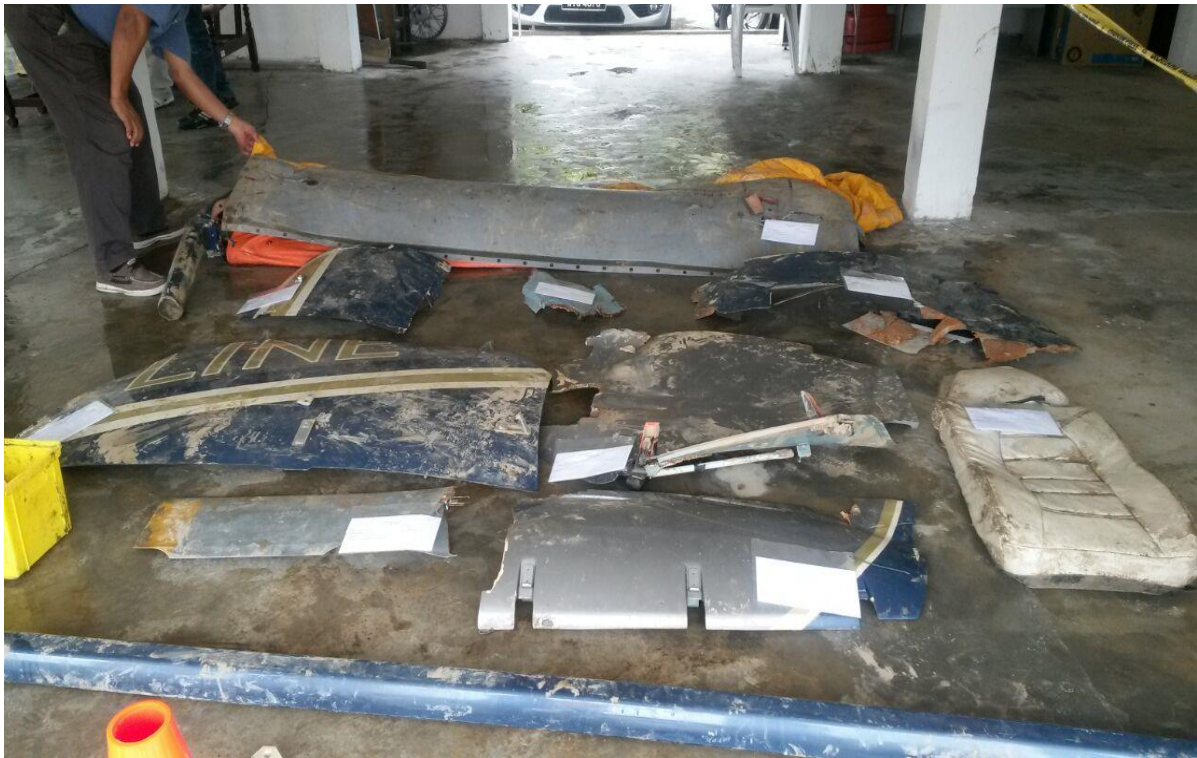
**Figure 5 – Parts collected and stored at Sebuyau Police station**

The main wreckage has not been found. However, several pieces of the helicopter parts were found scattered within the suspected impact area in the river vicinity. See Figure 5 and Figure 6 depicting the pictures of the helicopter parts recovered.

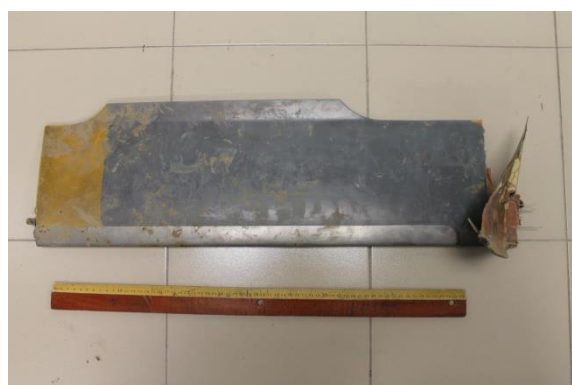
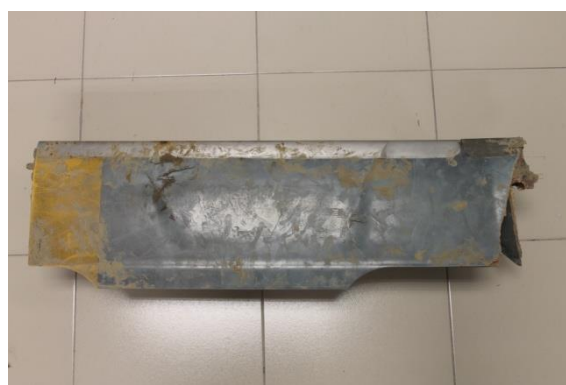
**Figure 9:** Recovered rotor blade

Part of the tail rotor blade was discovered by the search team on 06 May 2016. The rotor was taken to STRIDE for detailed analysis on the breakage pattern. The recovered tail rotor blade is as shown in Figure 9.

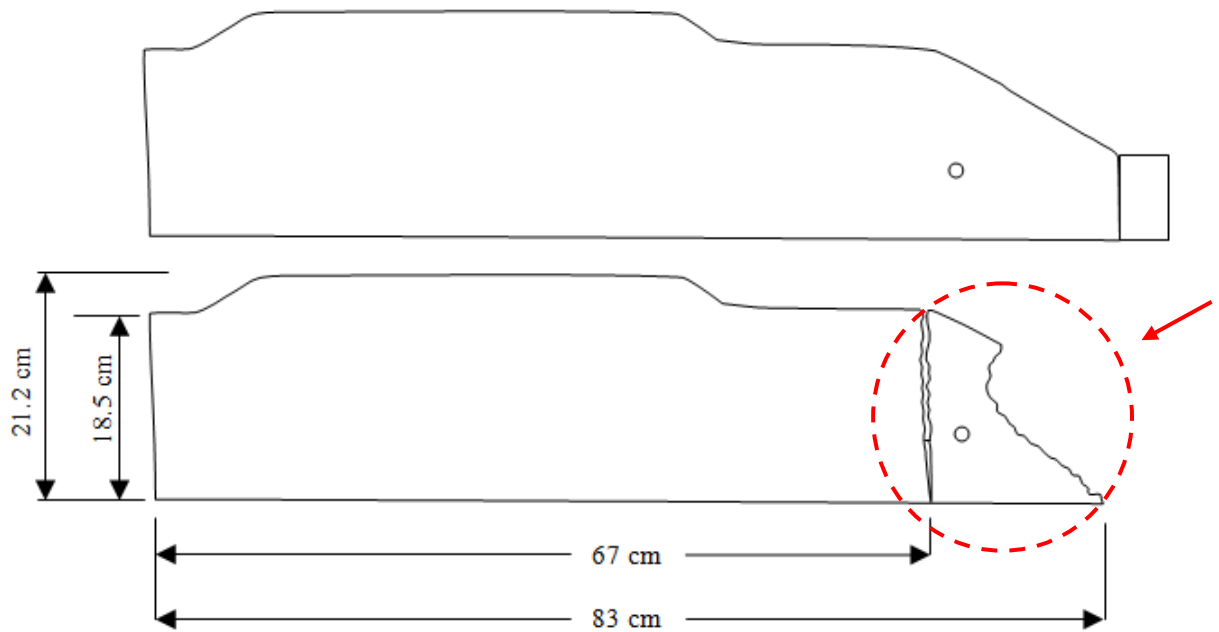
**Figure 11** : Illustrated drawing of tail rotor blade

An illustrated drawing of the tail rotor blade in Figure 11 shows the fractured location and the straight crack line found as received. The location of the tail rotor blade unit and detailed type of material in each section of the helicopter are shown in Figure 12.

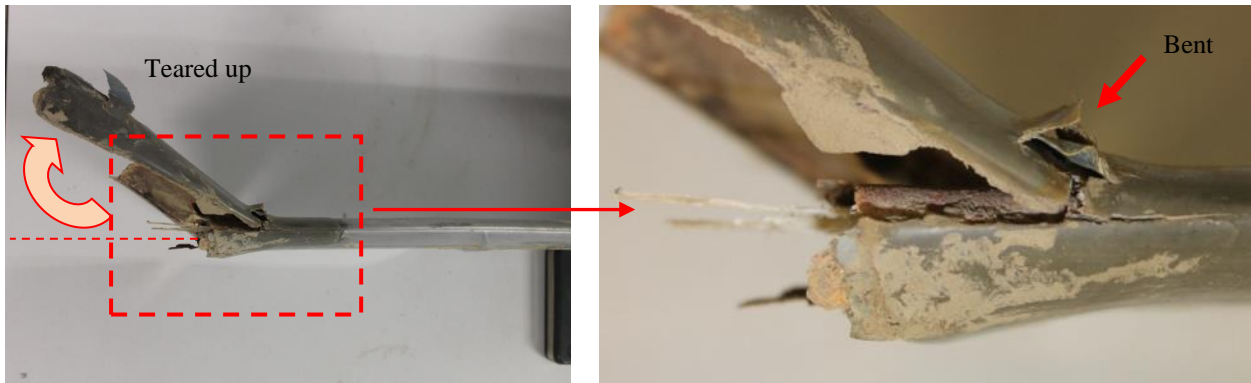
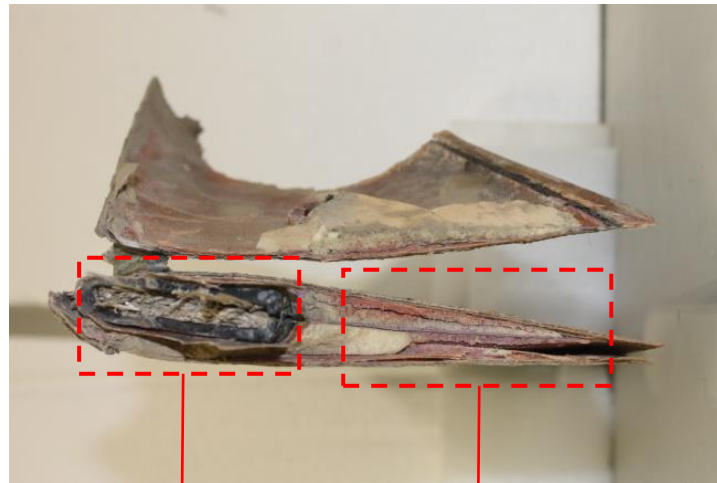
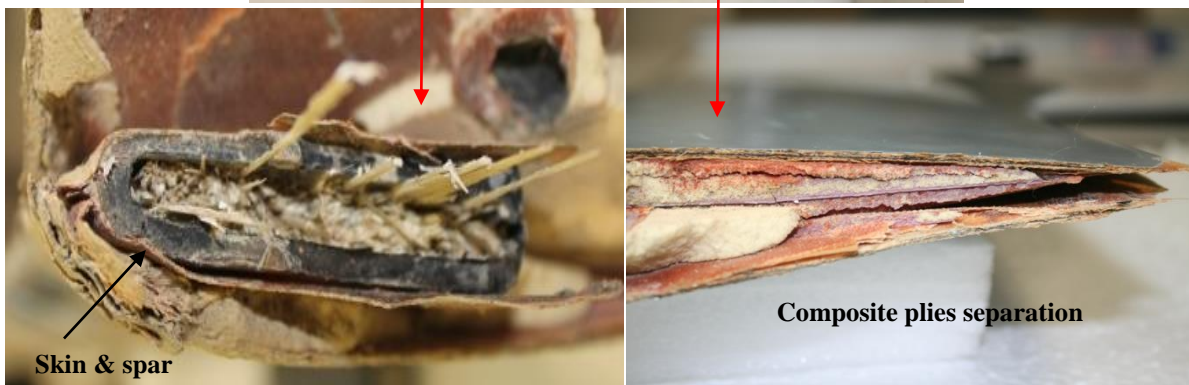
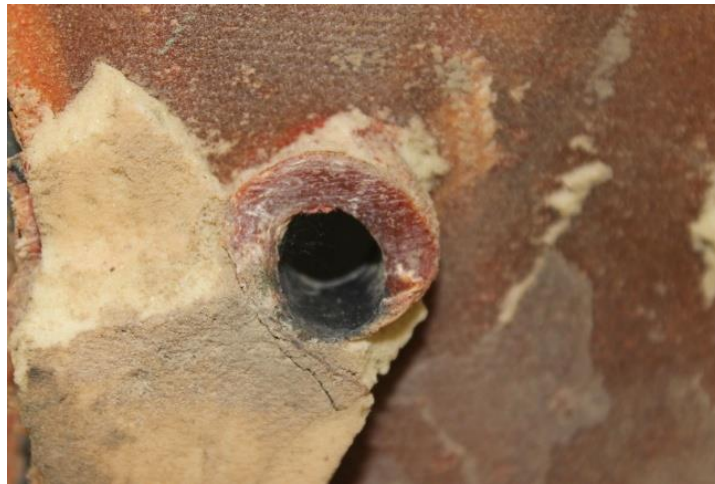
**Figure 14:** The damage due to high impact

Figure 14 shows several locations of damage occurred. It was observed that the leading edge of the tail rotor blade was torn up (Figure 14 (a)) at the root section caused by high impact force. From the cross section of Figure 14 (b), it was evident

that the skin and spar was fractured due to consistent overload force. The same findings were expected as further examination of the inner section of the teared up tail rotor blade showed that it had experienced overload force as seen in Figure 14 (c).

1.19.2.4 Visual examination of the tail rotor blade showed several damage has occurred. It was observed that the leading edge of the tail rotor blade was teared up at the root section. It also found an evidence of the damage and the fractured skin, spar, hole and composite plies separation due to the high impact. The inner and outer skin of the tail rotor blade found to has several paints peeled off, scratched and dented surfaces.

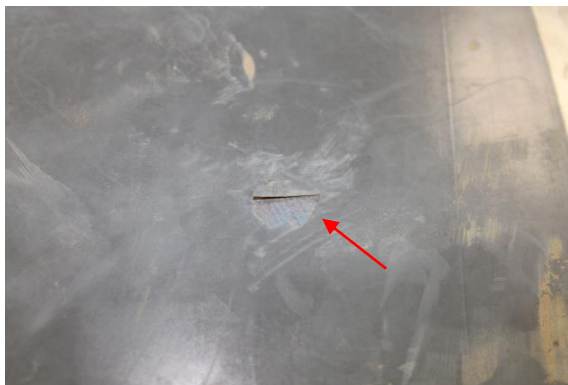
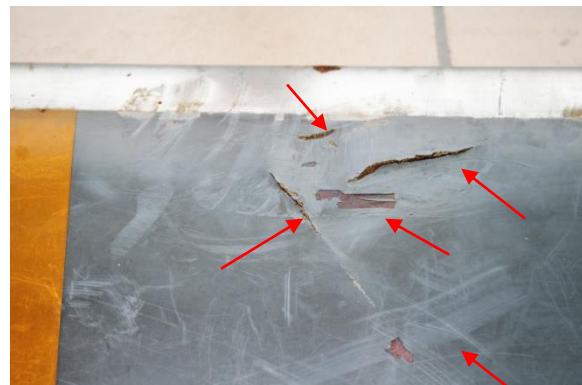
**Figure 15:** Damage at inner and outer skin of tail rotor blade

Examination on the inner and outer skin of the tail rotor blade showed, several locations of peeled off paint, scratched and dented marks as shown in Figure 15 (a) and 15 (b). This is due to impact from foreign or unknown outside object.

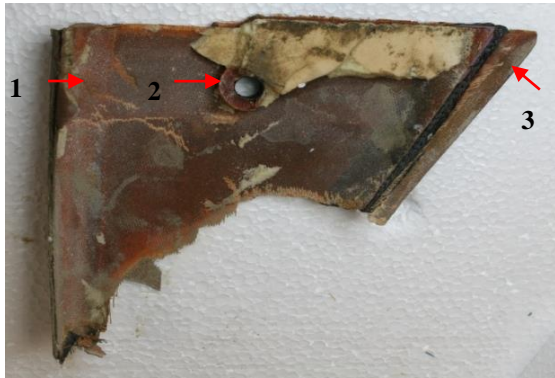
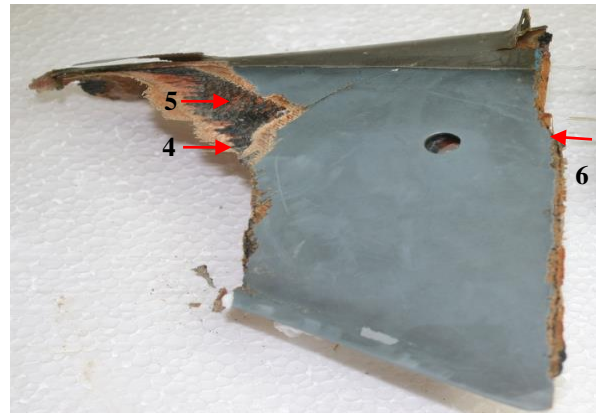
**Figure 16** : Selected locations for macroscopic examination

Further analysis was done using Zeiss Stereo Microscope for macroscopic examination. Six locations were marked based from the severe condition as shown in Figure 16. At Location 1, the arrow shows the direction of bending forces which acted along the leading edge of the blade. The marking from the high impact force are shown by the striation lines at the damaged hole at Location 2. Sign of fractured along the trailing edge of the blade indicates a consistent upward direction of high impact at Location 3. Cracking traces of fibers are the result of high impact at Location 4 and 5. Severe damage showed that high impact happened at the outer skin and middle part of the span near the trailing edge. As a result, the skin and the fibers were twisted and pressed downwards from that deep impact in Location 6.

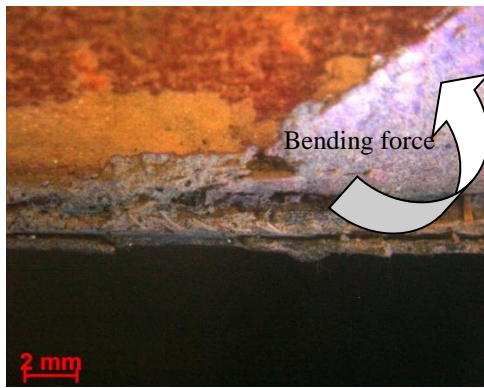
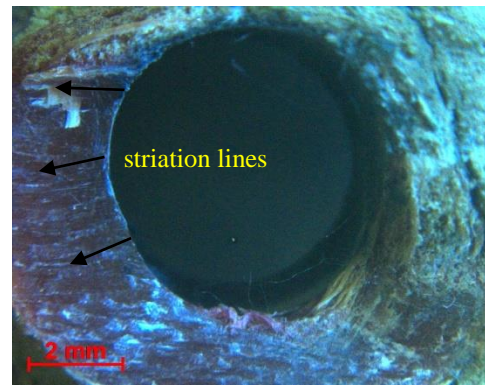
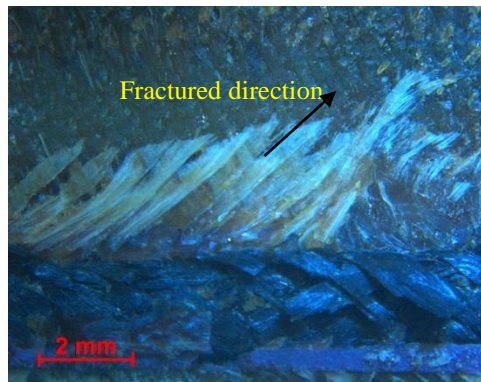
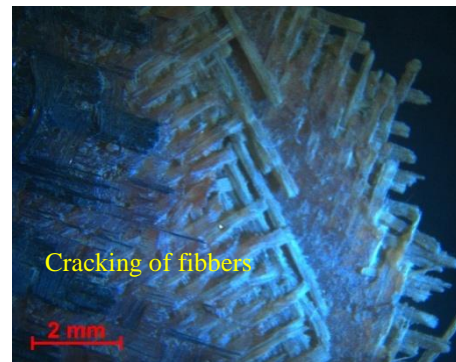
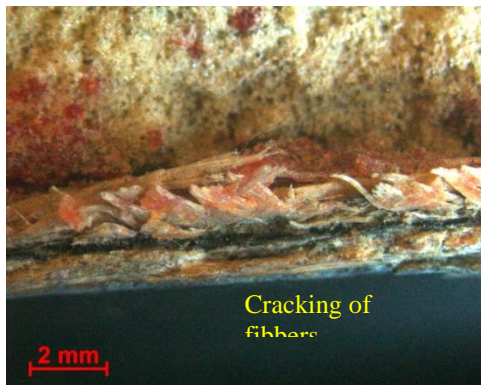
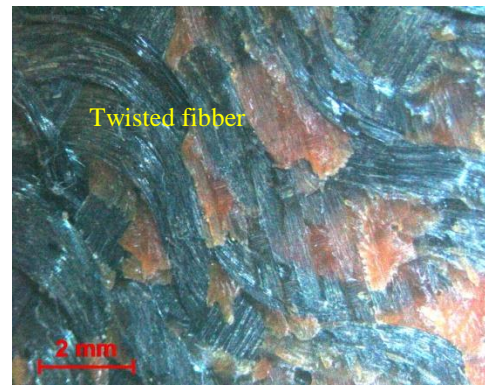
**Figure 17:** Tail Rotor Blade fracture direction due to the impact

1.19.2.5 Macroscopic examination could suggest the impact and fractured direction of the blade during the separation. Examined on the several locations of the carbon fiber and composite plies showed similarities in direction resulted from the high

impact of the adjacent object (could be tail boom). Carbon fiber and glass epoxy has fractured in multi directional to indicate the incident load is higher than the ultimate strength of the material. Twisted and disoriented carbon fiber material indicates high impact coupled with the rotating tail rotor blade during the impact.

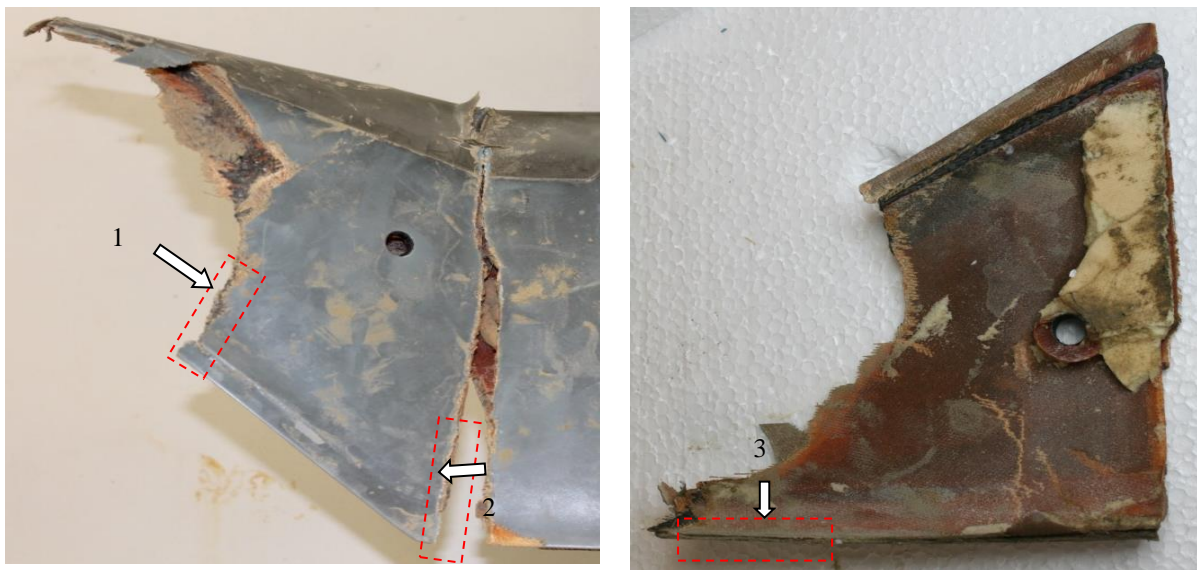
**Figure 18:** Three (3) different location of the fractured teared off the root section examined under SEM

Microscopic examination was carried out using Scanning Electron Microscope (SEM) on the selected regions of the fracture surface as shown in Figure 18. Figure 19 shows a micrograph of the fracture surface that revealed a fibers rupture in pull out mode due to over load during the incident.

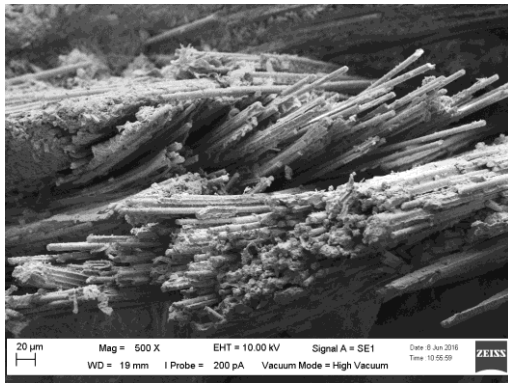
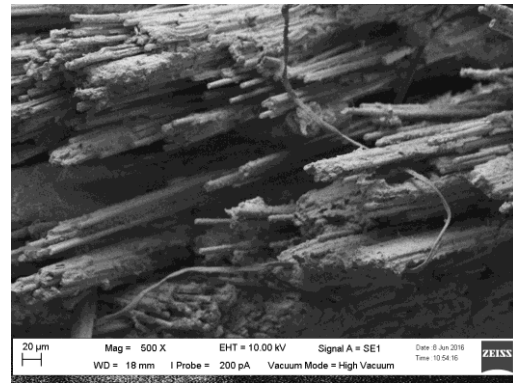
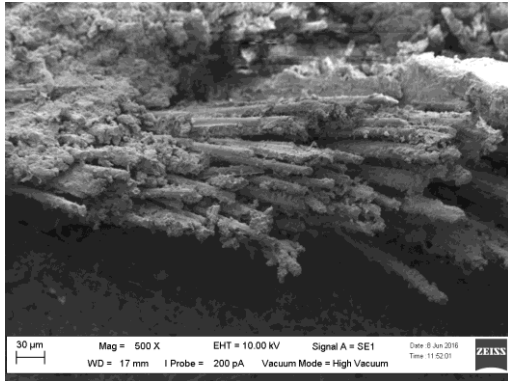
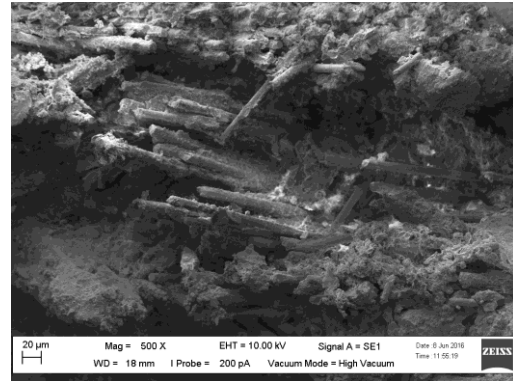
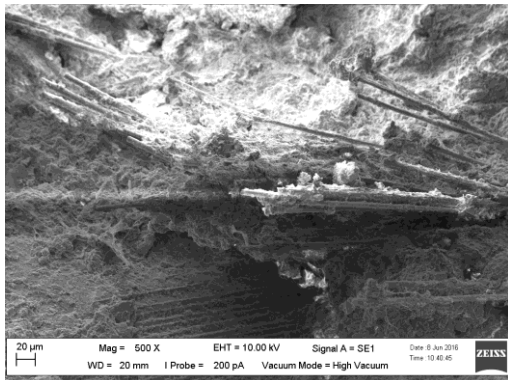
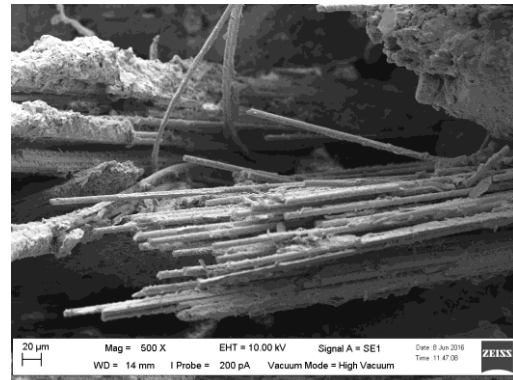
**Figure 19:** SEM images of the broken rotor blades show a fibers rupture in pull out mode during the incident

1.19.2.6 SEM analysis of the fractured tail rotor blade found the fractured fiber in pull out mode to indicate the high impact and overload failure.

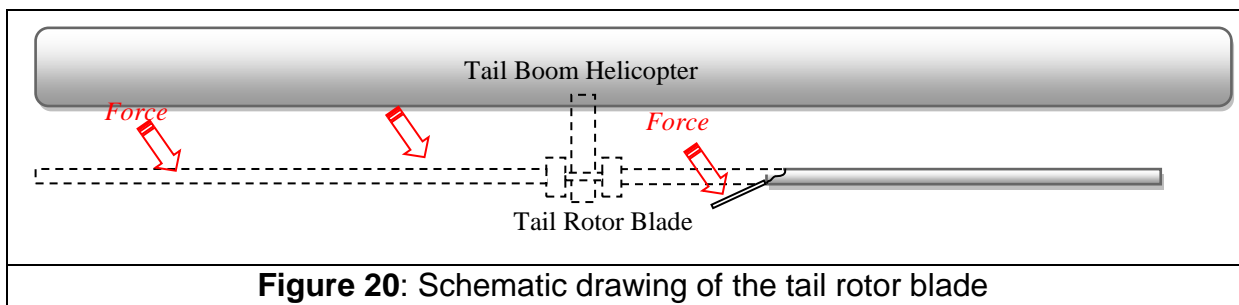
**Figure 20:** Schematic drawing of the tail rotor blade

1.19.2.7 The finding of examination has been simplified in the schematic drawing (Figure 20) to show the sequence of the event that could contribute to the tail rotor blade failure.

1.19.2.8 From the examination, it was suggested the tail rotor blade was struck and detached from its position by the tail boom at high impact. There is no other premature crack or abnormalities found in the examination.

2.3.2 The investigation strongly believed that the tail rotor was at high energy rotational speed shortly before the impact. The absence of damage at the blade leading edge indicated that it did not strike any hard object, instead the tail rotor blades strike the river surface. This was indicated by the sideways bending of the blade.
