AIRCRAFT ACCIDENT FINAL REPORT

A 04/19

Accident Involving a Tecnam P2002 JF Registration 9M-MZC at Kuala Klawang, Negeri Sembilan on the 29 June 2019

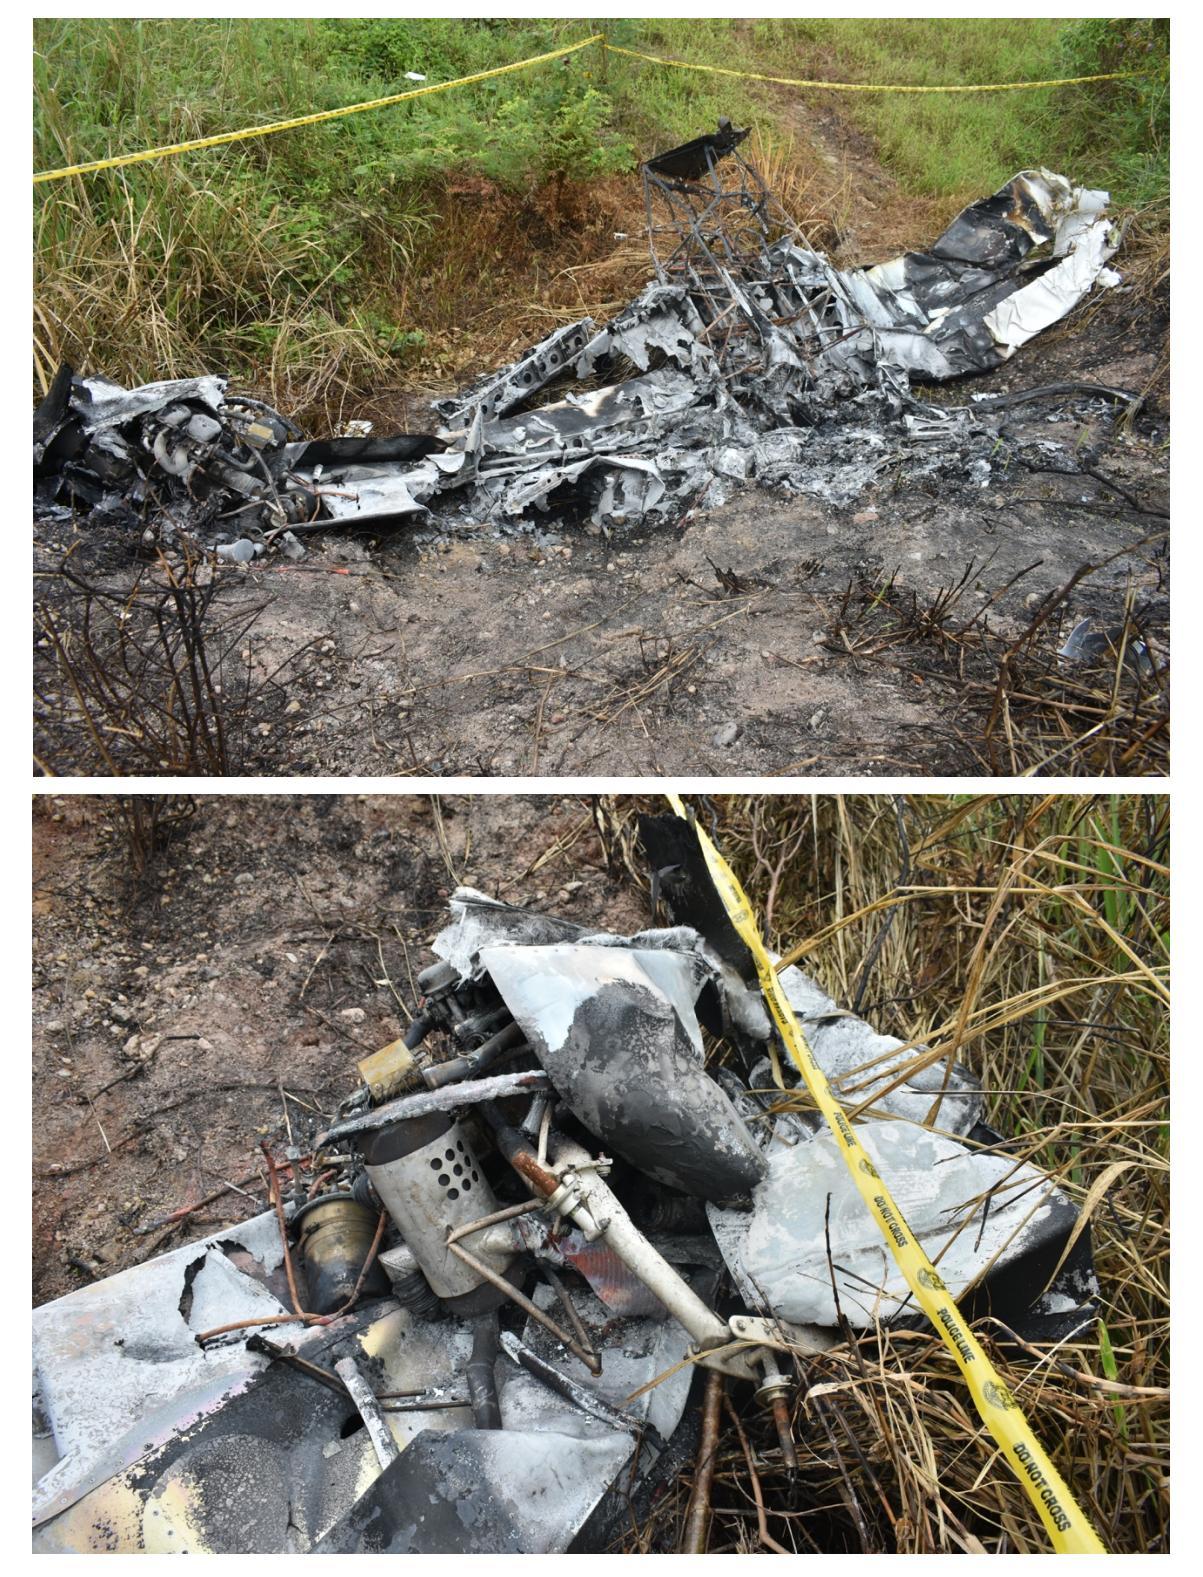
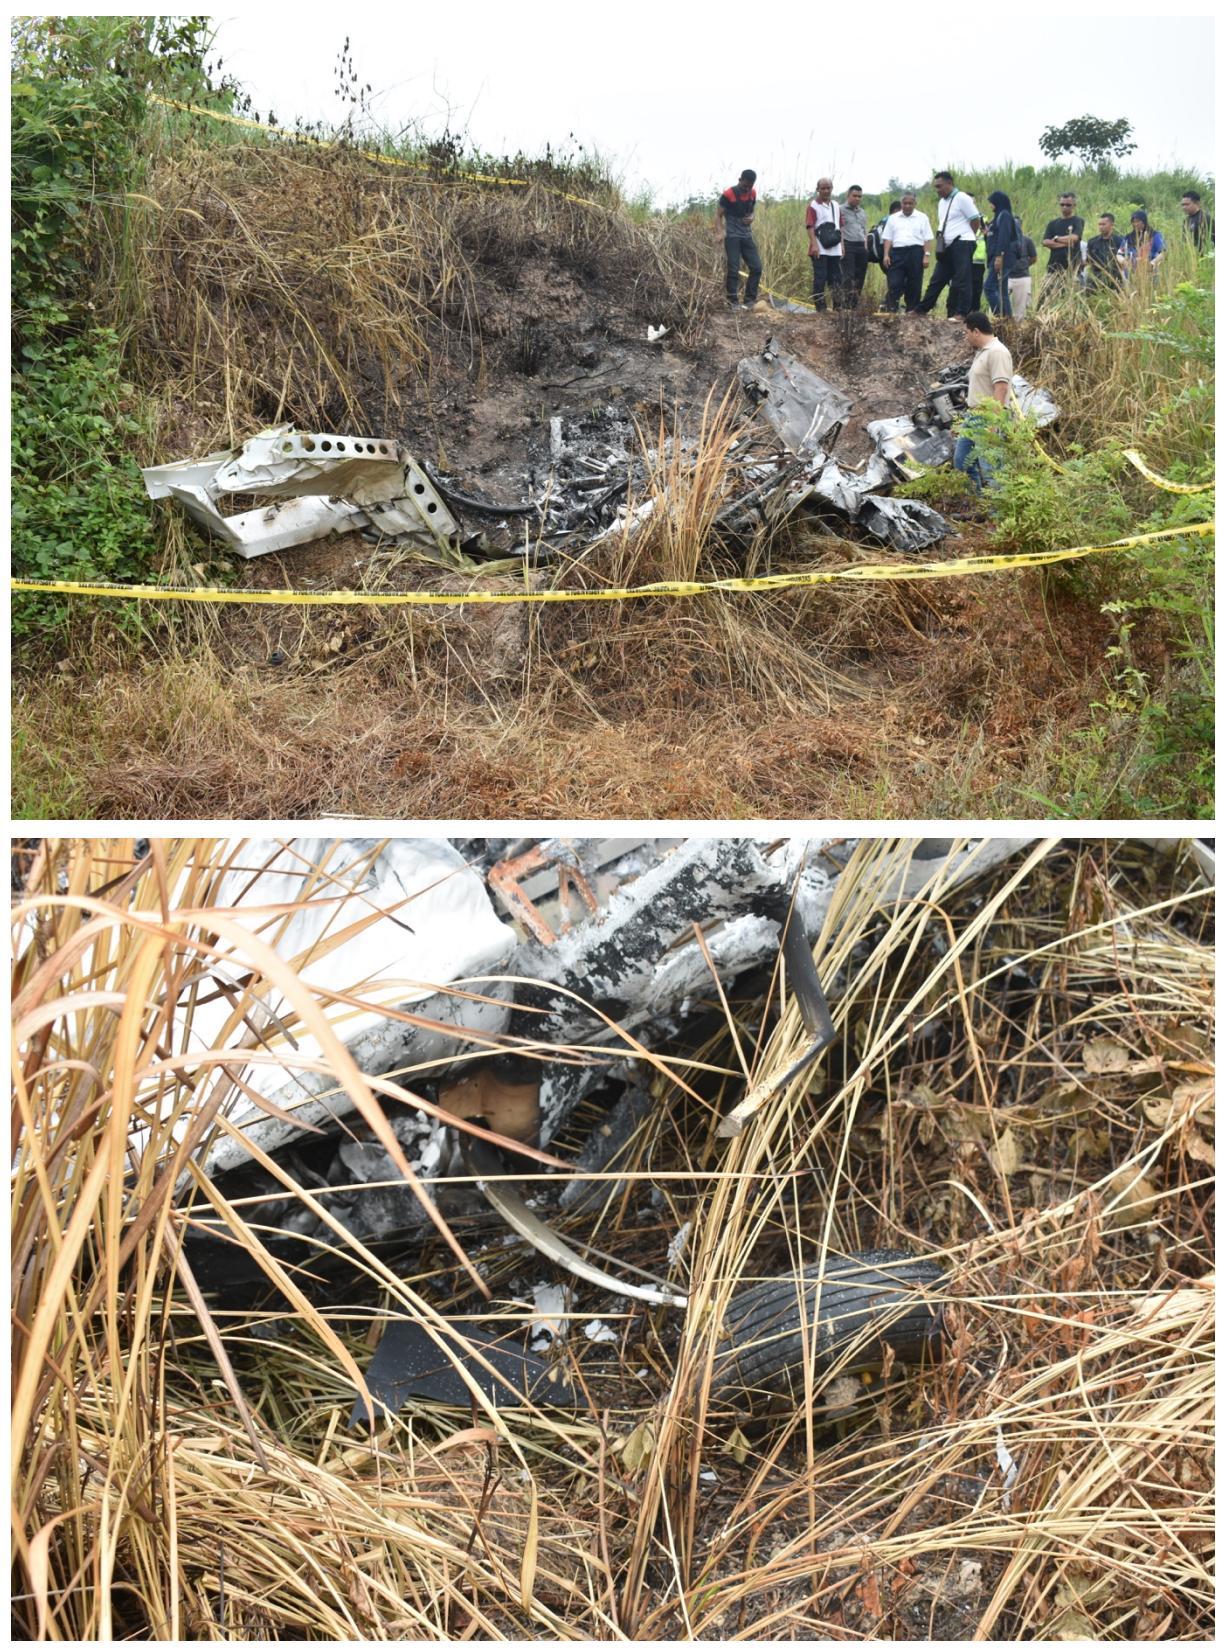
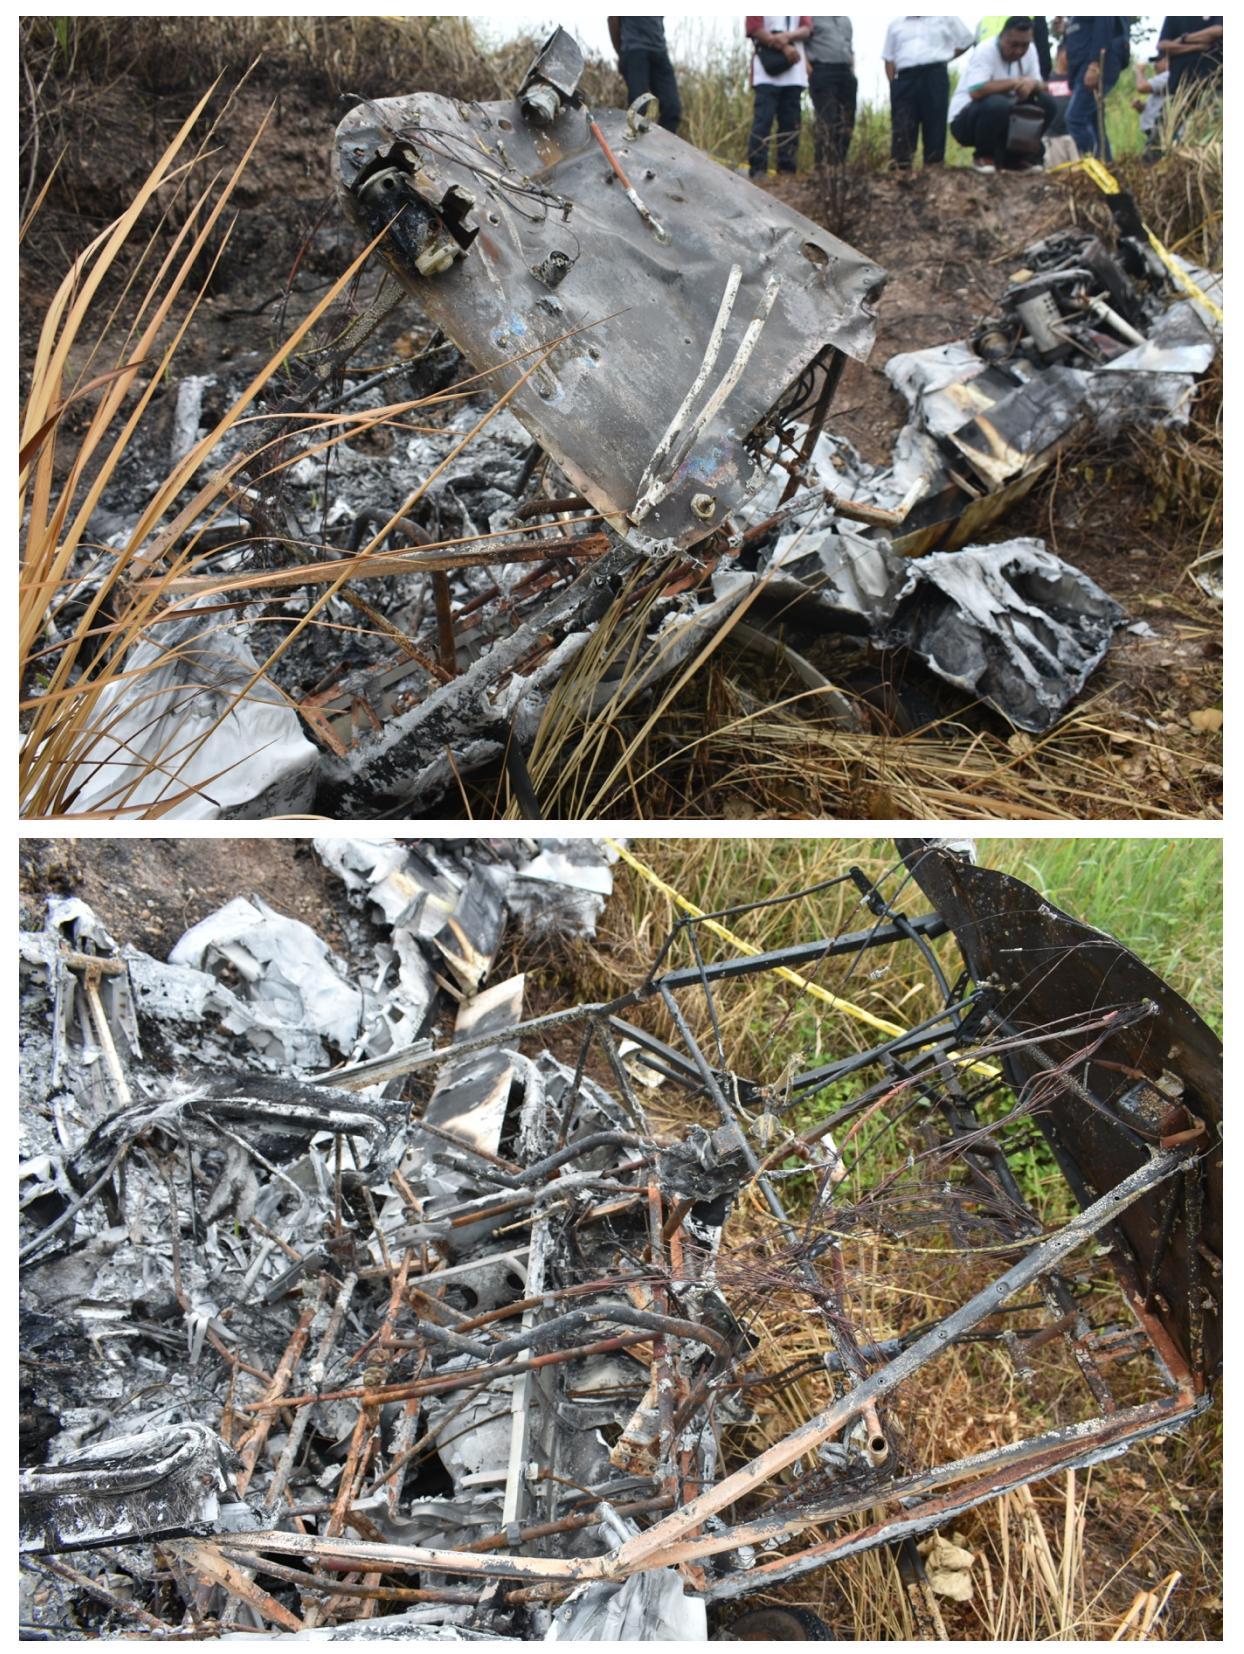
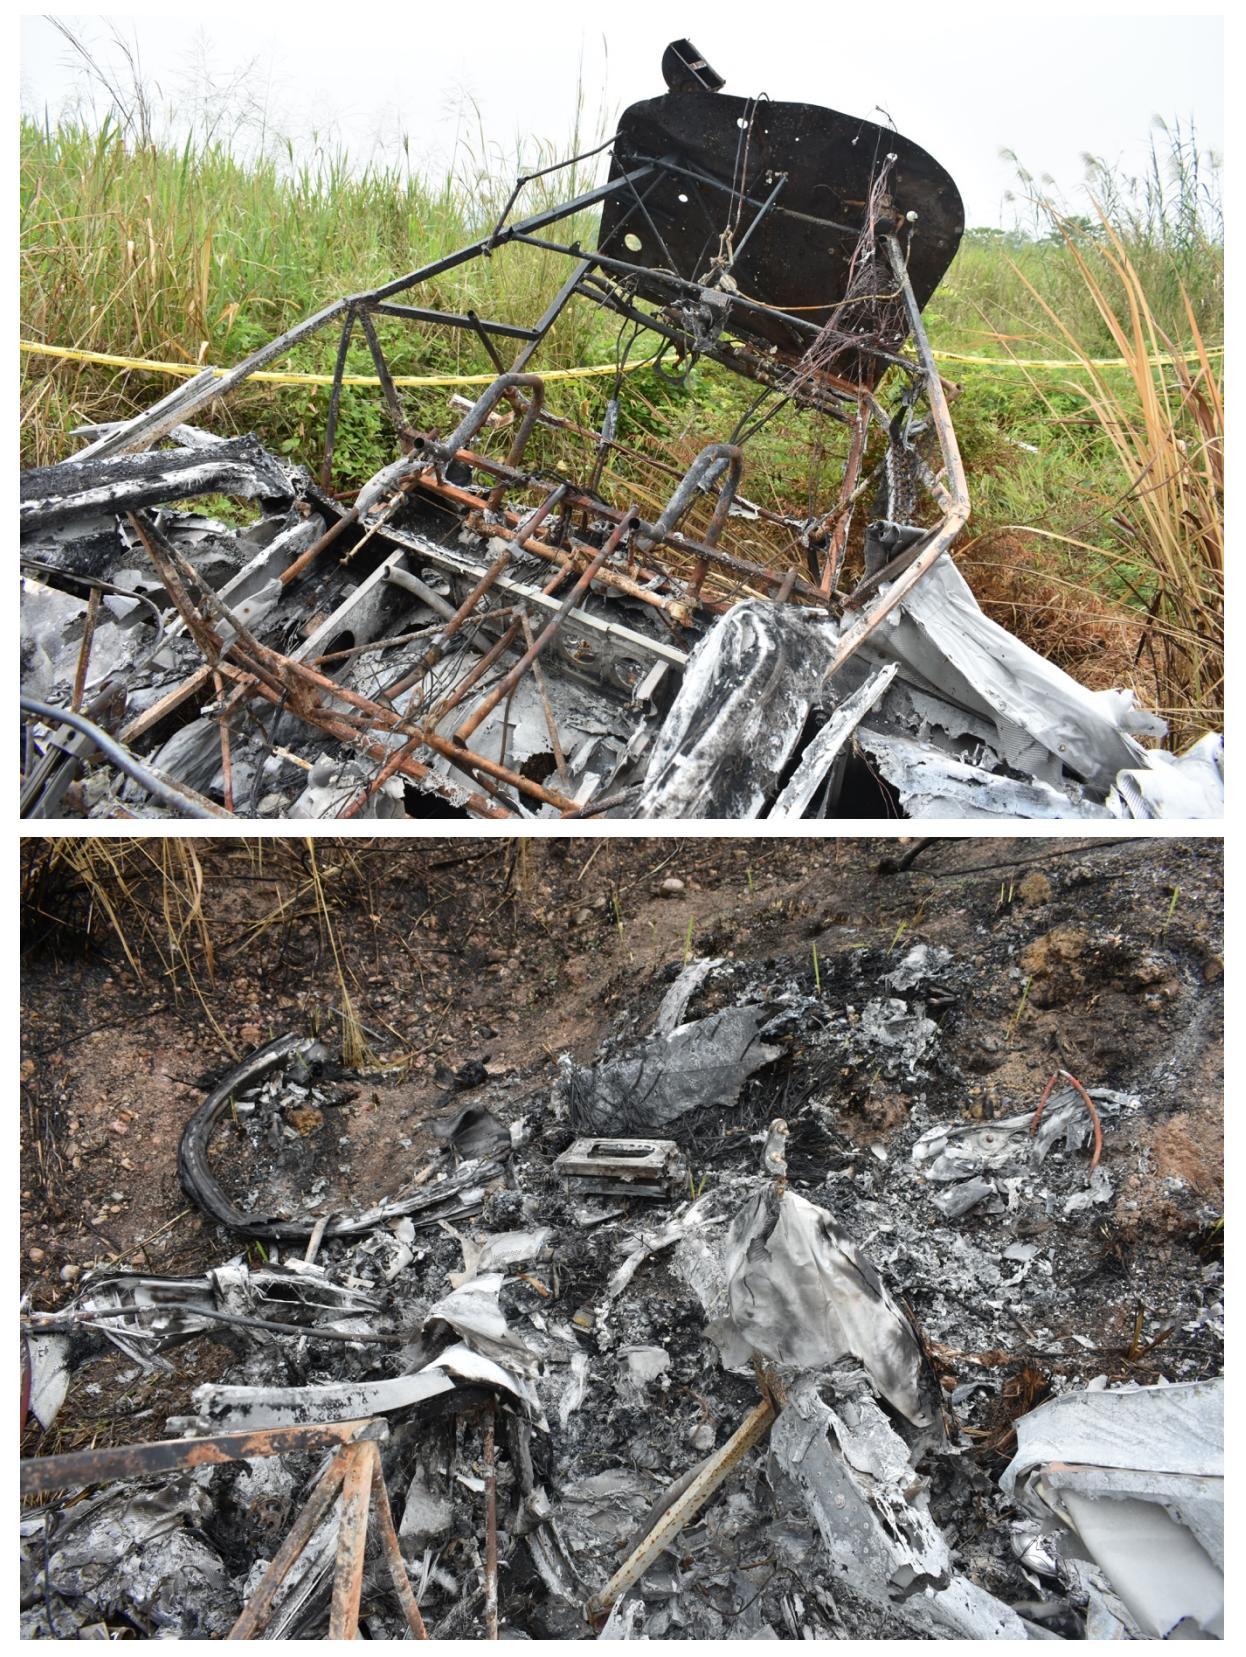
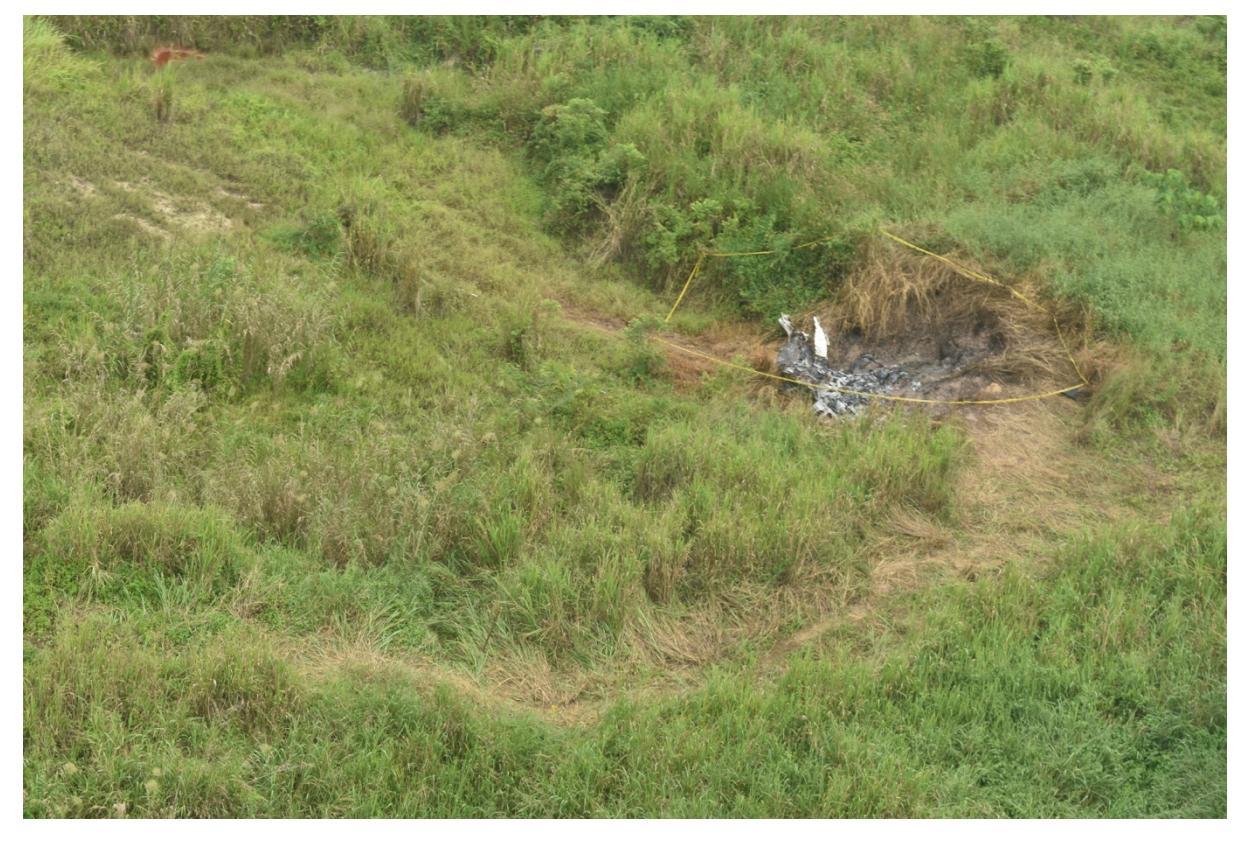
9M-MZC

The aircraft was a total write-off due to the post-accident fire. Please refer to **APPENDIX A** for some images taken on-site for the damage assessment.

On landing, the aircraft went through some brush and long grass before impacting an embankment nose first. At this point the fuel cells most probably ruptured with the fuel igniting on contact with the hot surfaces of the engine. The subsequent fire totally consumed the aircraft.

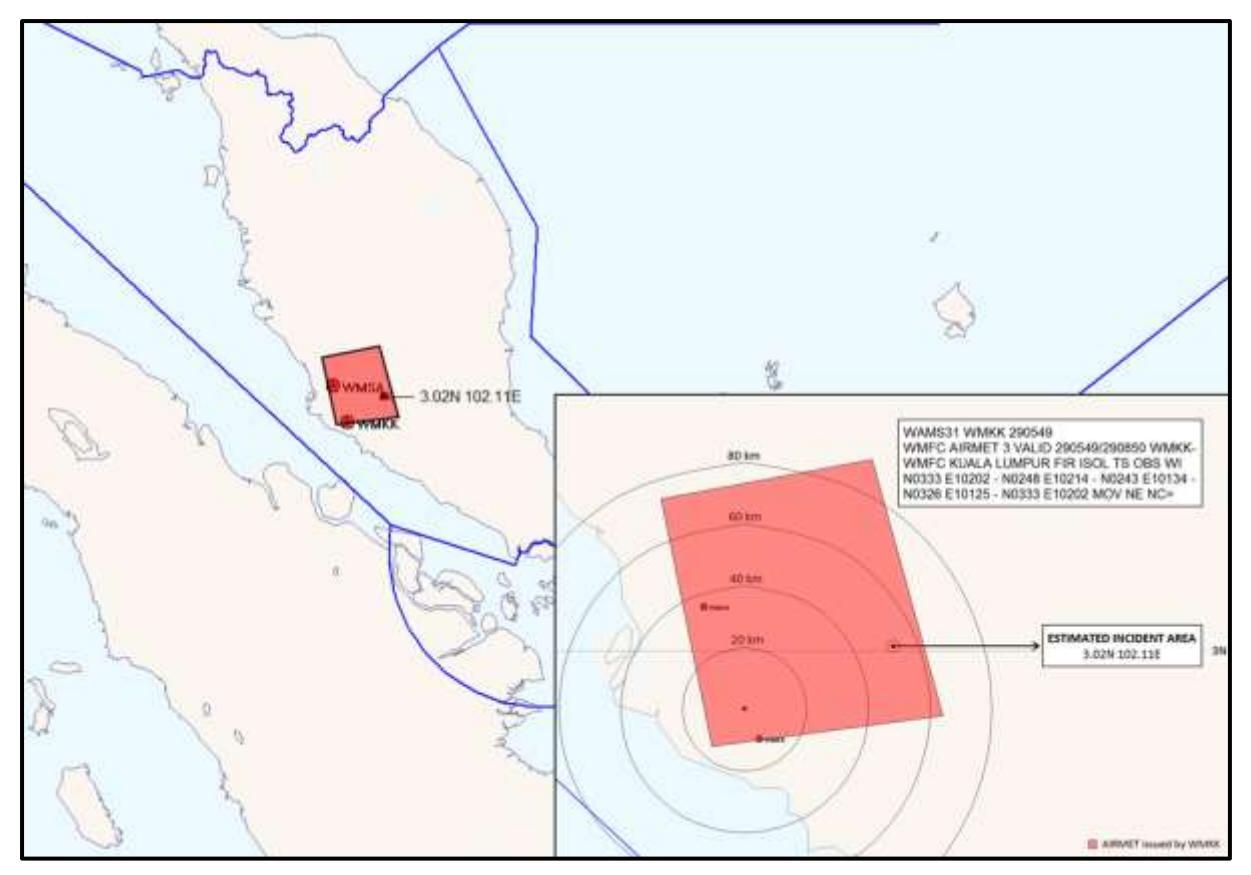
Figure 1: AIRMET issued by National Aviation Meteorological Centre at 0549UTC

Figure 1 shows the en-route weather phenomena information for low level aircraft operation (AIRMET) issued by WMKK on 29th June 2019.
