# AIRCRAFT ACCIDENT

# A 01/22

Diamond DA 40 D, Registration 9M-HMW

at Langkawi International Airport, Kedah

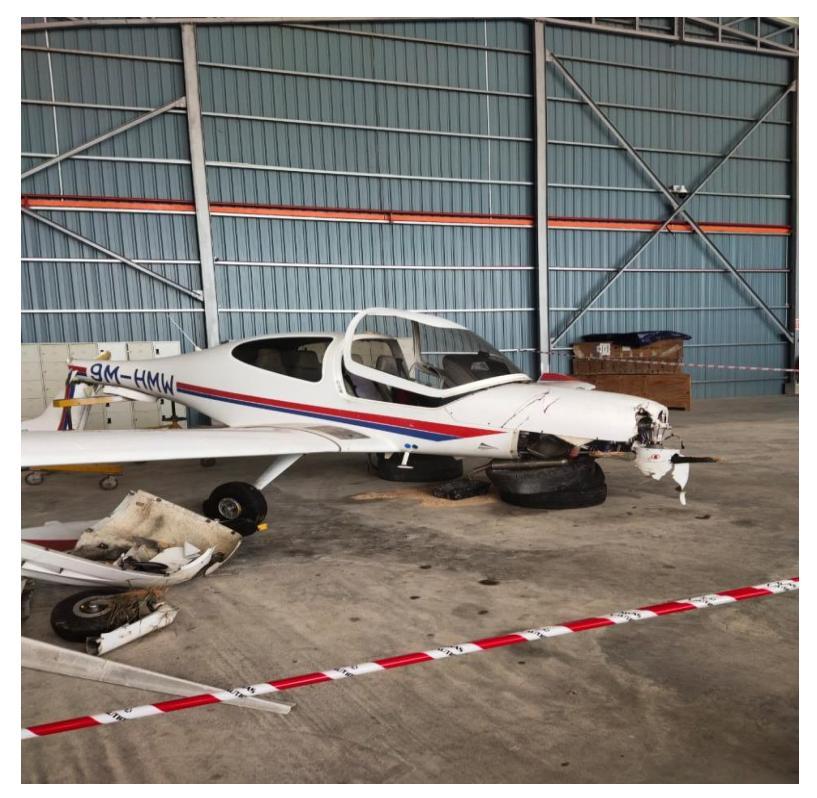
- a. All propeller blades broken.
- b. Nose spinner damaged.
- c. Gear box casing broken.
- d. Lower engine cowling broken and detached.
- e. Upper engine cowling broken at right intercooler duct.

- g. Nose landing gear broken.
- h. Left main tyre assembly broken and detached from strut.
- i. Left main landing gear strut bent and twisted.
- j. Tail cone / empennage fully broken 5ft from rudder.

Figure 2: Aircraft parked and impounded at hanger after salvage activities from crash site

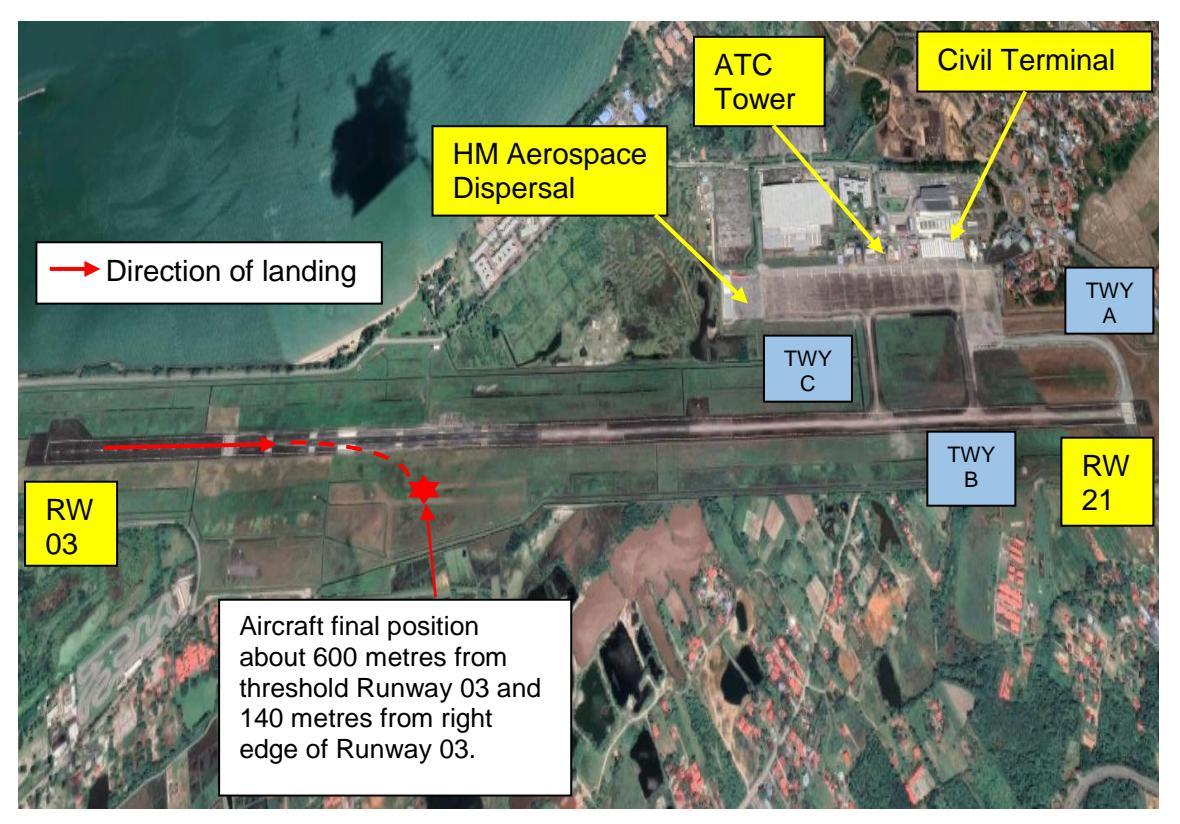
Figure 9: Landing path and final position of aircraft (Diagram not to scale)

The aircraft suffered major damage in this accident. The aircraft had bounced while attempting to land and veered to the right side of the runway during the attempt go-around. The first impact point was about 120m from the right runway edge and about 600m from Runway 03 threshold. No skid marks were observed on the runway and grass area till the first impact point. The aircraft came to a rest about 140m from the right runway edge with the aircraft nose pointing to the ATC tower.

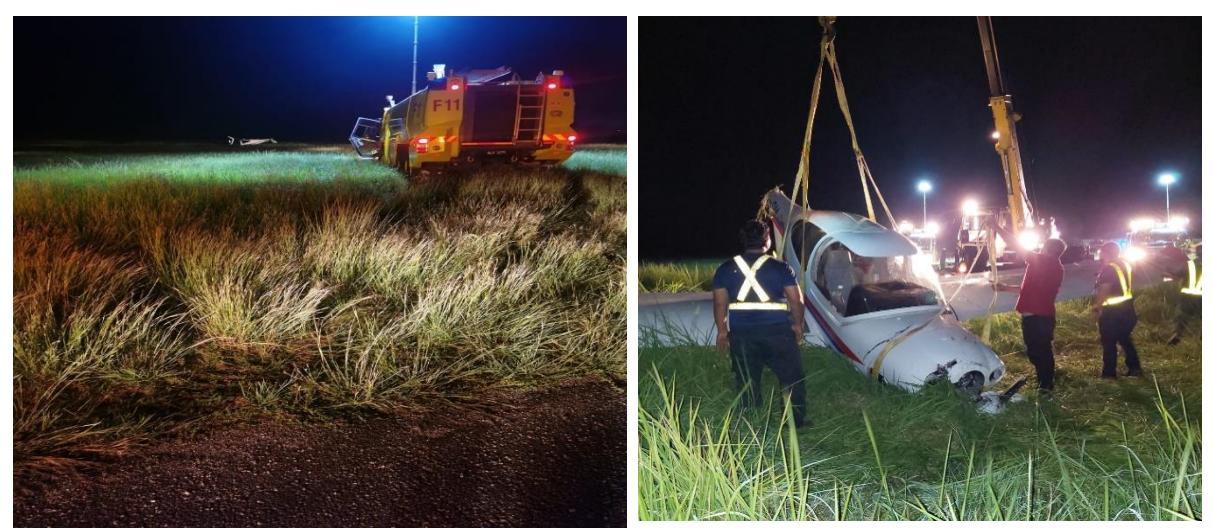
Figure 24: Night – **Evidence Limitation**: Aircraft skid marks and grass foliage evidence around the first impact point to aircraft final stop position were mostly lost due to rescue work by AFRS vehicle and wreckage salvage work by heavy lift crane and personnel movement. Nevertheless, first impact point and final aircraft rest position can be identified clearly.

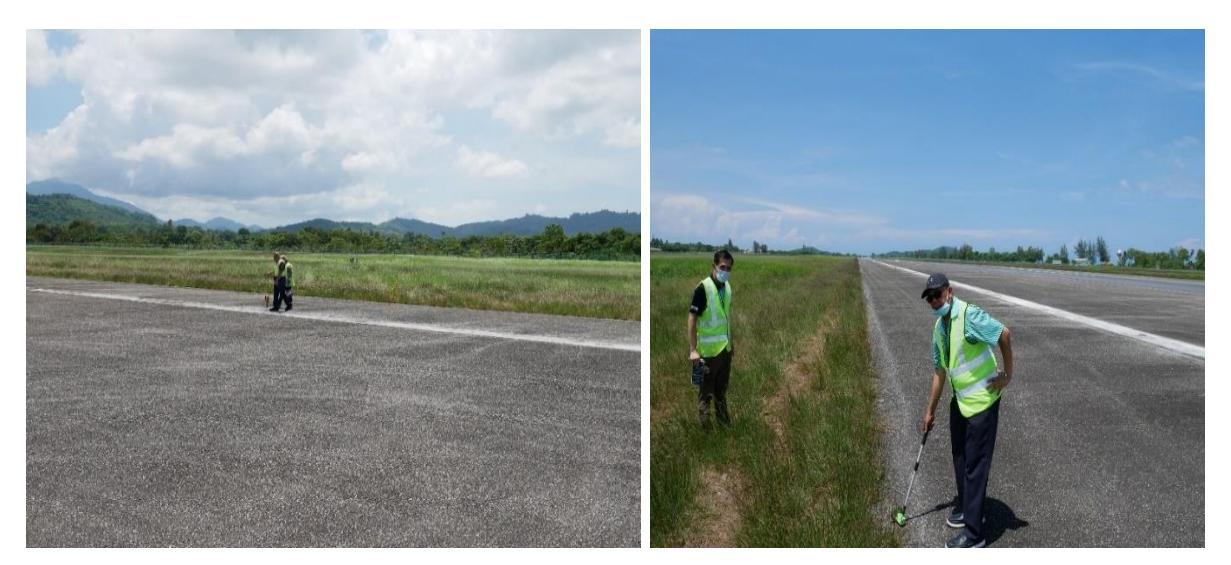
Figure 25: Day - No aircraft tyre track marks were observed on the runway at possible landing area or exiting the runway towards crash site.

Evidence on-site revealed that there were no tyre track marks observed on the possible landing point on the runway or exiting the runway to support a possible aircraft veering out of the runway during the landing roll (Figure 25 & 26).

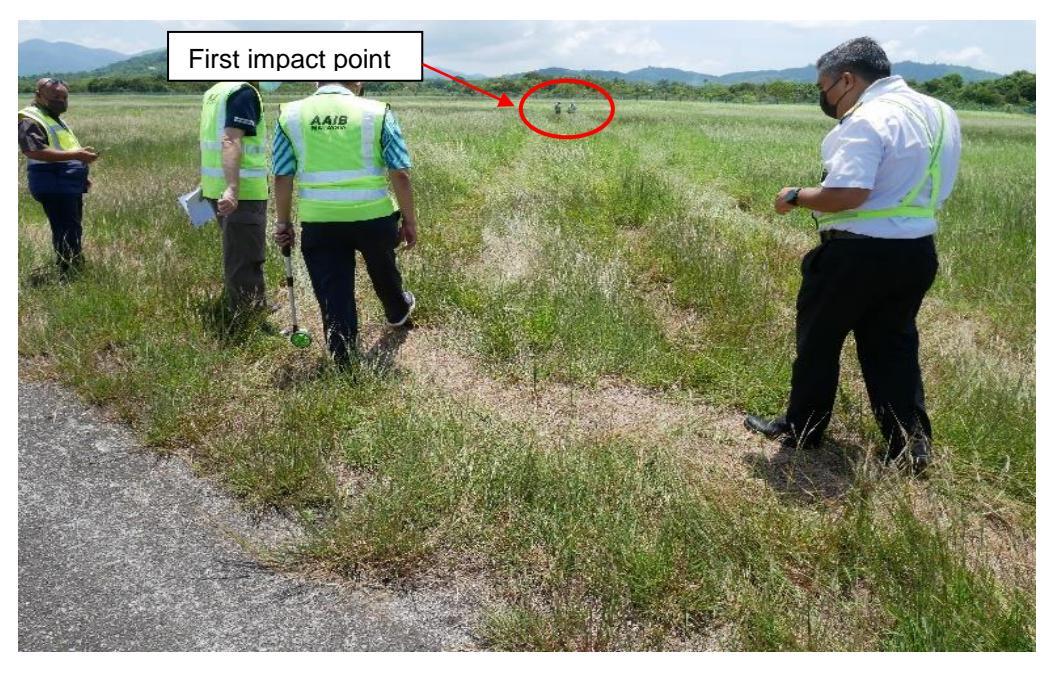
Figure 26: Day - No aircraft tyre track marks were observed exiting the runway towards the crash site. Only AFRS vehicle tyre marks were observed leading towards the crash site.

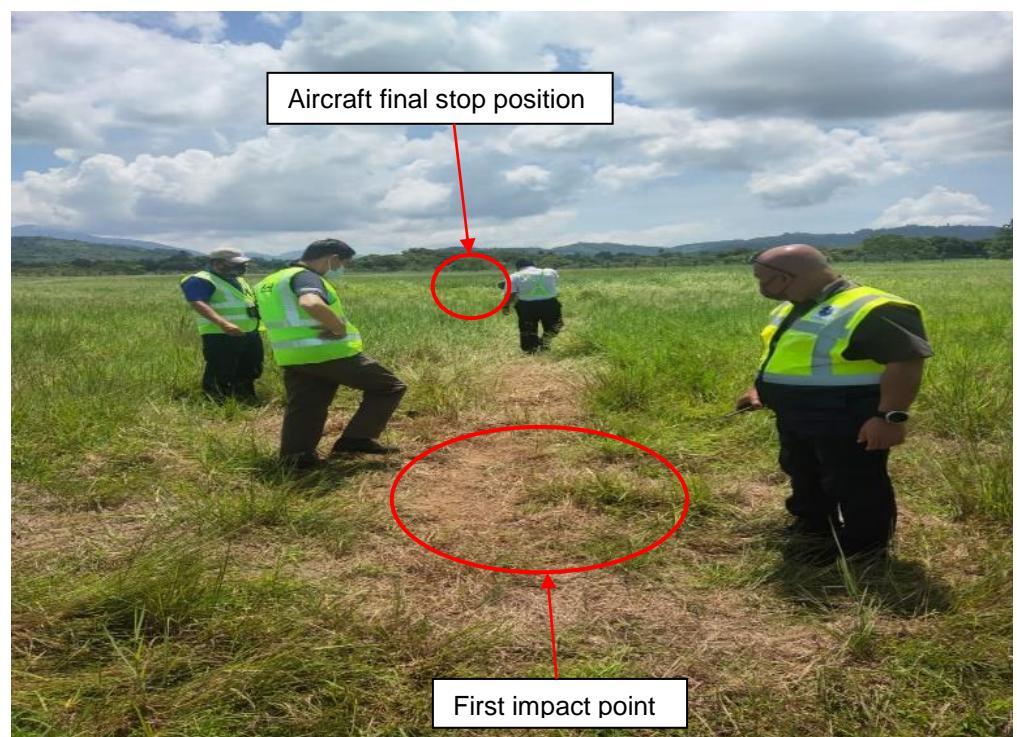
Figure 27: Day - First impact point area and aircraft final stop position view from right side edge of Runway 03.

The first impact point was about 120m from the right runway edge while the aircraft final rest position was about 20m ahead of the first impact point (Figure 27). Clear evidence of leaked aircraft engine oil and propeller debris was found at the first impact point (Figure 28). The lower engine cowling and tail skid which detached on impact was also located very close to this impact point (Figure 29).

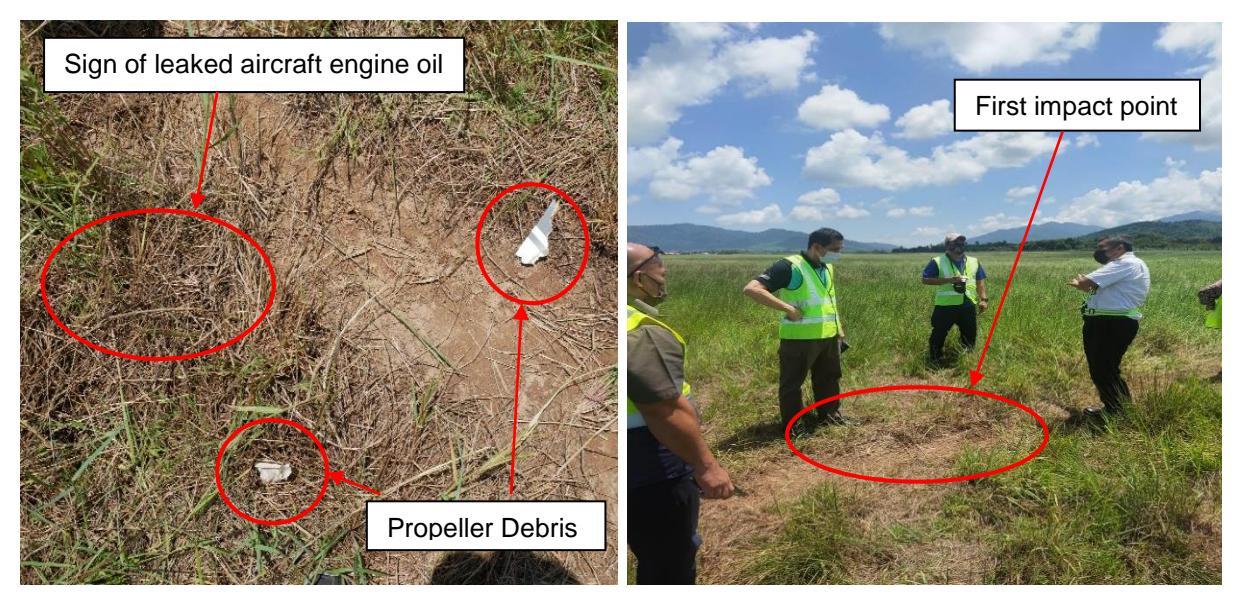
Figure 28: Day - First impact point area. Sign of leaked aircraft engine oil and propeller debris at impact area.

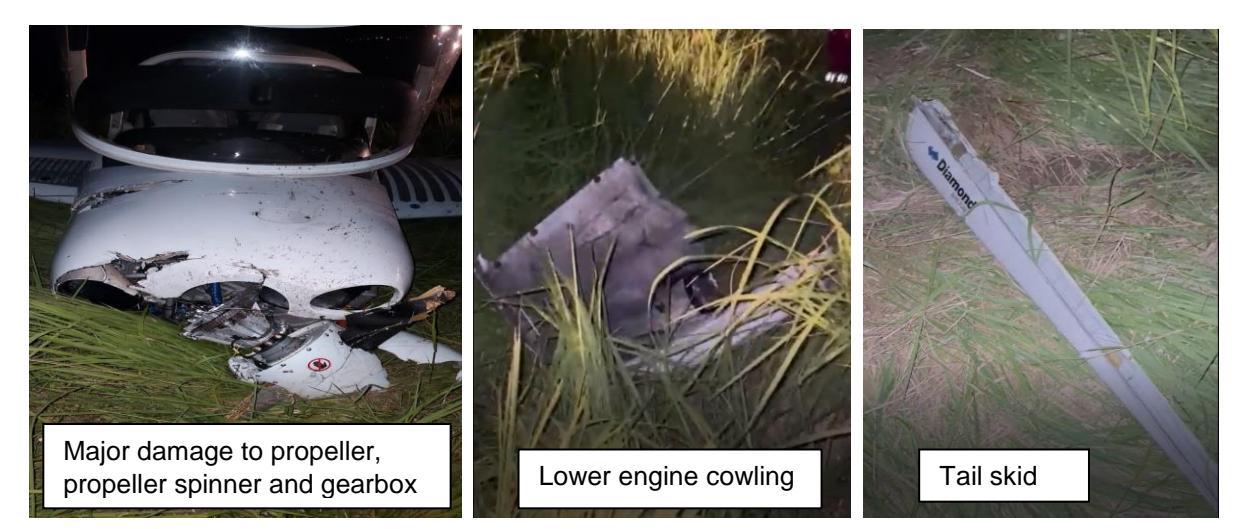
Figure 29: Night – Evidence of heavy impact on the nose section of the aircraft which resulted in major damage to all the propellers, propeller spinner and gearbox at first impact point. The nose landing gear broke and the nosewheel detached from nose landing gear strut on impact to the ground. The lower engine cowling and the tail skid was also found nearby this area.

Post-accident damage assessment revealed that there were major damages to all the propellers, propeller spinner and gearbox. The nose landing gear strut was found broken and the nosewheel had detached from nose landing gear strut. The LH

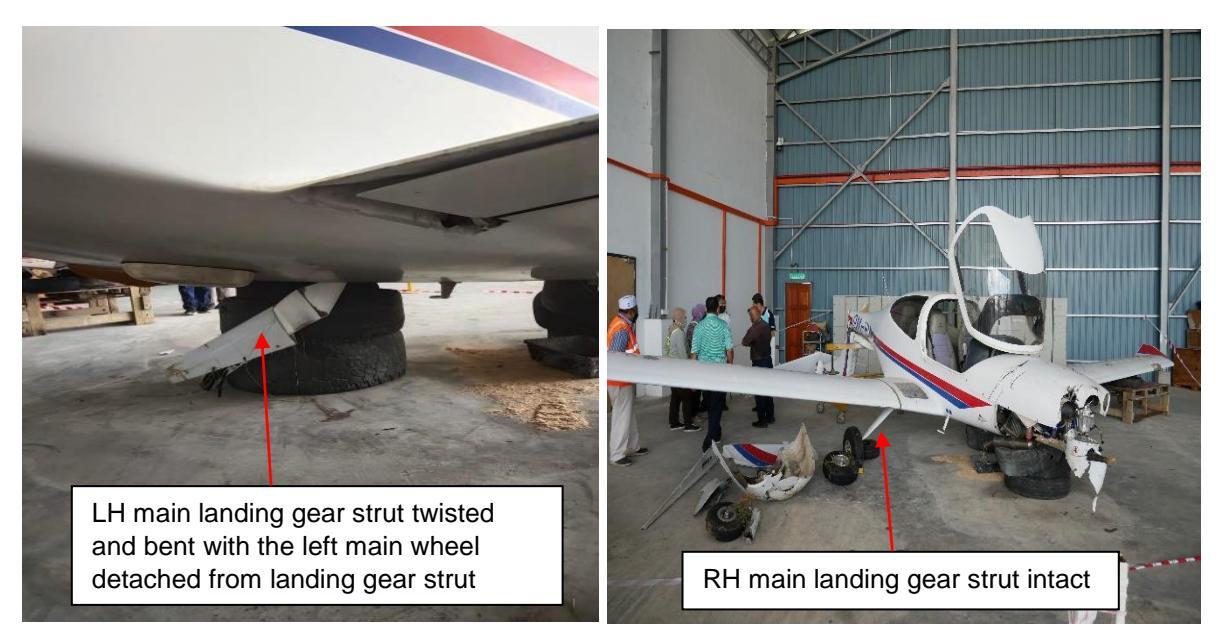
Figure 30: Day - LH main landing gear strut twisted and bent with the left main wheel detached from landing gear strut. RH main landing gear strut remained intact.

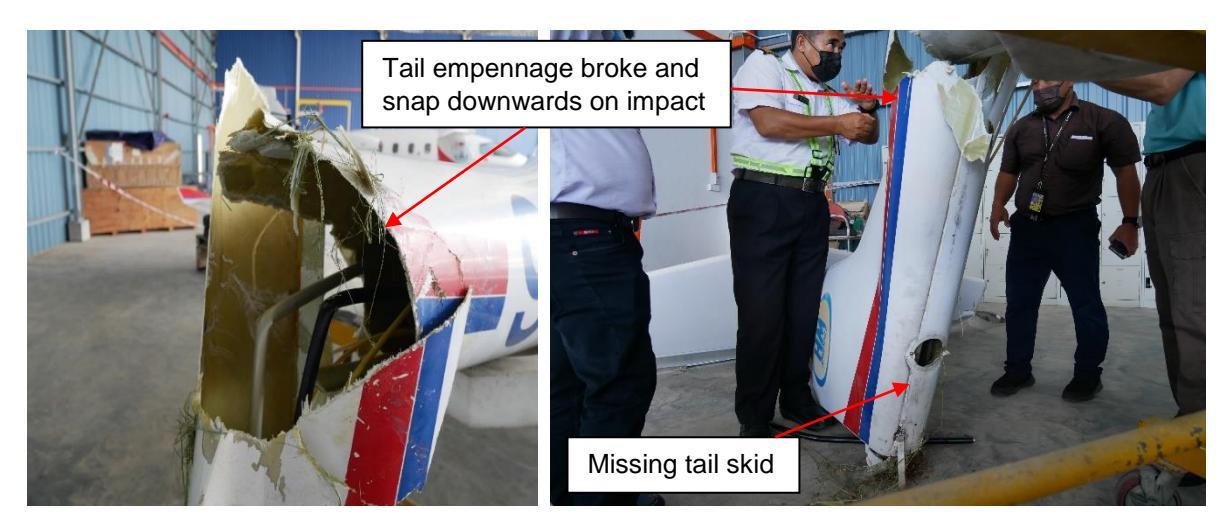
Figure 31: Day - Tail empennage broke and snap downwards on impact. The aircraft tail skid was missing and found near the first impact point area.

It is also analysed that the aircraft had impacted the ground nose section first with the aircraft nose facing roughly about 30° to the right of Runway 03 centreline. This is supported by the duty airborne FI's statement that he saw the aircraft suddenly veering off to the right on landing. Evidence also shows that the aircraft had impacted the ground with a left wing low as the left-hand side of the aircraft suffered heavy damage. The aircraft tail empennage had also impacted the ground and snapped as the aircraft tail skid was also found close to the first impact point.

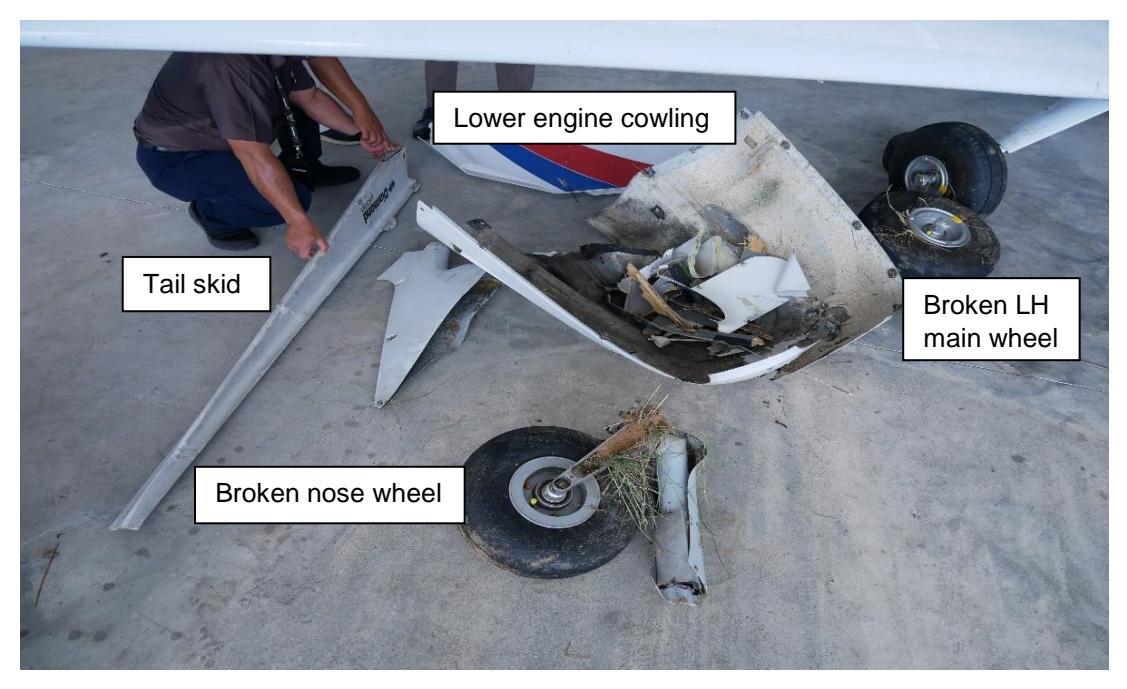
Figure 32: Day - Nose wheel, LH main wheel, Lower engine cowling and Tail Skid

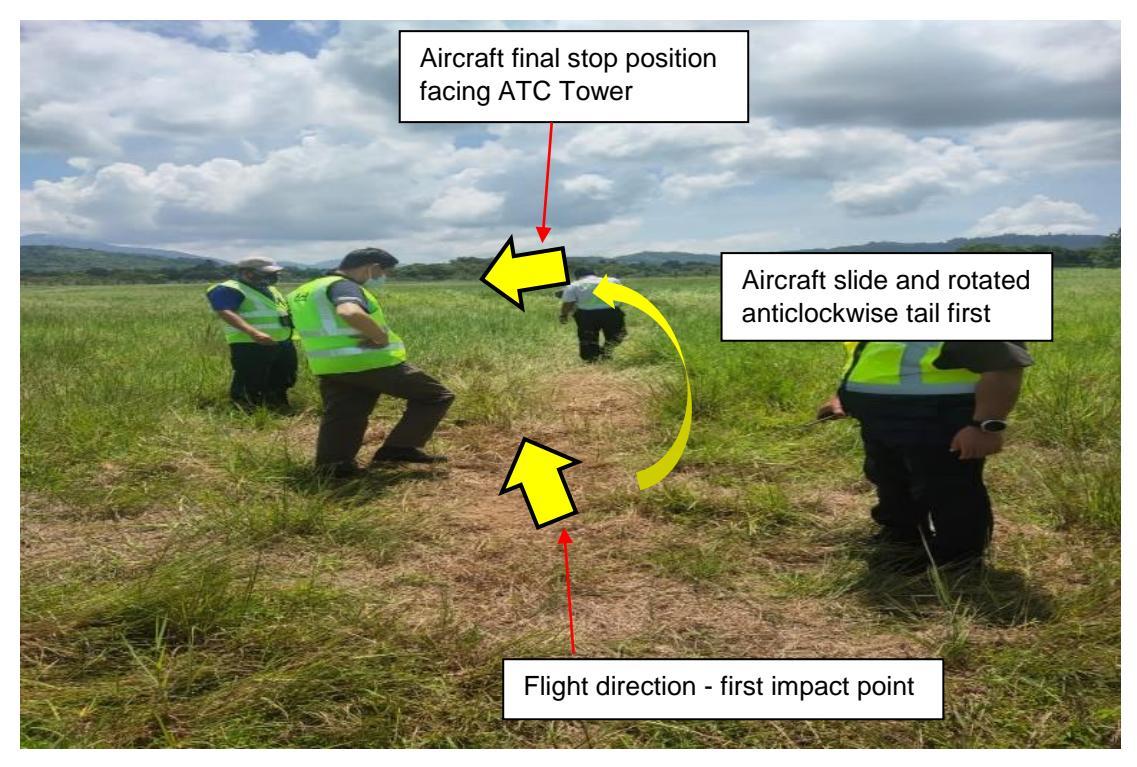
Figure 33: Day - Aircraft slide and rotated anticlockwise tail first before coming to rest with aircraft nose facing the ATC Tower.

The forward momentum of the impact most probably caused the aircraft to slide sideways for about 20m before coming to a full stop. The aircraft had rotated anticlockwise tail first for about 50° (estimated) while sliding sideways pivoting on the LH main landing gear strut which had twisted and broken off (Figure 33). The broken LH main landing gear strut and damage propeller spinner provided movement resistance for the aircraft to stop facing the ATC Tower (Figure 36 & 37). The aerial view location of first impact point, debris location and final aircraft position are shown in Figure 38.

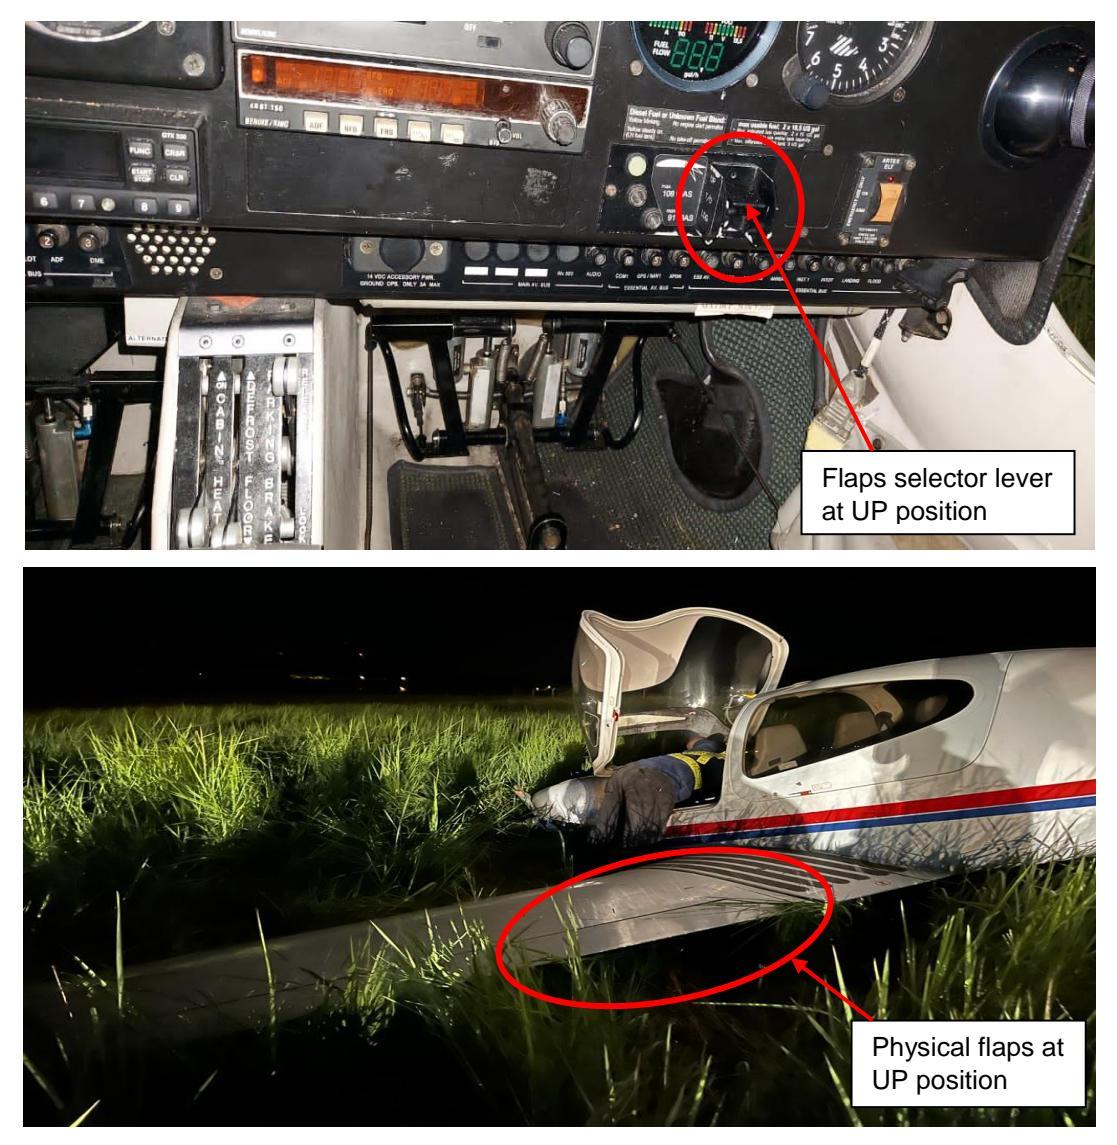
Figure 34: Night - Flaps Selector Lever and physical flaps at UP position

The over control of the flare attitude during landing and the incorrect execution of the go-around technique was the main unsafe act in this accident. The decision to salvage the bounced landing had caused the CP to act hesitantly to commence an immediate go-around. During the critical moment when the aircraft was airborne after the bounced, the CP's was hesitant to move the power lever to MAX and had incorrectly selected the flaps selector lever from LAND to UP instead of TAKE-OFF position.

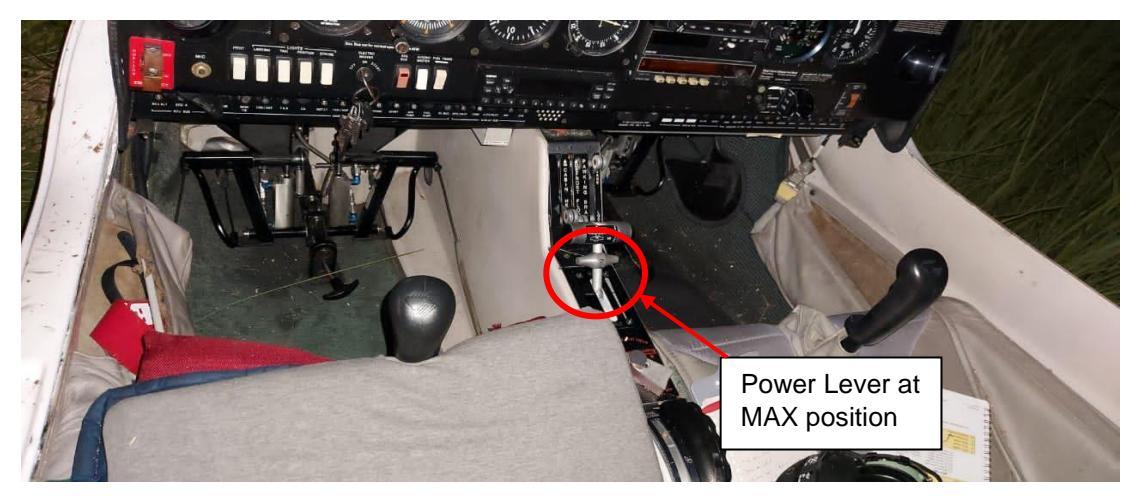
Figure 35: Night - Power Lever at MAX position

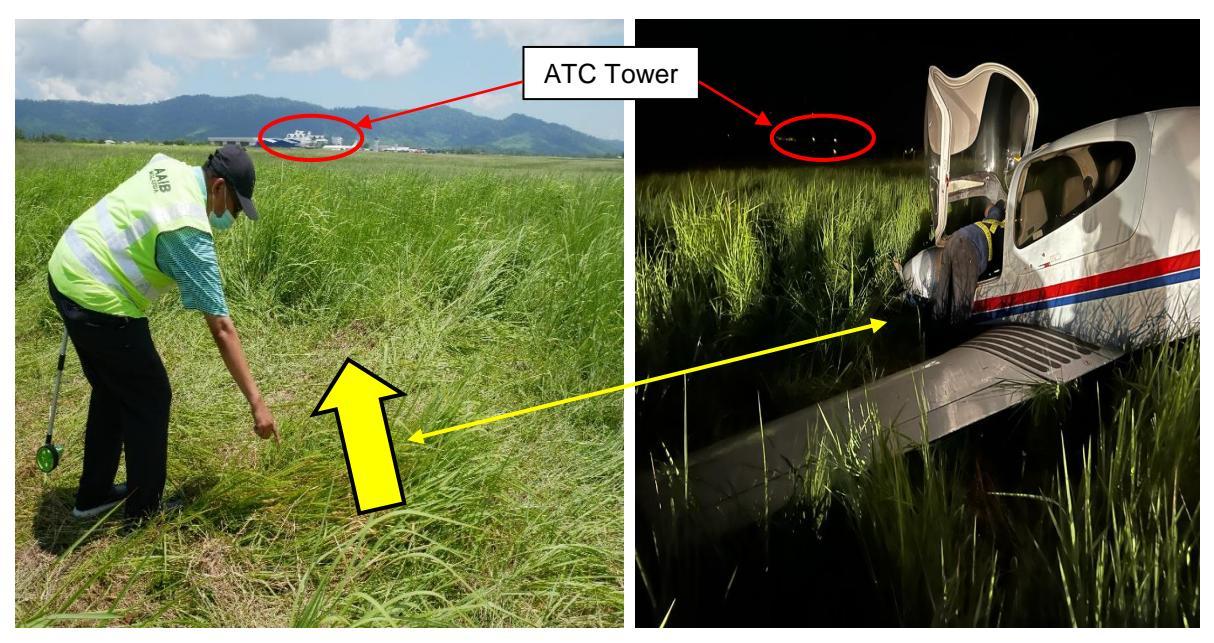
Figure 36: Day & Night - Aircraft final stop position facing ATC Tower.

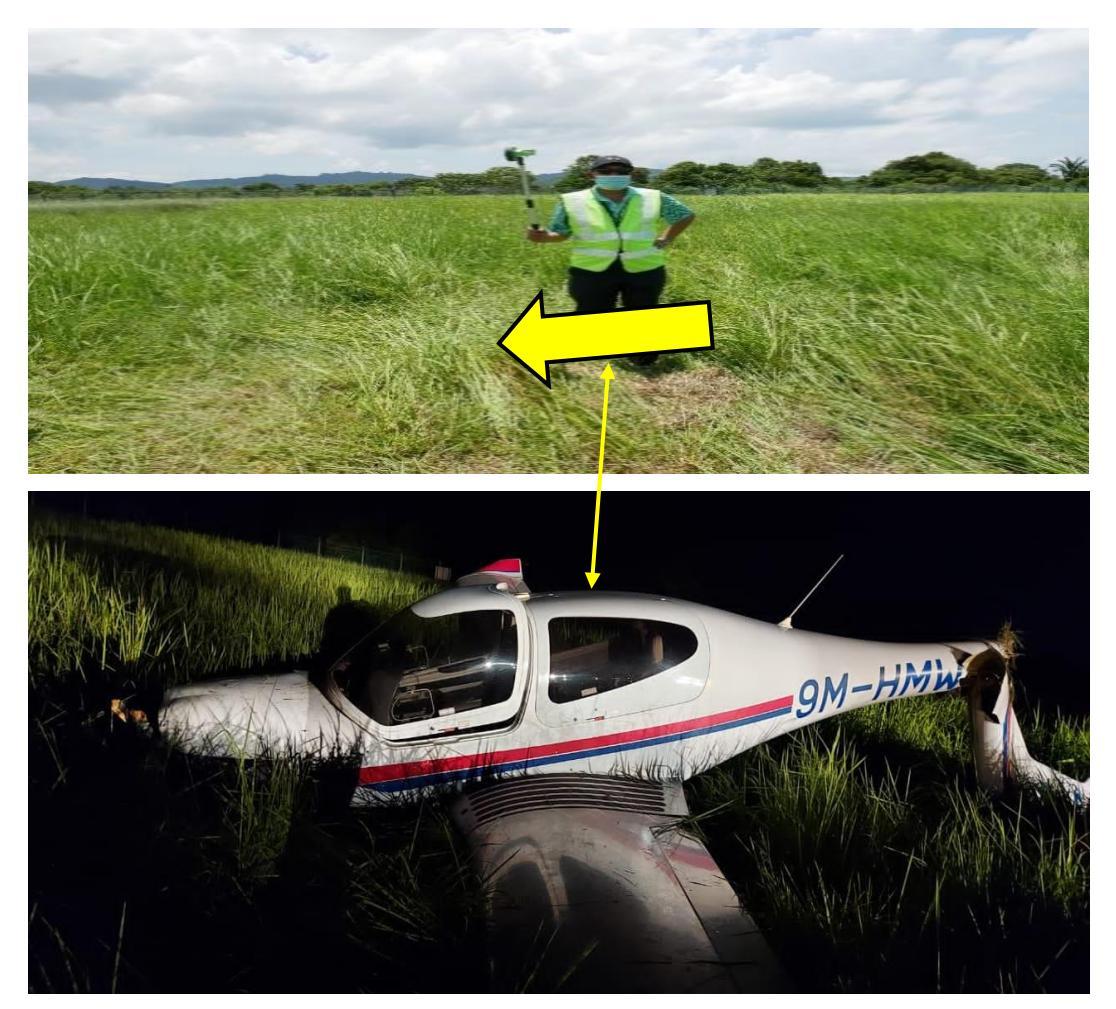
Figure 37: Day & Night - Aircraft final stop position with the broken tail empennage.

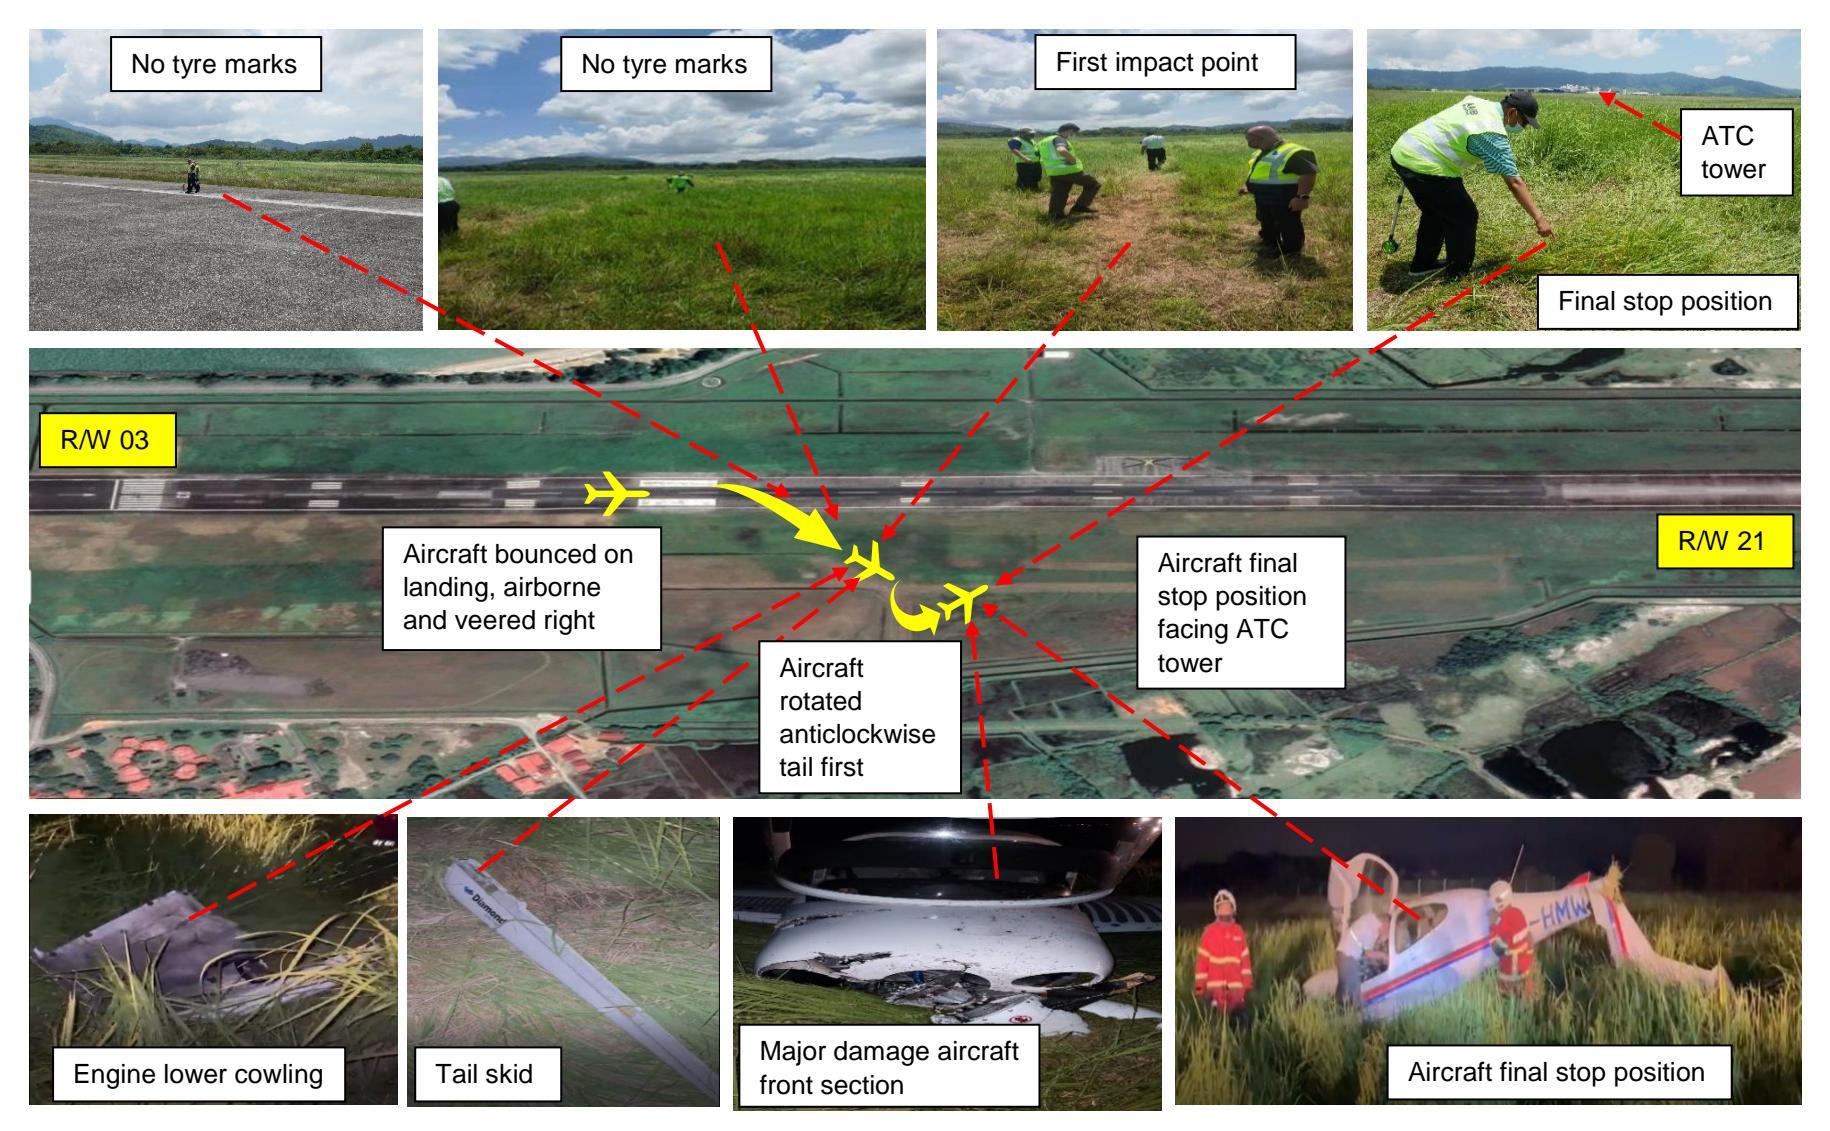
Figure 38: Aerial view location of first impact point, debris location and aircraft final position (Diagram not to scale)
