# AIRCRAFT SERIOUS INCIDENT FINAL REPORT

## SI 04/23

Incident Involving Fixed Wing Aircraft TBM 700A, Registration N188SJ at Kota Bharu Airport, Kelantan on the 4<sup>th</sup> August 2023

#### REPORT NO : SI 04/23

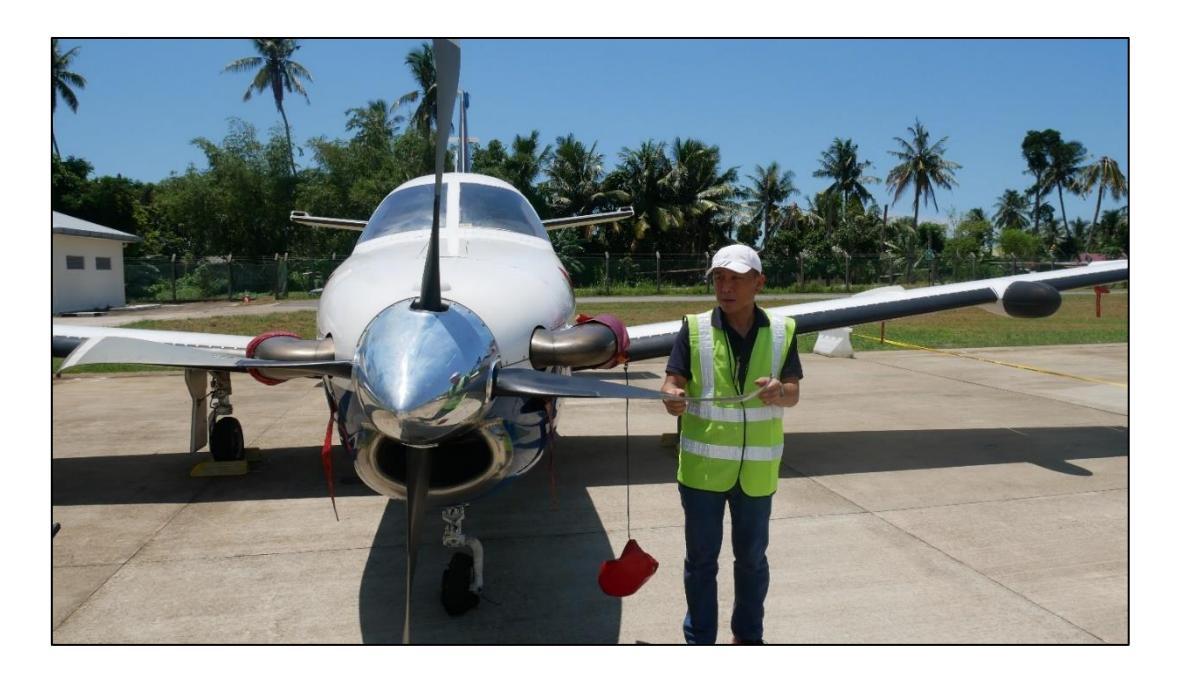
All four propeller blade tips were chipped. The nose landing gear tire had burst, and the rim was damaged. A damage assessment report was not made available to the investigation team.

Figure 1: All four propeller blades were chipped off

3.1.6.1 During the bounces, the aircraft's propeller struck the runway surface, causing damage to the propeller blades.

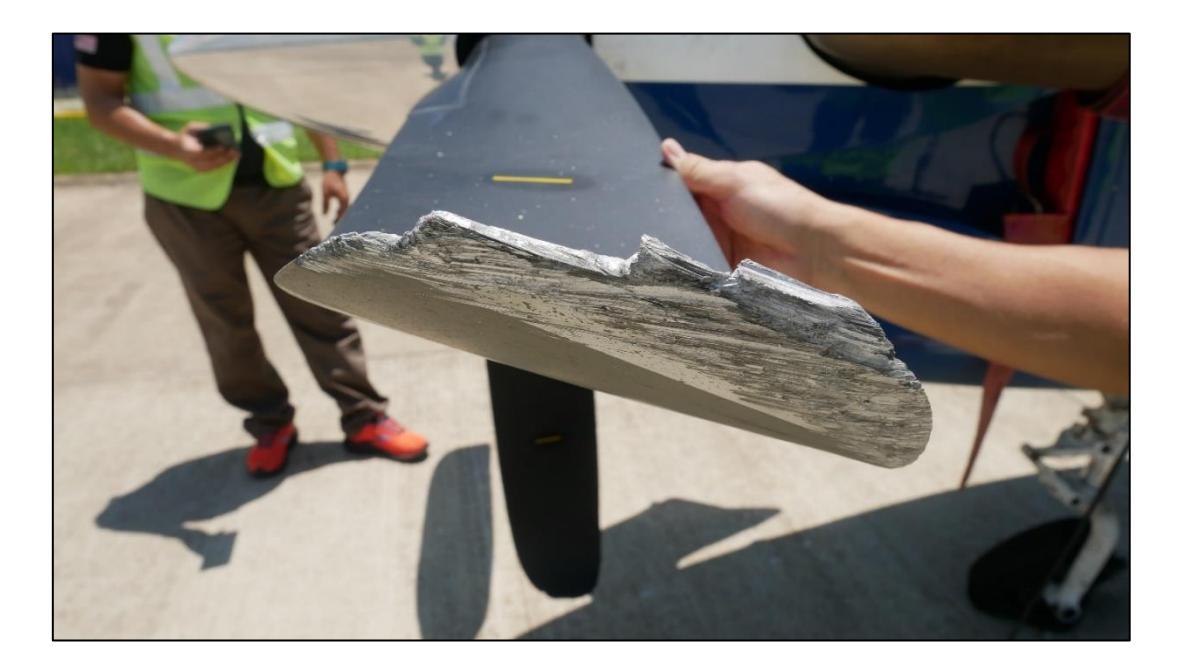
Figure 2: Damage to the propeller blade

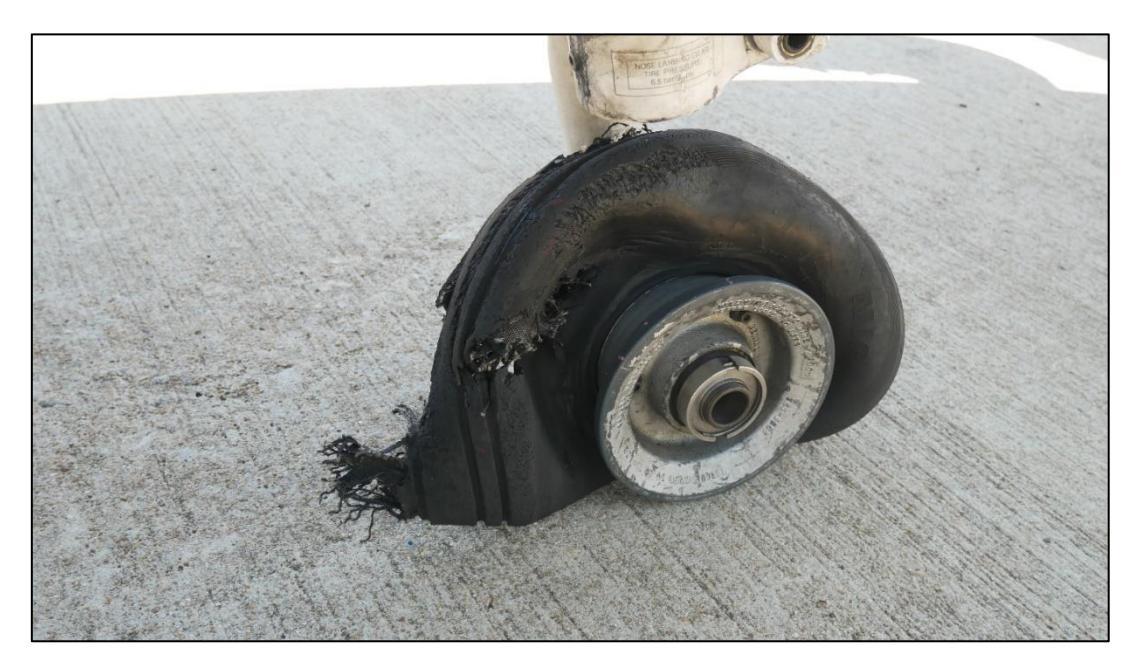
Figure 3: Damage to the tyre and rim

The tire was sent to the NTSB for testing to determine the cause of the burst. However, due to the severity of the run-flat damage, a definitive root cause could not be determined (Appendix A).

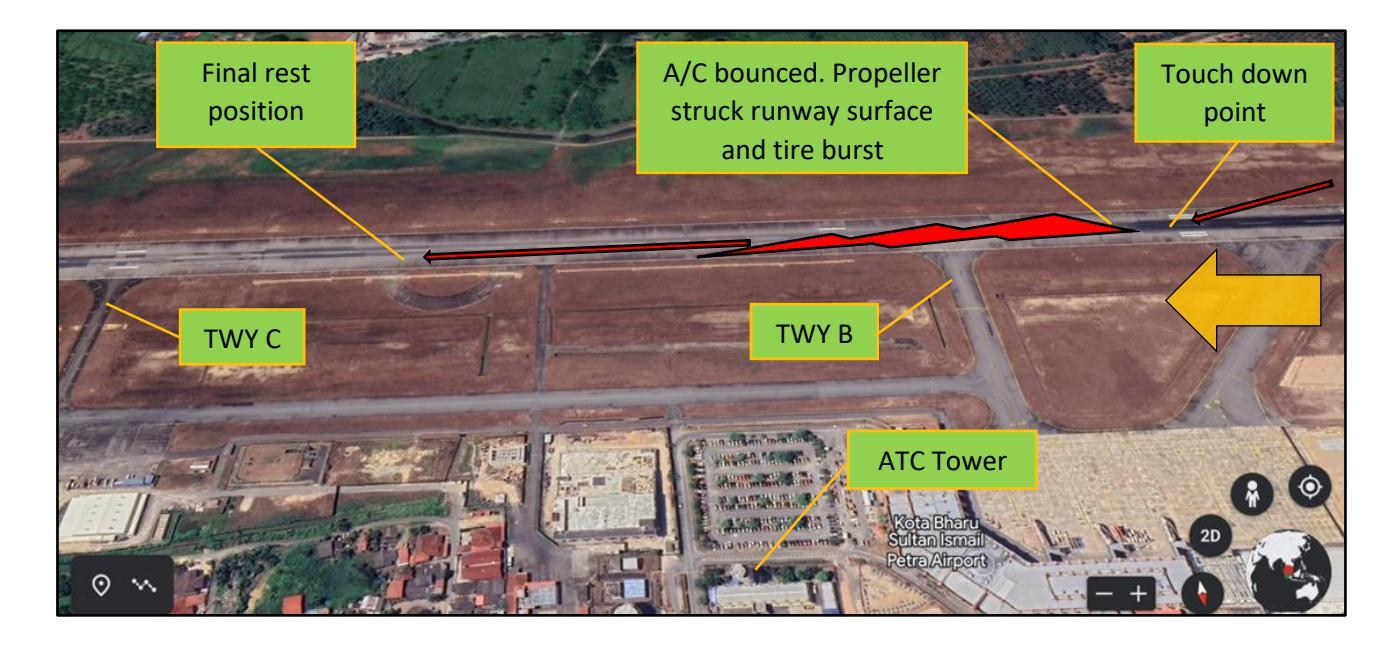
The following figure is an aerial view of the runway, showing the approximate location where the aircraft's landing gear touched down, and the nose of the aircraft began bouncing up and down. As a result of the bouncing, the aircraft's propeller struck the runway surface. The aircraft came to a stop approximately 70 meters from intersection C. After shutting down the engine, the aircrew disembarked to inspect the situation and found that the nose landing gear tire had burst and all the propeller tips were bent and chipped.

Figure 6: Landing path and final position of aircraft (diagram not to scale)

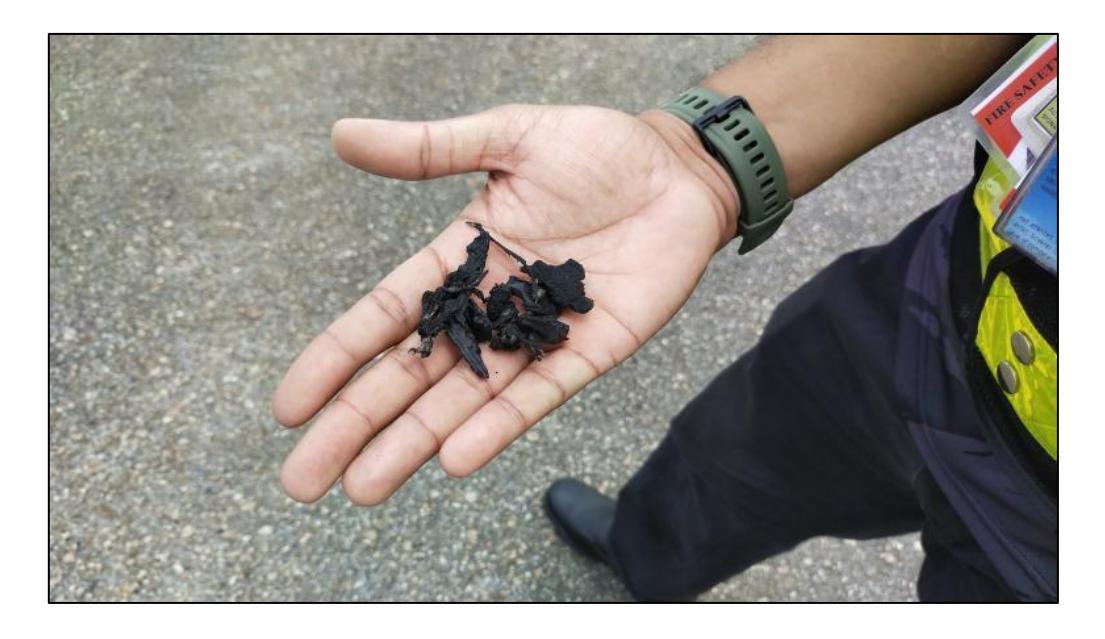
Figure 10: Aircraft tire debris

Some rubber debris was found scattered 100 to 150 meters, mostly on the left side of the runway behind the position where the aircraft stopped. The debris was collected by the Duty Officer while clearing the runway on that day.

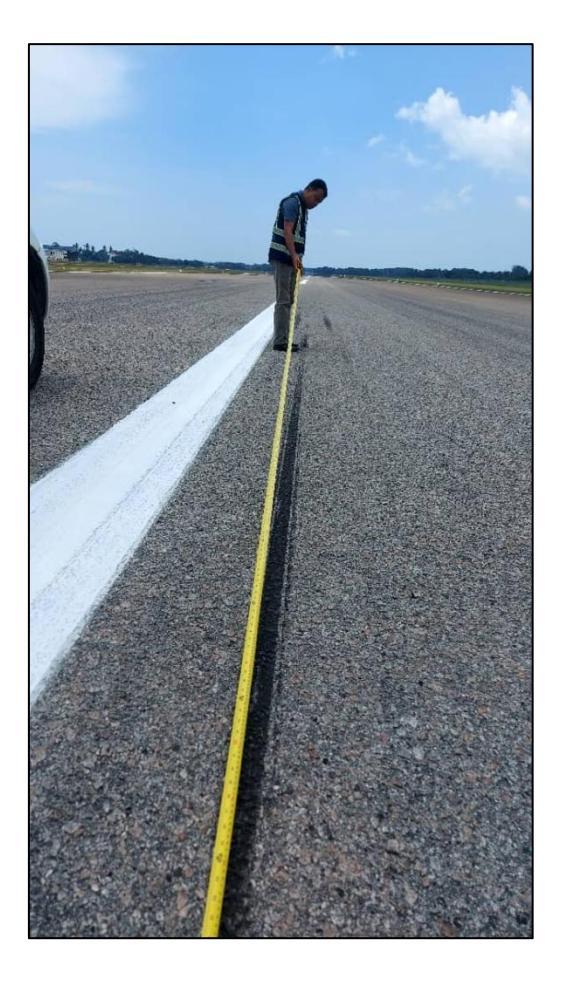
Figure 11: Aircraft tyre track marks were observed on the runway at the landing area or exiting the runway centreline towards the stopping point.

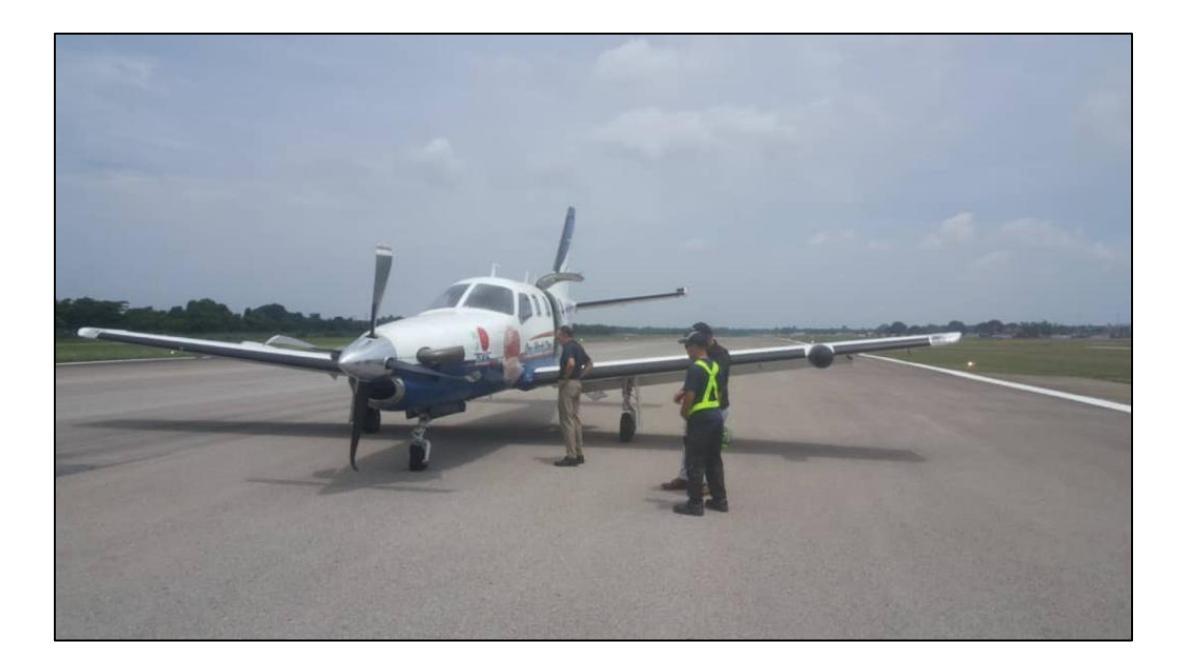
Figure 12: Aircraft's final stop position to the left of the runway centreline

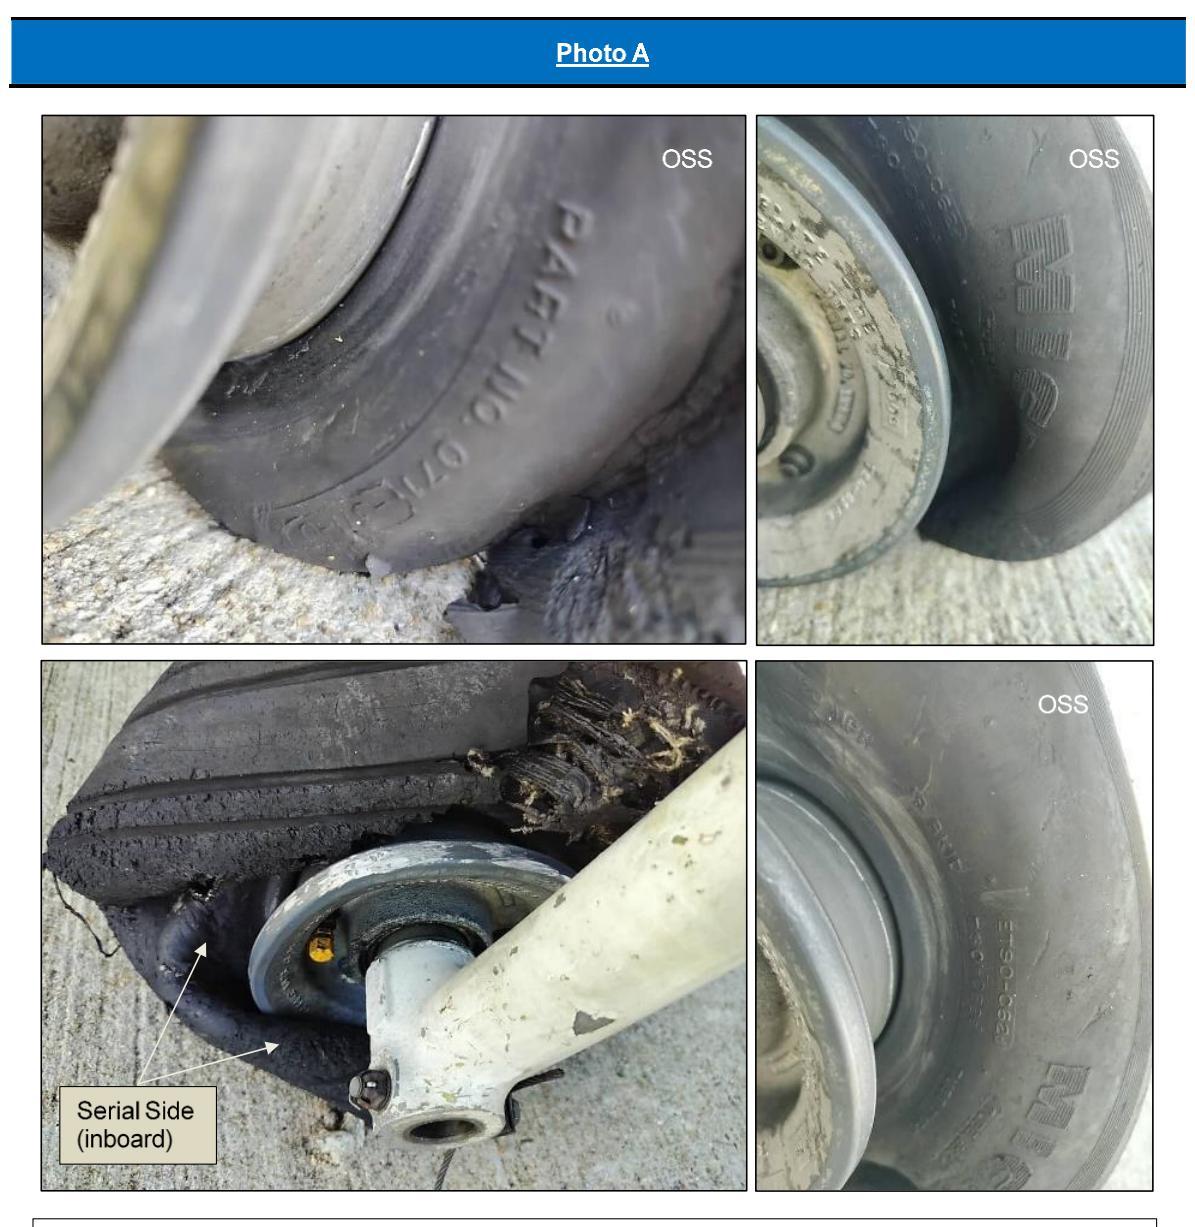
Photos were provided by the customer showing damages to the tire and positioning of the tire/wheel assembly on the aircraft. The Serial Side sidewall is shown installed on the inboard side.

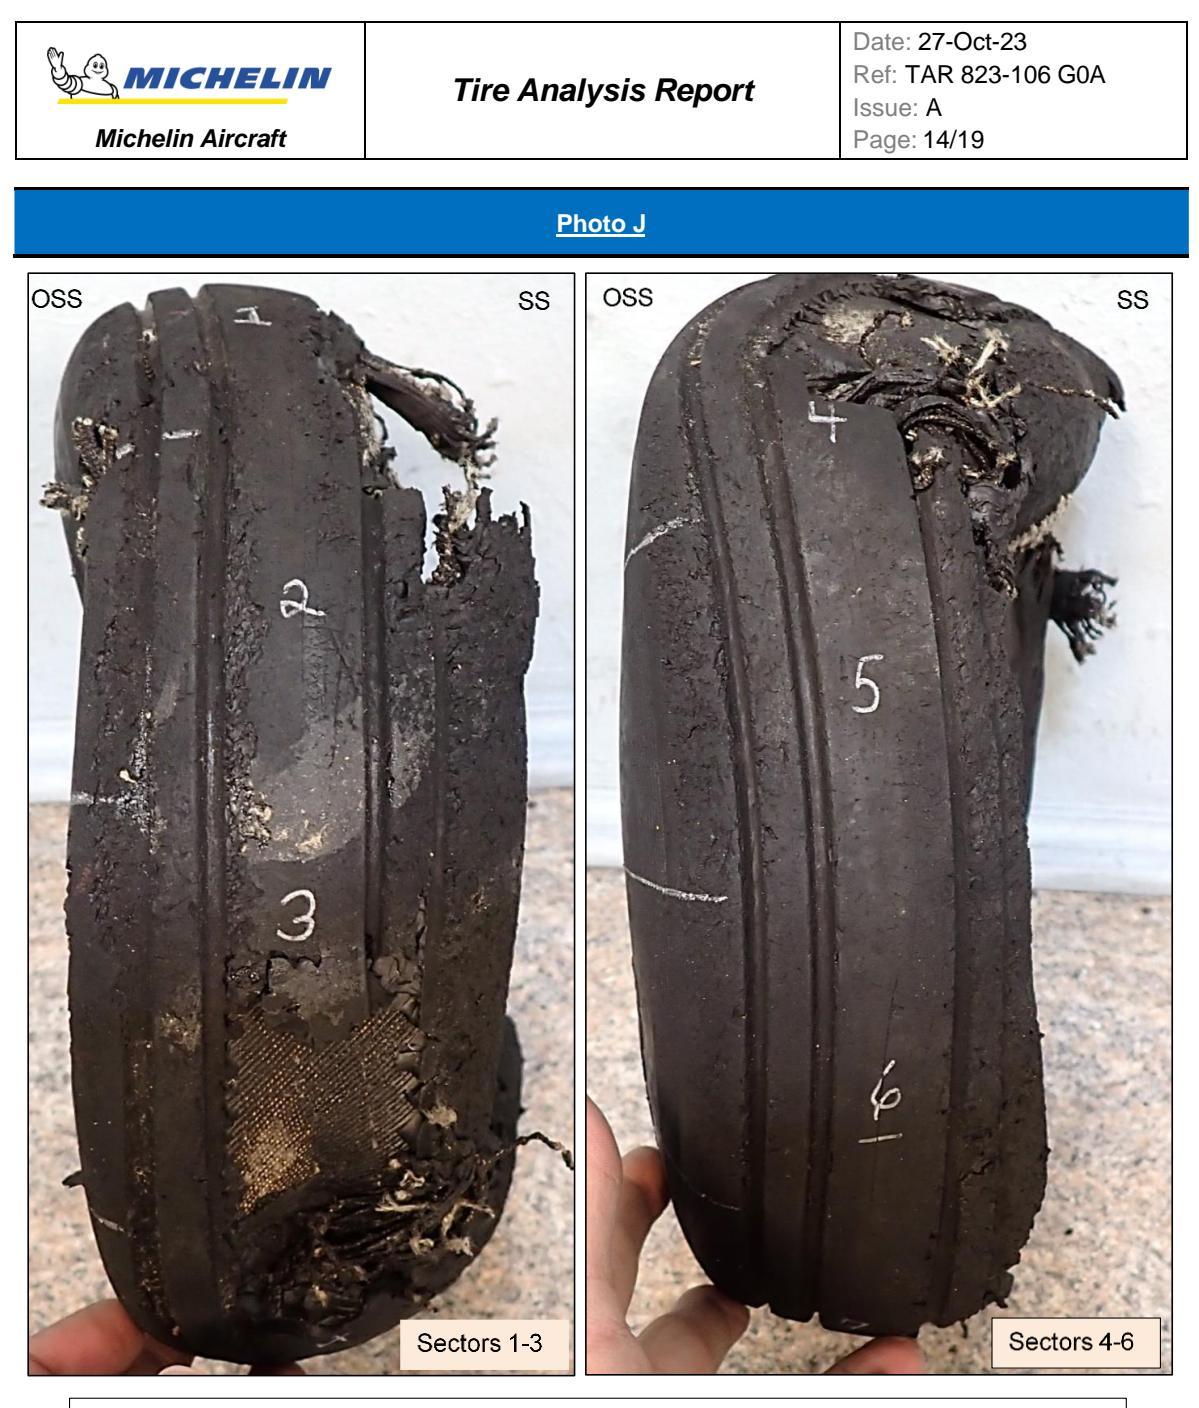
In the crown area of the tire, portions or all of the Serial Side intermediate tread rib are missing in sectors 1,3,4,10,11,&12. Portions of the center tread rib are missing in sectors 3,4,10,&11. In the area of the missing tread rubber in sector 3, no evidence of heat buildup, contamination, or unsticking was found. The remaining tread rubber shows severe abrasions, chunking, rubber tear outs, and longitudinal scratches at various locations around the tire.

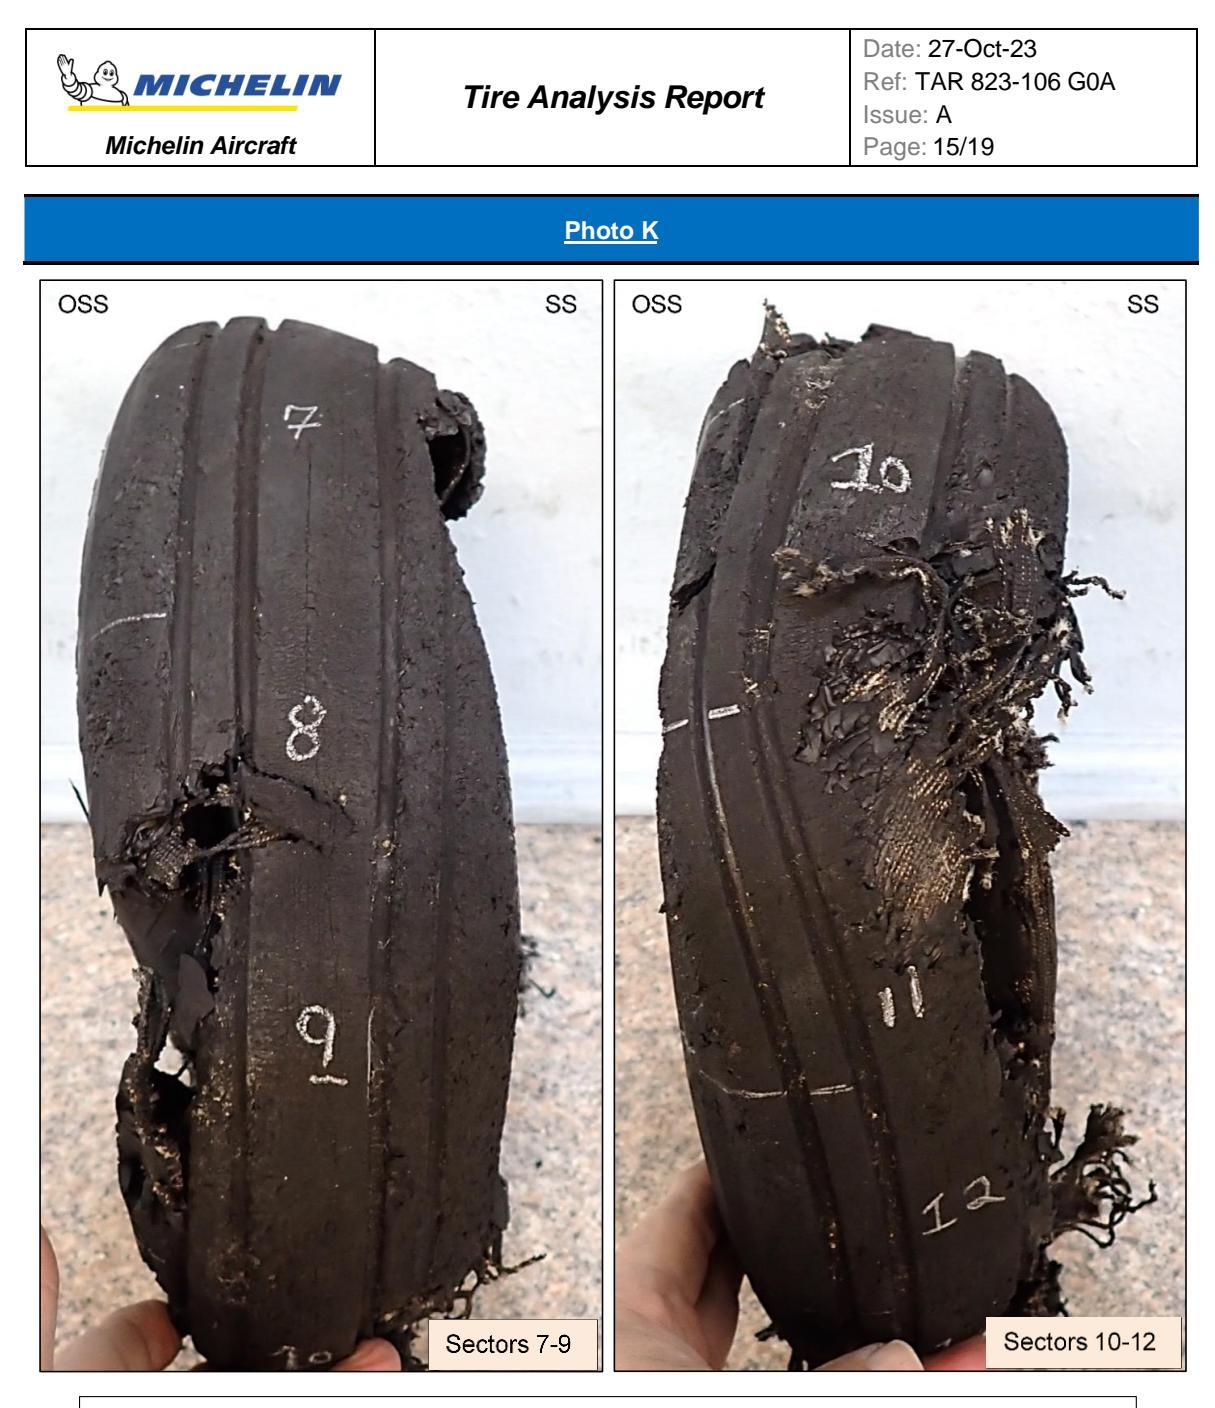
The loss of portions of the center tread rib and Serial Side intermediate tread rib are damages caused by the run-flat condition and are post failure damages. The severe abrasions, chunking, and rubber tear outs found on the remaining tread rubber at various locations around the tire are also damages caused by the run-flat condition and are post failure damages.

In the crown area of the tire, portions or all of the Serial Side intermediate tread rib are missing in sectors 1,3,4,10,11,&12. Portions of the center tread rib are missing in sectors 3,4,10,&11. In the area of the missing tread rubber in sector 3, no evidence of heat buildup, contamination, or unsticking was found. The remaining tread rubber shows severe abrasions, chunking, rubber tear outs, and longitudinal scratches at various locations around the tire.

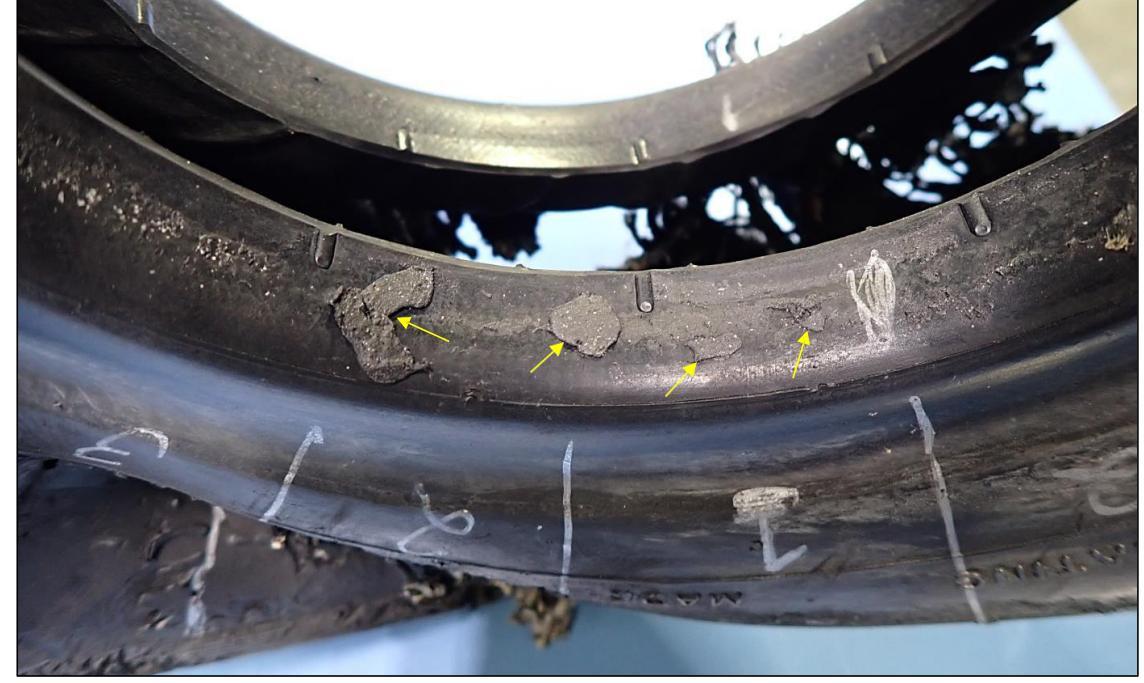
In sectors 1&2, the Opposite Serial Side bead flat shows a small amount of reverted rubber buildup

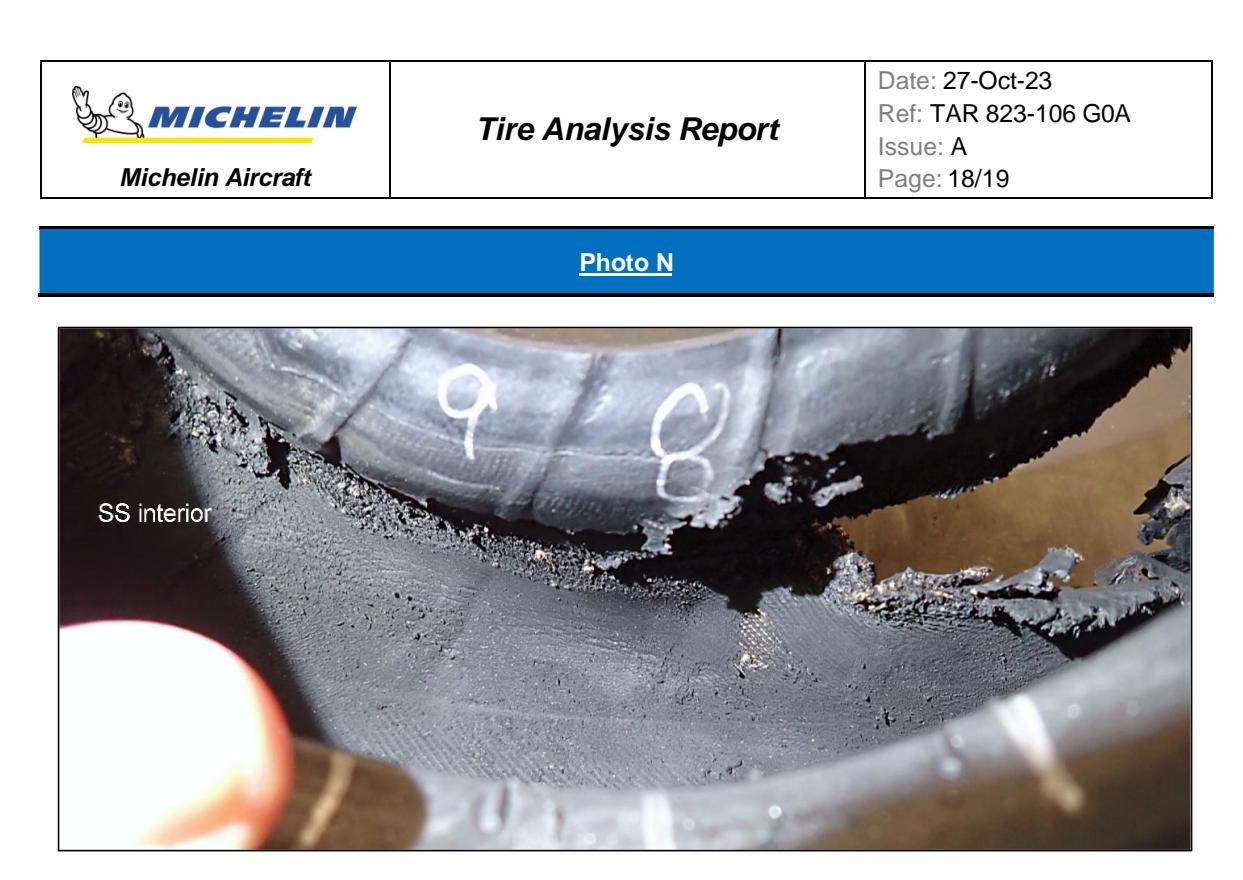
There are no bias or X-type ruptures to indicate a pressurized blow out. The sidewall ruptures with broken and frayed cord ends indicate run-flat damage as does the abrasion/wrinkling on the inner-liner. These types of damages are consistent with a slow loss of pressure.

The interior of the tire shows severe abrasions, exposed/broken/frayed ply cord, and wrinkling at various locations around the tire.

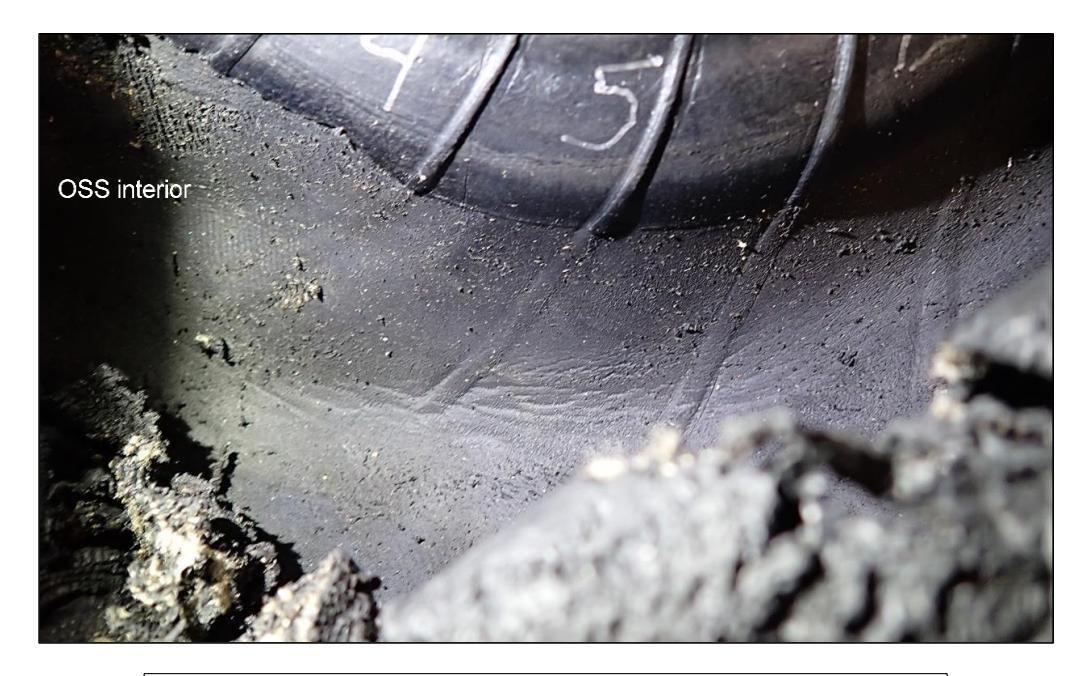
We did not find a puncture through the casing that would have resulted in a loss of tire pressure. Due to the severity of run-flat damages on this tire, a definitive root cause could not be determined.

The interior of the tire shows severe abrasions, exposed/broken/frayed ply cord, and wrinkling at various locations around the tire.
