AIRCRAFT ACCIDENT FINAL REPORT A 03/24 Air Accident Investigation Bureau (AAIB) Ministry of Transport Malaysia

Fixed-Wing Aircraft Blackshape BK 160TR, Registration I-POOC at Kapar, Selangor on 13 February 2024

FINAL REPORT NO: A 03/24

AVIATION SAFETY TECHNOLOGY PTE LTD,
SINGAPORE (PRIVATE OPERATOR) ¹
BLACKSHAPE BK 160TR
ITALY
I-POOC
KAMPUNG TOK MUDA, KAPAR, SELANGOR
MALAYSIA
13 FEBRUARY 2024 AT 1336 LT (0536 UTC)

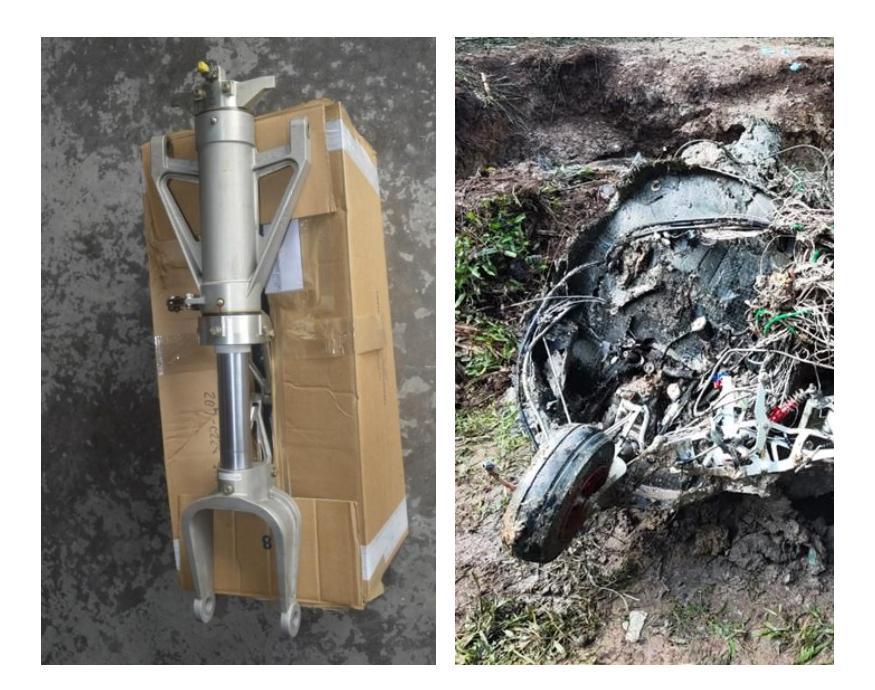
Nose Landing Gear (NLG) Replacement. The aircraft's NLG was removed and replaced with a new unit by unauthorised personnel in February 2024. This replacement was completed, with assistance from the pilot, shortly before the accident flight on 13 February 2024, which was apparently intended as a test of the newly installed NLG.

Figure 13. Old NLG Found at AAFC Hangar (Left) and Newly Installed NLG on Wreckage (Right)

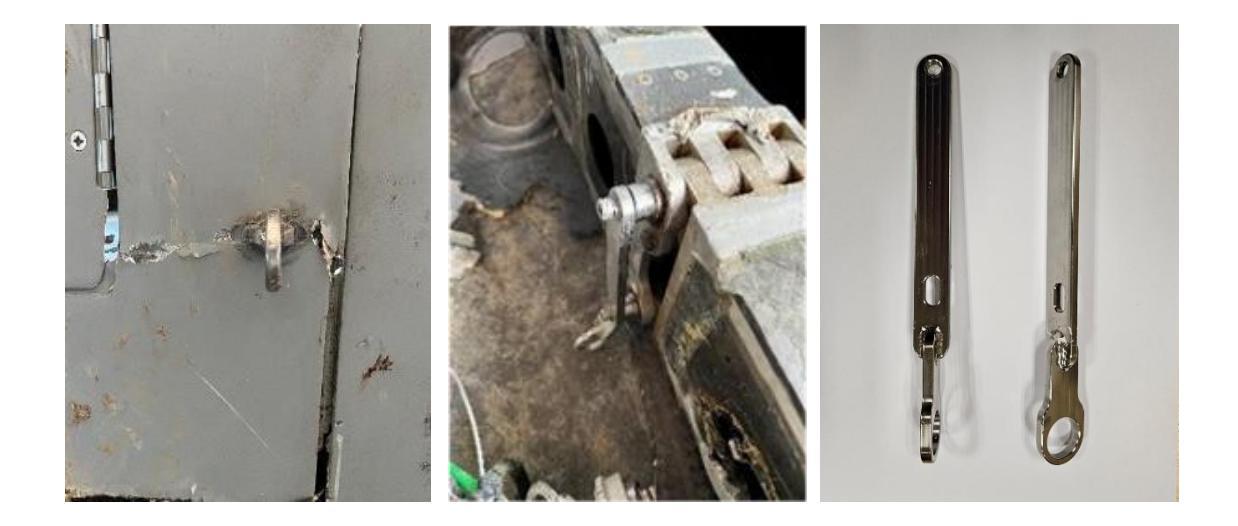
Installation of Non-Certified Tie-Down Rings. Non-certified 'tie-down ring' parts were installed on the underside of each wing, near the main landing gear wheel well. These were bolted through the composite wing skin onto the joint of the wing fitting with the main spar. Witness testimony indicates these parts were installed by the pilot on 23 November 2023.

Figure 14. Tie-Down Ring on the Underside of the RH Wing Near Wheel Well (Left); Tie-Down Ring Bolted to the LH Wing Joint (Centre); Two New Similar Parts Found at the Pilot's Locker at AAFC (Right) • Routine Maintenance by Unauthorised Personnel. In late November 2023, unauthorised personnel performed routine maintenance activities such as replacing spark plugs and the air filter element. The maintenance log kept by the late pilot suggests other irregular maintenance activities may have occurred.

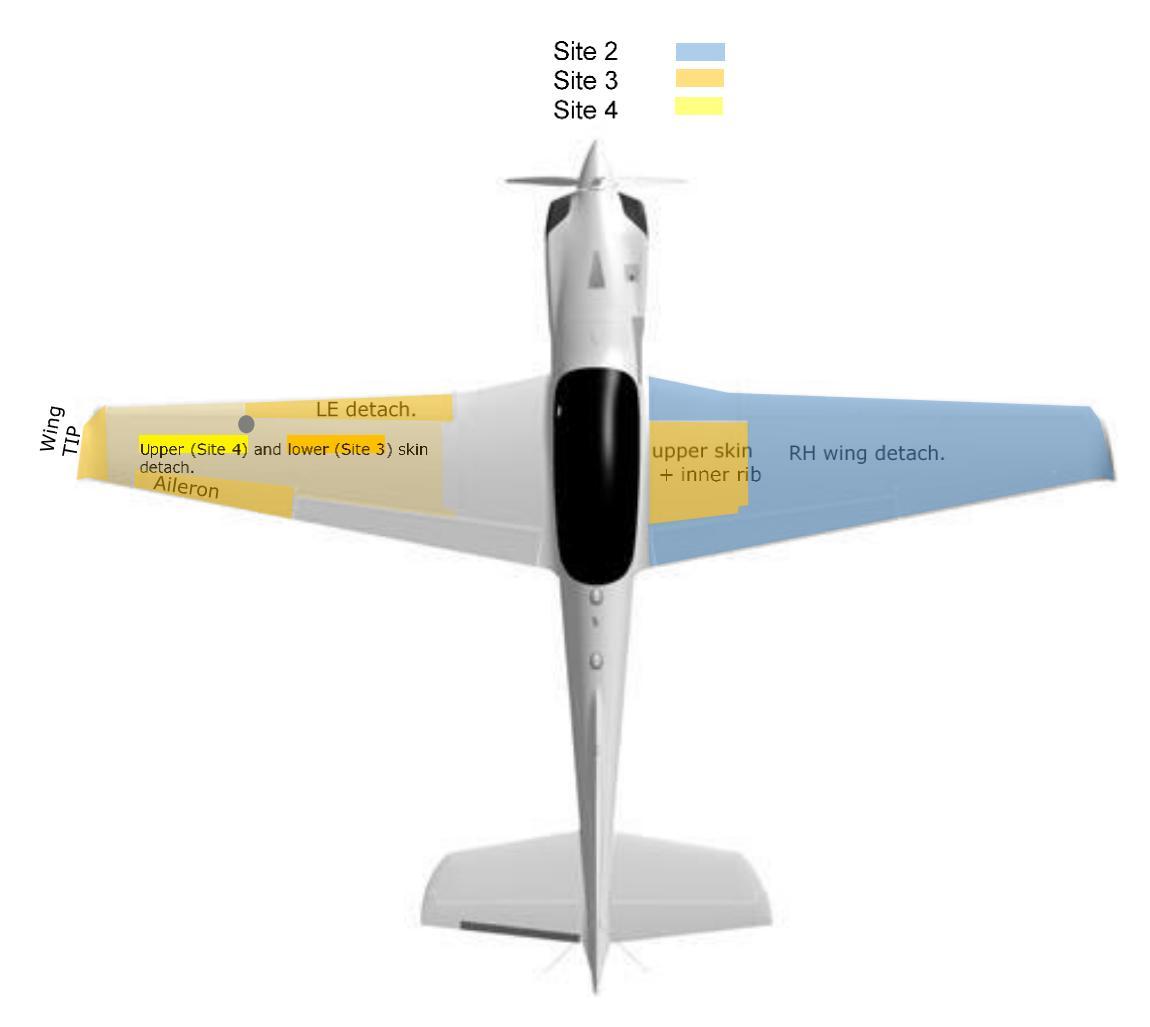
The distribution of debris around Sites 2, 3, and 4 strongly indicates that large structural parts separated from the aircraft while it was in flight, before impacting the ground in the oil palm plantation. No evidence of pre-crash or post-crash fire was found on any debris at these sites.

Figure 17 below displays the major separated structural parts found after the accident. Smaller debris, such as canopy fragments at Site 3, are not included in the illustration. Notable damage includes the left (LH) aileron, which detached from its hinges, and the aileron connecting rod, which separated from the bellcrank. The right (RH) wing, which detached at both the front and rear spars, was found at Site 2. The RH wing's inner upper skin, detached along with the inner rib, was found at Site 3. The LH wing's upper skin was located at Site 4, while the lower skin was found at Site 3.

Figure 17. Structural Parts Recovered from Various Sites

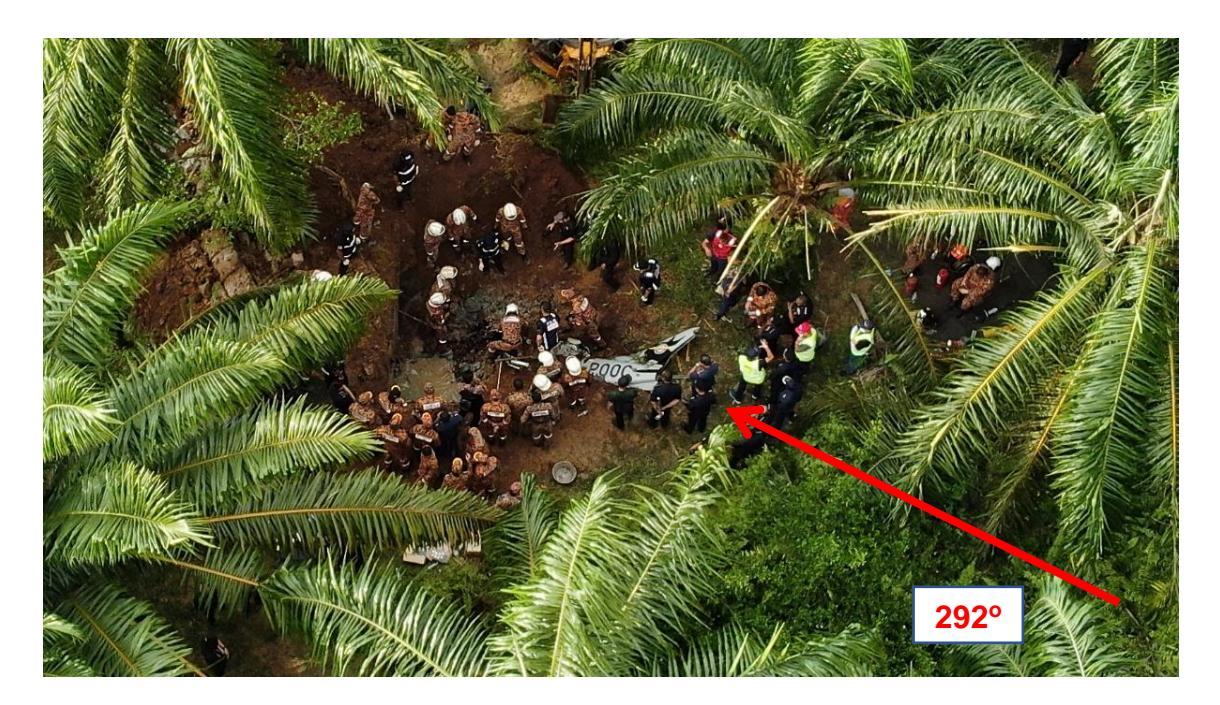
Numerous debris and aircraft parts were scattered around the impact site, within a radius of approximately 50 metres. No evidence of pre-crash or post-crash fire was found on the wreckage at or around the impact point.

Figure 19. Impact Point of Main Wreckage

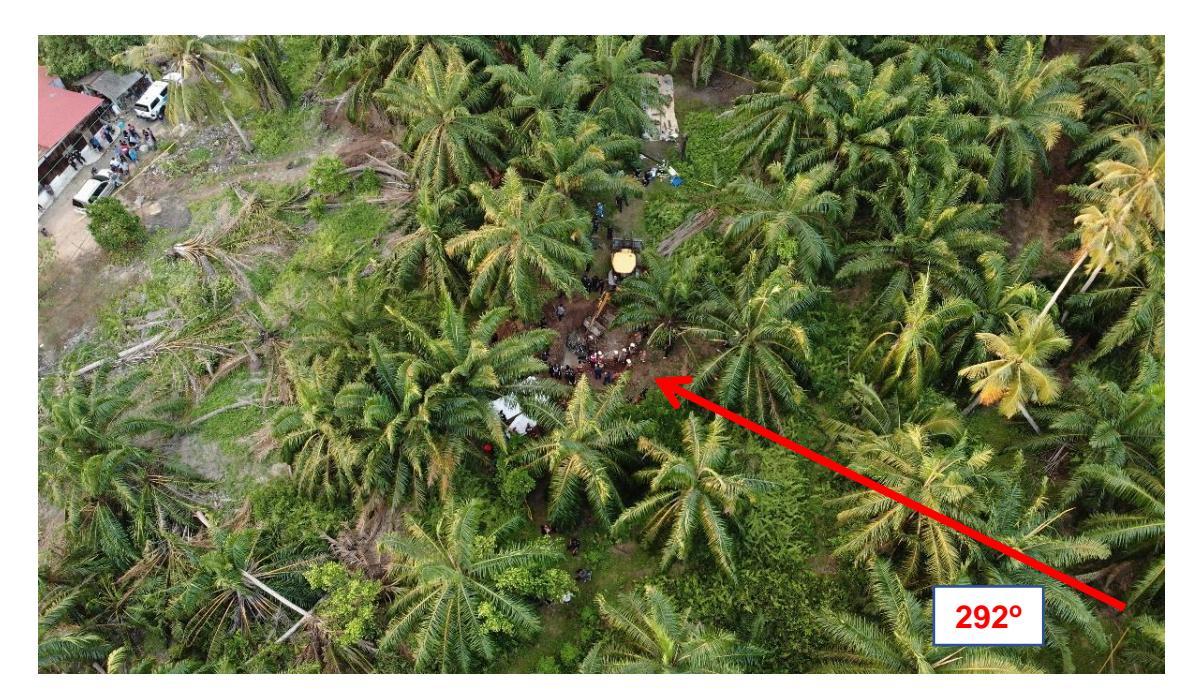
Based on the orientation of the partially buried fuselage, ground markings near the wreckage, and freshly broken branches at the top of an adjacent palm tree, the aircraft impacted the ground at an approximate heading of 292°. The vertical angle from the impact point on the ground to the top of the broken branches indicates that the aircraft struck the ground at an approximate 45° downward trajectory.

Figure 20. Impact Point of Main Wreckage and Travel Direction of Aircraft Impacting Ground

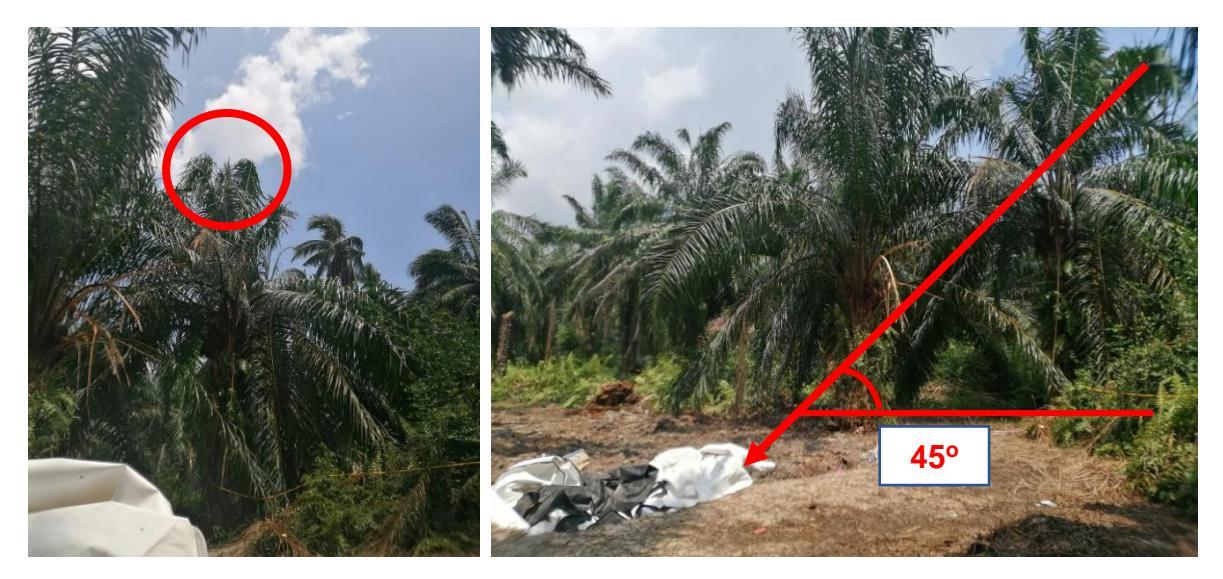
Figure 21. Broken Palm Branches (Left) and Aircraft Downwards Trajectory (Right)

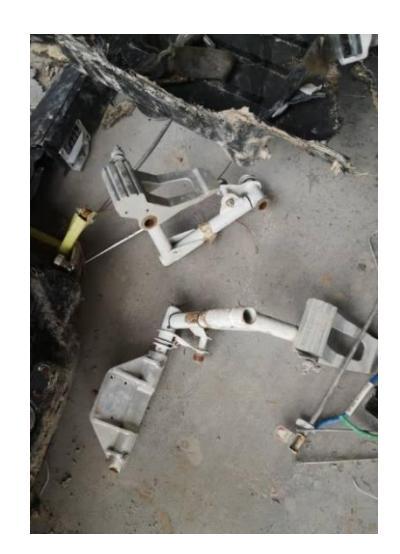
Figure 27. Pilot's Rudder Pedal Broken into Two Pieces

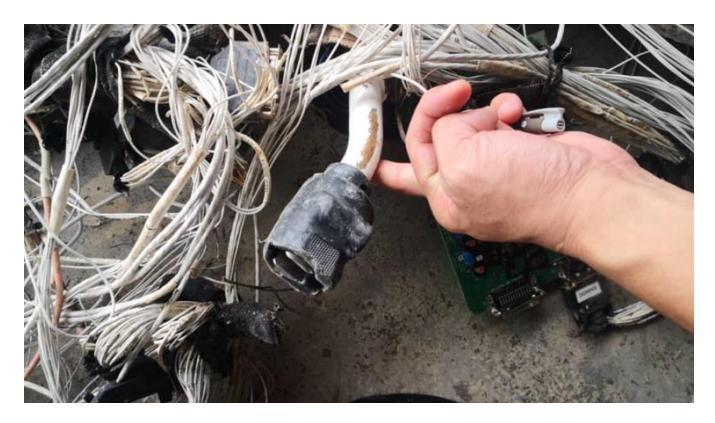
Figure 28. Pilot's Control Column Broken into Half.

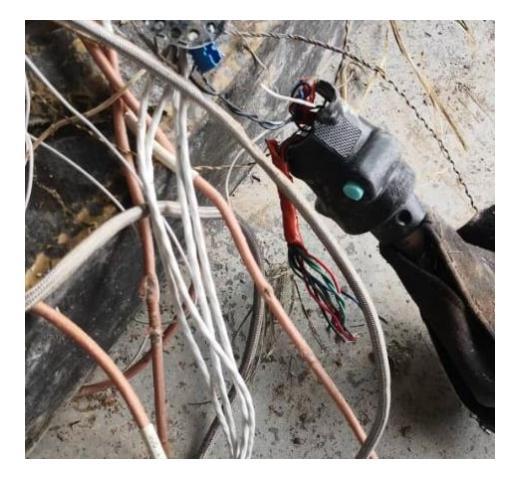
Figure 29. Rear Seat Control Column Broken into Half

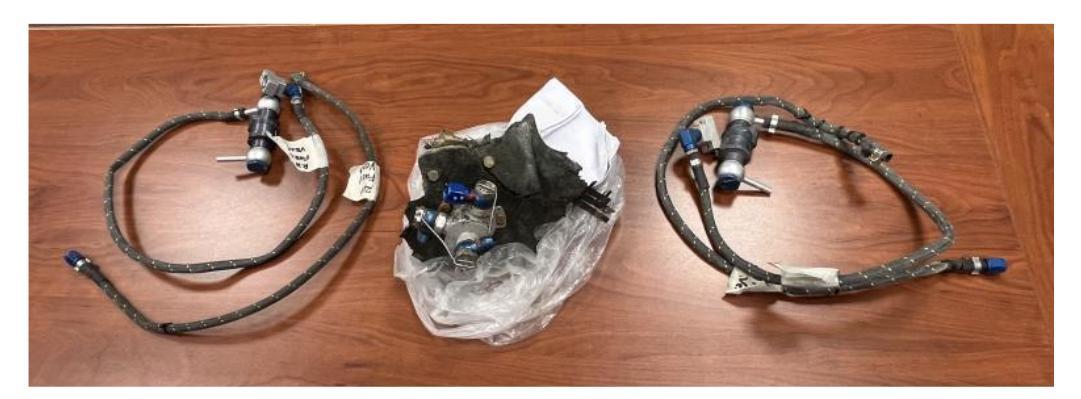
Figure 31. Fuel Components Tested by ANSV (Courtesy of ANSV) Fuel Valve (Centre); Inner and Outer Fuel Vent Lines (Left – LH; Right – RH)

• Fuel Vent Lines Inspection. The vent lines showed no structural damage aside from minor impact marks and were confirmed to be unobstructed, with stable pressure observed during all flight simulations, including inverted flight.

- Fuel Valve Alignment and Functionality. A minor misalignment in the fuel valve assembly—about 30 degrees of rotation and a 5 mm offset—was noted, likely due to accident impact, but was determined to have no significant effect on functionality. Flow through the valve was confirmed to be correct, with the selected tank identified as the LH tank.
- **Disassembly and Examination**. Internal examination showed that the valve moved freely with proper flow in each tank selection, and the electric motor operated normally, allowing unrestricted selector movement.
- **Conclusion**. The fuel valve and vent lines were found to be in good condition, without malfunctions or deviations from standards. These components remain in ANSV custody for any future needs by AAIB.

This analysis indicates that neither the fuel valve nor the vent lines contributed to the accident through mechanical failure.

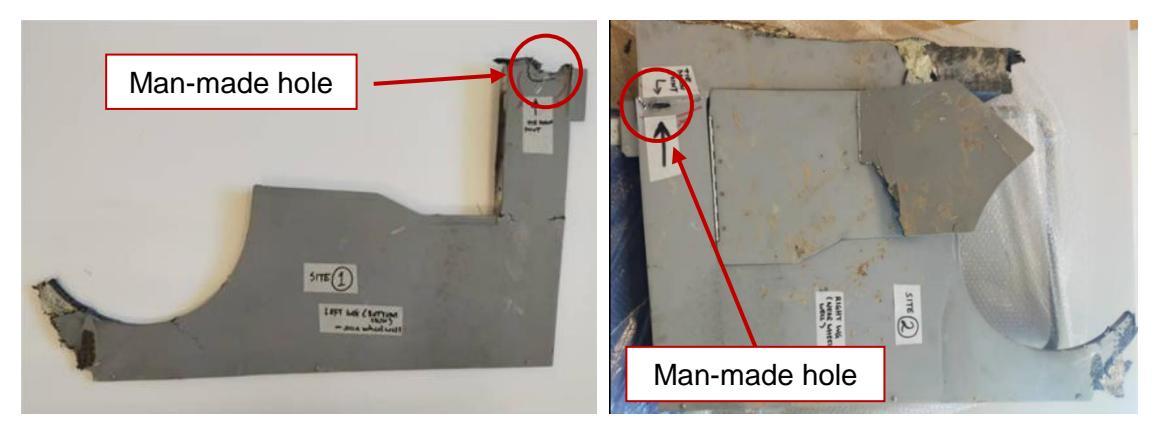
Most significantly, the installation of non-compliant 'tie-down rings' through man-made holes in the wings, combined with operational stresses, had serious implications for the aircraft's structural integrity and directly affected its airworthiness. The impact of these factors on the aircraft's airworthiness is further examined in Section 2.3.4.

Figure 36. Man-Made Holes on The Underside of The Aircraft Wings, Near the Wheel Wells (Left Picture: LH Wing; Right Picture: RH Wing)

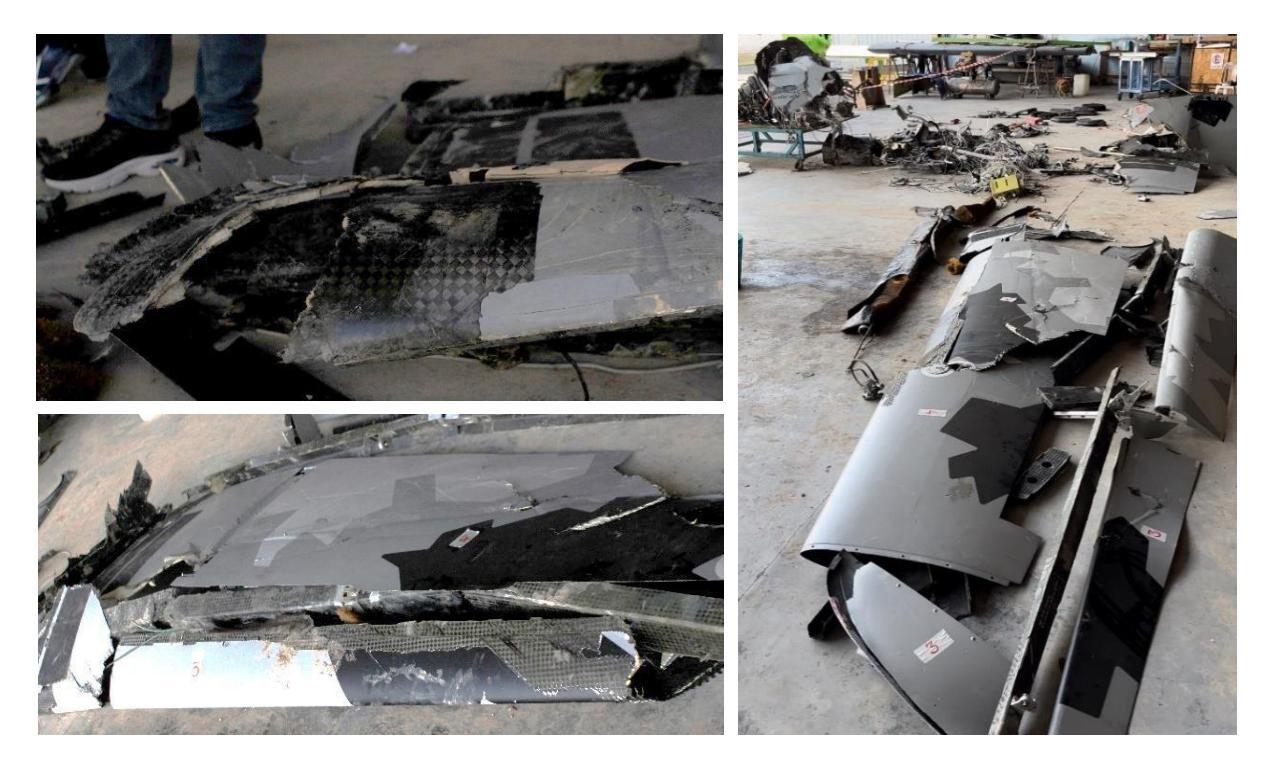
The LH wing main spar, aft spar and ribs were found at Site 1, the main wreckage area. The front and rear spar breaking points are compatible with high energy impact.

Figure 1. LH Wing

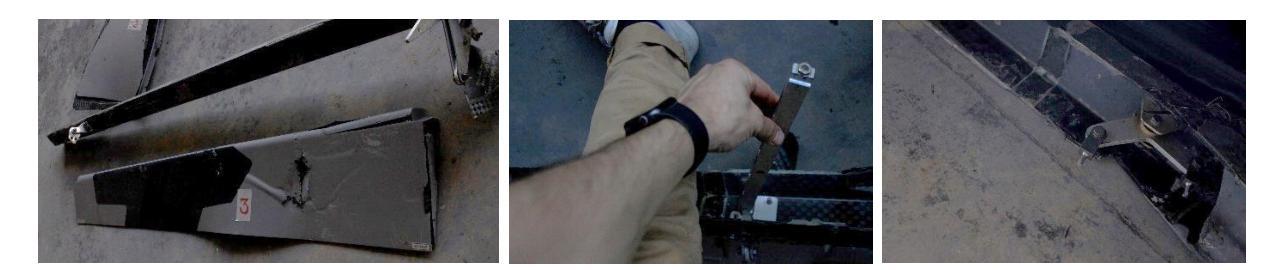
The LH aileron was found bent almost in the middle of its span. The aileron was detached from the hinges. The connecting rod was detached from the bellcrank.

Figure 2. LH Aileron Connecting Rod, and Bellcrank

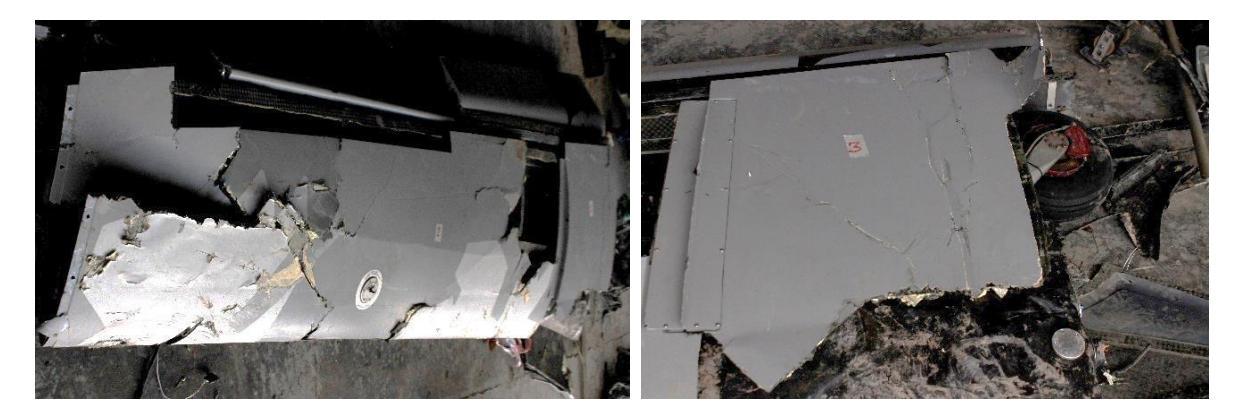
The whole RH wing (except for the inner upper skin) was found at Site 2, about 560 metres to the east of the main wreckage. The RH wing inner upper skin, together with the inner rib, was found at Site 3. Refer to paragraph 5 below for the failure mode of the upper skin. The failure mode of the inner rib is interlaminar failure. The RH flap and aileron were found connected to the wing.

Figure 3. RH Wing

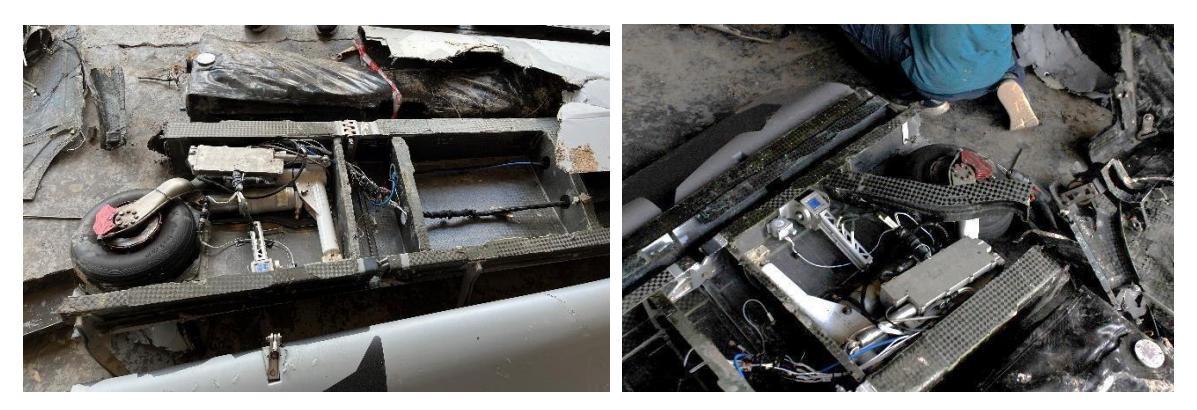
The MLG was found installed in the wing box in its retracted position. The forward (FWD) and rear (RWD) wing spars were totally cracked at the intersection with the fuselage monocoque, where the lower side fuselage spars are installed.

Figure 4. RH MLG

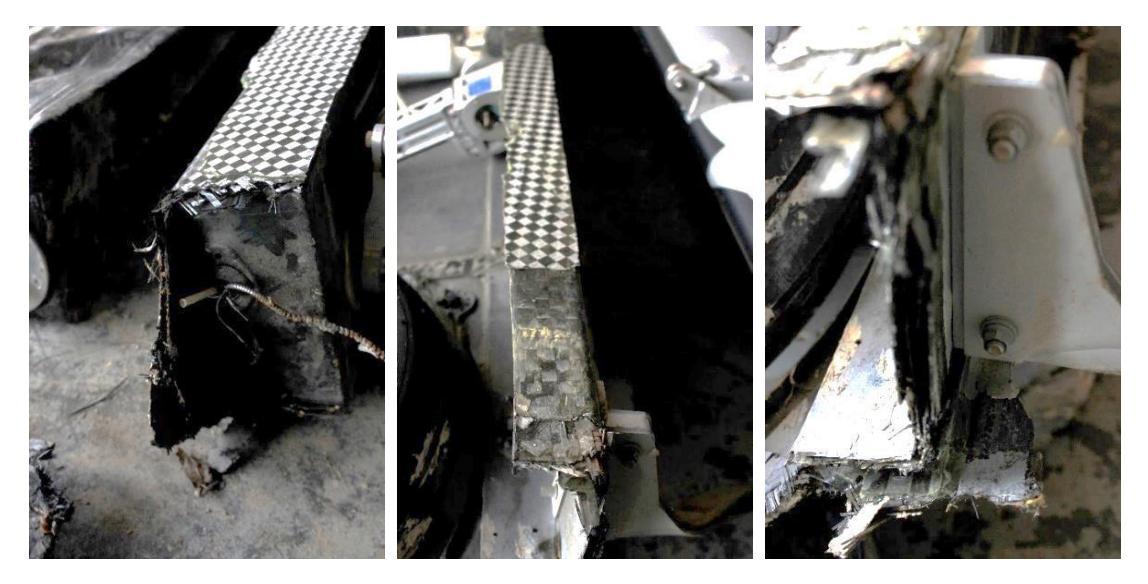
Figure 5. RH Wing Main and Rear Spar Crack

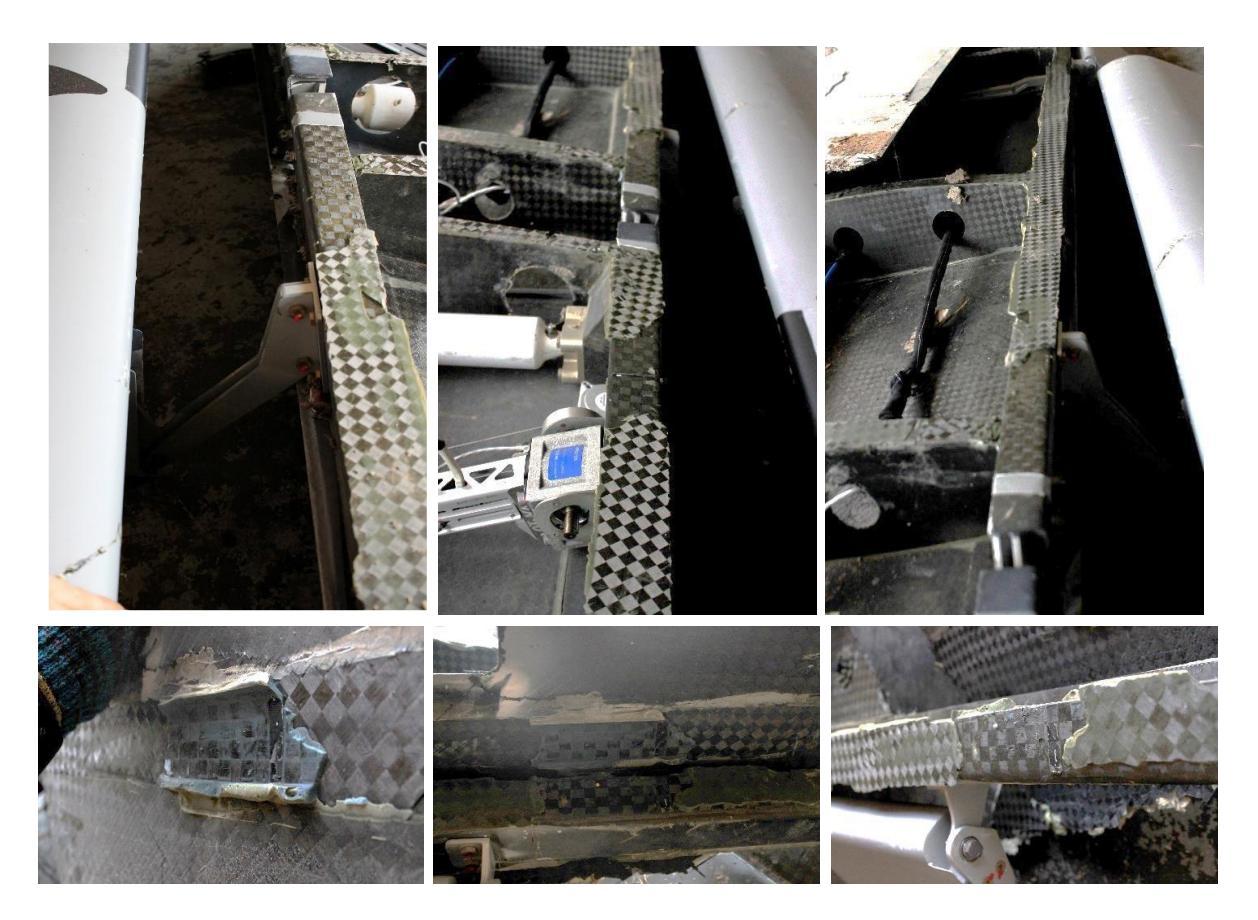
The failure of the skin/spar junction seems to be an interlaminar failure. The portion of laminate bonded to the wing spar remained attached to the spar cap revealing no failure of the bonding. The inner ribs of the wing box seem to have experienced the same failure mode.

Figure 6. Skin/Spar Failure Mode

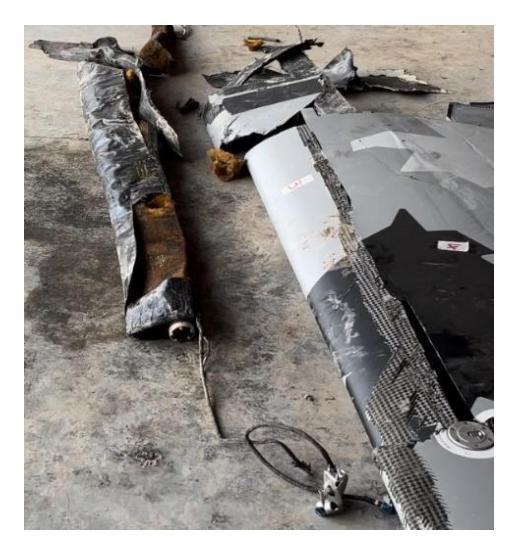
7.1 LH Fuel Tank. The bladder of the LH fuel tank appears to be torn apart in correspondence of the filler cap. The rest of the damage is probably due to the ground impact with the main wreckage.

Figure 8. LH Fuel Tank

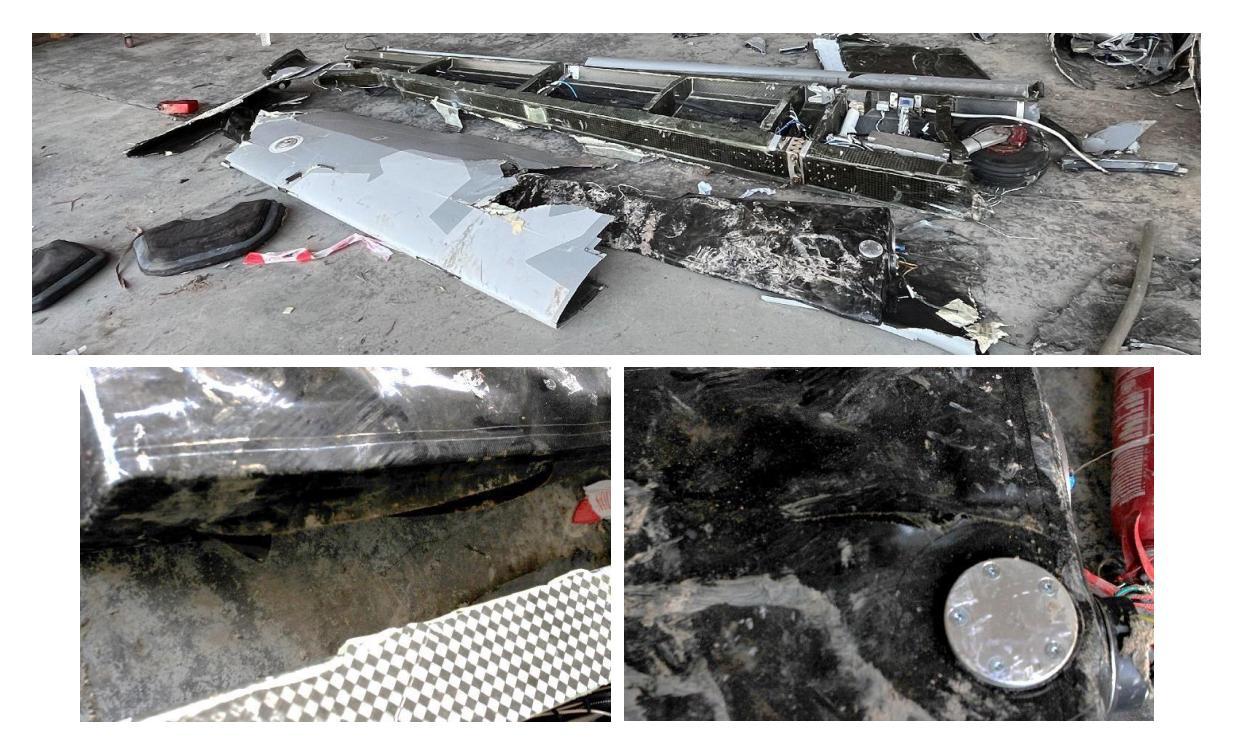
7.2 RH Fuel Tank. The RH fuel tank appears in good condition. There is no sign of collapse. Signs of rupture are found in the inner part of the tank.

Figure 9. RH Fuel Tank

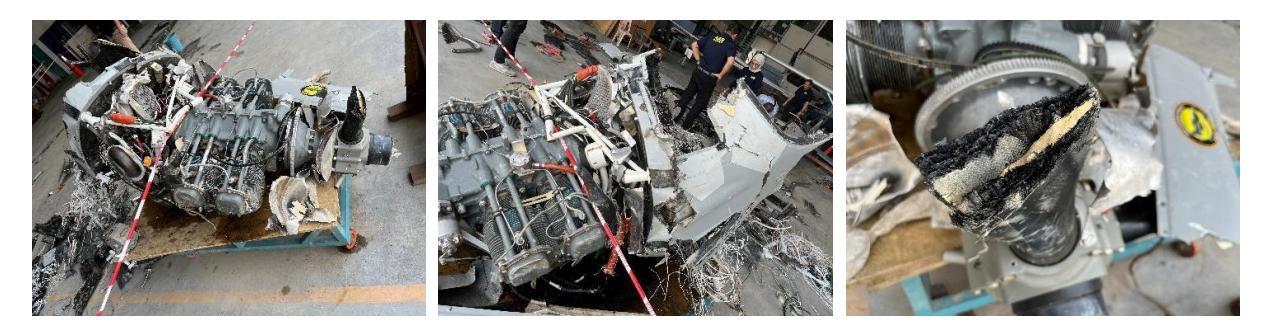
The engine compartment was found two metres under the ground. All damages appear to be caused by the high energy ground impact. Two blades where found cracked around the root. One blade is missing from the rotating shaft.

Figure 10. Engine Compartment and Propeller

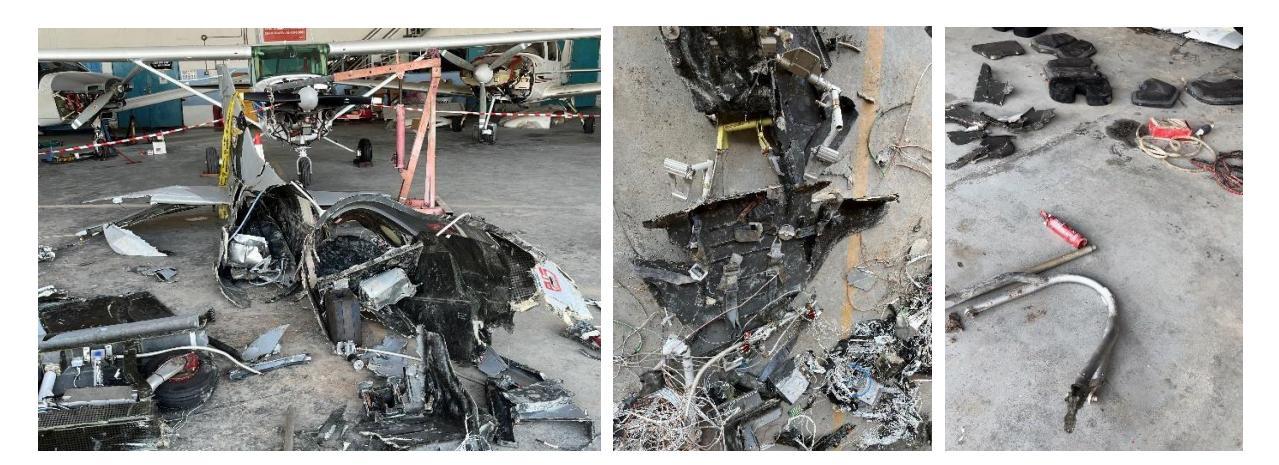
Both cockpits were found destroyed by the high energy ground impact. The roll bar and the seat cushions are retrieved as shown below.

Figure 11. Cockpit (Destroyed)

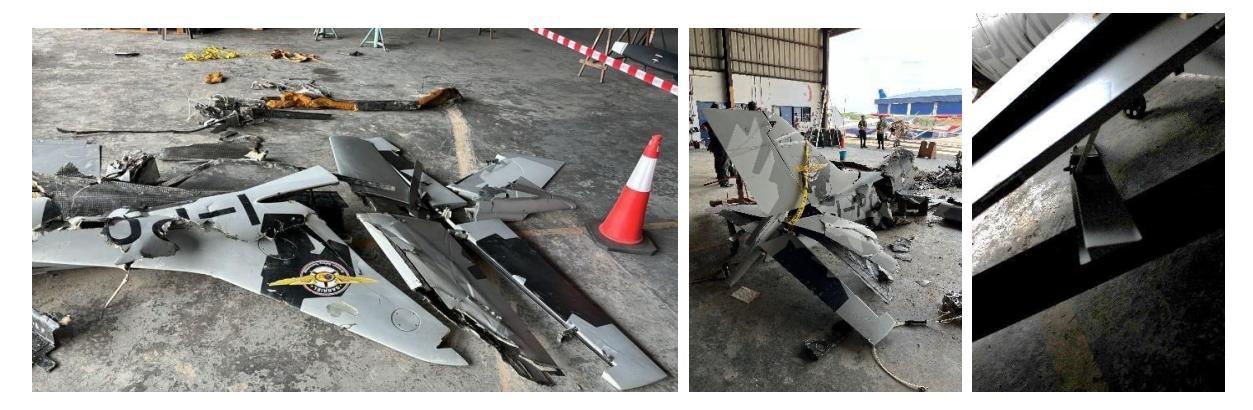
The rudder was found detached from the vertical stabiliser through the hinges. The horizontal stabiliser was found detached from the fuselage. The elevator was partially detached from the horizontal stabiliser through the hinges. The elevator trim was found detached from the elevator through the hinges. The lever to the trim motor was found in place.

Figure 19. Tail Destroyed (Left), Tail Reconstructed (Middle), Trim Tab (Right)

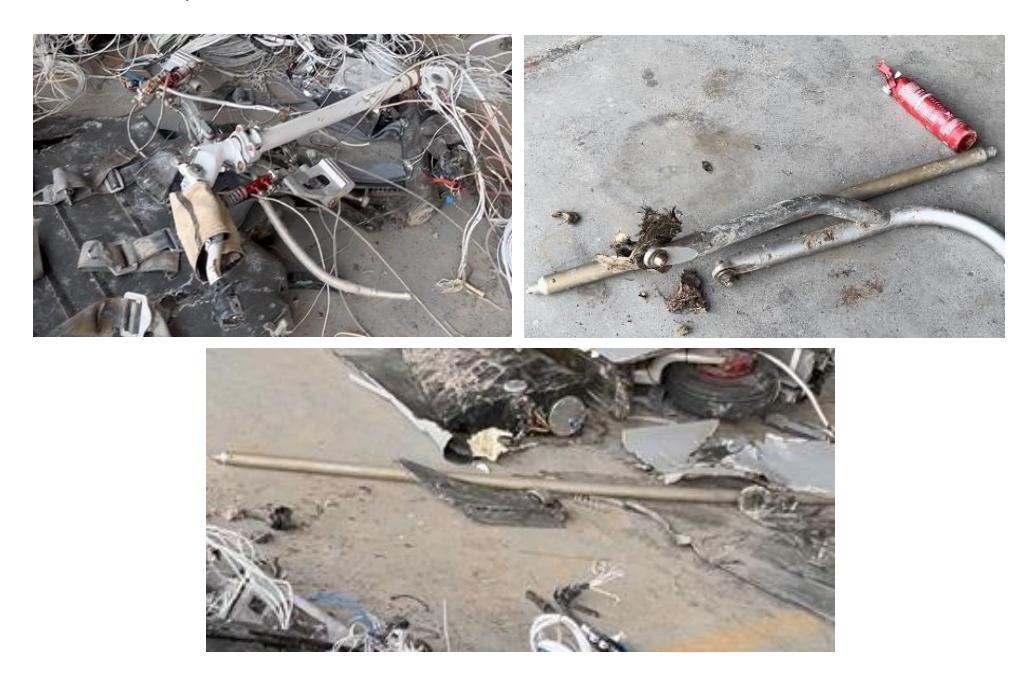
12.1 Longitudinal. All connecting rods are found disconnected from the forks (weakest elements).

Figure 20. Longitudinal Control: Control Column (Top Left), First Connecting Rod (Top Right), Last Connecting Rod (Bottom)

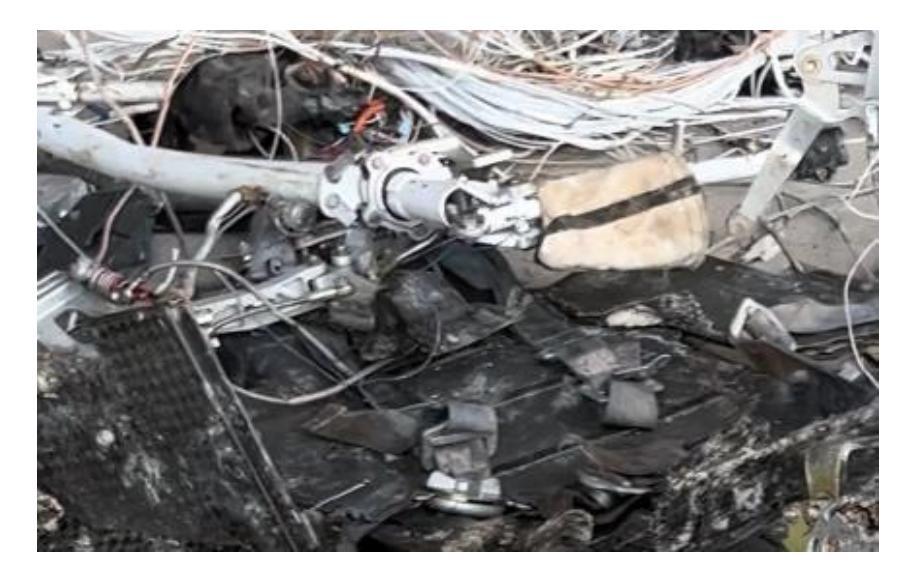
12.2 Lateral. The connecting forks to the control column are broken, probably due to high energy impact. The end connecting rod is detached from the bellcrank (refer to paragraph 3).

Figure 21. RH and LH Aileron Connecting Forks to The Control Column

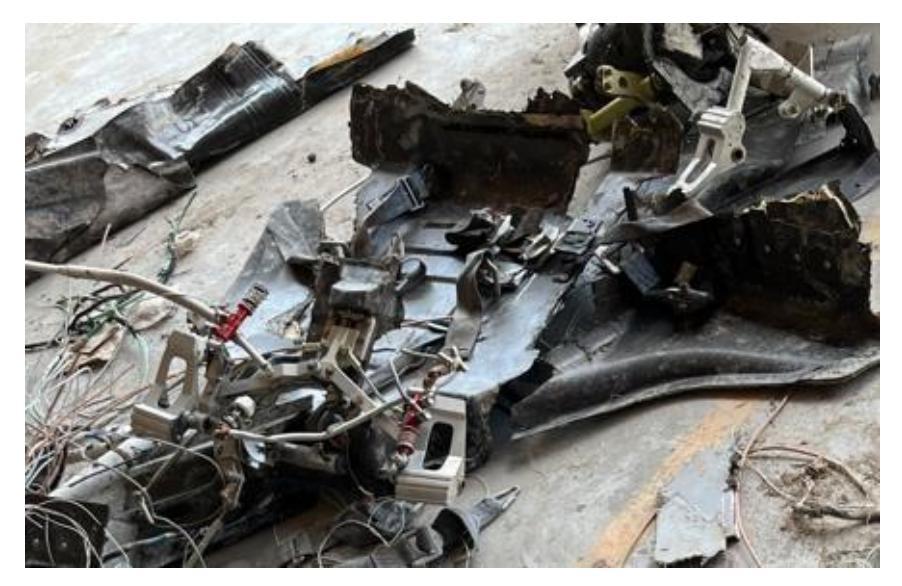
12.3 Directional control. The forward and aft pedal systems, and their connecting elements are found broken, compatible with the high energy impact,

Figure 22. Front and Rear Pedal Assembly

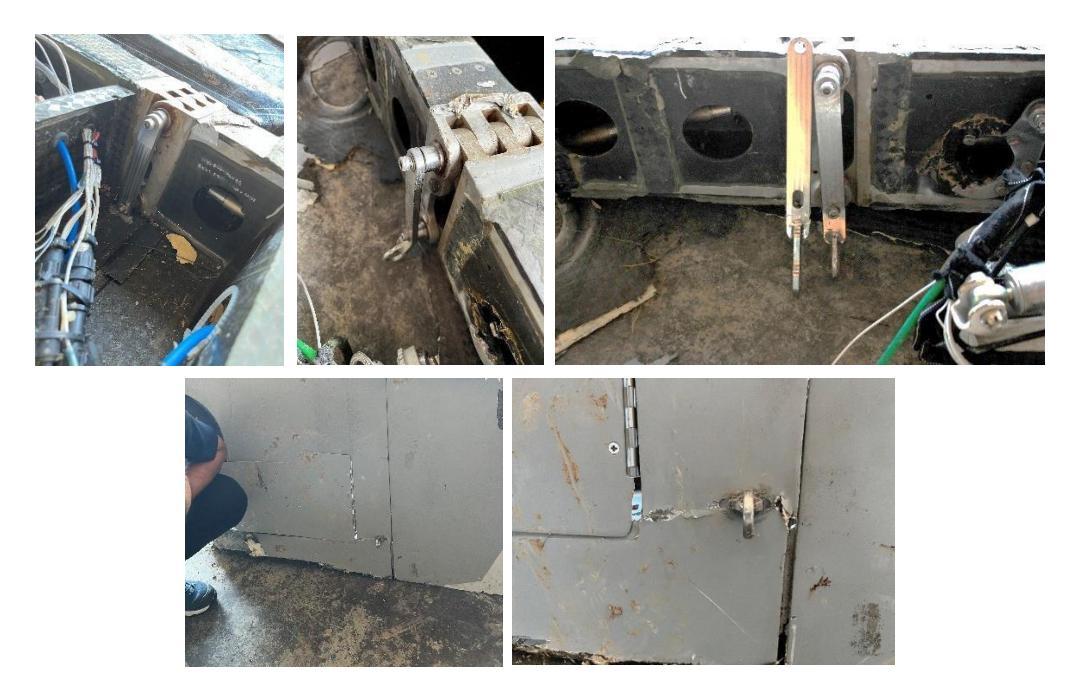
Figure 28. Non-Conforming Parts Installed on The LH And RH Wing Fitting

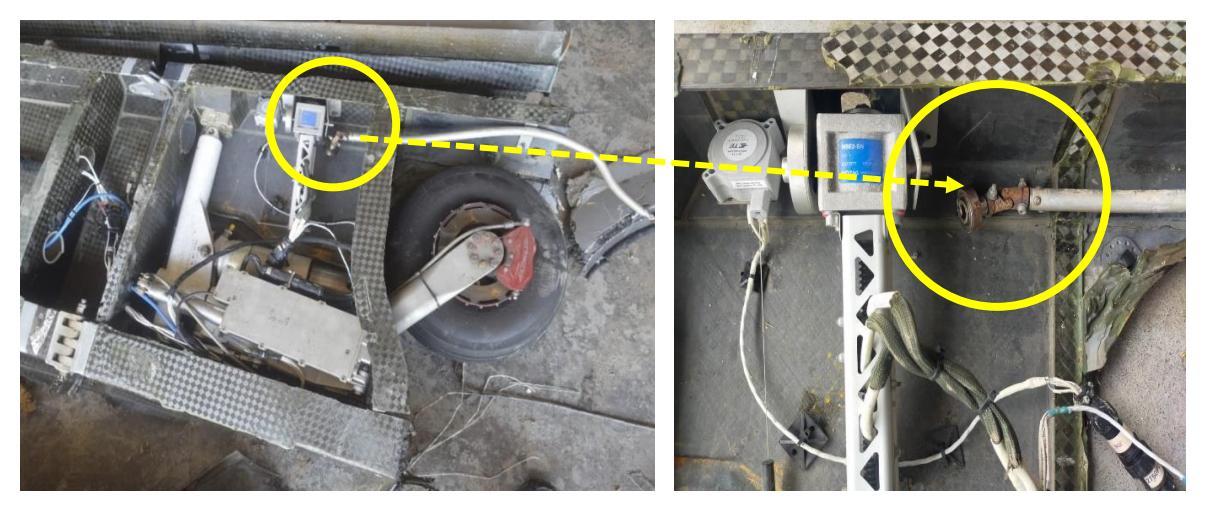
Figure 31. Physical condition of the connecting rod and shaft inside the RH wing (After recovery from the crash site – Site 2)

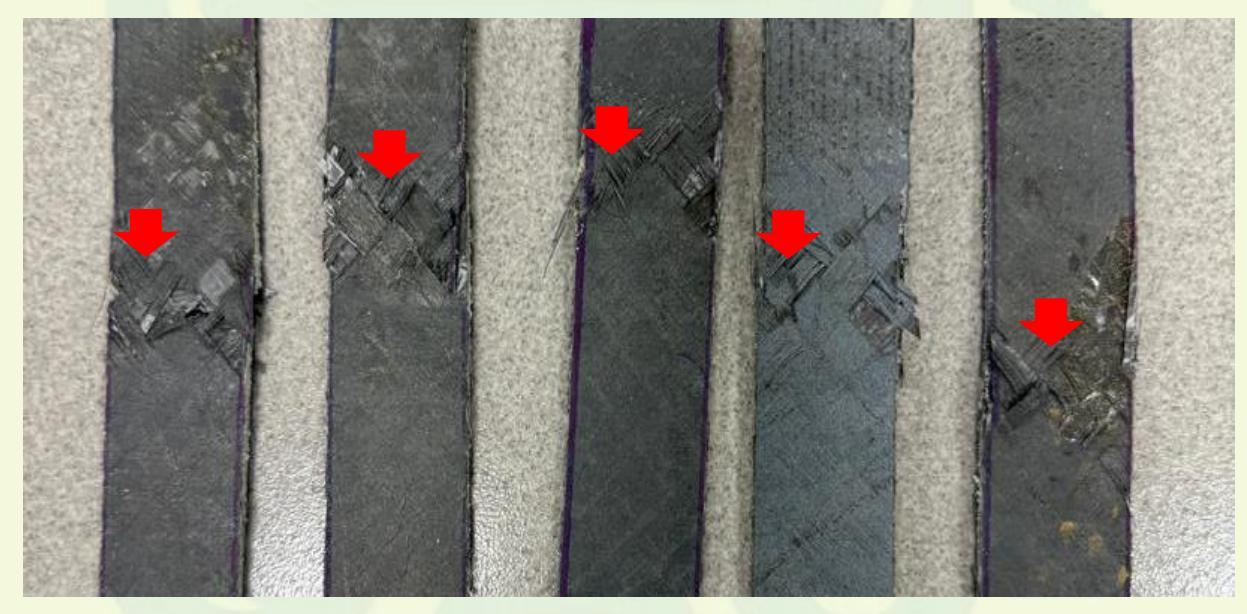
Figure 36. Photograph of Test Specimens after Tensile Properties Testing – Failure Type: Fiber Pullout (Red Arrows) Due to Tensile Loads

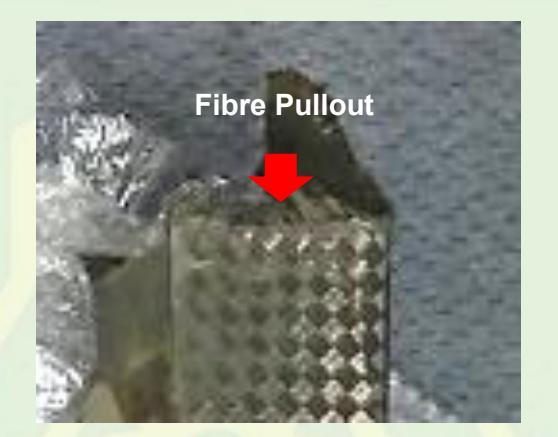
Figure 37. Fibre Pullout Found on ROI 1 of Component at Site 2; Sample ID: BSKU/IPOOC/004(S2) - Right wing - near to the wheel well

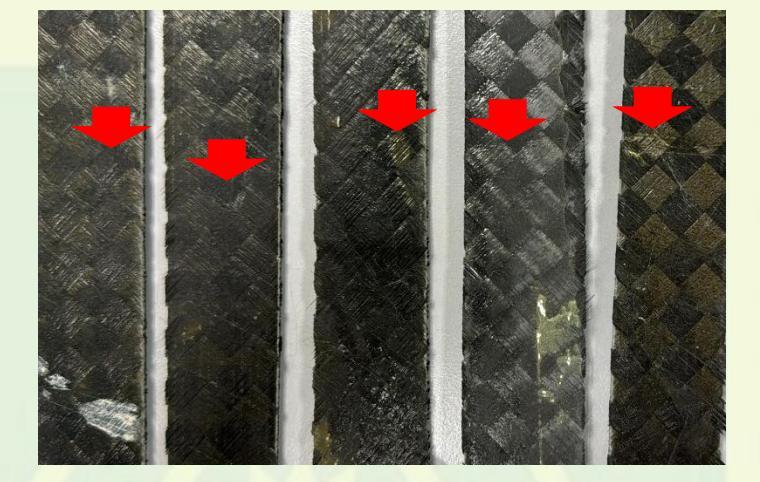
Figure 38. Photograph of Test Specimens after Compressive Properties Testing – Red Arrows Indicating Fibre Deformation
