AIRCRAFT ACCIDENT

FINAL REPORT

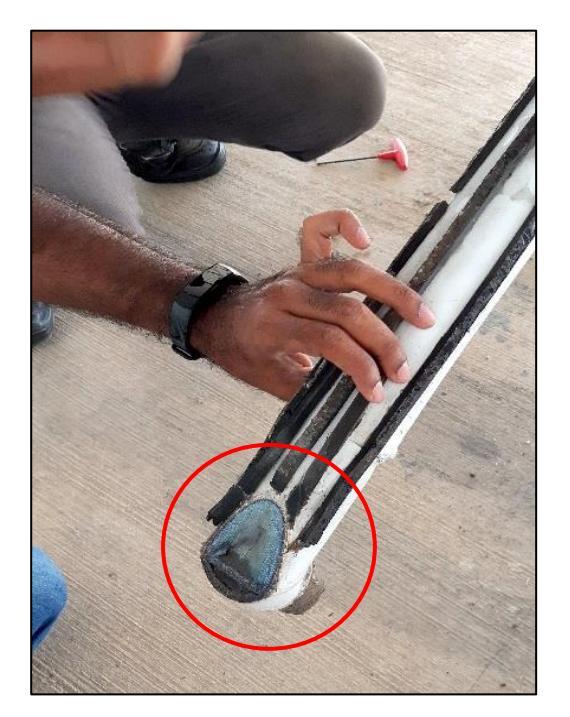
The aircraft sustained substantial damage. The propellers and the whole nose wheel structure were severely damaged by the impact sustained when the nose gear collapsed onto the runway during the third landing. The pictures below received from the damage assessment report made by the operator illustrate some of the damages suffered by the aircraft as a result of the accident.

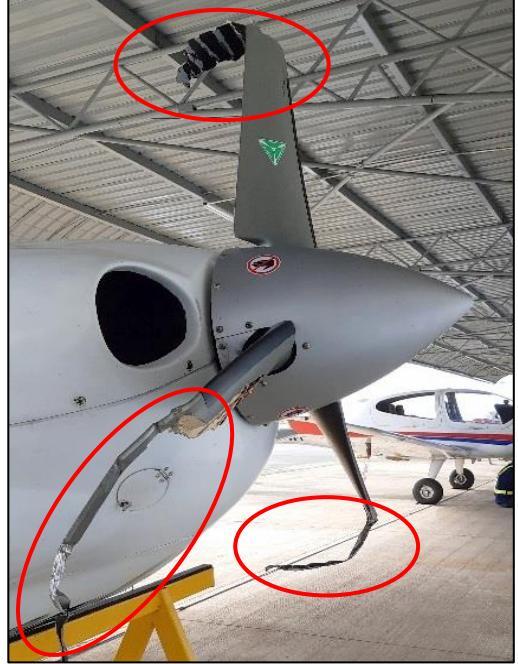
Picture 1: Nose landing gear (NLG) strut badly scraped at the NLG leg pivot end due to contact with the runway during the landing roll.

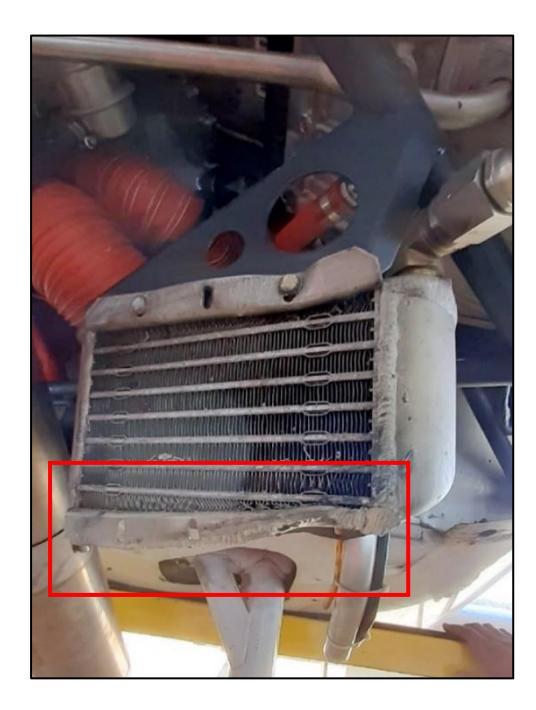
Picture 2: All three propeller blades broke, and tips were missing.

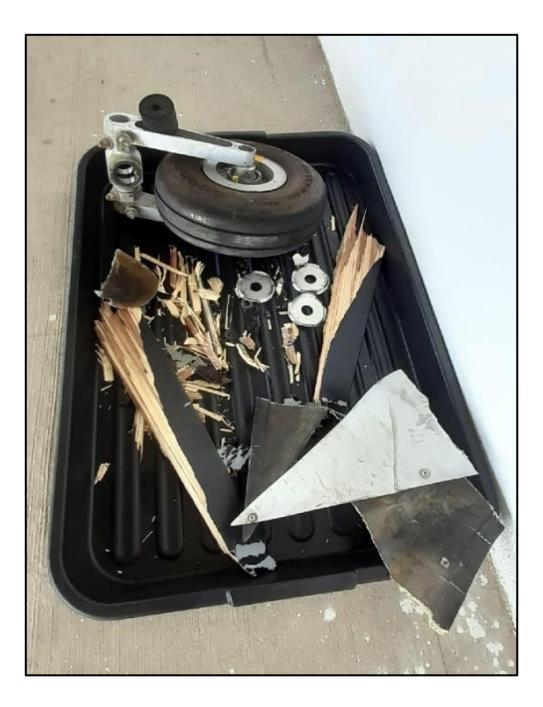
Picture 3: Oil cooler scraped at the **Picture 4:** NLG strut fairings broken. bottom part.

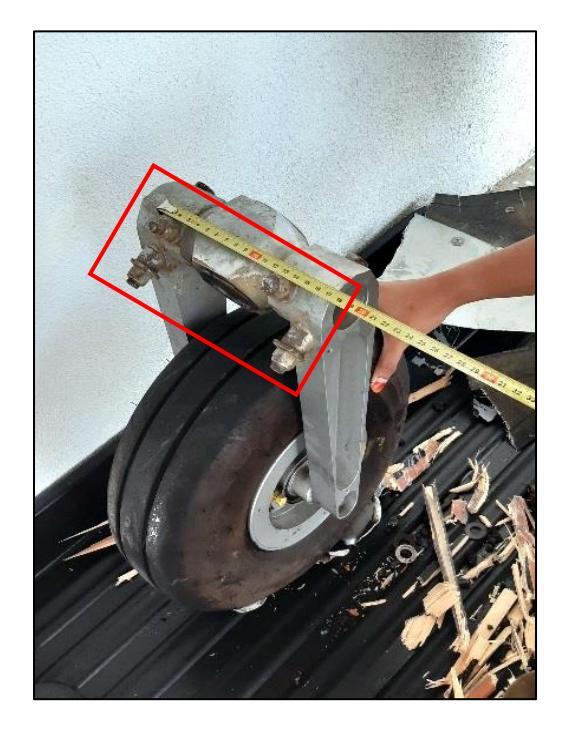
Picture 5: NLG yoke scrapped due to contact with the runway.

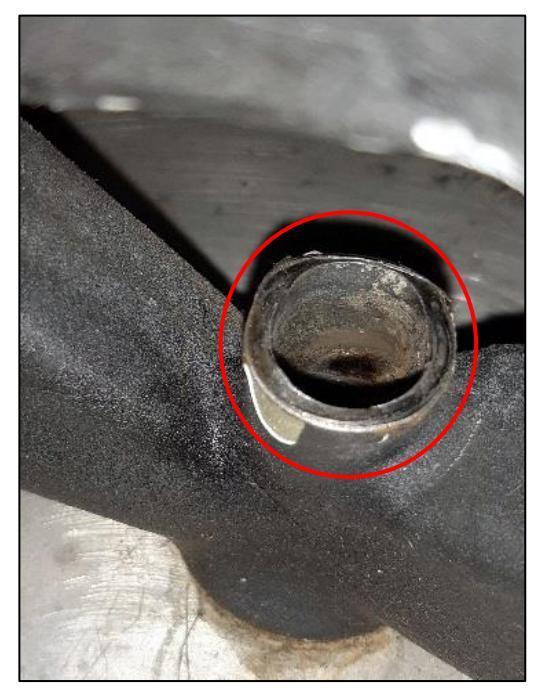
Picture 6: Engine mount frame – elastomer upper connecting bolt hole (at bulkhead firewall) found elongated.

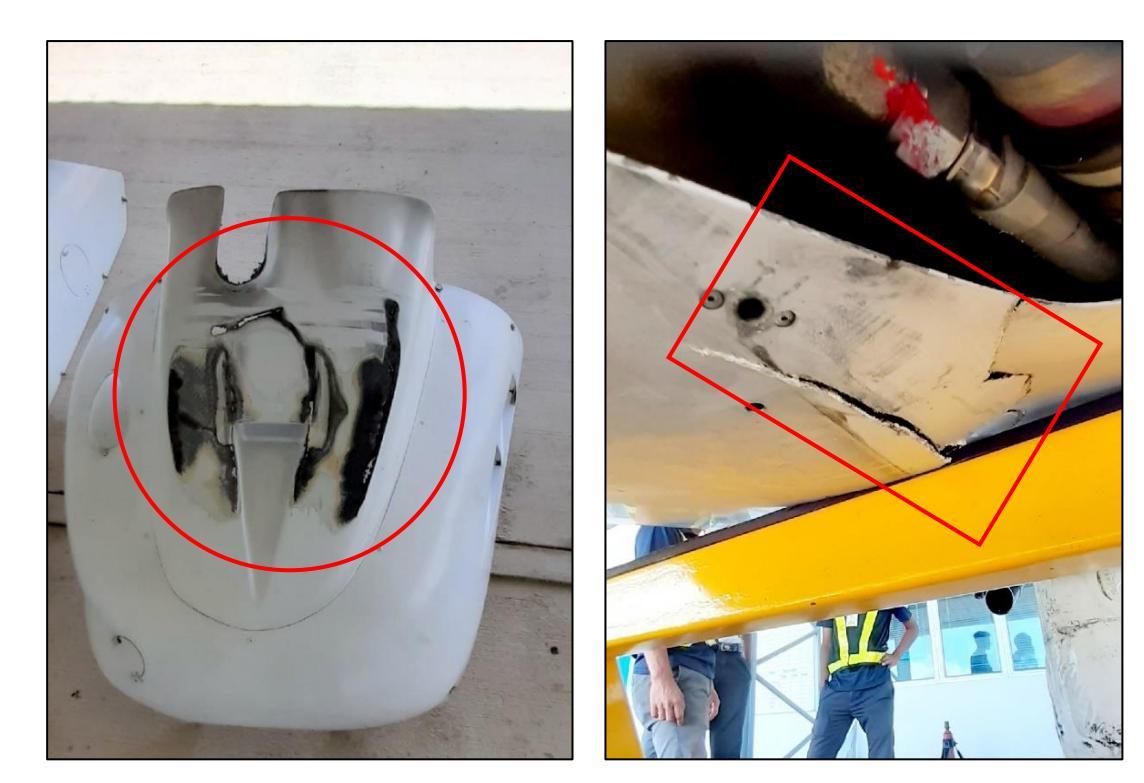
Picture 7: Lower engine fairing badly scraped.

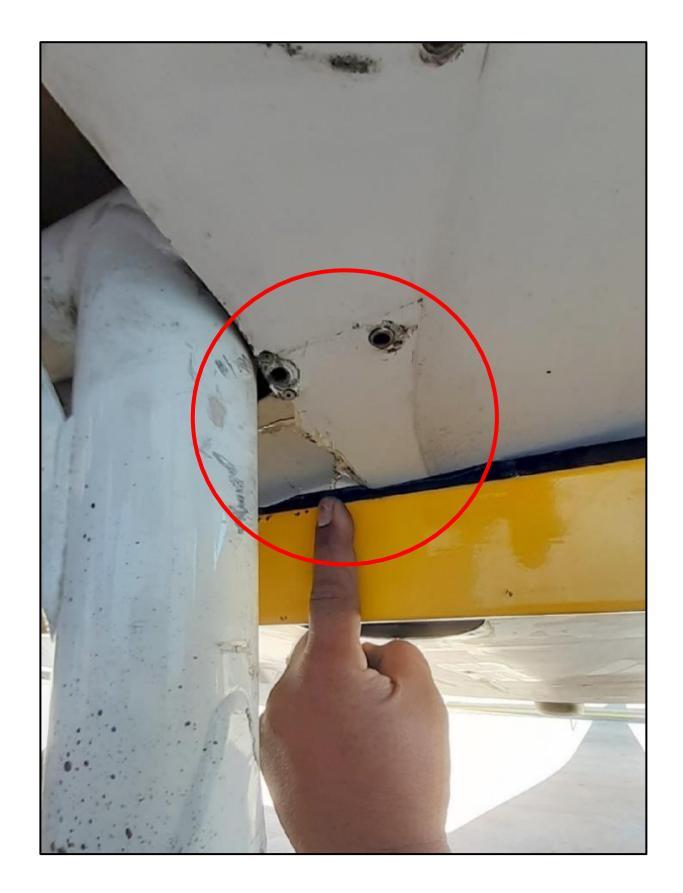
Picture 9: Fibre structure at NLG trunnion bulkhead found damaged.

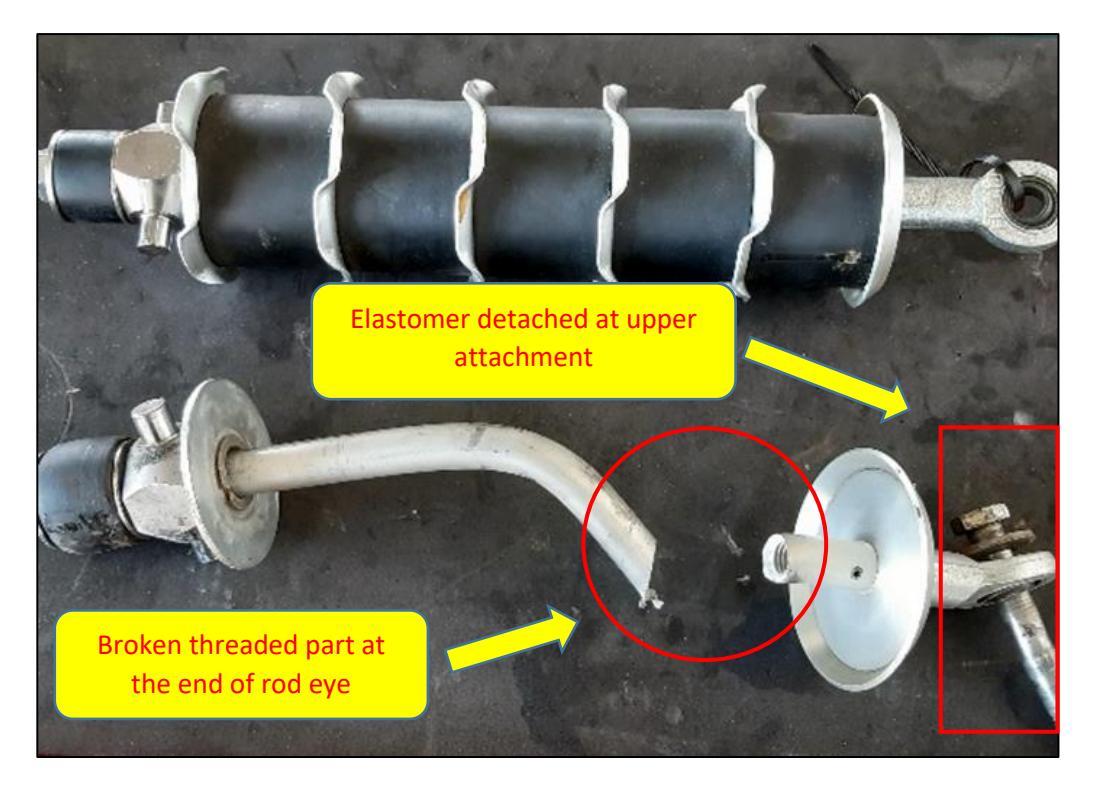
Picture 10: NLG shock absorber Elastomer detached at the upper attachment. It was broken at the threaded part of the rod eye end.

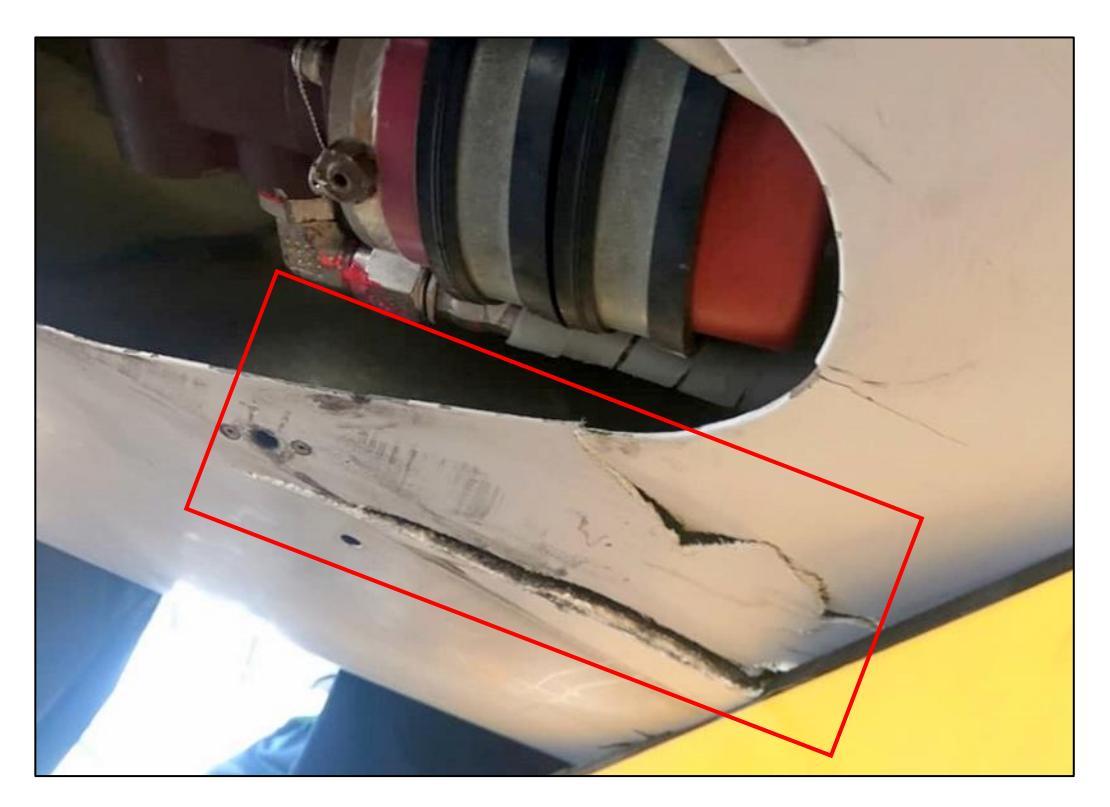
Picture 11: Fibre structure above NLG RH trunnion found punctured.

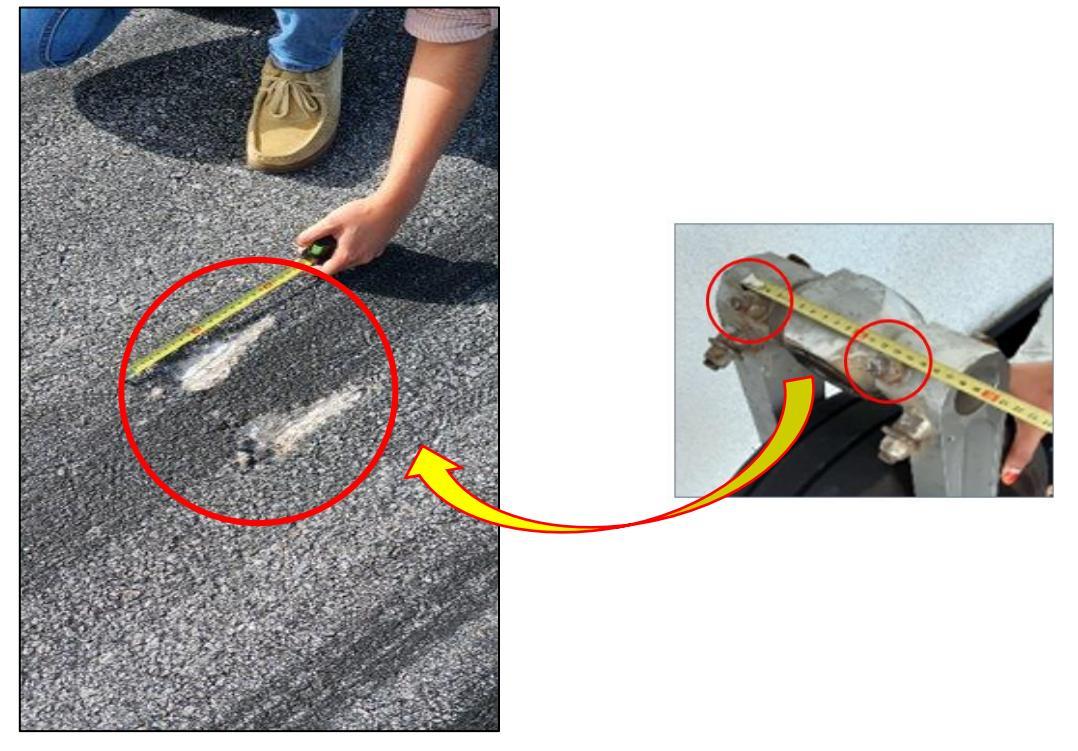
Picture 12: Bolt and nut marks embedded on the runway surface

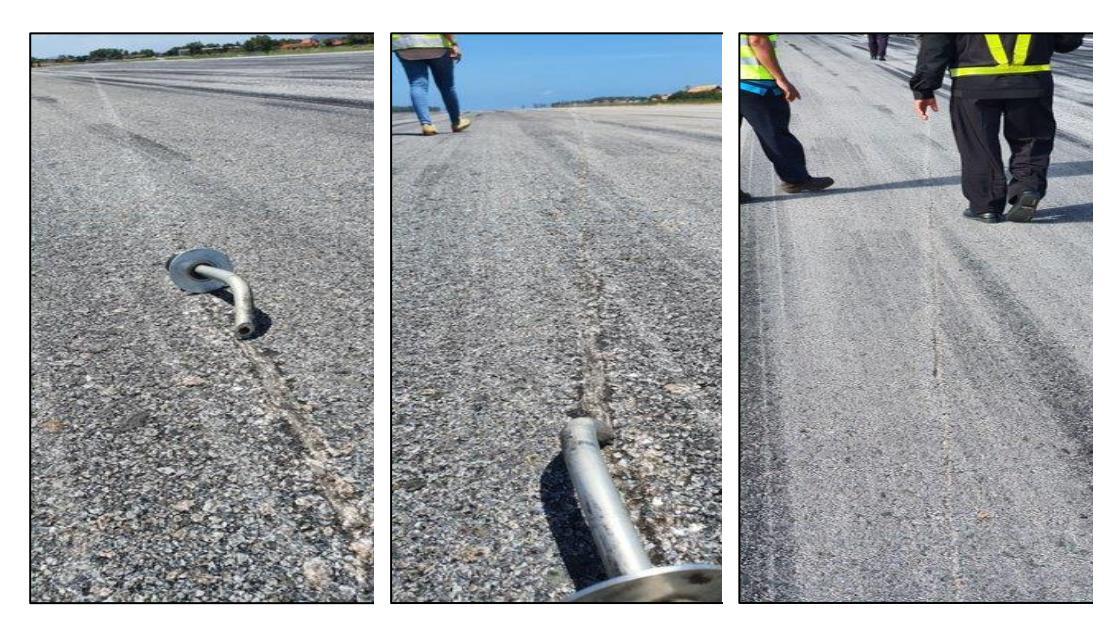
Picture 13, 14, and 15: Marks from the broken rod

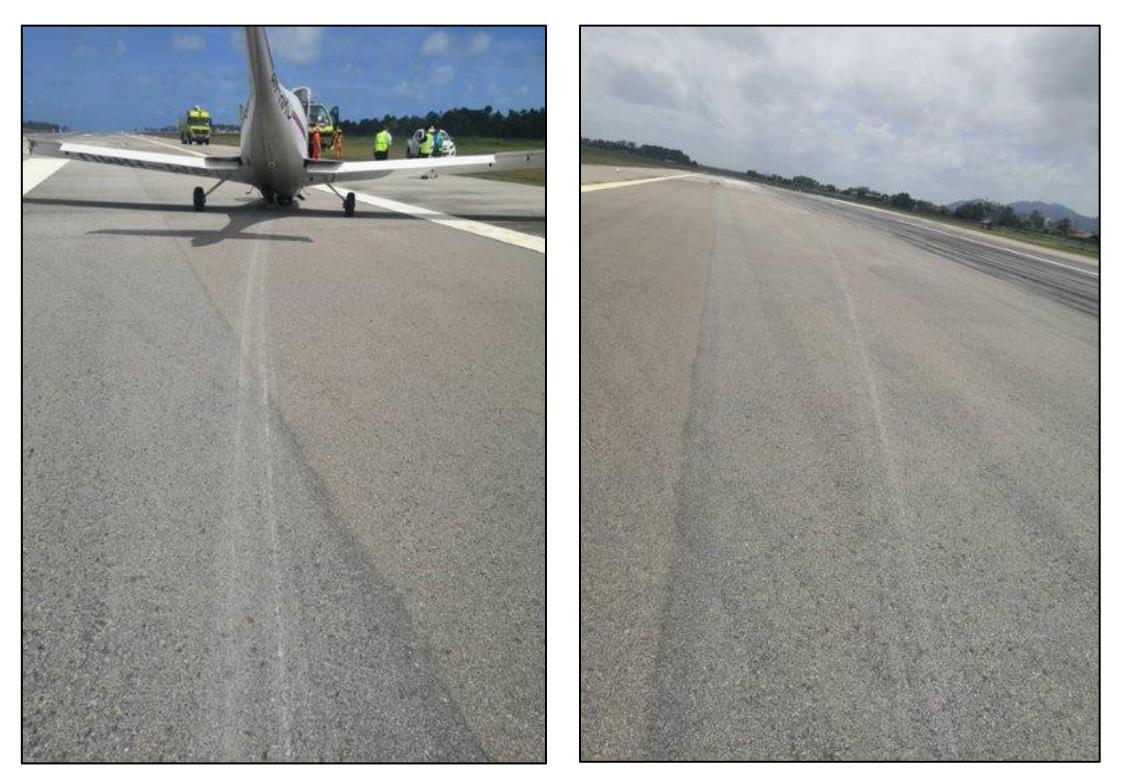
Picture 16 and 17: Skid marks cause by the nose wheel fork

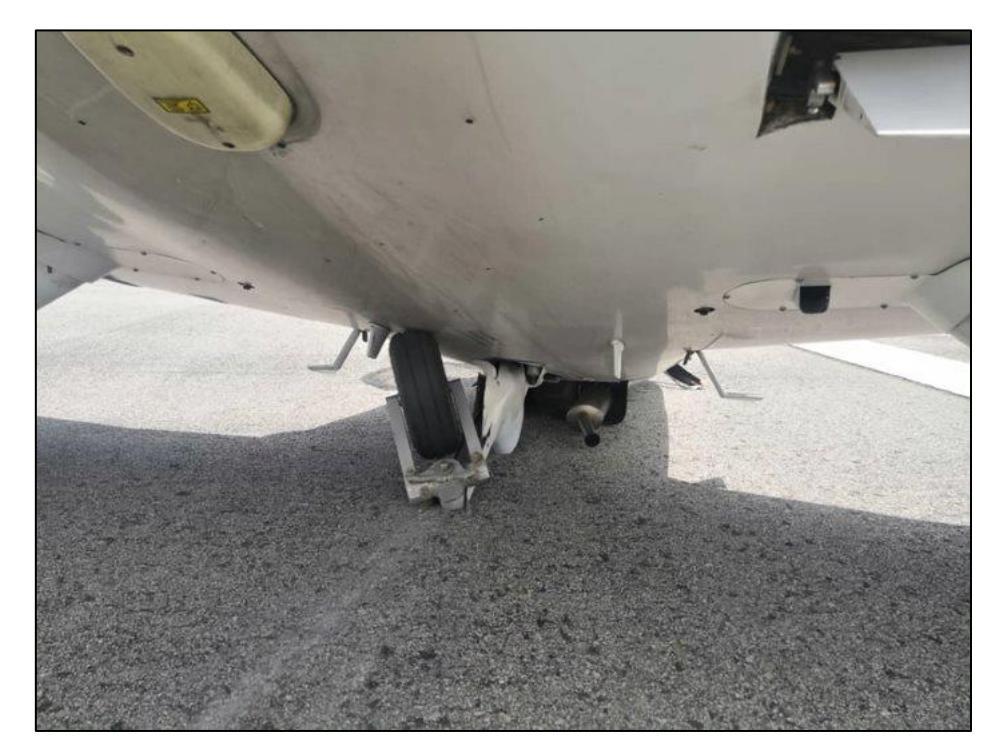
Picture 18: Rear view of the nose wheel

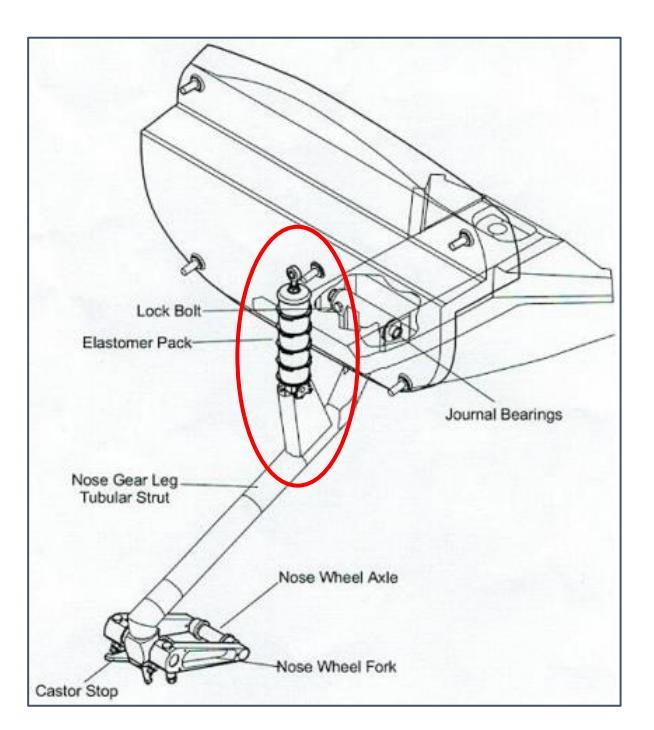
Figure 2: Diamond Star DA 40D's aircraft nose landing gear with elastomer pack

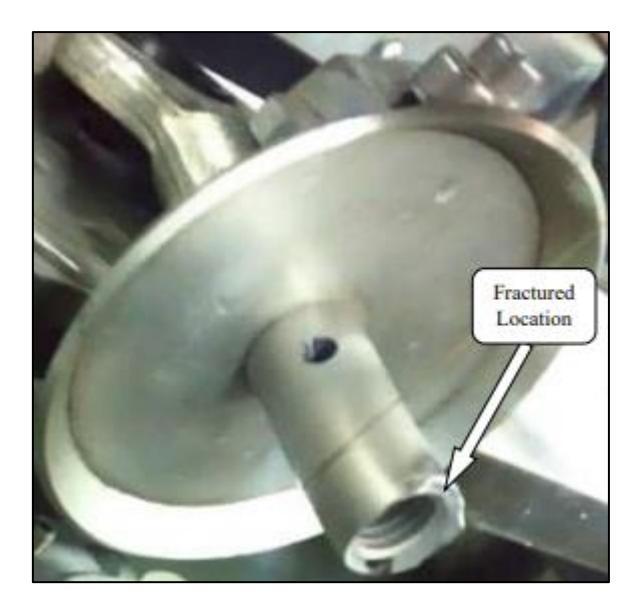
Figure 3: Diamond Star DA 40D's aircraft fractured nose landing gear elastomer pack.

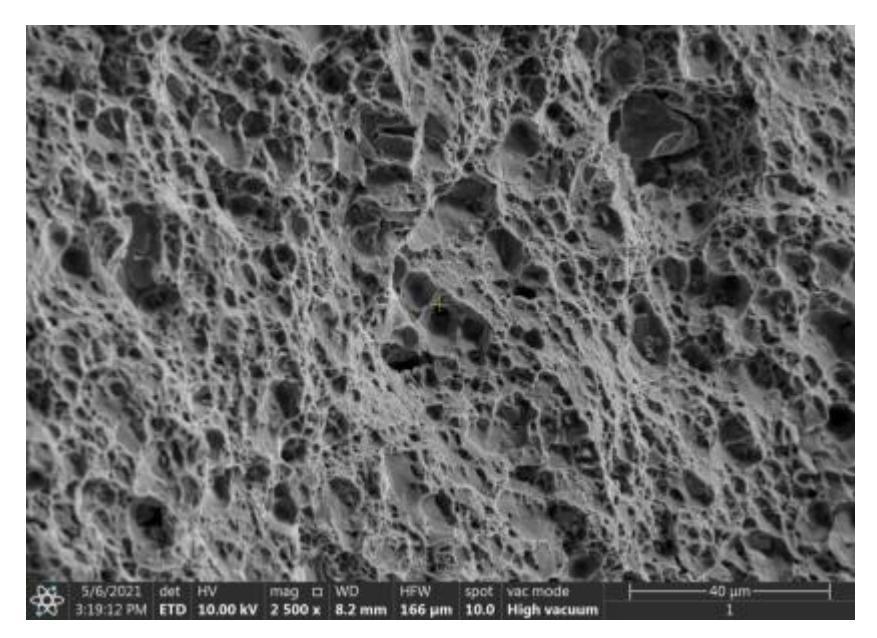
Figure 4: Fracture surface of Diamond Star DA 40D's aircraft nose landing gear elastomer pack on 2500x magnification.

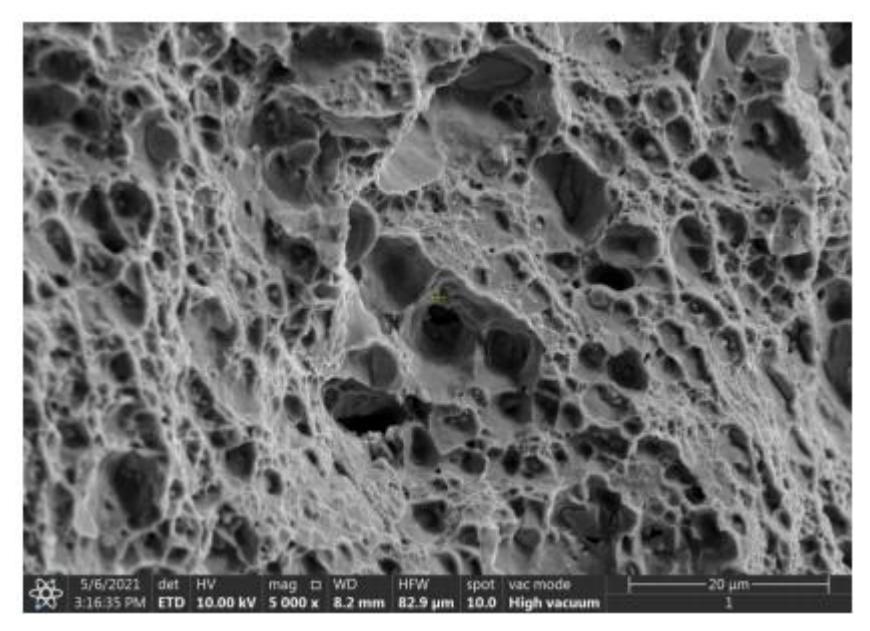
Figure 5: Fracture surface of Diamond Star DA 40D's aircraft nose landing gear elastomer pack on 5,000x magnification.

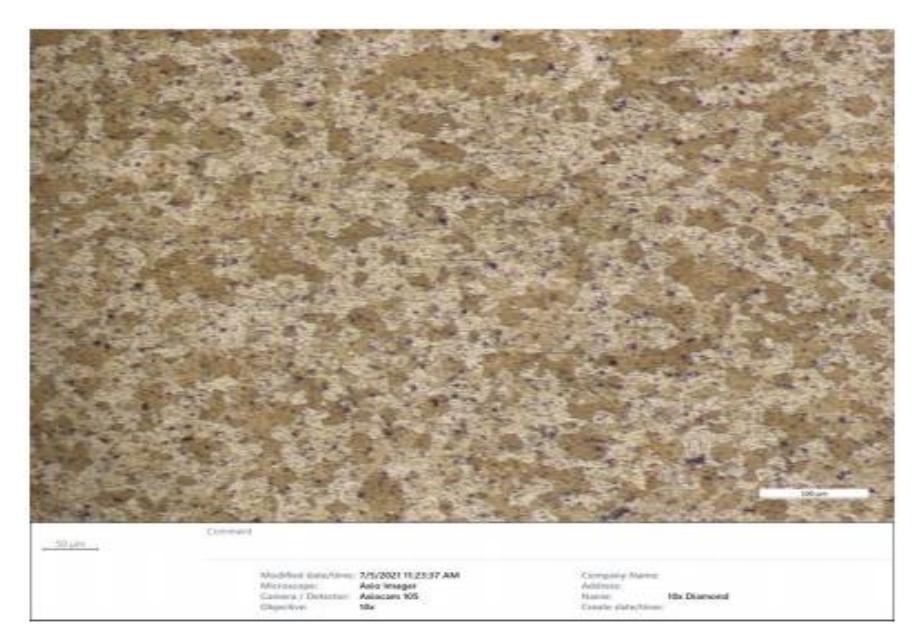
Figure 6: Microstructure of surface of Diamond Star DA 40D's aircraft nose landing gear elastomer pack on 10x magnification.

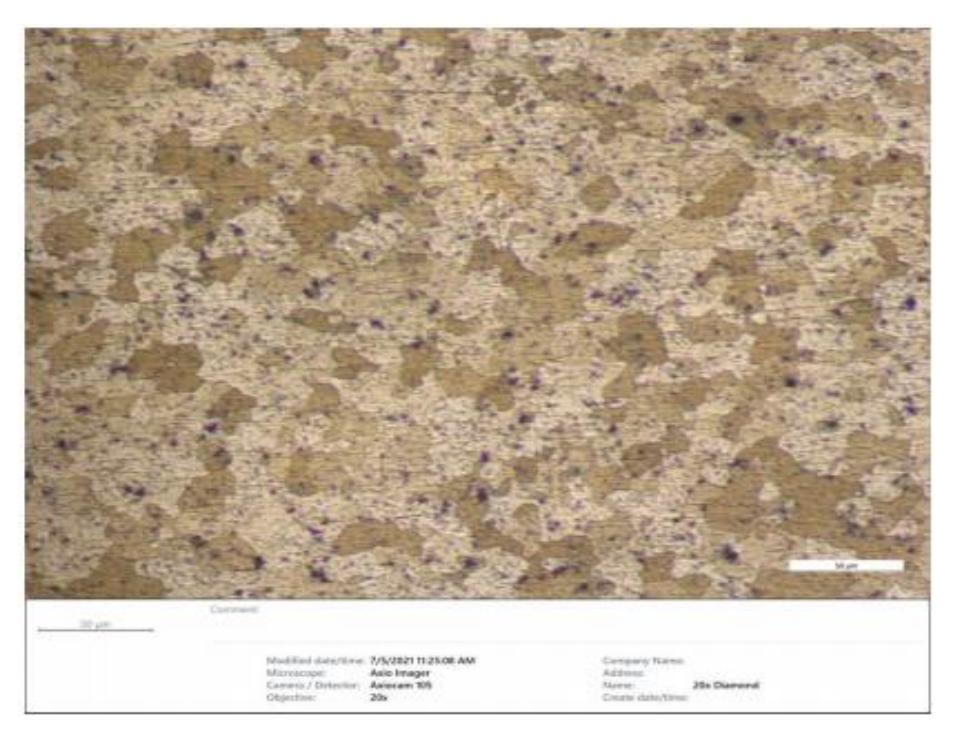
Figure 7: Microstructure of surface of Diamond Star DA 40D's aircraft nose landing gear elastomer pack on 20x magnification.
