# AIRCRAFT SERIOUS INCIDENT FINAL REPORT SI 08/20 Air Accident Investigation Bureau (AAIB) Ministry of Transport Malaysia

Serious Incident Involving Fixed Wing Aircraft Beechcraft Bonanza F35 Registration N5045B at km 47.8 Southbound, North South Expressway (PLUS) Near Sedenak, Kulai, Johor. on the 22 November 2020

REPORT NO.	: SI 08/20
OPERATOR	:	PRIVATE
AIRCRAFT TYPE	:	BEECHCRAFT BONANZA F35
NATIONALITY	:	UNITED STATES
REGISTRATION	:	N5045B
PLACE OF OCCURRE	NCE :	KM 47.8 SOUTHBOUND NORTH SOUTH EXPRESSWAY (PLUS) NEAR SEDENAK, KULAI, JOHOR
DATE AND TIME	:	22 NOVEMBER 2020 AT 1105LT

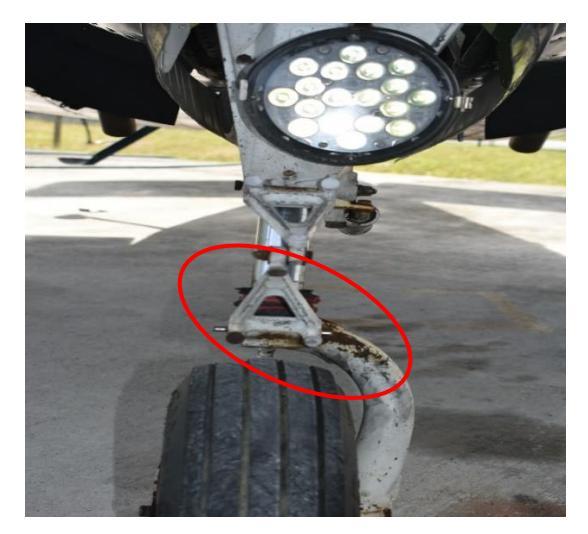
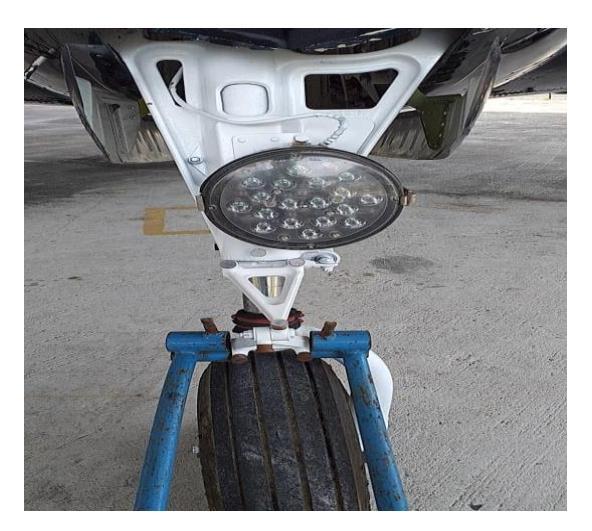
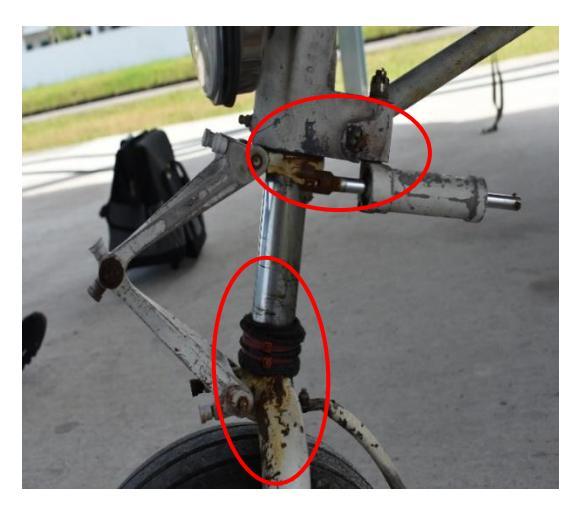
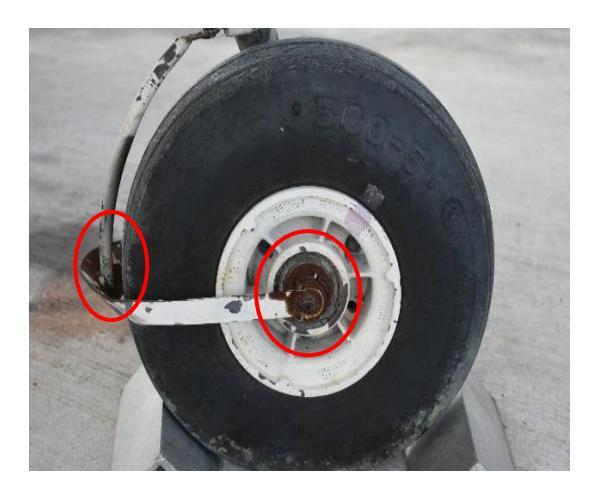
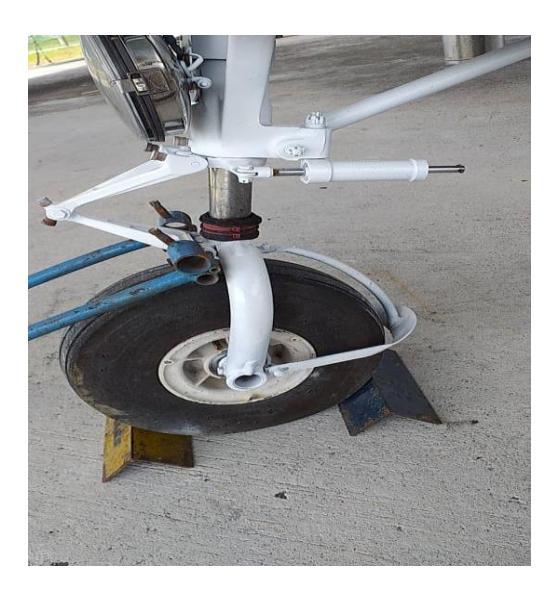
Figure 24: Corrosion at nose gear shock strut before and after corrosion treatment

The annual inspection check calls for the inspection of the nose gear shock strut for corrosion as in Figure 23. It was observed that the aircraft nose gear shock strut shows sign of severe corrosion at various places despite undergoing annual inspection in March 2020 as in Figure 24.

Proactive actions and adherence to preventive maintenance guide by the AMP is important to ensure the aircraft is in airworthy condition and is safe to fly especially for an old aircraft. There is a period of about 8 months between the annual inspection in March 2020 and the incident date in November 2020 when the corrosion was observed on the nose gear shock strut by the investigating team.

There is no evidence to suggest that the annual inspection for corrosion on the nose gear shock strut was not carried out properly. There is a high probability that the corrosion appeared due to storage conditions as the aircraft did not fly for about 7 months after being certified airworthy due to the COVID-19 pandemic flying restriction imposed by the government of Malaysia and Singapore. However, this does not relinquish the AMP from the responsibilities of ensuring preventive maintenance are carried out when signs of corrosion are observed during daily maintenance checks. Nevertheless, corrosion treatment had been carried out and the nose gear shock strut had been rectified after the observation made by the investigating team.

Corrosion treatment was carried out on the nose gear shock strut after the observation by the investigation team. Comparison of the nose gear shock strut before and after treatment are as shown in Figure 24.

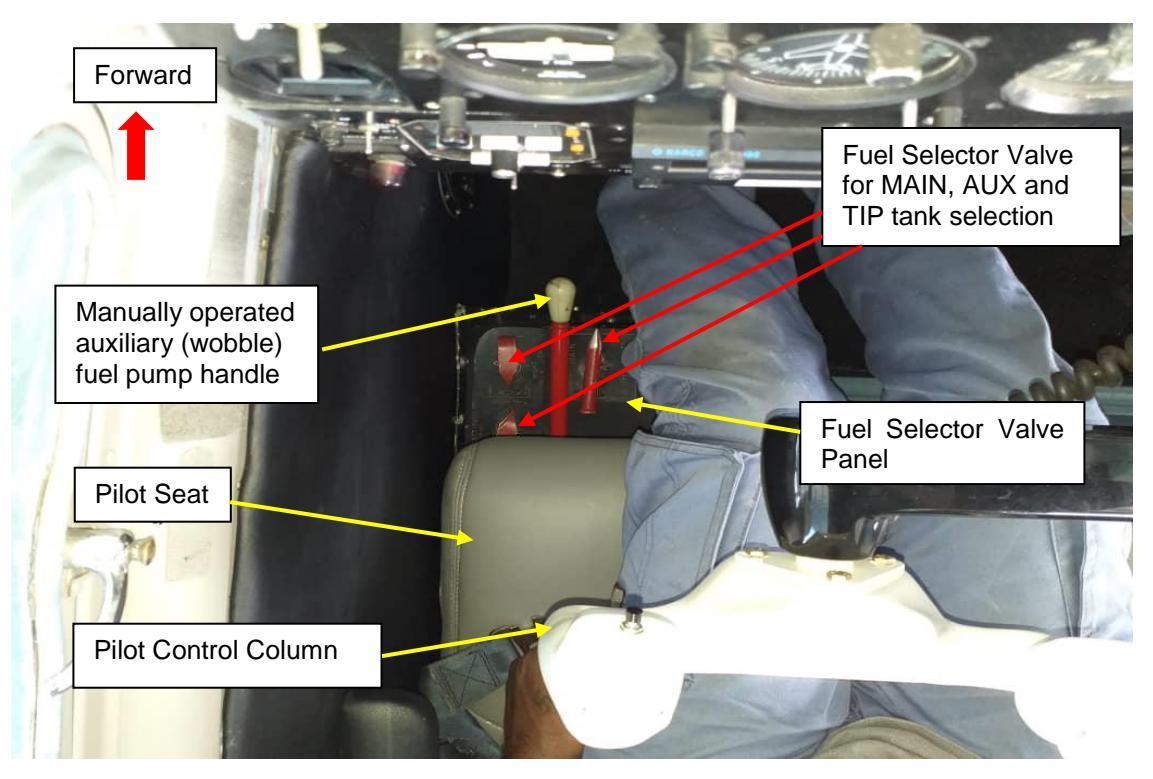
Figure 26: Top view location of the fuel selector valve panel in the cockpit

The location of the fuel selector valve panel is not in line of sight of the pilot when the pilot is in seated flying position (Figure 26). Any switch of tanks in flight requires the pilot to physically lean forward and glance at the fuel selector valve panel to ensure the correct selector valve is selected corresponding to the tank desired. It also requires the pilot to feel for the detent when turning the selector to ensure the selector valve is set to the correct position.

It was observed that the view of the selector valve panel from the pilot's seated flying position is limited. There is a possibility for the pilot to incorrectly select from the RIGHT MAIN to the LEFT MAIN tank instead of the intended AUX tank. It can be argued that it is unlikely for the pilot to turn the selector valve from RIGHT MAIN (handle facing right of aircraft) to LEFT MAIN ((handle facing left of aircraft) while the AUX tank position is facing rear of aircraft at the fuel selector panel.

The pilot who is also the owner of the aircraft had agreed to replace the present fuel selector system to a simplified version and to relocate the fuel selector to position it in between the pilot and co-pilot bottom seat rest. The simplified version and relocation will enable the pilot to have a better view and easier access to select the required fuel selector valve corresponding to the desired fuel tank during flight. The proposed fuel selector modification is to enhance the system thereby minimising or eliminating opportunity for errors and also to improve flight safety. The proposed modification is subjected to FAA's approval.

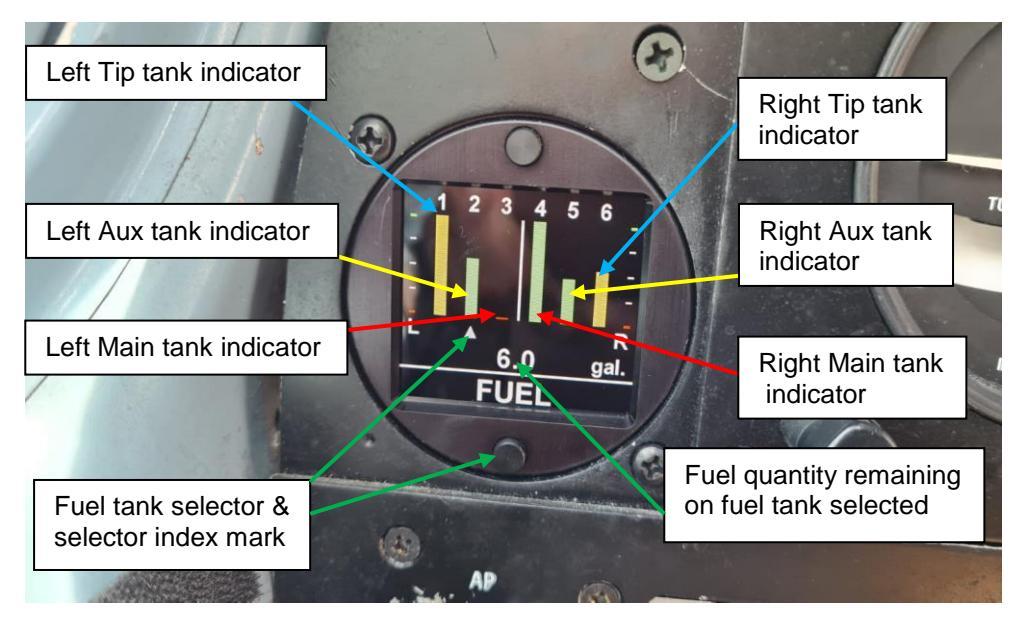
Figure 33: Fuel Gauge indication after emergency landing

The fuel gauge indication after the emergency landing on the day of the incident is shown in Figure 33. The indication shows both tip tanks close to empty (yellow bar indication), left and right auxiliary tank about half full, right main tank full while the left main tank indicate zero fuel (red bar indication).

The above discrepancy between the fuel quantity remaining reading in flight and actual fuel quantity remaining in the fuel tanks on ground was a result of a faulty sending unit (sensor) which caused an overreading to the left main tank indication on the fuel gauge in the cockpit. The overreading was found to be caused by the bad and dirty float in the sending unit.

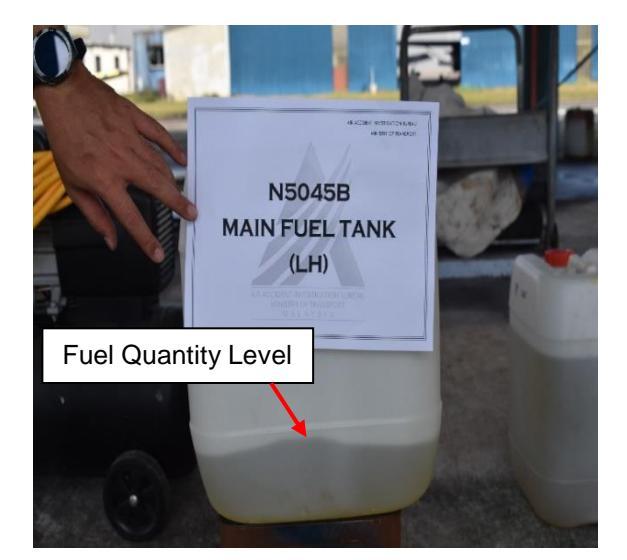
**LEFT MAIN** Tank – quantity about **1 gallon**

Nevertheless, on-site physical fuel quantity check after the emergency landing revealed that the fuel quantity on the left main tank was physically empty and the left main tank fuel indicator on the fuel gauge was indicating zero fuel quantity. The right main tank and both auxiliary tanks were observed to have reasonable amount of fuel in the tanks (see paragraph 1.18.3) while both the tip tanks were close to empty.

3.1.4 On-scene investigation at the incident site observed that the Left Main Tank fuel gauge indicates zero. Physical inspection of the Left Main Tank found the tank was empty.
