AIRCRAFT SERIOUS INCIDENT FINAL REPORT SI 04/24 Air Accident Investigation Bureau (AAIB) Ministry of Transport, Malaysia

Fixed Wing Aircraft Boeing 737-800, Registration 9M-LCM at Kuching International Airport, Sarawak on 13 February 2024

REPORT NO.: SI 04/24

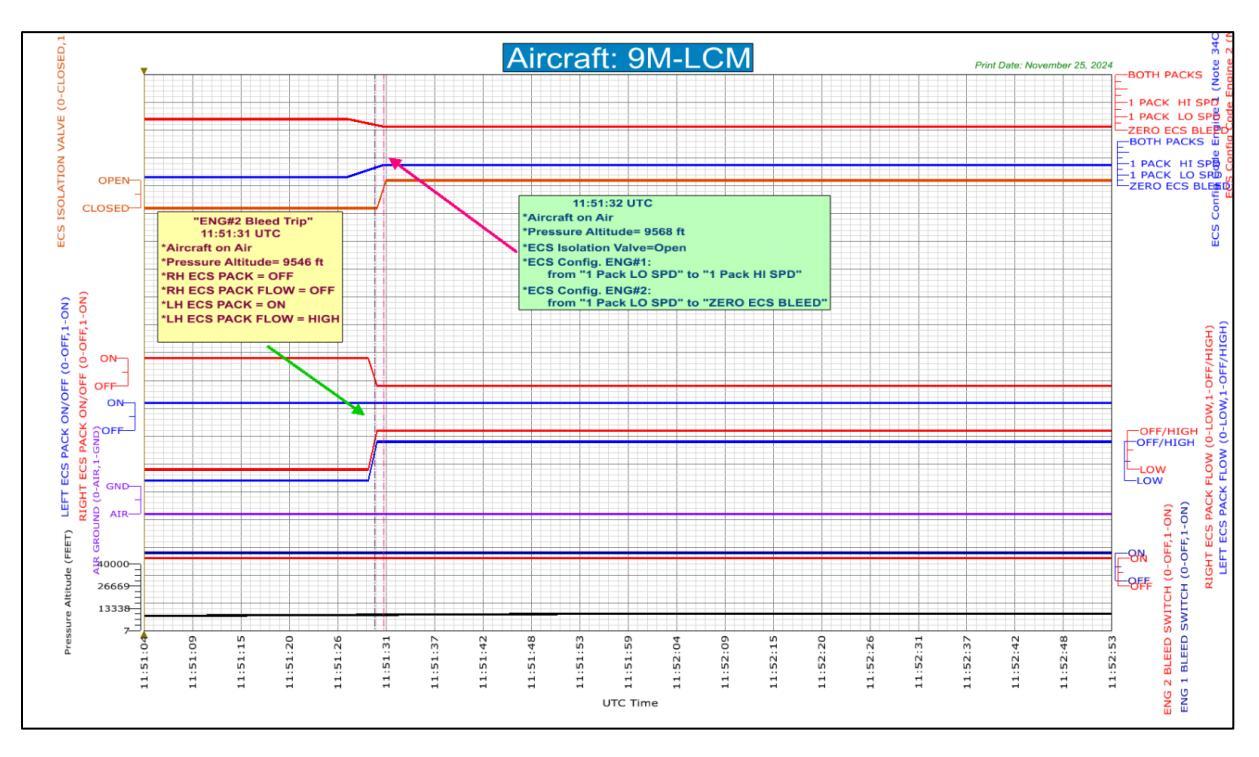
Figure 10: Engine No 2 Bleed Trip Event - Environmental Control System (ECS)

- At 19:47:57 LT, during the climb, the Engine No 2 bleed trip-off light illuminated, accompanied by a 'Master Caution' warning at a pressure altitude of 5,452 ft.
- This occurred due to the engine bleed air temperature or pressure exceeding a predetermined limit, triggering the over-temperature/over-pressure condition.
- Attempts to reset the system were unsuccessful, leaving the aircraft to operate

with a single bleed for the remainder of the flight.

- At 19:51:31 LT, with a pressure altitude of 9,546 ft:
 - 'RH ECS PACK' was set to OFF, and 'RH ECS PACK FLOW' was OFF.
 - 'LH ECS PACK' was ON, and 'LH ECS PACK FLOW' was set to HIGH.
- At 19:51:32 LT, with a pressure altitude of 9,568 ft:
 - 'ECS Isolation Valve' was OPEN.
 - 'ECS Config. Engine No 1' changed from "1 Pack LO SPD" to "1 Pack HI SPD."
 - 'ECS Config. Engine No 2' changed from "1 Pack LO SPD" to "ZERO ECS BLEED

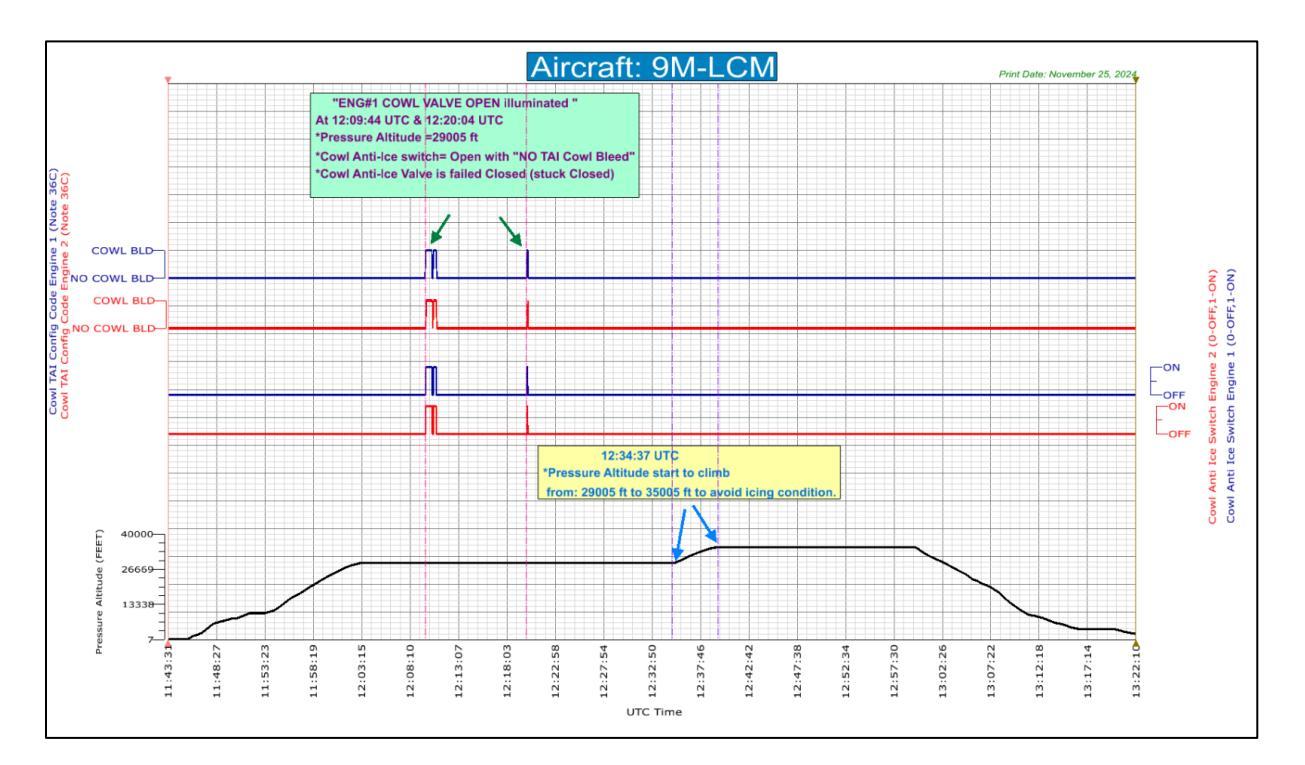
Figure 11: Engine No 1 TAI Disagree Event

- At 20:09:44 LT and 20:20:04 LT, during cruise with icing conditions (visible clouds and TAT below 10°C) at a pressure altitude of 29,005 ft, the "Cowl Anti-Ice switch" was set to OPEN. When the pilot attempted to open the cowl TAI switch, the COWL VALVE OPEN light illuminated, prompting the crew to switch off the COWL TAI. This was repeated several times.
- On Engine No 1, the COWL VALVE OPEN light was illuminated in bright blue, and an amber TAI indication appeared on the CDS, indicating that the cowl antiice valve was "not in the commanded position."
- The ENG ANTI-ICE switch was ON, showing that the cowl anti-ice valve had failed closed (stuck closed), leading to a failure of the thermal anti-ice system on this engine.
- At 20:34:37 LT, the aircraft began to climb, increasing the pressure altitude from 29,005 ft to 35,005 ft to avoid the icing condition.

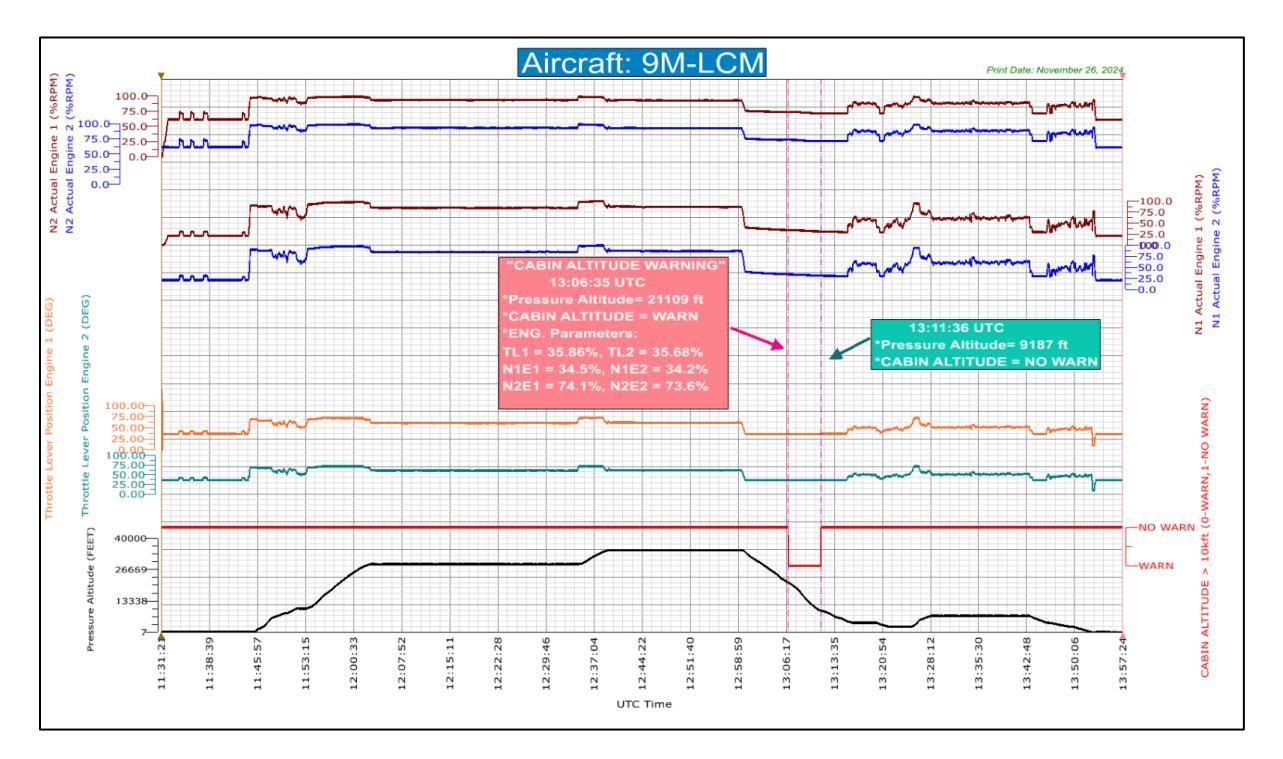
Figure 12: Cabin Altitude Warning Event

• With the aircraft operating on a single pack and a low engine power setting (Flight IDLE), it is suspected that the high-pressure regulator valve (PRSOV) failed to open according to the proper schedule.

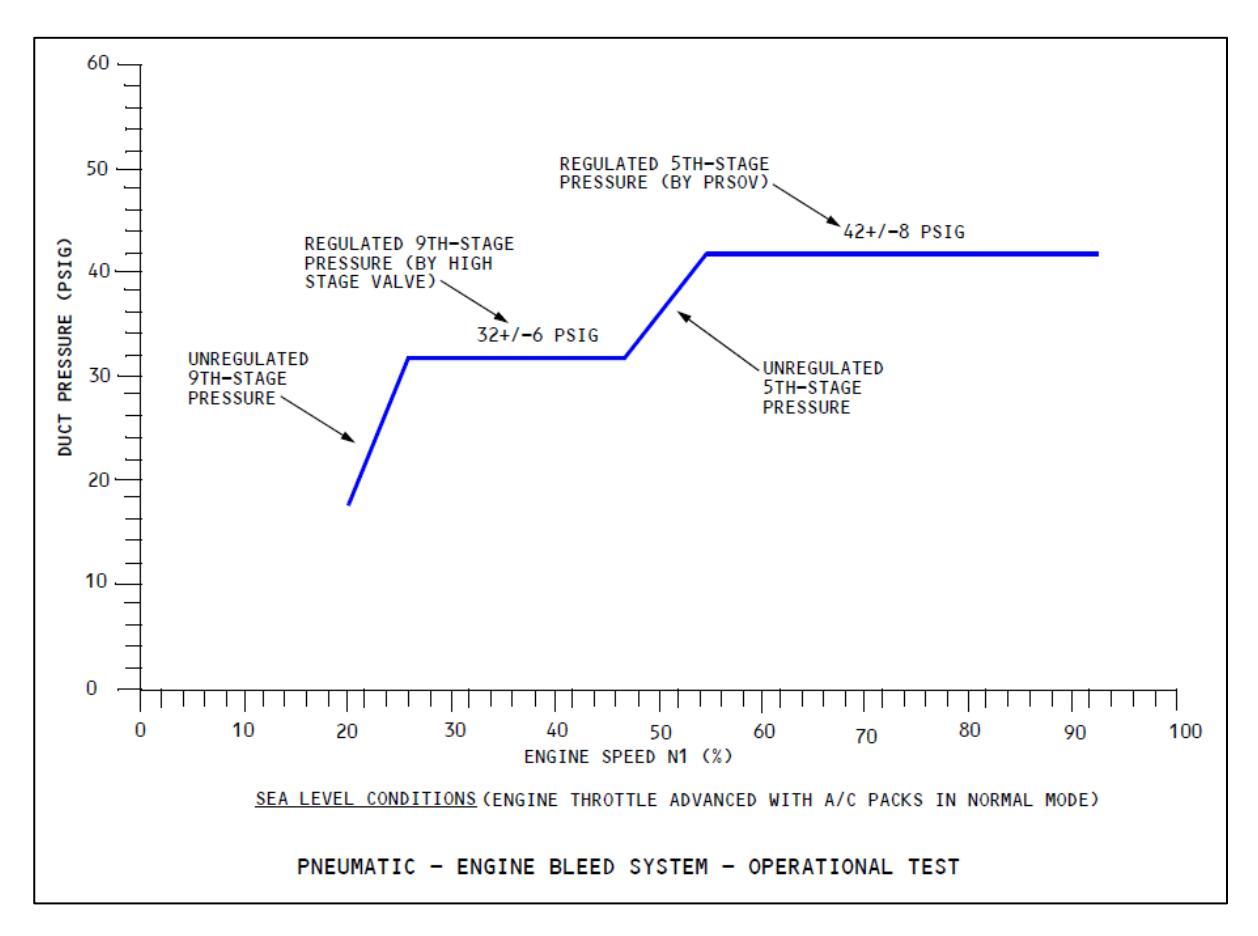
Figure 13: Engine Bleed Air Operation

Under normal conditions, the HSV remains fully open during low engine power settings, providing pneumatic pressure to the cabin. However, during descent, the cabin vertical rate indication increased, and the pneumatic supply to the cabin decreased. This condition led to the decompression event. Since there was no indication of a bleed trip for Engine No 1, it suggests that the PRSOV remained open during descent, and the low bleed indication pointed to an issue with the HSV. The HSV was likely partially open or stuck closed, which caused the bleed air supply pressure to drop. During an idle run check, the maintenance crew discovered that the

HSV was difficult to operate and could not return to the closed position. It was confirmed that the HSV was sticky and needed replacement, which resolved the low bleed problem. The HSV, being the original component on the aircraft with 18,244 flight hours, was likely affected by aging.

Based on FIM 36-10 Support, during ground idle, the engine bleed pressure supplied by the HSV (9th-stage) is typically between 18-32 psig. During flight idle (with the throttle retarded), the engine bleed pressure supplied by the HSV ranges from 20-32 psig. The maintenance crew conducted a cabin leakage confirmation through a pressurisation test to verify that there were no leakage issues on the aircraft. The results of this test were satisfactory. Therefore, it was concluded that the cabin decompression was caused by an abnormality in the operation of the HSV during descent.
