AIRCRAFT ACCIDENT

FINAL REPORT

A 06/24

Accident Involving Fixed Wing Aircraft Cessna 172N,

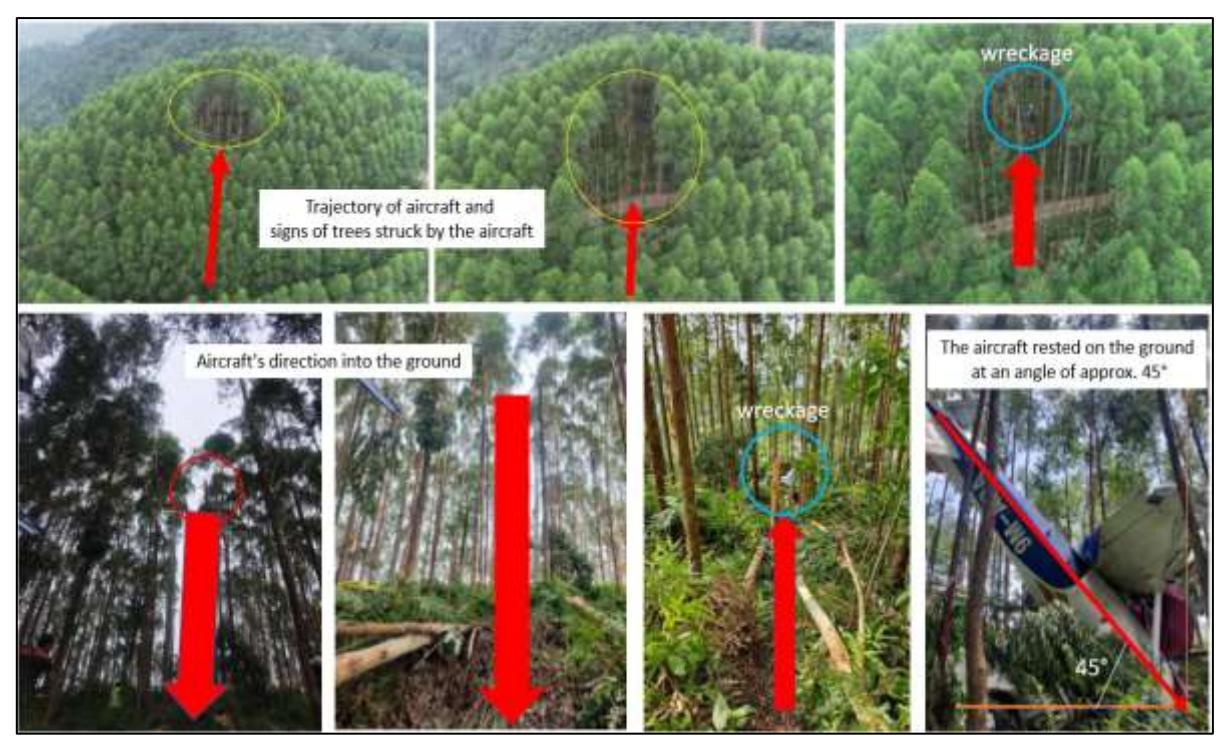
Figure 6: The trajectory of the aircraft before impact with the ground

The aircraft suffered significant damage after striking trees and crashing into the ground. The crash location coordinates are shown in Figure 5. Figure 6 illustrates the aircraft's trajectory before the crash, while Figure 7 depicts its post-accident condition.

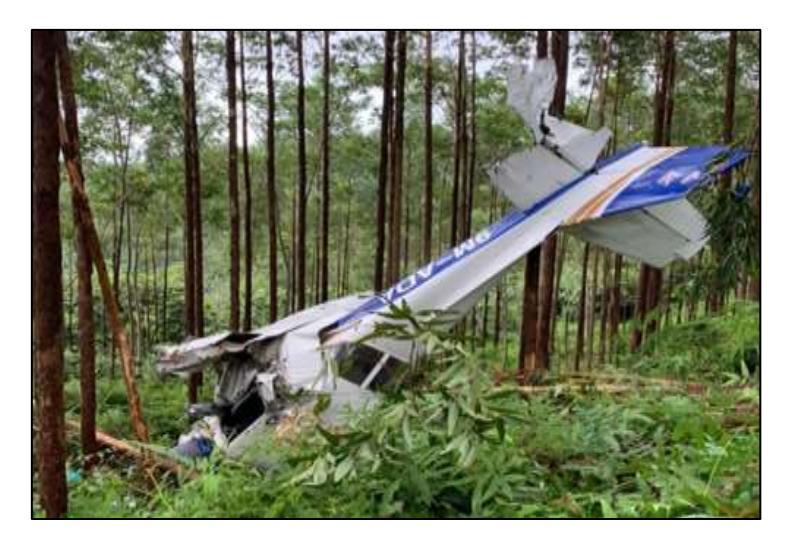
Figure 8: Post-accident condition of the aircraft

The investigation team visited the crash site and visually inspected the aircraft wreckage to gather physical evidence crucial for understanding the event. It was observed that the aircraft had impacted the ground in a severely damaged condition. The aircraft came to rest in an almost inverted position, surrounded by tall trees at the top of a hill, as shown in Figure 8.

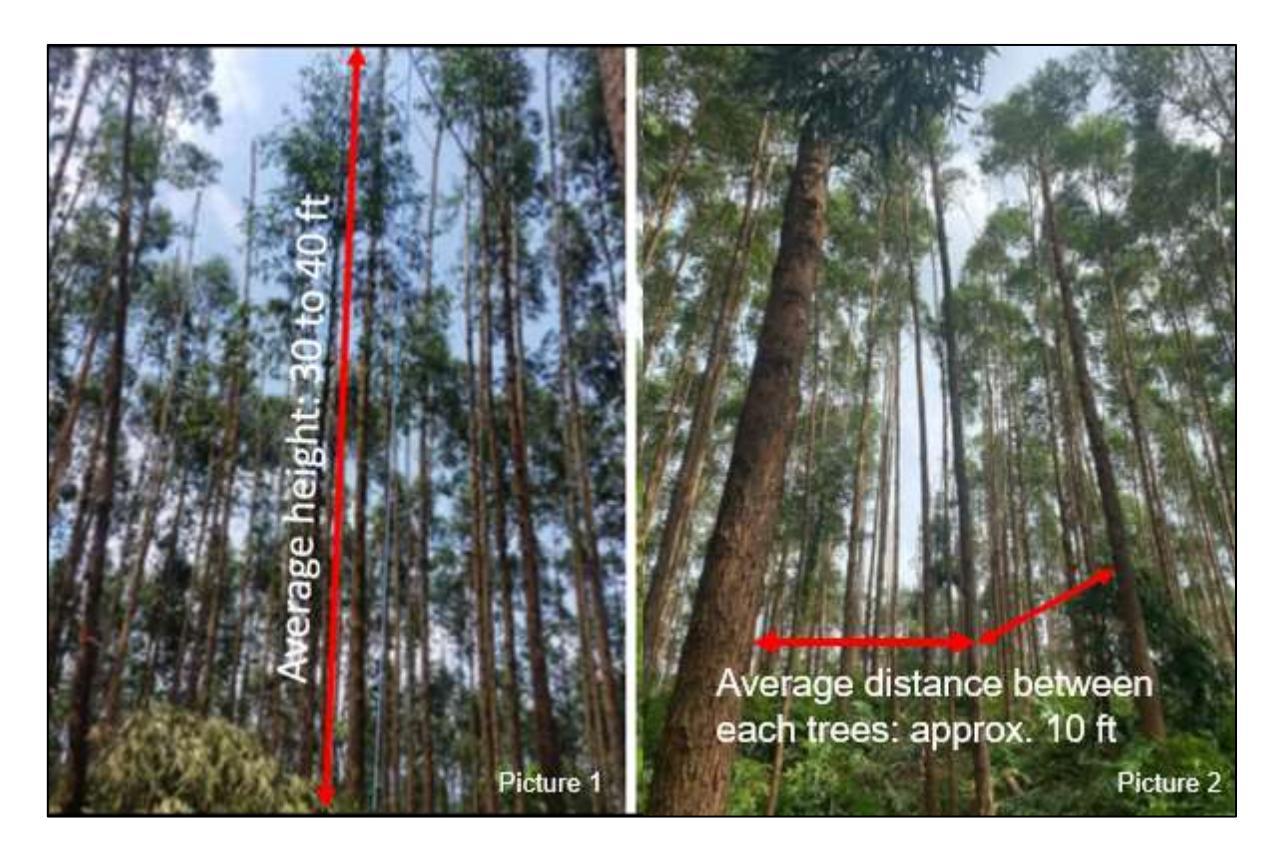
Figure 9: Tall trees, averaging 30 to 40 ft in height and spaced approximately 10 ft apart, were located on the hill

It was also observed that the trees at the crash site had an average height of approximately 30 to 40 ft, with an average spacing of around 10 ft between each tree, as shown in Figure 9.

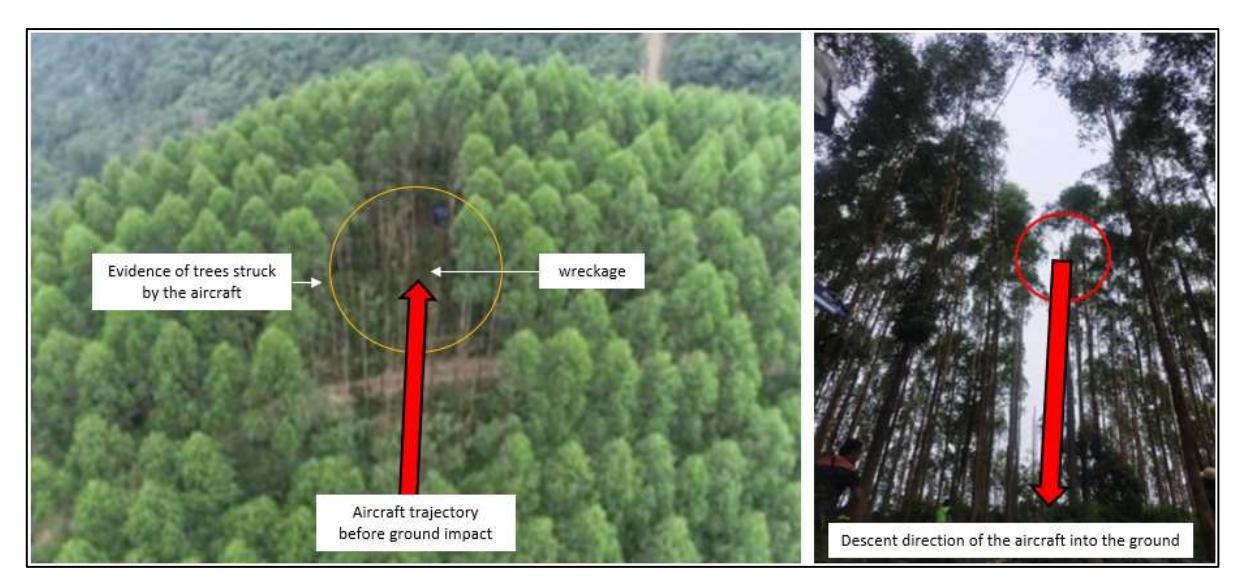
Figure 10: Aircraft trajectory into terrain and descent path before the crash

Evidence suggests that the aircraft struck several tree branches and trunks before its final impact with the ground. Figure 10 also illustrates the aircraft's trajectory and descent path prior to the crash.

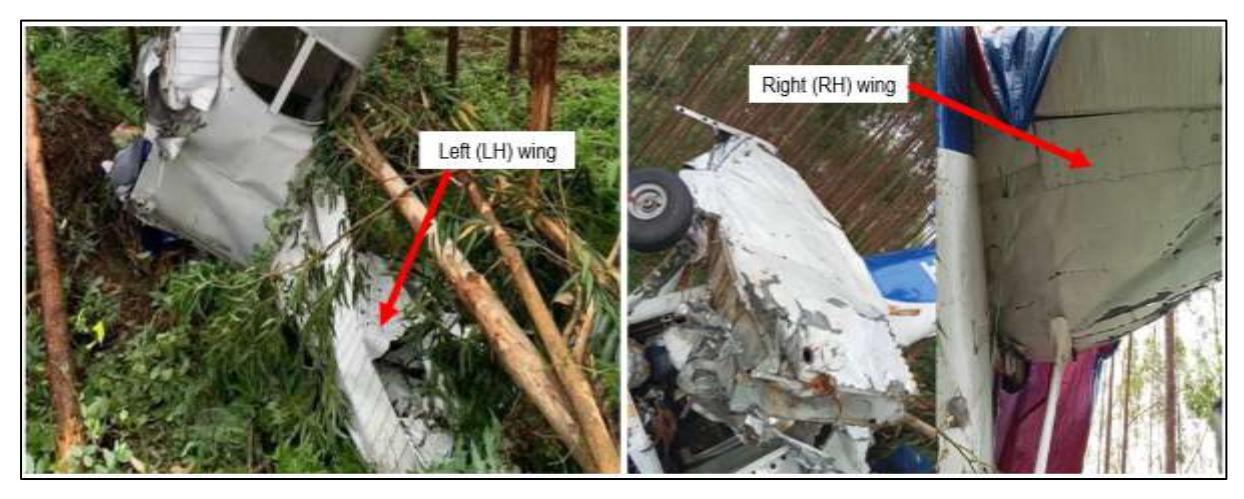
Figure 11: Conditions of left (LH) and right (RH) wing after accident

A visual inspection of the wreckage revealed that the left (LH) wing was damaged, showing more scratches from striking tree branches and trunks, while the right (RH) wing was bent and twisted upwards, as shown in Figure 11.

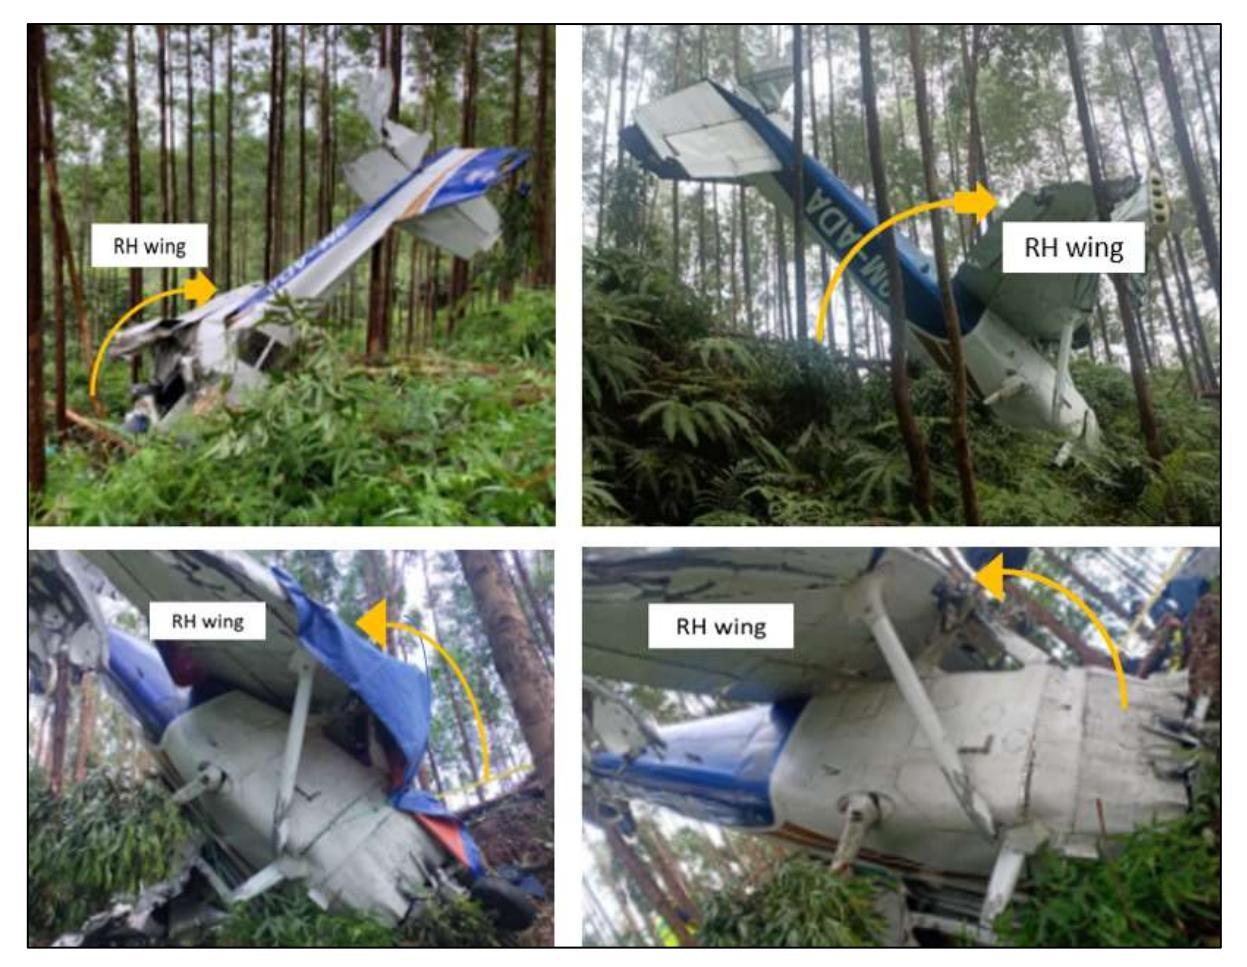
Figure 12: Position of right (RH) wing after aircraft impacting the ground

Both wing struts were found to be severely damaged. The wing assembly sustained impact forces from tree branches, trunks, and the collision with the ground. It is likely that the LH side of the aircraft struck the tops of tree branches first, leading to a loss of control. The aircraft then struck with several more branches and trunks before impacting the ground. This impact crushed the LH wing and caused the RH wing to bend and twist upwards, ultimately leaving the aircraft resting in an almost inverted position, as shown in Figure 12.

Despite sustaining severe damage, the aircraft's impact was likely cushioned by the tree canopy, and both crew members were extremely fortunate to have survived the crash. As the aircraft struck and descended through the trees, the tree canopy helped dissipate its speed and momentum before it made final contact with the ground.

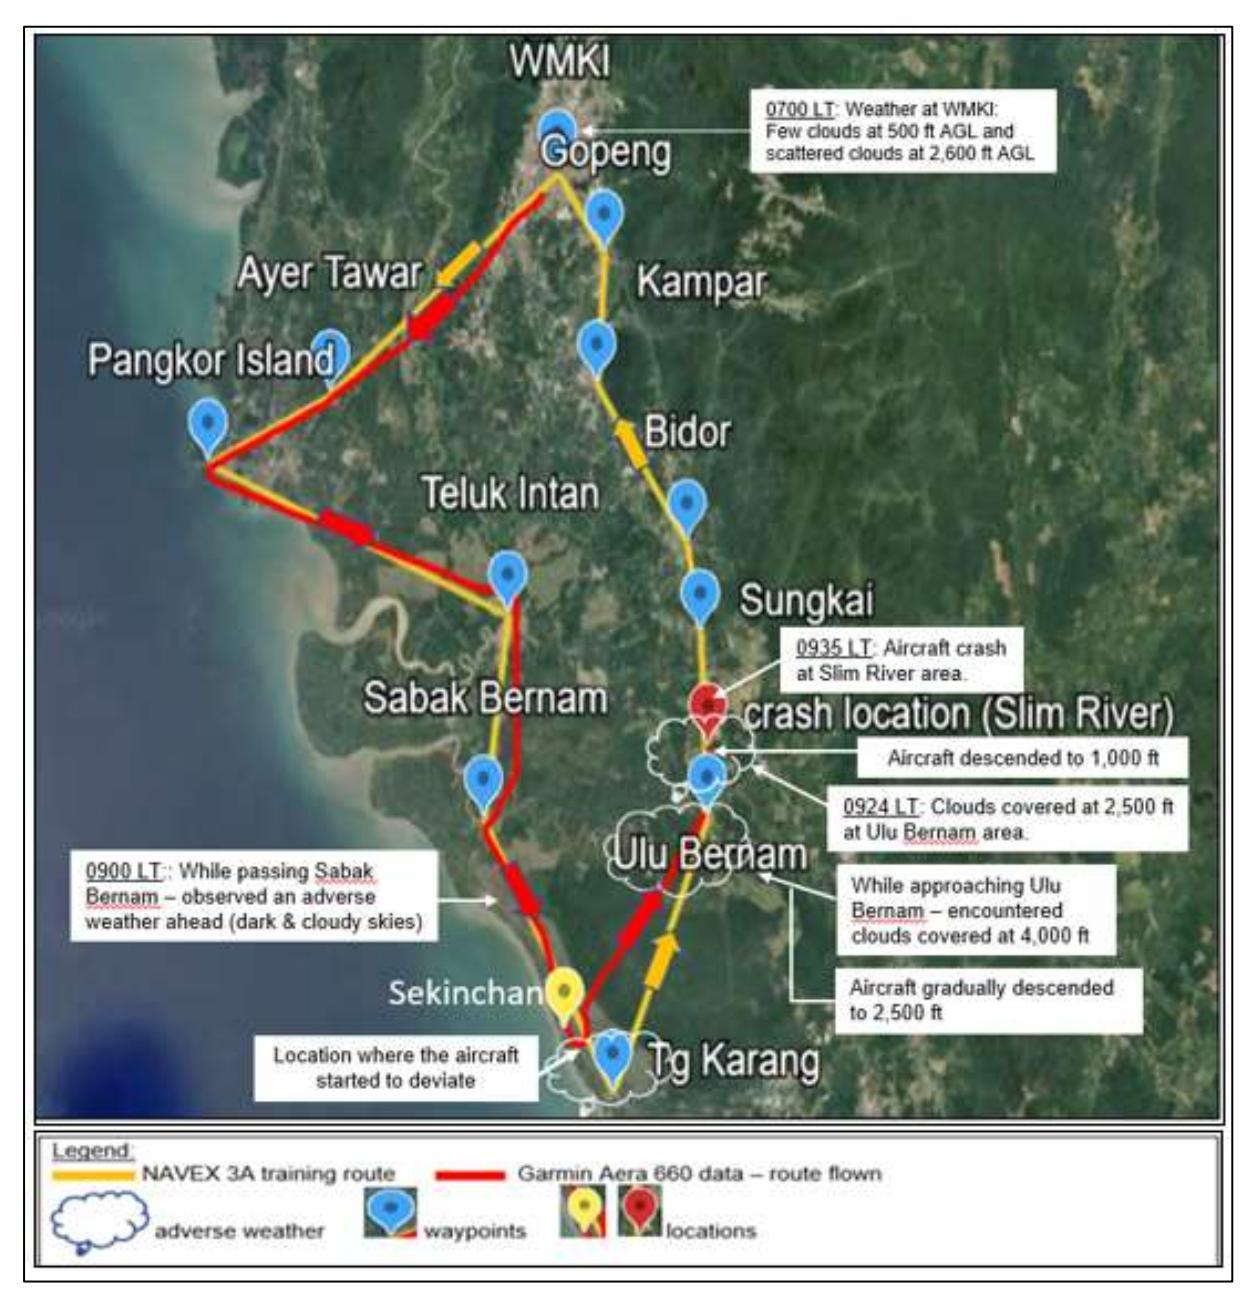
Figure 18: Illustration of the entire sequence of events¹³

While descending to 1,000 ft, the Safety Pilot took control of the aircraft. However, shortly after reaching this altitude and attempting to level off, the aircraft inadvertently entered IMC. With visibility lost, the Safety Pilot struggled to maintain visual contact with the terrain, leading to a likely loss of orientation and situational awareness— particularly regarding the high ground surrounding the aircraft's position. As a result, the aircraft unintentionally struck the tree canopy, became uncontrollable, and collided with multiple branches and trunks before crashing to the ground. Figure 18 illustrates

the sequence of events, based on witness interviews, as well as data from the Garmin device and METAR reports.
