# **AIRCRAFT SERIOUS INCIDENT**

# **FINAL REPORT**

# SI 02/24

Fixed Wing Aircraft Textron Aviation Cessna 172P, Registration 9M-AZP

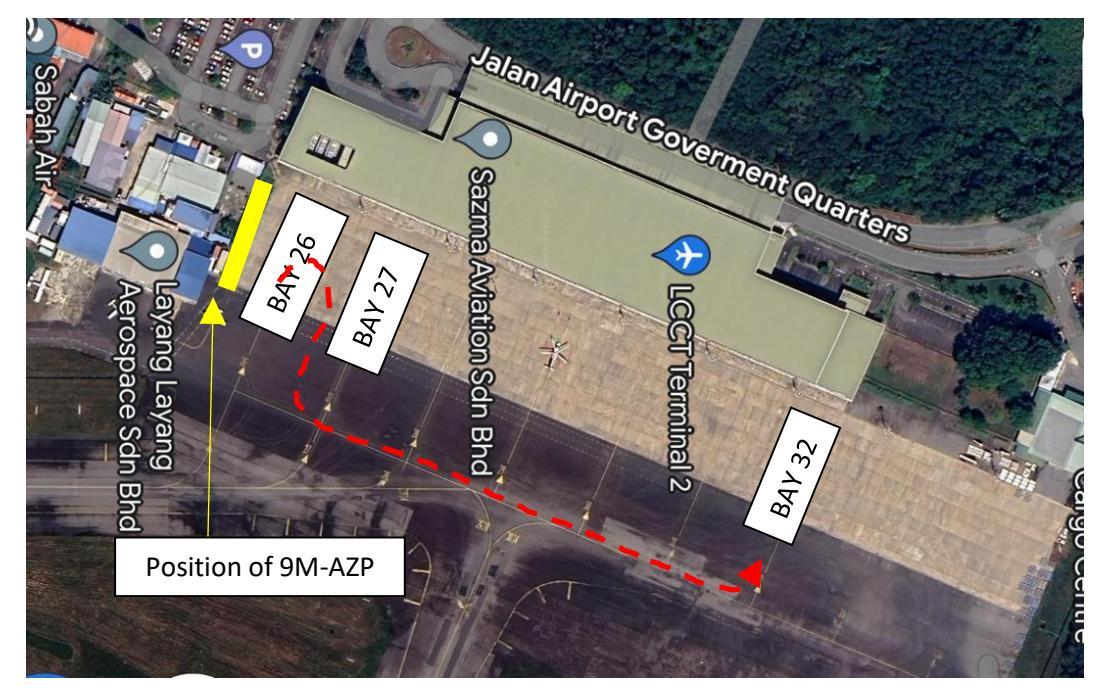
Figure 1: Position of Aircraft

The jet blast generated during this manoeuvre caused the Cessna 172P, registration 9M-AZP, to shift from its parking position, as shown by the yellow arrowhead in Figure 1. The force dislodged all wheel chocks and caused the tail section of the Cessna to contact the ground. The momentum from the blast propelled the aircraft into a sliding motion, which ended when the left-hand wingtip collided with the roll cage of a forklift parked within the hangar. Additionally, the Spraidex zinc sheet installed at the perimeter fence, as indicated by the yellow rectangle in Figure 1, was dislodged by the jet blast. This damage nearly caused the fencing to collapse.

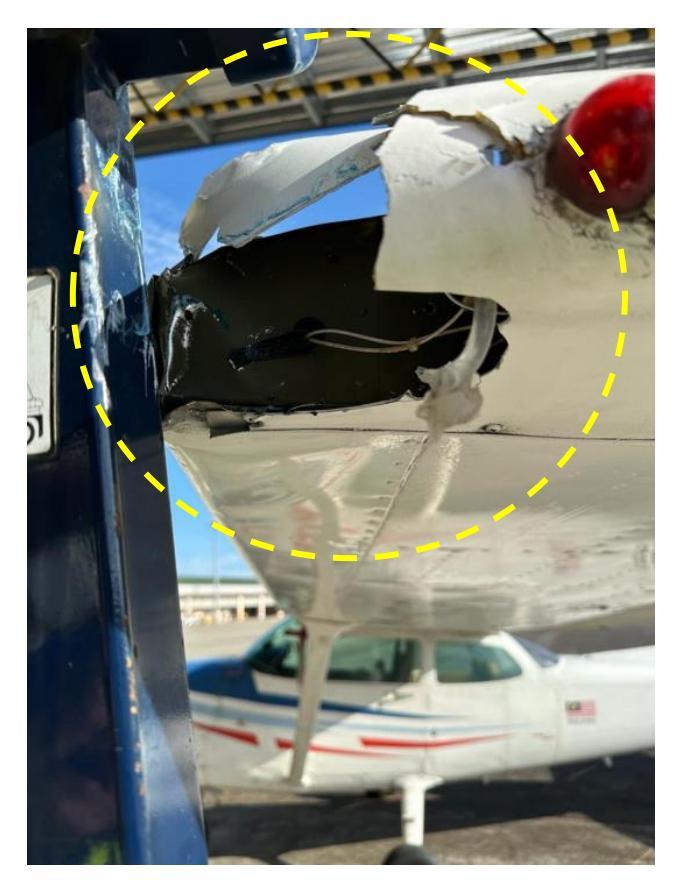
Figure 2: LH wing tip damage area

Significant damage was observed on the left-hand (LH) wingtip assembly, as shown in Figures 2, 3, 4, and 5, including noticeable cracks and puncture damage in the forward section. Analysis confirms that the LH wing sustained impact forces upon collision with a forklift parked nearby, caused by the jet blast generated during the taxiing of the aircraft from the terminal. Assessments have determined that the deformation of the wingtip assembly exceeds permissible limits.

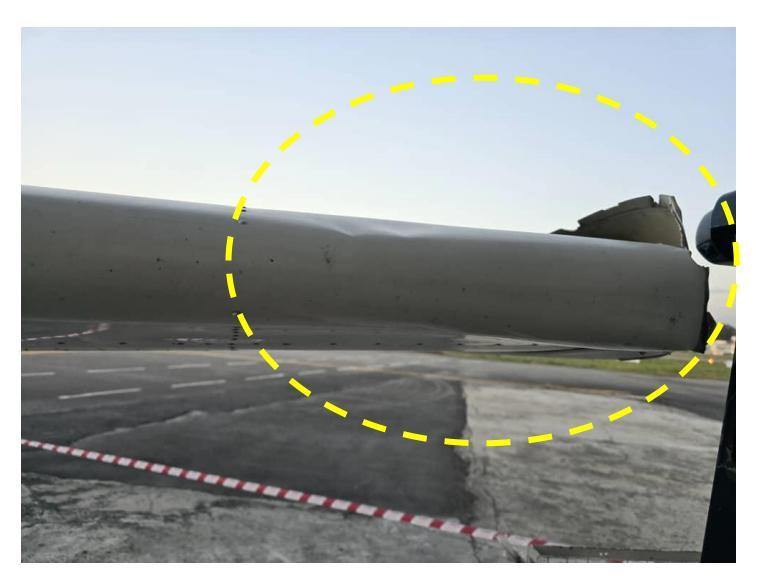
Figure 3: Visible deformation of LH wing tip

The left-wing leading edge exhibits a significant inward deformation, attributed to the forces generated by the jet blast. No additional defects have been identified; further inspections are required.

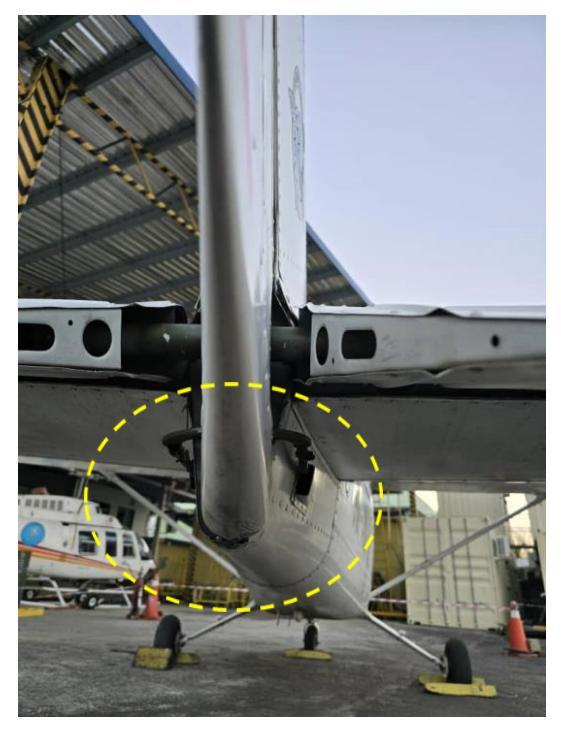
Figure 5: Tail Section

The tail section and tail cone were severely impacted against the ground due to the jet blast, which caused the aircraft to shift from its parked position. No additional defects have been identified at this stage; further inspections are required.

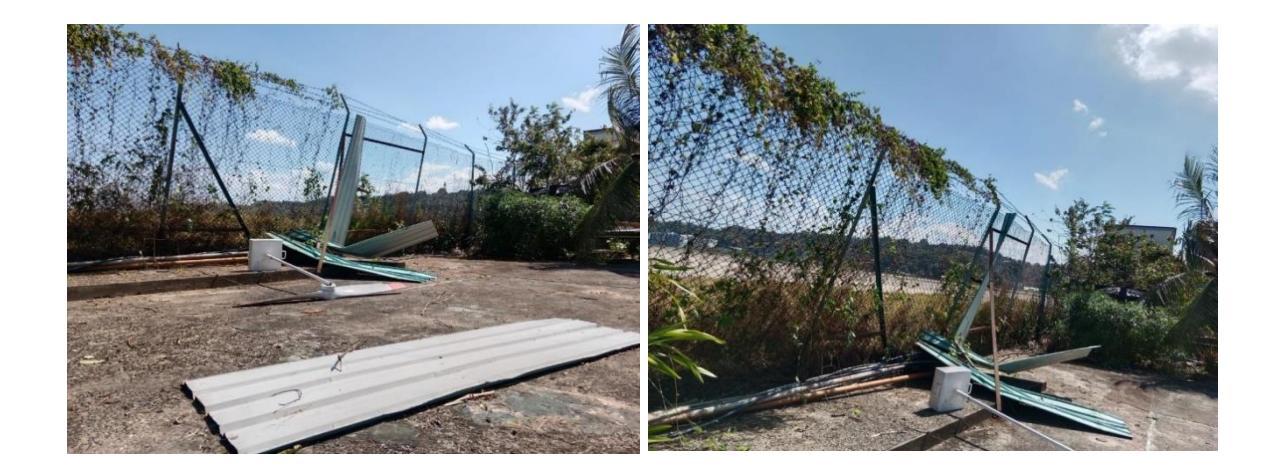
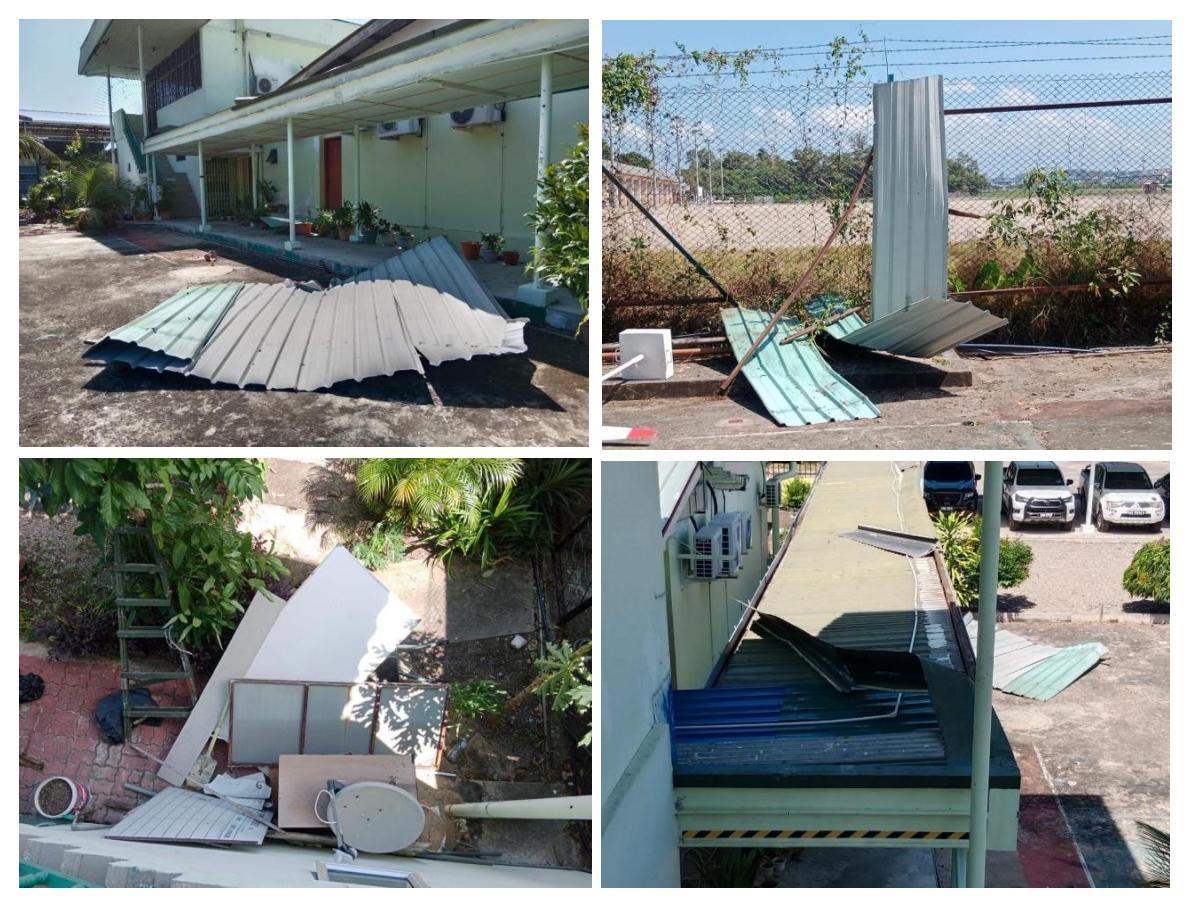
Figure 6: Damage sustained by the perimeter fence and inside compound LLA

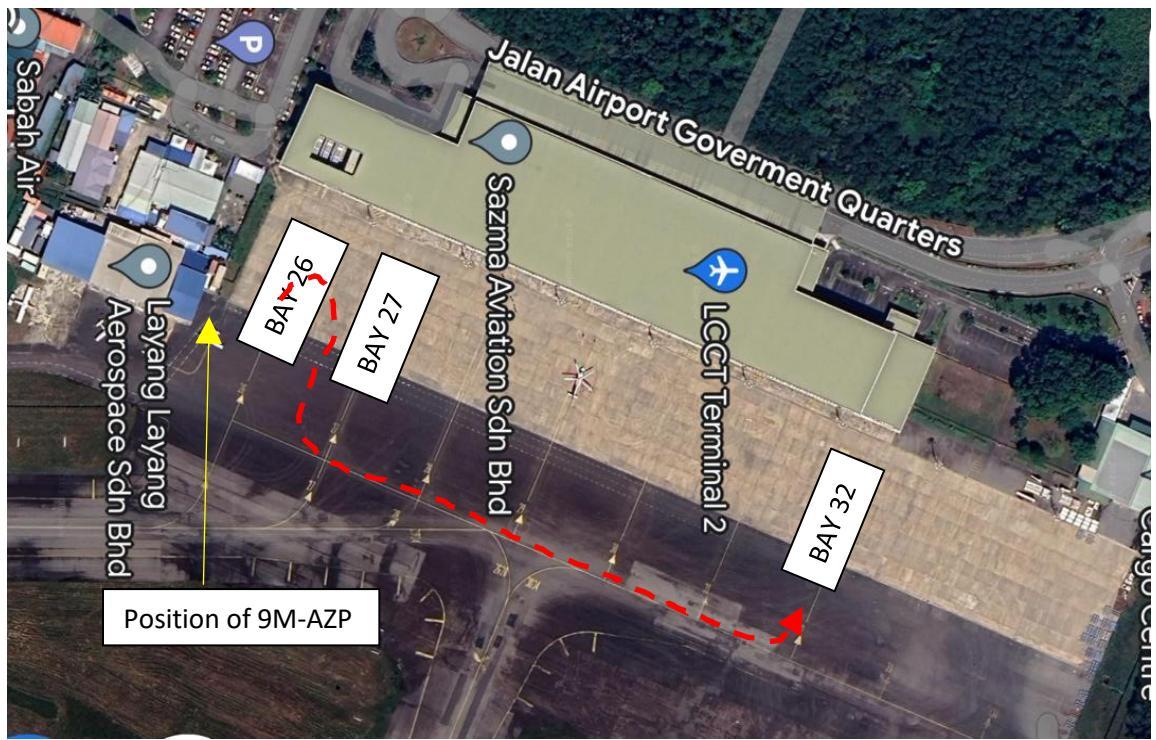
Figure 8: General description map of the incident

Figure 8 below provides a general layout of KKIA Terminal 2 and the location of the incident. The Bombardier Global 5000 aircraft, registration T7-SABAH, started up using the push-in/pull-out (PIPO) method at Bay 26 to reposition to Bay 32. Initially facing the terminal, the aircraft taxied and performed a 180-degree tight turn to avoid Bay 27, which was occupied by a Weststar AW139 helicopter. The red dashed line in Figure 8 indicates the taxi route taken by the Bombardier Global 5000.

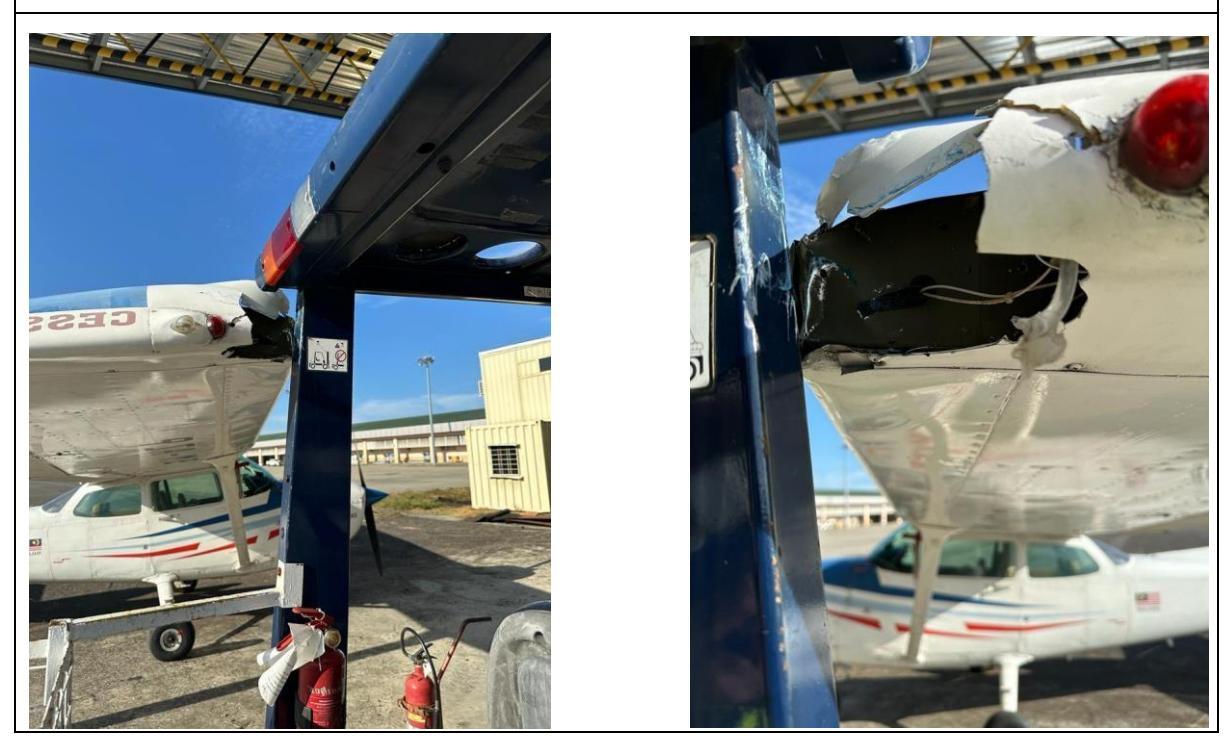
Significant damage has been observed on Left Wing Tip assembly, with noticeable crack and puncture damages on the front area. Preliminary analysis indicates that the left wing sustained impact or striking forces by impacting with forklift parked nearby, likely attributable by jet blast from the aircraft taxi from terminal. Upon initial assessment, it is apparent that the Wing tip assembly has exceeded the permissible limit for deformation.

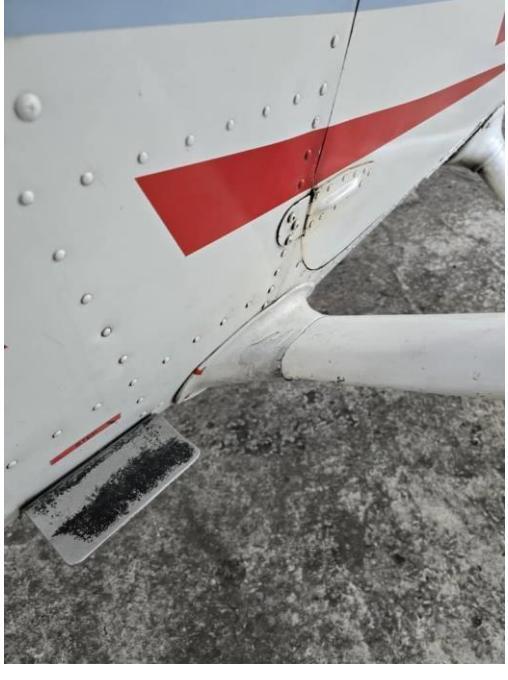
| Components | |
|---|--|
| There is no available damage that can been seen during the visual inspection. No additic defects have been identified until further inspection. | |

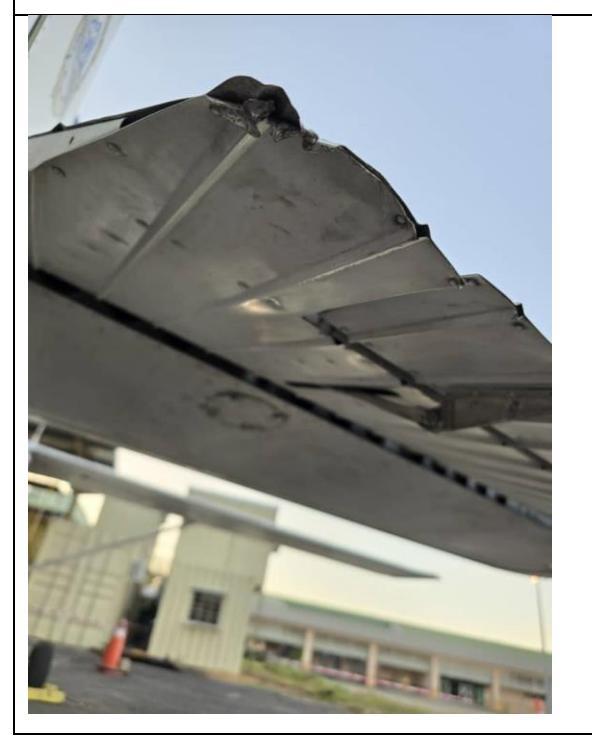
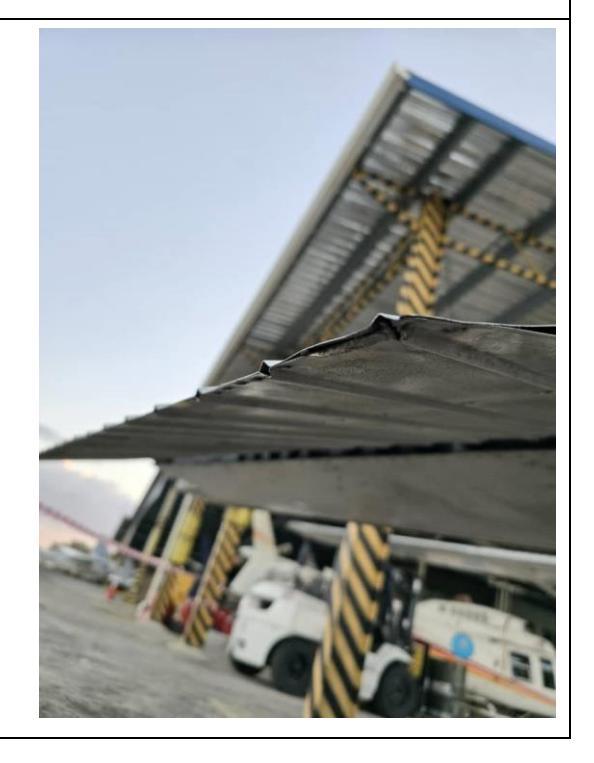
LH AND RH ELEVATOR ASSEMBLY

Both LH and RH Elevator assembly trailing edge cracked and dented due impact caused by tail strike. No additional defects have been identified until further inspection.
