# **DEBRIS EXAMINATION REPORT**

## **SAFETY INVESTIGATION FOR MH370**

**Malaysia Airlines MH370 Boeing B777-200ER (9M-MRO)  
08 March 2014**

**Identification of Debris (Item 6 in the “Summary of Possible MH370 Debris Recovered”) recovered south of Chidenguele, Mozambique on 24 April 2016**

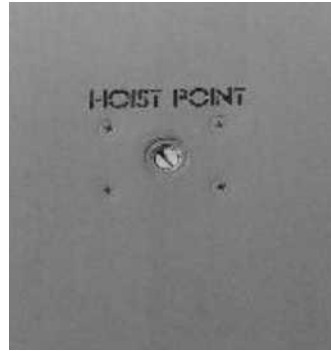
The words "HOIST POINT" were still visible and in the correct location. The fonts used for the words on the part matched those on the fan cowl of the aircraft.

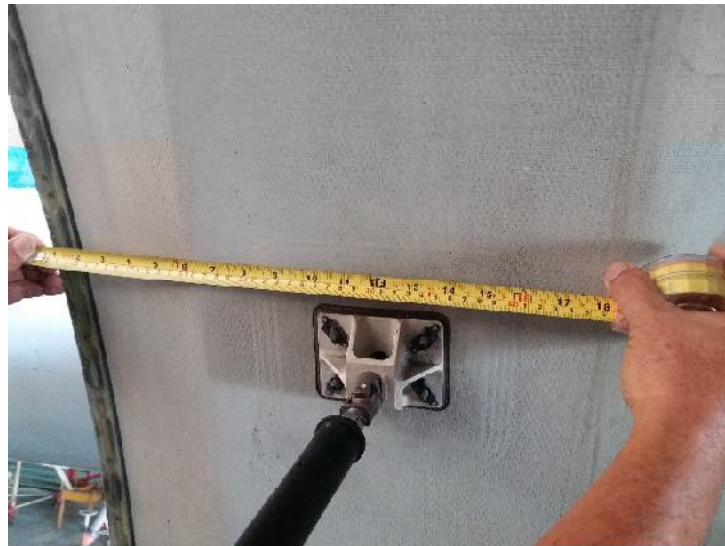
The dimension from the forward edge of the part to the start of the core ramp, which was 18 in., was also consistent with that of the fan cowl on the aircraft, as shown in the above figure.

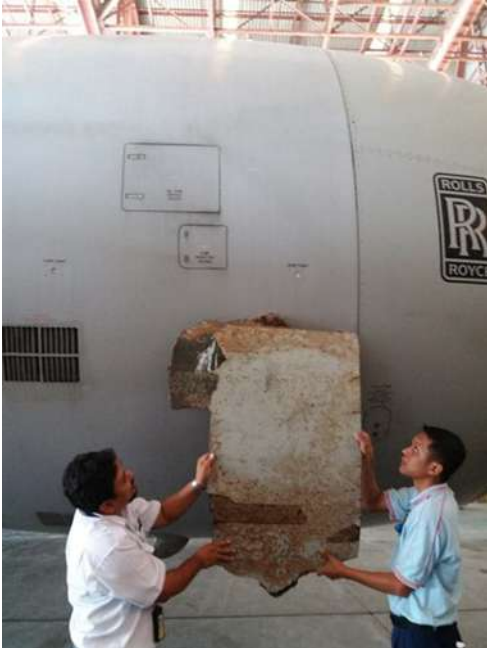
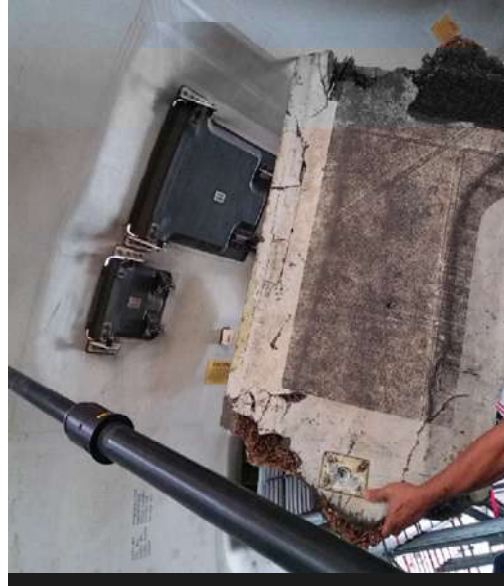
The part was brought near to the right fan cowl and was found to physically resemble it in terms of shape, size, colour and features.

Based on the above, the part is confirmed to be part of the **Right Fan Cowl** of a B777 aircraft.

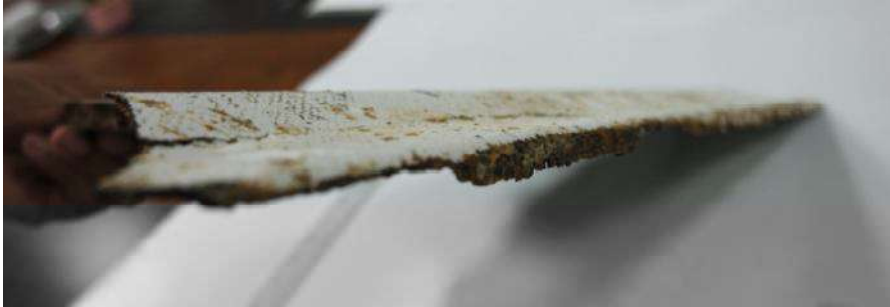
The part had fractured at all sides. One side had fractured immediately after the corner radius. The fibres appeared to have been pulled away and there were no visible kink on the fibres. The core was not crushed; it had fractured along the skin fracture line.

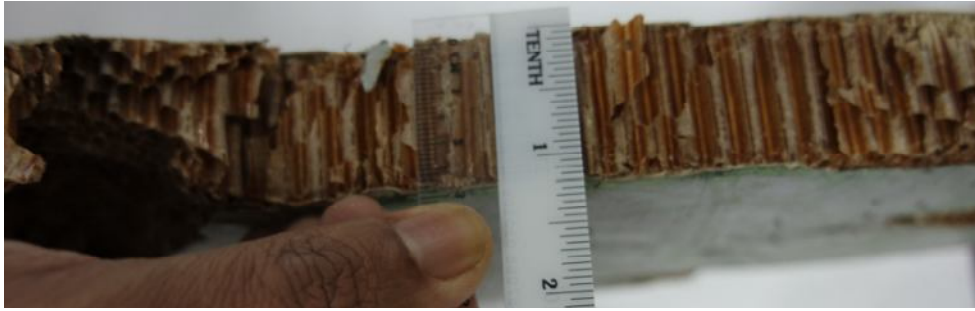
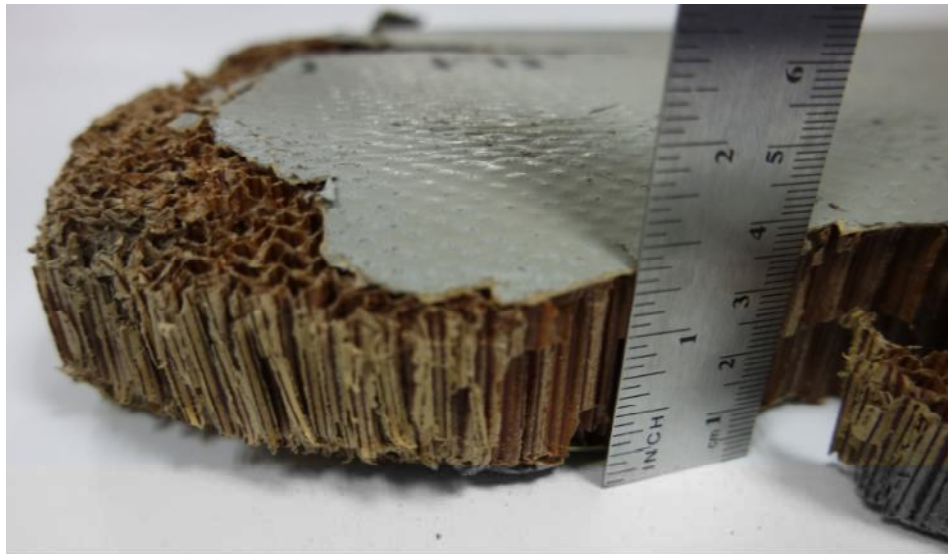
The carbon fibre laminate had fractured and appeared to have pulled out but there was no crush on the core.

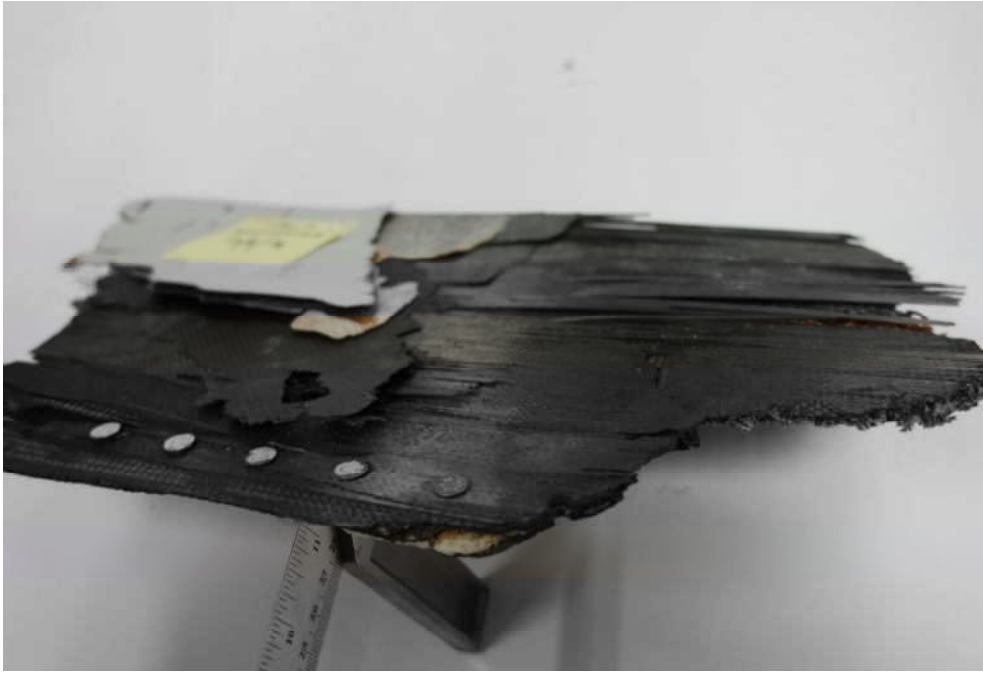
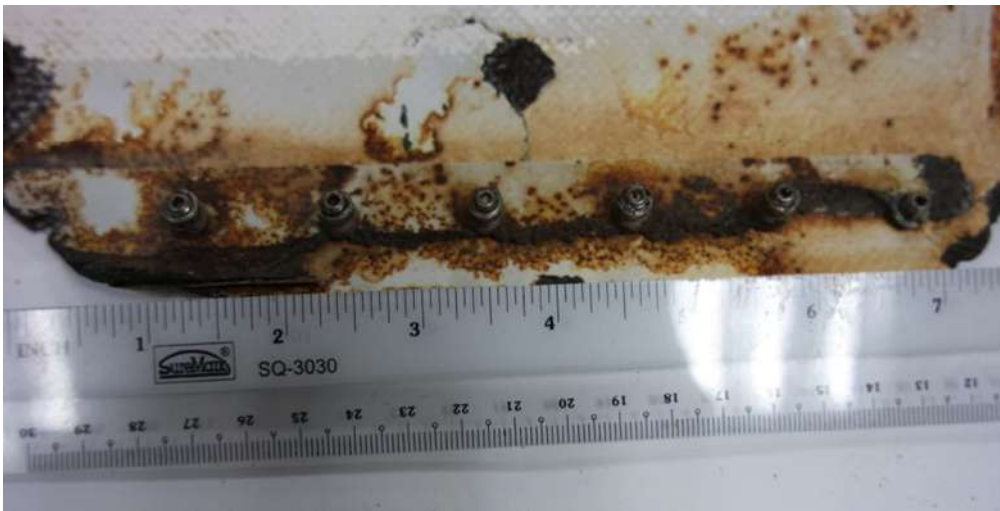
The item was a typical Carbon Fiber Reinforced Plastic (CFRP) construction with honeycomb core. One of the layers in the laminate top surface was clearly visible to be made of Unidirectional Carbon fibers. The fasteners were attached to an angle made of CFRP which was broken at one of the flanges. However, the angle radius was still visible.

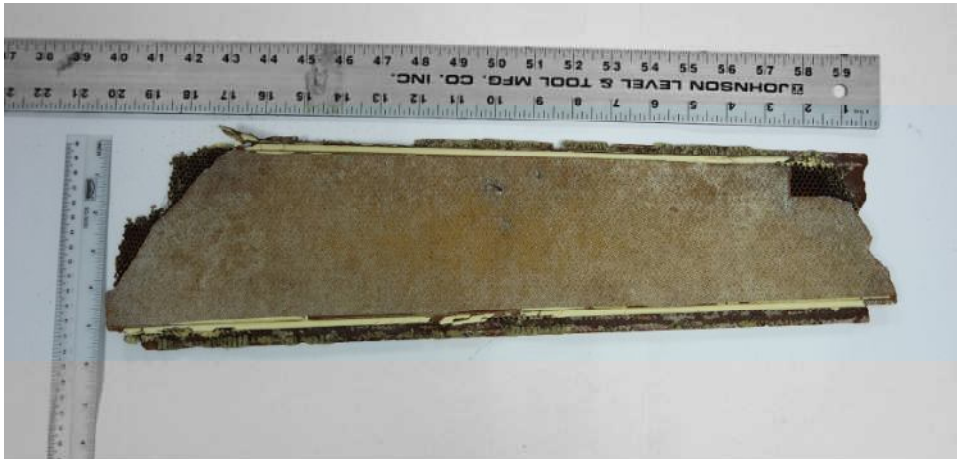
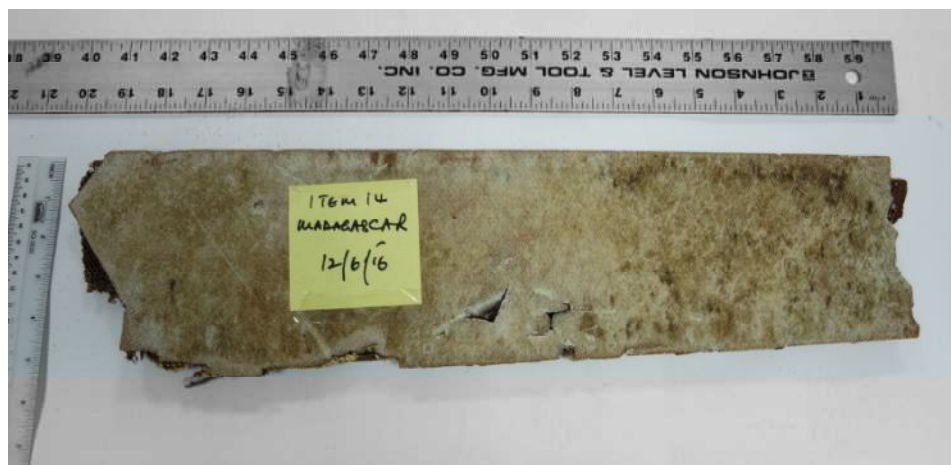
The part was taken to a B777-200ER, formally operated by Malaysia Airlines (MAS), undergoing a maintenance check at Subang, Malaysia, for identification purposes. The part did not have any distinguishing features to match any on the aircraft. The part resembled a cabin interior piece based on the decorative finish. It did not have any identification numbers.

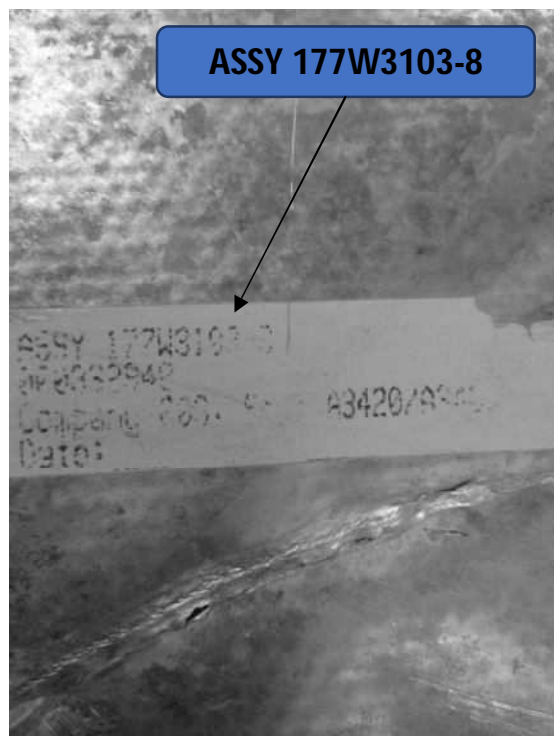
On the interior side of the part, there was still a decal with part identification numbers. Refer to the picture below. The Assembly (Assy) Number 177W3103-8 was visible. When referred to the Boeing 777 Illustrated Parts Catalog (IPC) this part was confirmed to be the right vertical stabilizer panel between the auxiliary and front spar. The red/white paint on the panel and the paint configuration appeared to match that of the Malaysia Airlines 'kite' logo on the right side of the vertical stabilizer. Refer to the photos below.
