DEBRIS EXAMINATION REPORT

SAFETY INVESTIGATION FOR MH370

**Malaysia Airlines MH370 Boeing B777-200ER (9M-MRO)
08 March 2014**

Identification of Debris (Item 6 in the “Summary of Possible MH370 Debris Recovered”) recovered south of Chidenguele, Mozambique on 24 April 2016

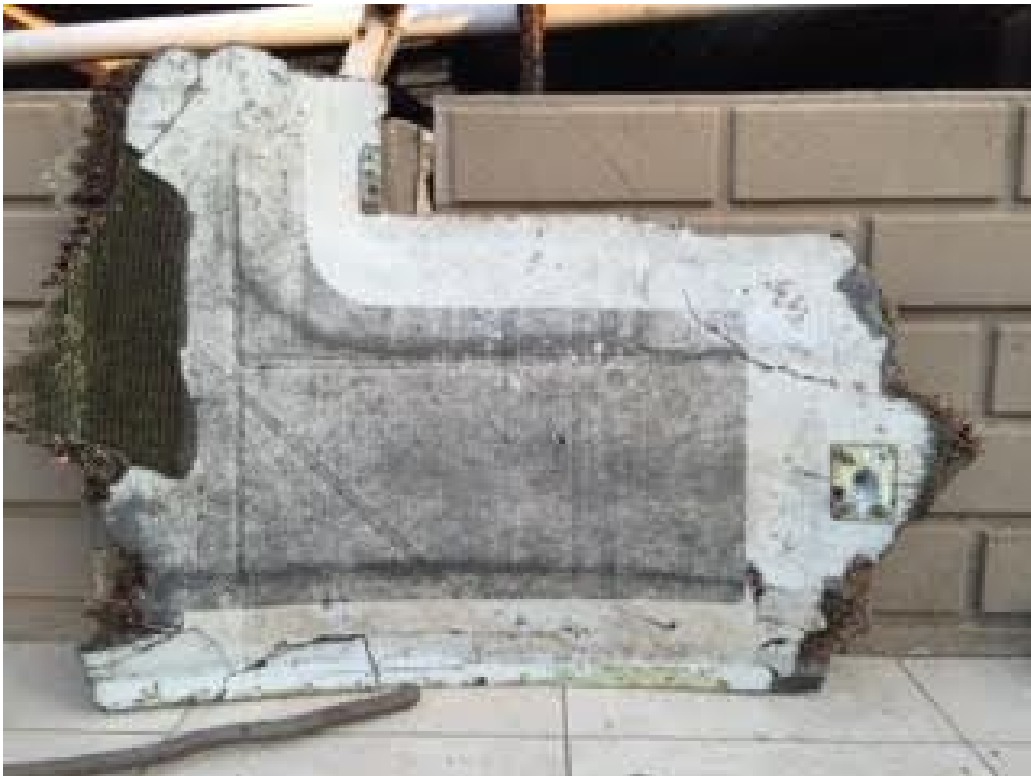
This item was recovered south of Chidenguele in Mozambique on 24 April 2016. It is identified as Item No. 6 from the items recovered; refer to the “*Summary of Possible MH370 Debris Recovered*”.

The part was measured to be approximately 54 inches in length and weighed 8.44 Kg.

The structure was of composite honeycomb sandwich with non-metallic core. It had a number of fracture lines and one of the sides which was the 'end of part', was intact. The external skin was dark grey in colour and the inner skin was white.

A part of a metal bracket was still attached on the debris and it was observed that another one had broken off. This was the attachment for the "Hold-Open Stay Rod"

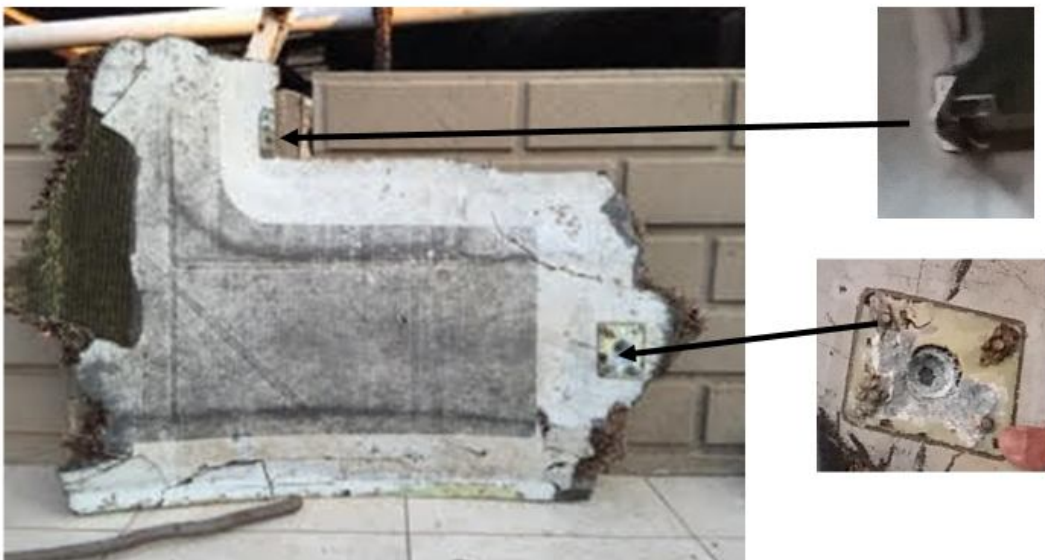
The part was taken to a B777-200ER, formerly operated by Malaysia Airlines (MAS), undergoing a maintenance check at Subang, Malaysia, for identification purposes. The possible location of the part on the aircraft was determined.

The hinge bracket, number of fasteners and fasteners' pitch on the part were consistent with those on the right engine fan cowl on the aircraft. The mount found on the part was also consistent with the mount of the fan cowl "Hold-Open Stay Rod" in regards to its location, shape and size of the mounting bracket.

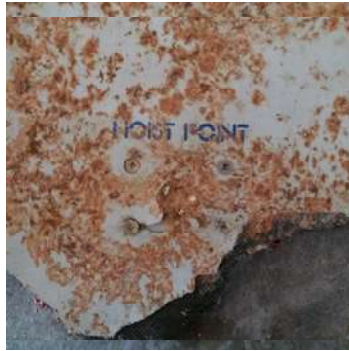
The words "HOIST POINT" were still visible and in the correct location. The fonts used for the words on the part matched those on the fan cowl of the aircraft.

The dimension from the forward edge of the part to the start of the core ramp, which was 18 inches, was also consistent with that of the fan cowl on the aircraft, as shown in the above figure.

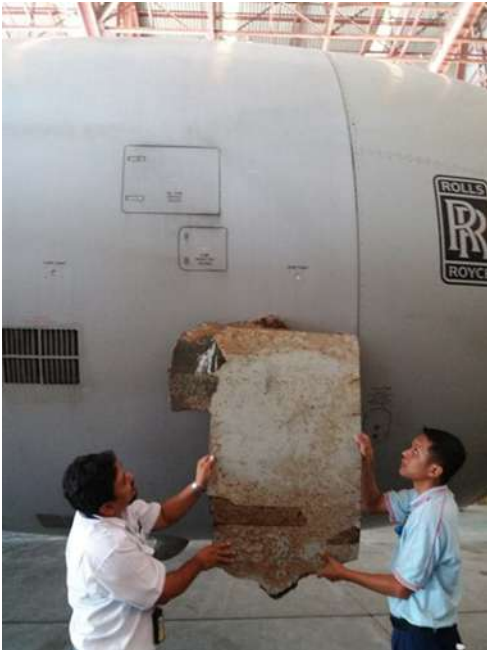
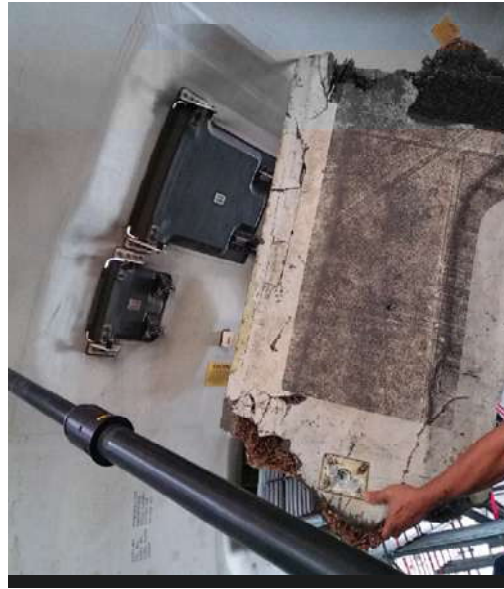
The part was brought near to the right fan cowl and was found to physically resemble it in terms of shape, size, colour and features.

Based on the above, the part is confirmed to be part of the **Right Fan Cowl** of a B777 aircraft.

The fracture on the laminate appears to be more likely a tension failure. The honeycomb core was intact and there was no significant crush on the honeycomb core. All the metal parts were detached and the fastener holes for the hinge door brackets were clearly visible. The attachment for the "Hold-Open Stay Rod" was detached and corrosion was visible on the remaining metal part.

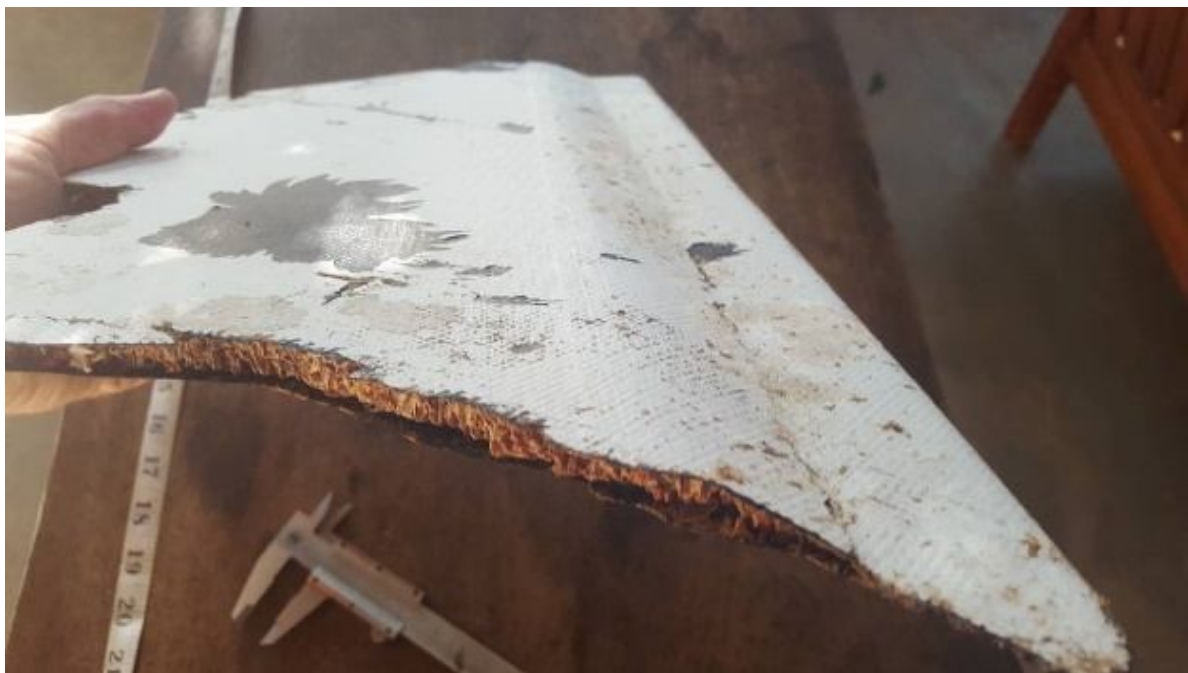
This item was recovered at Anvil Bay, Chemucane, Mozambique on 30 April 2016. It is identified as Item No. 7 of the items recovered; refer to the “*Summary of Possible MH370 Debris Recovered*”.

The part was a typical Carbon Fiber Reinforced Plastic (CFRP) with non-metallic honeycomb core. The part was triangular in shape and approximately 22 inches at its longest edge. It weighed 0.31 Kg. The white paint on both sides of the debris had faded. It had an ‘end of part’ which had a distinctive corner radius but the length of the possible flange could not be determined since it had fractured immediately after the radius. There were no identification numbers on the part. The overall plan form of the part is not flat, it had a curvature.

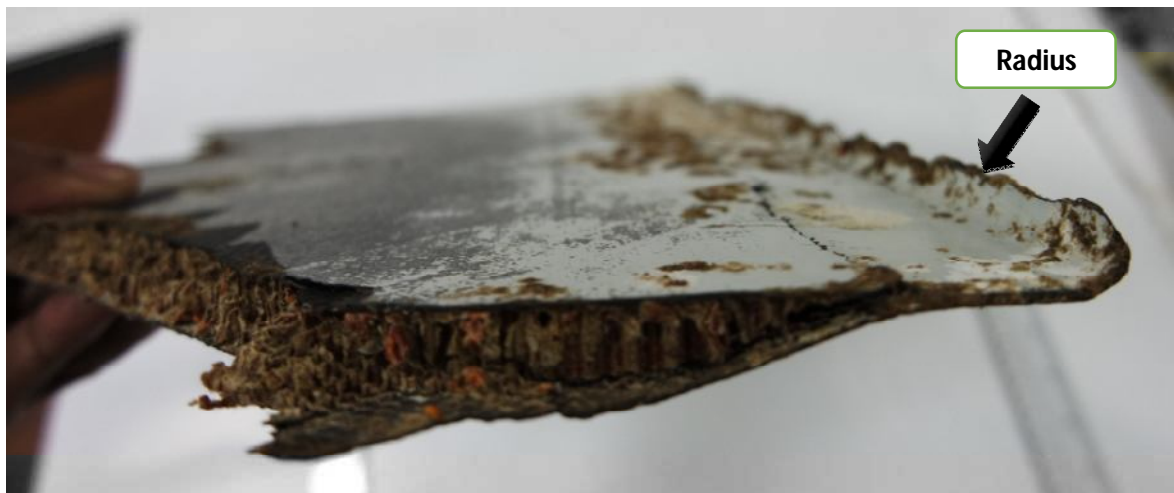
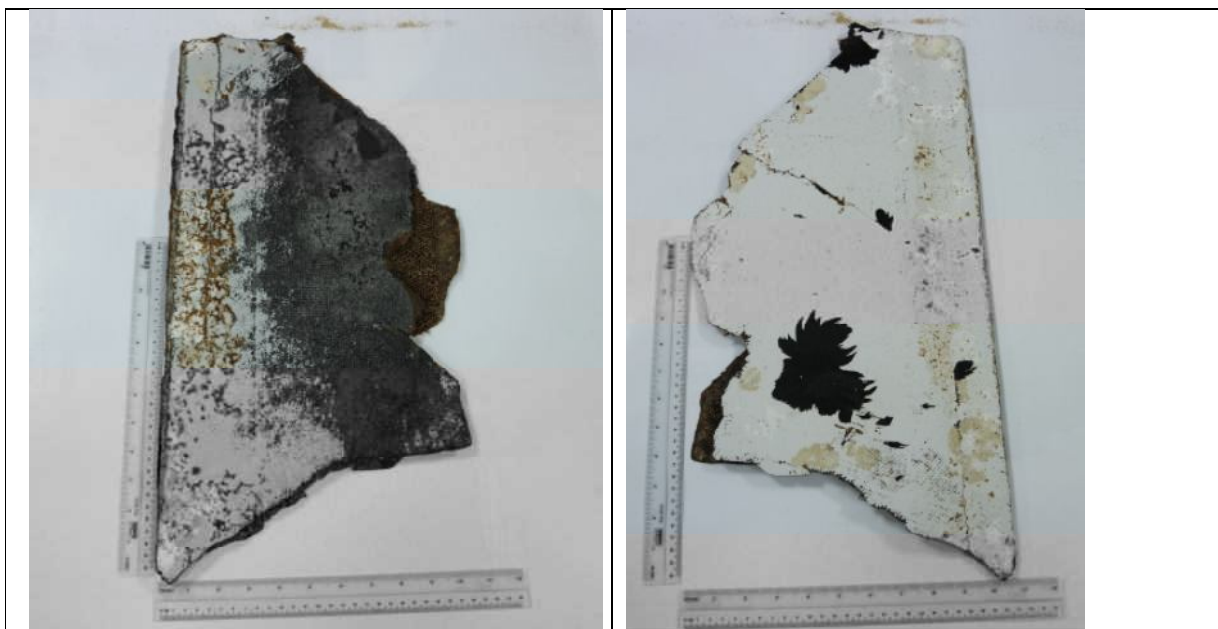
The exact location of the part on the aircraft could not be identified since it did not have any markings or numbers and there were no peculiar features which could match it on the aircraft except for one edge of the part which had a distinct radius, which suggested that the joining part would be at an angle. While the construction was similar to a B777 part, there was no conclusive evidence to determine the origin of this part with respect to the aircraft.

After review of the B777 Illustrated Parts Catalogue (IPC), the most possible location of the part was determined to be the wing to fuselage body fairing. The location of where the part was

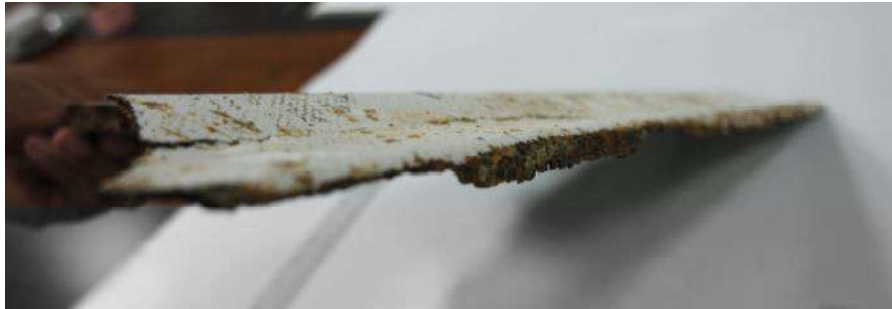
The part had fractured at all sides. One side had fractured immediately after the corner radius. The fibres appeared to have been pulled away and there were no visible kink on the fibres. The core was not crushed; it had fractured along the skin fracture line.

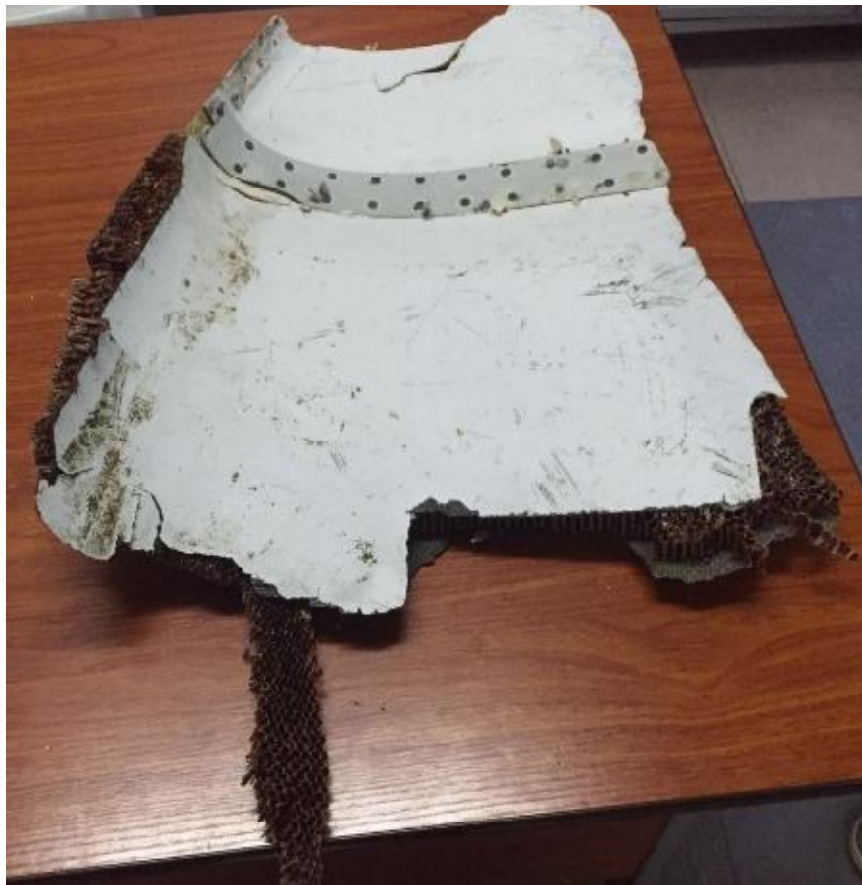
This item was recovered at Gris Gris Beach, Mauritius on 24 May 2016. It has been identified as Item No. 8 of the items found; refer to the “*Summary of Possible MH370 Debris Recovered*”.

Initial assessment indicated that this could be a flap support fairing tail cone of a B777. The part was identified from the legible numbers that were observed on the inner surface. The following part number 113W9154-401 and serial number 407 were visible on one side. The profile of the part resembled the wing flap support fairing tail cone.

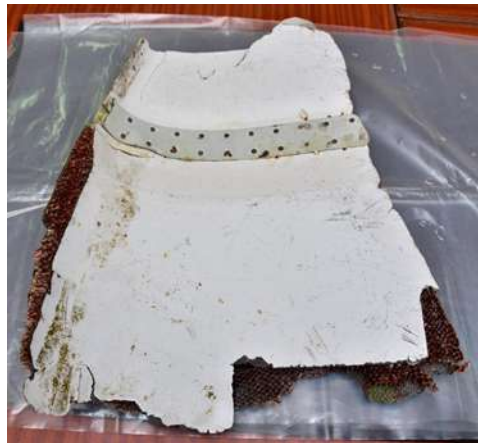
The Debris – external surface

The part number was cross referenced to the Boeing component maintenance manual and drawings. This identified it as a component of the wing flap support fairing assembly and the fit closely matched that of the No. 1 flap support fairing. As the records of where these fairing tail cones are fitted are not normally kept by airlines, the serial number 407 could not be tracked to any particular aircraft.

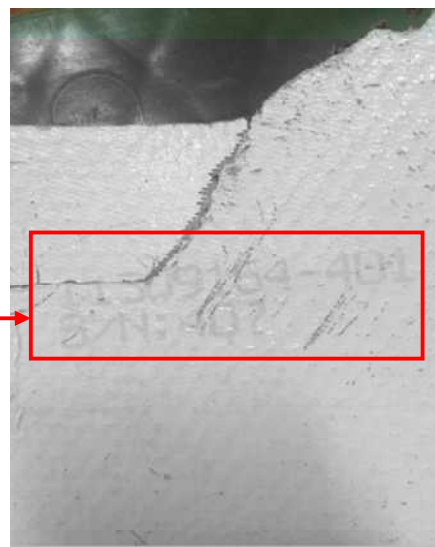
Inner side of the debris

The fracture line on the part showed the fibers to be 'pulled out' showing tension failure. Most of the core was intact and there was no sign of excessive crush.

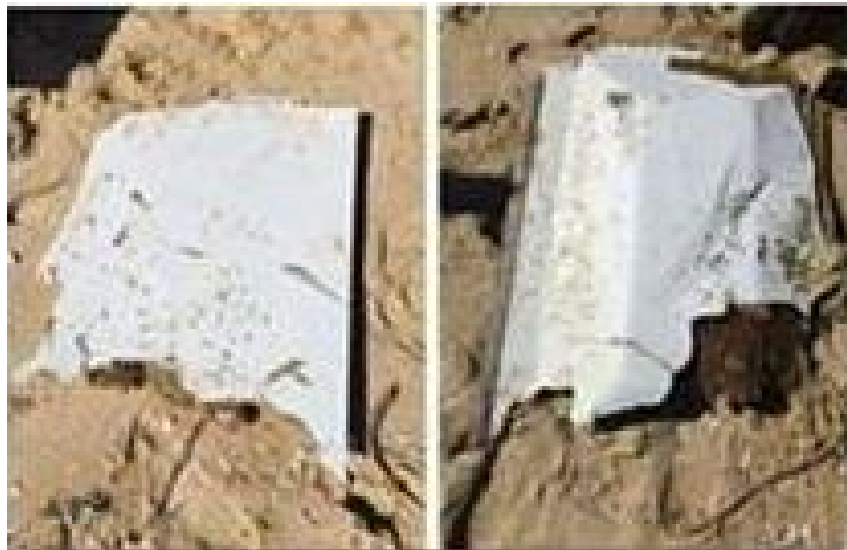
Item 9 was recovered at Macenta Peninsular, Mozambique on 22 May 2016 while Item 15 was recovered at Riake beach, Nosy Boraha Island, Madagascar on 06 June 2016. These parts were identified as Item No. 9 and 15 of the items found; refer to the “*Summary of Possible MH370 Debris Recovered*”.

Both debris (Items 9 and 15) were of composite structure with non-metallic honeycomb core and of Graphite Fibre Reinforced Plastic (GFRP) construction. The upper surfaces of the parts were painted with grey paint. The core ramps were visible at two places for Item 9 and three places for Item 15. Rub strips were still intact on one edge of the parts. Item 9 was weighed and found to be 2.18 Kg, while Item 15 was 3.34 Kg.

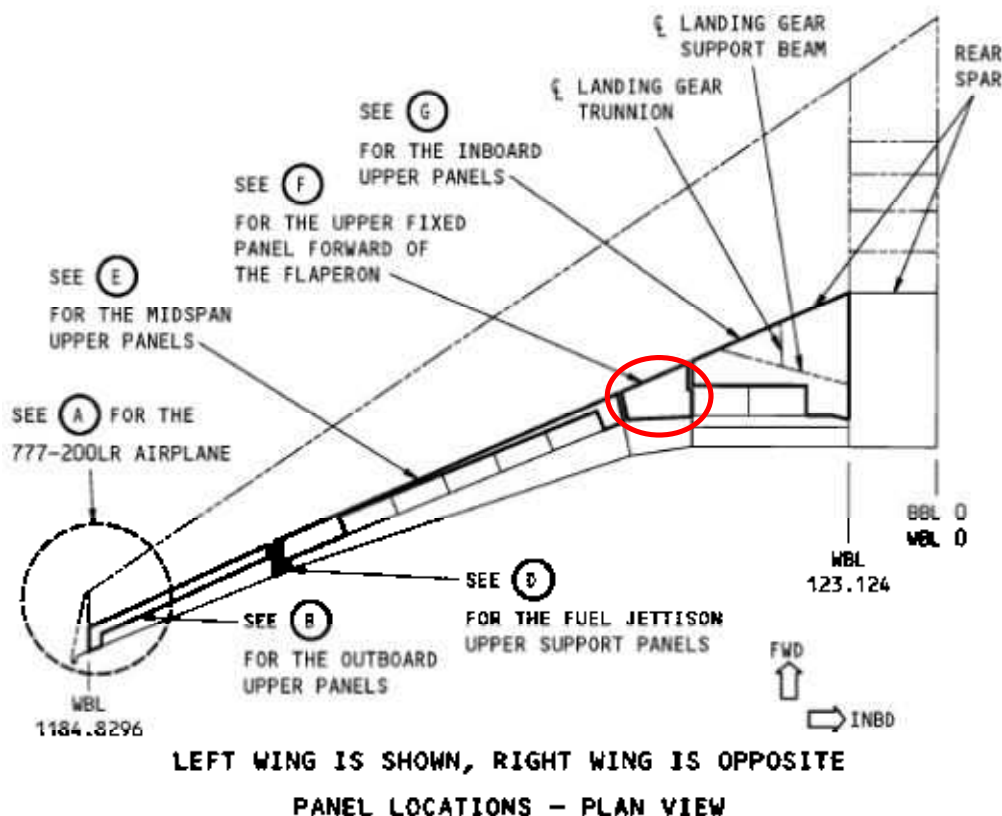
Item 9 matched the left part (outboard section) of the Upper Fixed Panel forward of the flaperon on the **left** wing.

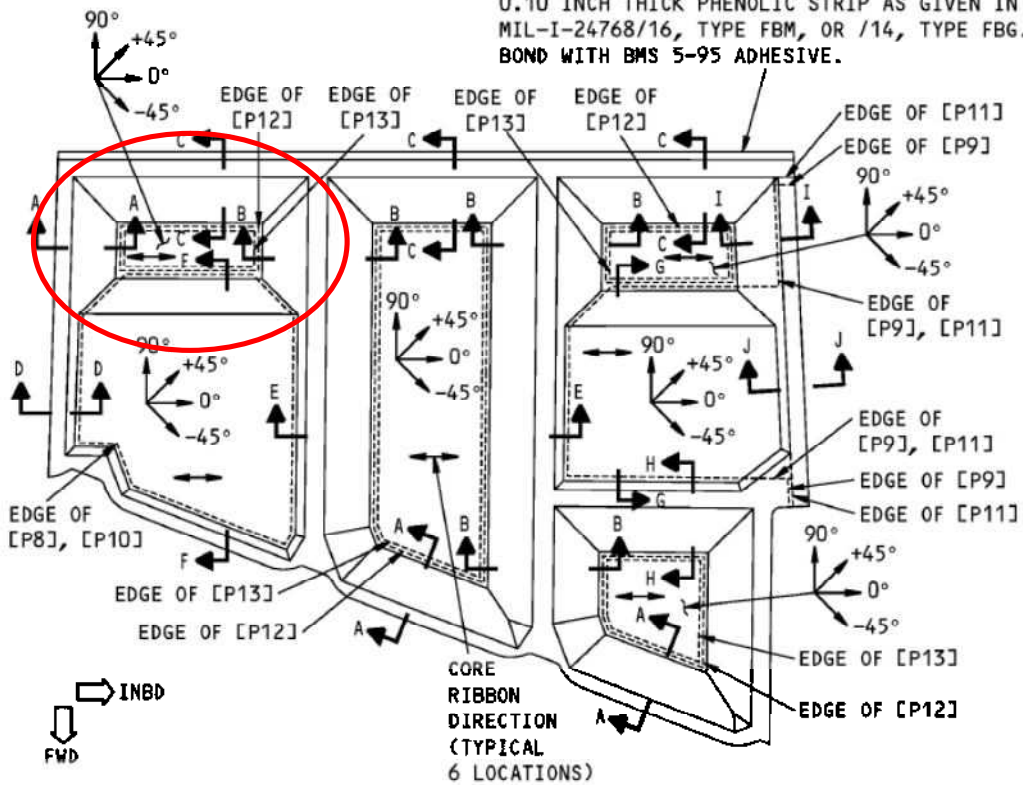
PLY LAYUP AND CORE RIBBON DIRECTION
777-200/200ER AIRPLANES

RUBSTRIP.
0.10 INCH THICK PHENOLIC STRIP AS GIVEN IN
MIL-I-24768/16, TYPE FBM, OR /14, TYPE FBG.
BOND WITH BMS 5-95 ADHESIVE.

Further verification was carried out with reference to the B777 Aircraft Structure Repair Manual (SRM) which indicated that the panel was indeed the Upper Fixed Panel forward of the left flaperon.

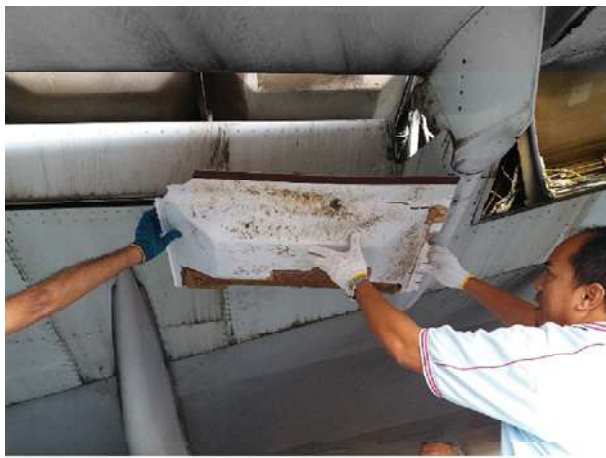
Item 15 against Upper Fixed Panel forward of Right Flaperon

Similar matching process was carried out on Item 15; it was identified to be the outboard section of the "Upper Fixed Panel forward of the flaperon" on the **right** wing (refer to figure below). The pitch of the fasteners' holes on the right side (outboard) of the panel was measured to be 2 in. and that matched that on the debris.

Item 15 had fractured at two places; the rear section was intact with the rub strip. The outboard section had the fasteners torn out with some of the fastener holes still recognizable. The inboard section was observed to have signs of 'net tension' failure as it had fractured along the fastener holes.

Item 9 is confirmed to be the outboard section of the "Upper Fixed Panel forward of the flaperon" on the **left** wing whilst item 15 is confirmed to be the outboard section of the "Upper Fixed Panel forward of the flaperon" on the **right** wing. From the locations where they were found, and being consistent with the drift path modeling for debris from an aircraft ending its flight in the South Indian Ocean, it is highly likely that they are from MH370 (aircraft registered as 9M-MRO).

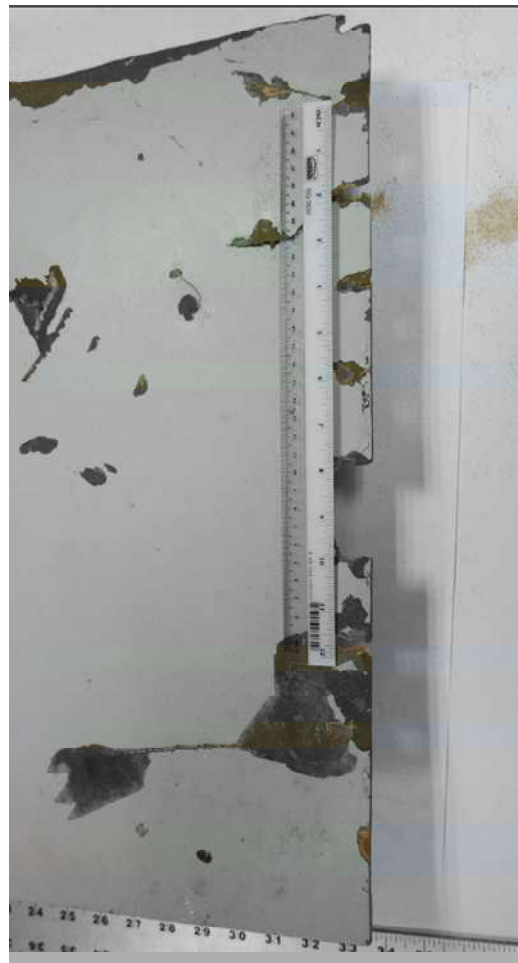
Fastener pitch – 2 inches

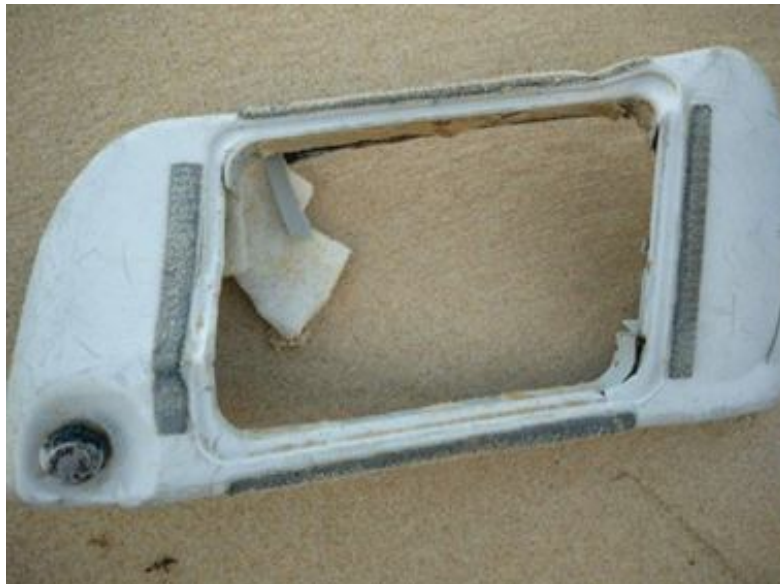
This item was recovered at the Riake beach, Nosy Boraha Island, Madagascar on 06 June 2016. The part is identified as Item No. 11 of the 25 items found; refer to the “*Summary of Possible MH370 Debris Recovered (15 August 2016)*”.

The part was intact with slight distortion. There was no sign of burnt marks or any other sign that the part had been exposed to fire.

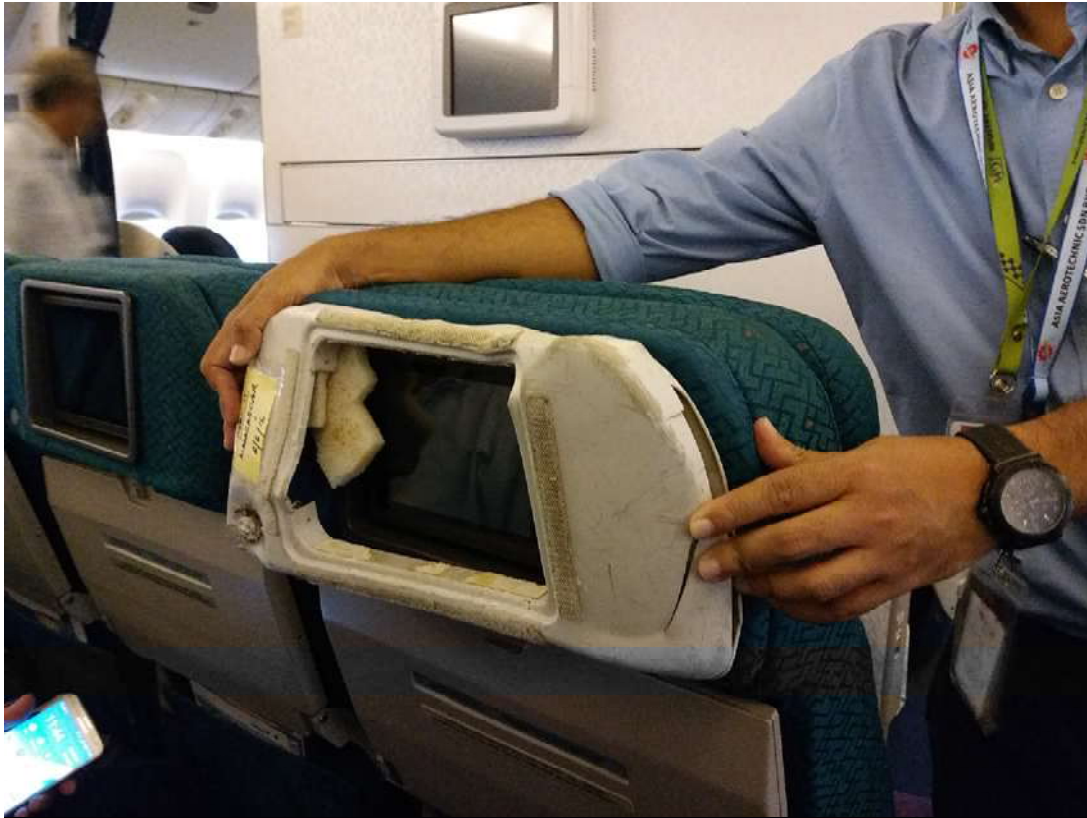
fabric used on the Malaysia Airlines (MAS) B777 on the center seats. The location of the coat hanger on the left conforms to the Right Hand, Triple Seat Assembly column in the Economy (EY) class.

The item is confirmed to be part of the seat back trim panel for encasing the IFE monitor. From the location where it was found, and being consistent with the drift path modeling for debris

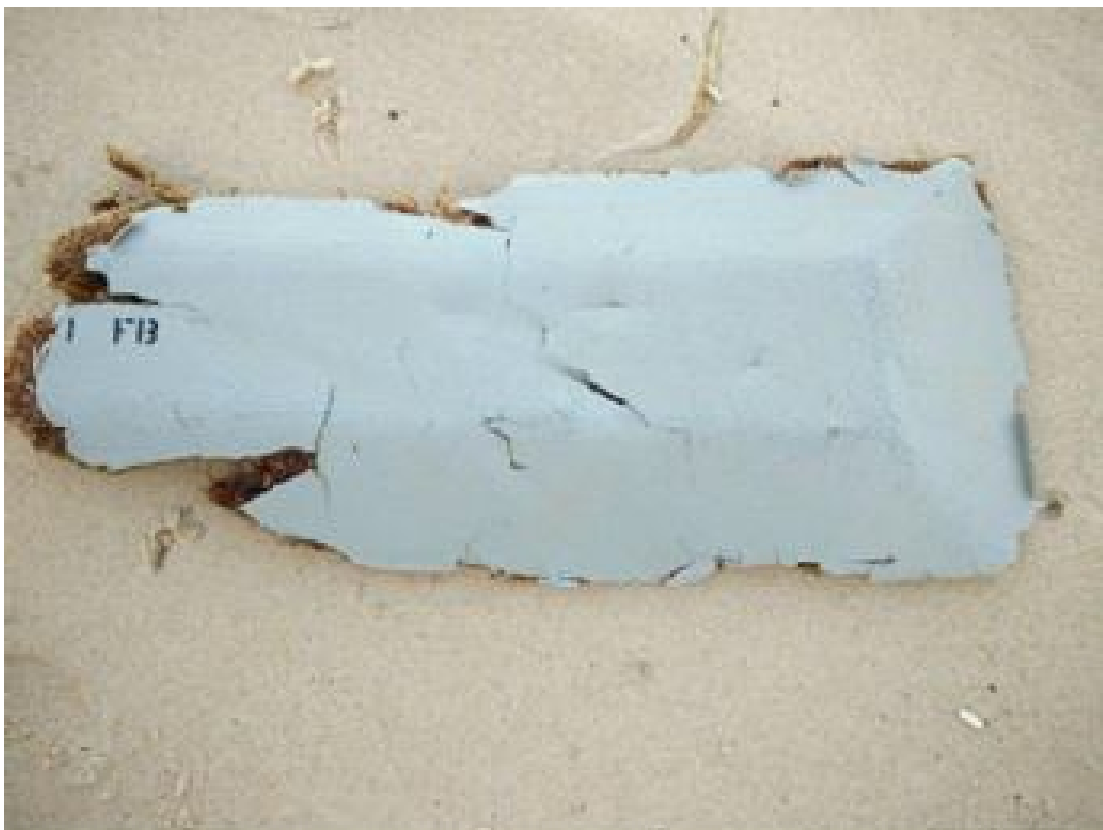
This item was recovered at Riake beach, Nosy Boraha Island, Madagascar on 06 June 2016. It is identified as item 12 of the items recovered; refer to the "*Summary of Possible MH370 Debris Recovered*".

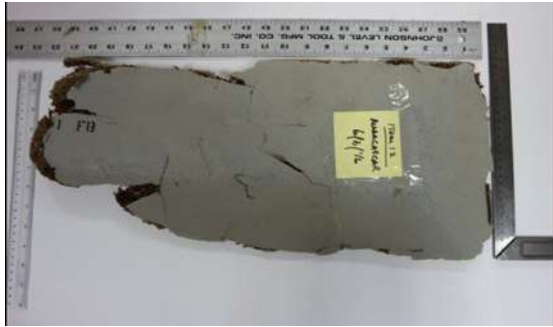
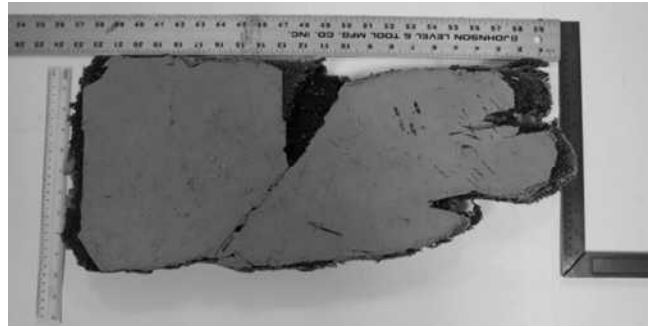
It was made of Carbon Fibre Reinforced Plastic (CFRP) with honeycomb core. The honeycomb core was measured to be more than 1 inch thick. The core taper was observed to be prominent. It was approximately 23 inches by 10 inches in size.

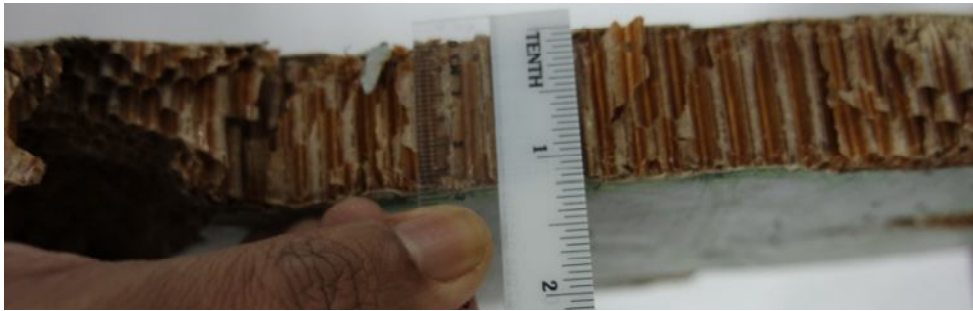
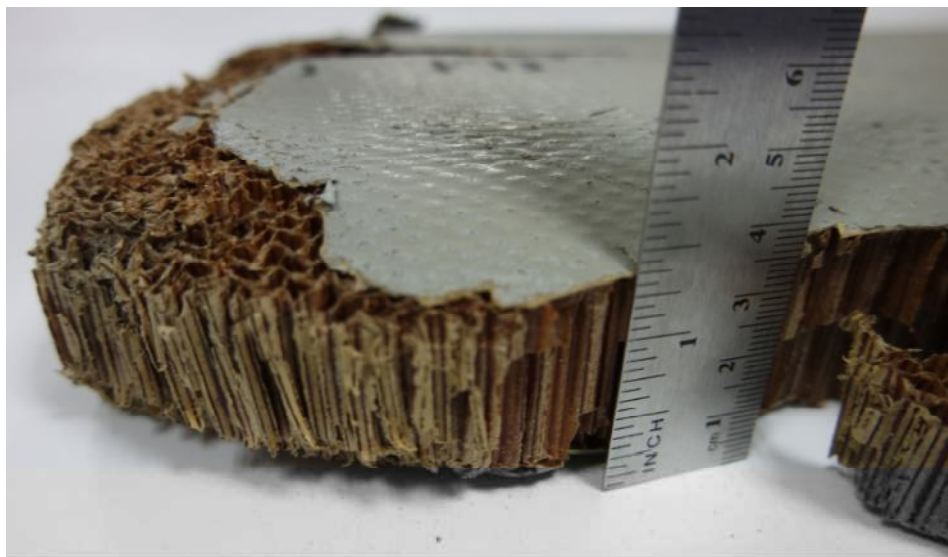
The carbon fibre laminate had fractured and appeared to have pulled out but there was no crush on the core.

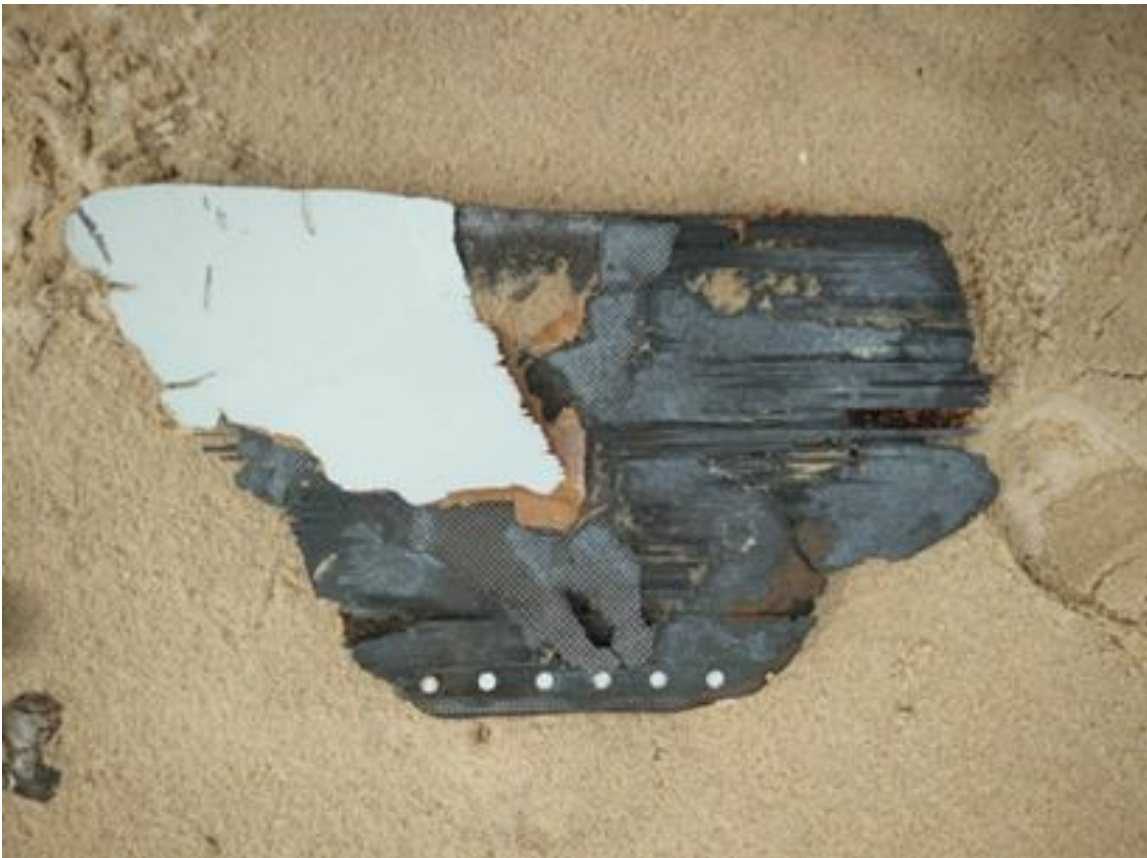
This item was recovered from Riake Beach, Nosy Boraha Island, Madagascar on 12 June 2016. The part was identified as Item No. 13 of the items recovered; refer to the “*Summary of Possible MH370 Debris Recovered*”.

The item was a typical Carbon Fiber Reinforced Plastic (CFRP) construction with honeycomb core. One of the layers in the laminate top surface was clearly visible to be made of Unidirectional Carbon fibers. The fasteners were attached to an angle made of CFRP which was broken at one of the flanges. However, the angle radius was still visible.

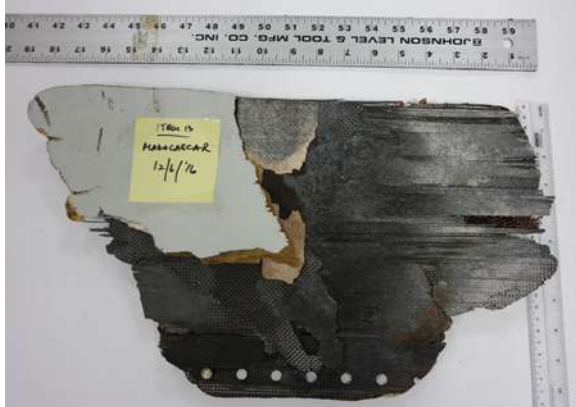
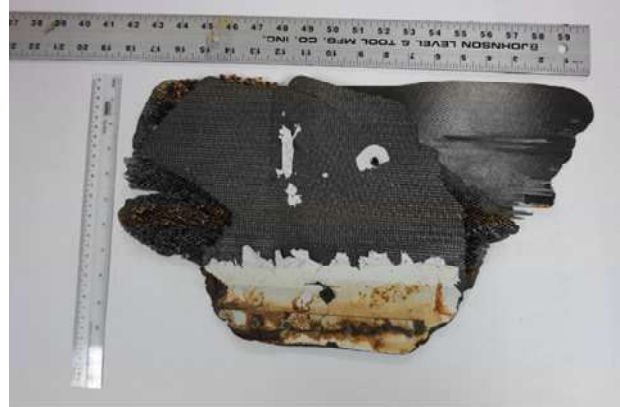
The item was measured to be approximately 19 inches in length and 10 inches in width and weighed 0.375 Kg.

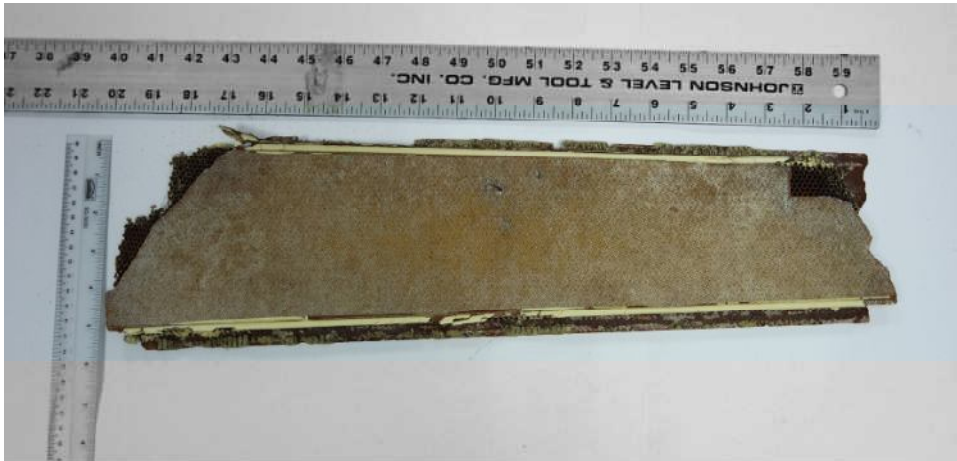
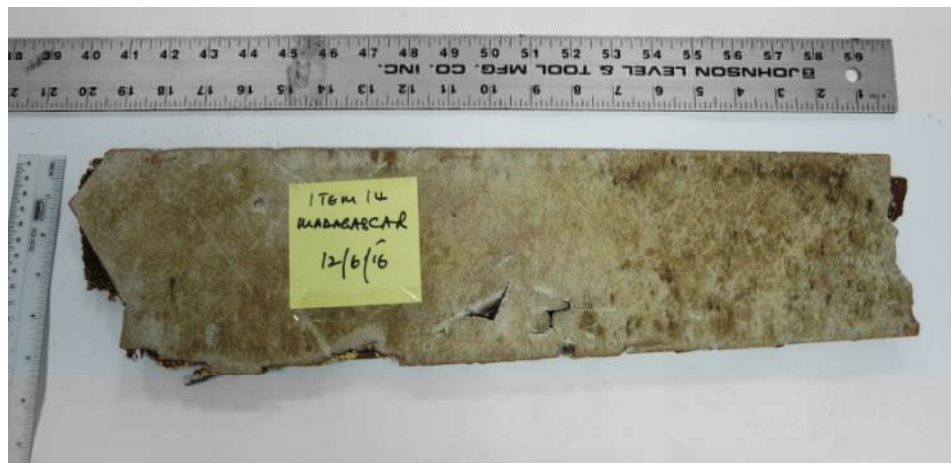
The part was taken to a B777-200ER, formerly operated by Malaysia Airlines (MAS), undergoing a maintenance check at Subang, Malaysia, for identification purposes. The part did not have any distinguishing features to match any on the aircraft. The part resembled a cabin interior piece based on the decorative finish. It did not have any identification numbers.

The part was fractured on all sides. The fibres appeared to be pulled rather than being compressed.

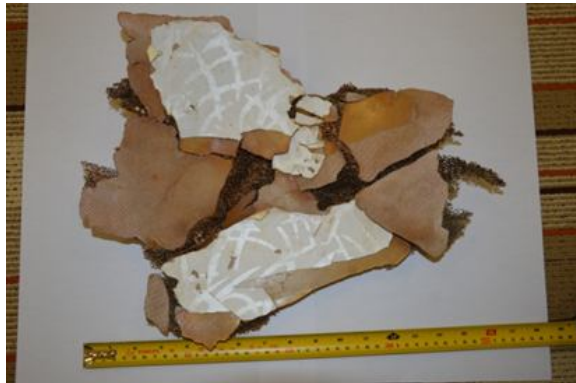
Item No. 16

Items 16 and 17 were found on 12 June 2016 in Antsiraka Beach, Madagascar. These items were taken to Air Accident Investigation Board (AAIB) Malaysia office in Putrajaya, Federal Territory, Malaysia and stored in the quarantine room before they were removed and brought to Science & Technology Research Institute for Defence (STRIDE) for detailed examination.

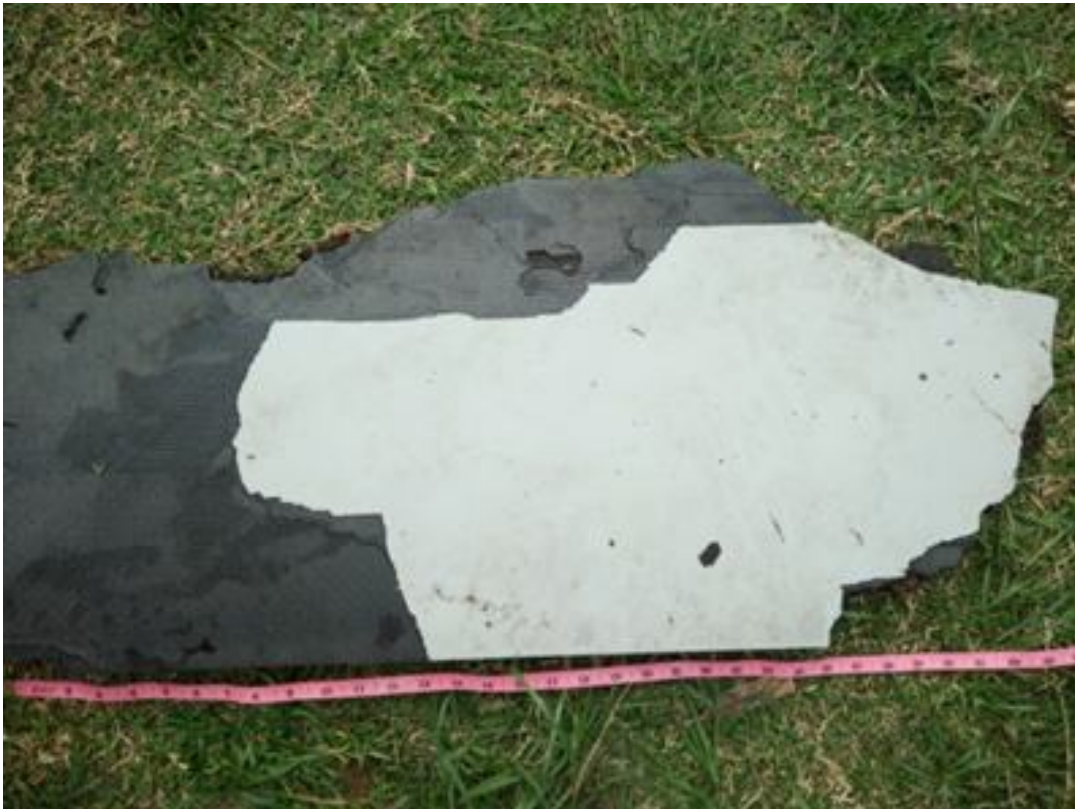
This item was recovered from Antsiraka beach, Madagascar on 12 June 2016. The part is identified as Item No 18 of the items found; refer to the “*Summary of Possible MH370 Debris Recovered*”.

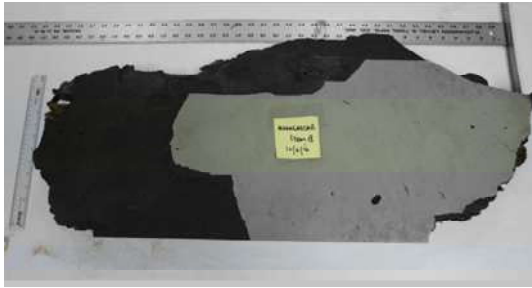
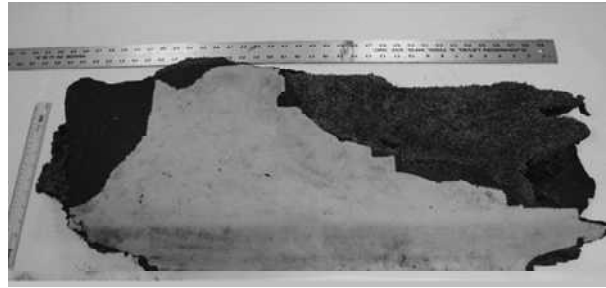
The part was observed to be Carbon Fiber Reinforced Plastics (CFRP) honeycomb sandwich. The core was nonmetallic honeycomb. Both the outer and inner skins were made of carbon fibre and were white in colour. The part size was approximately 36 inches by 12 inches in dimension and the weight was 3.34 Kg.

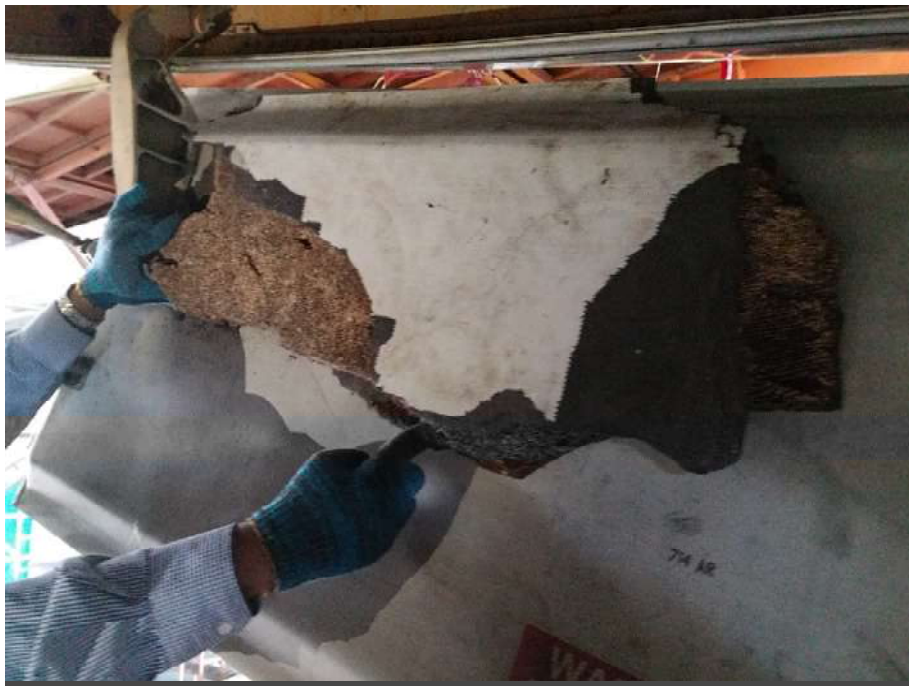
The part was taken to a B777-200ER, formerly operated by Malaysia Airlines (MAS), undergoing a maintenance check at Subang, Malaysia, for identification purposes. The part did not have any identification numbers on it. However the features on the part resembled the Right Nose Gear Forward Door. The oval depressions on the inner skin and the orientation of a diagonal, raised bar matched that on the Right Nose Gear Forward Door on the aircraft.

The above photo shows the item matched the Right-Hand Nose Gear Forward Door. The photo below shows the oval depressions and the raised diagonal bar.

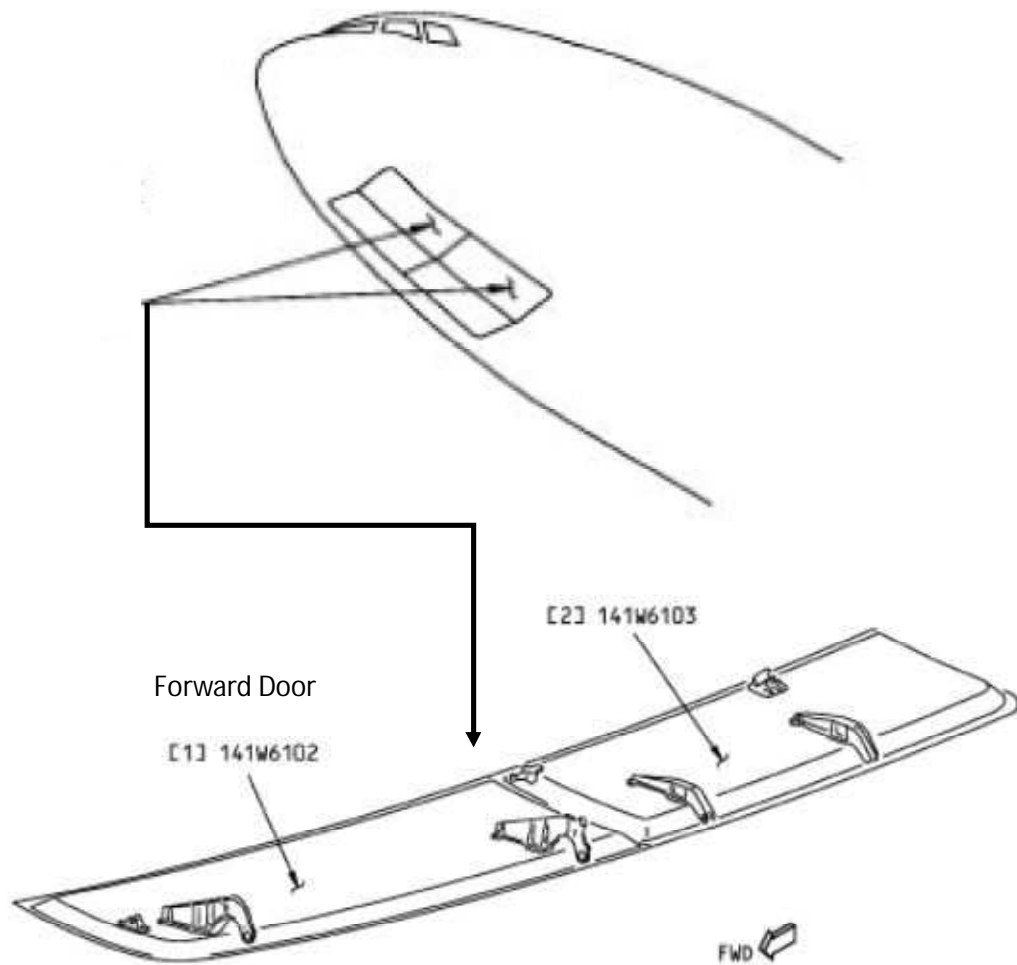
LEFT SIDE IS SHOWN, RIGHT SIDE IS OPPOSITE

The part was fractured on three edges except at one end, the edge where the hinges were installed. Close visual examination of the fracture lines showed the fibers were pulled and there was no sign of kink.

The part is positively identified as the Right Hand Nose Gear Forward Door of a B777 aircraft. From the location where it was found, and being consistent with the drift path modeling for debris from an aircraft ending its flight in the South Indian Ocean, it is highly likely that it is from MH370 (aircraft registered as 9M-MRO).

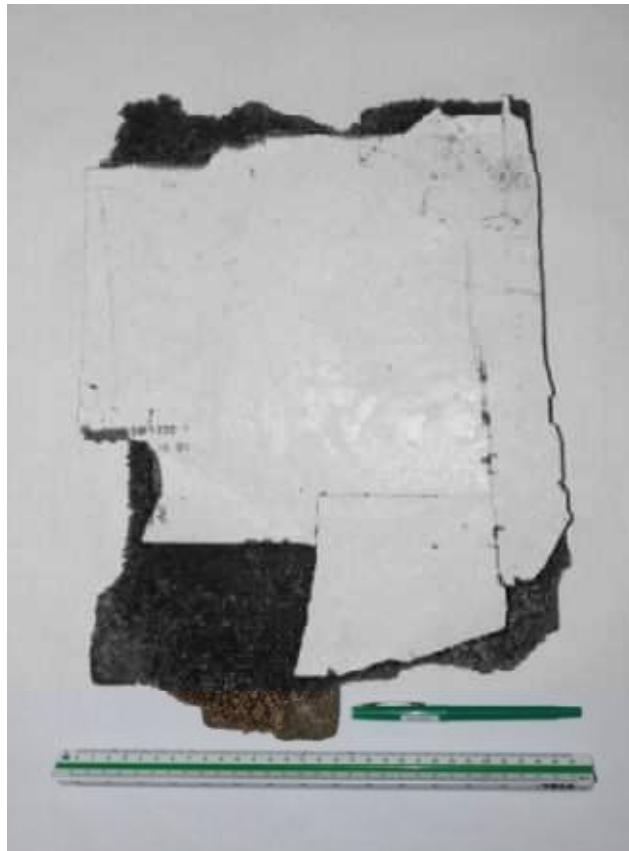
This item was recovered from Kosi Bay mouth, Northern Kwa Zulu Natal, South Africa on 21 June 2016. It was identified as Item No. 20 of the items recovered; refer to the “*Summary of Possible MH370 Debris Recovered*”.

The part was Carbon Fibre Reinforced Plastic (CFRP), honeycomb sandwich design. It had non-metallic honeycomb core. The part was measured to be approximately 12 inches by 20 inches in size and weighed 0.315 Kg.

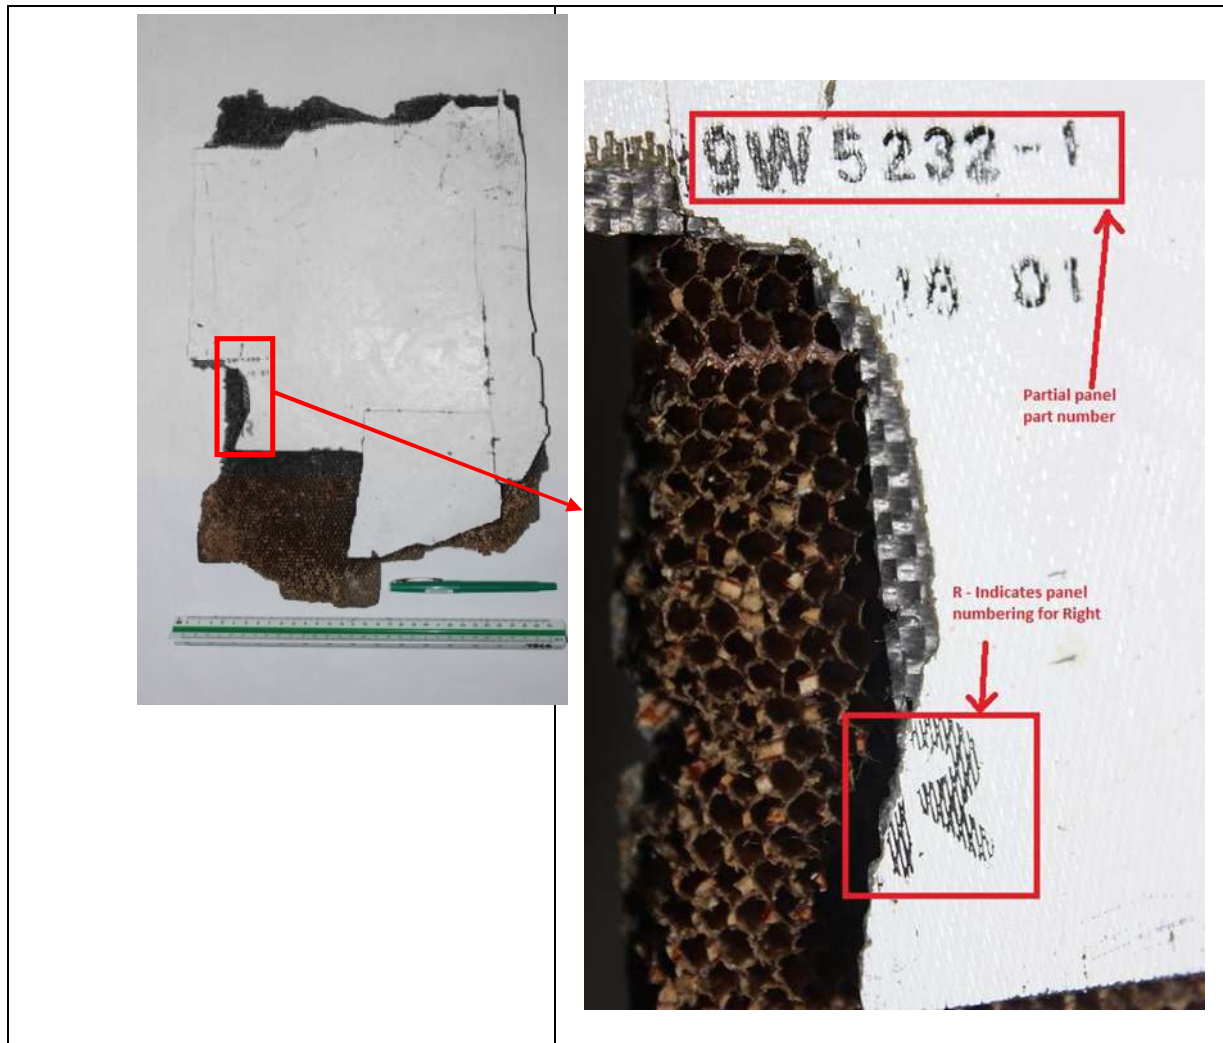
This part was fractured on all sides. Visual examination of the fracture lines indicated that the fibers appeared to have pulled away with no sign of kink on the fibers.

This item is confirmed to be part of the right aft wing to body fairing panel from a B777 aircraft. From the location where it was found, and being consistent with the drift path modeling for debris from an aircraft ending its flight in the South Indian Ocean, it is highly likely that it is from MH370 (aircraft registered as 9M-MRO).
