DEBRIS EXAMINATION REPORT

SAFETY INVESTIGATION FOR MH370

**Malaysia Airlines MH370 Boeing B777-200ER (9M-MRO)
08 March 2014**

Identification of Debris (Item 6 in the “Summary of Possible MH370 Debris Recovered”) recovered south of Chidenguele, Mozambique on 24 April 2016

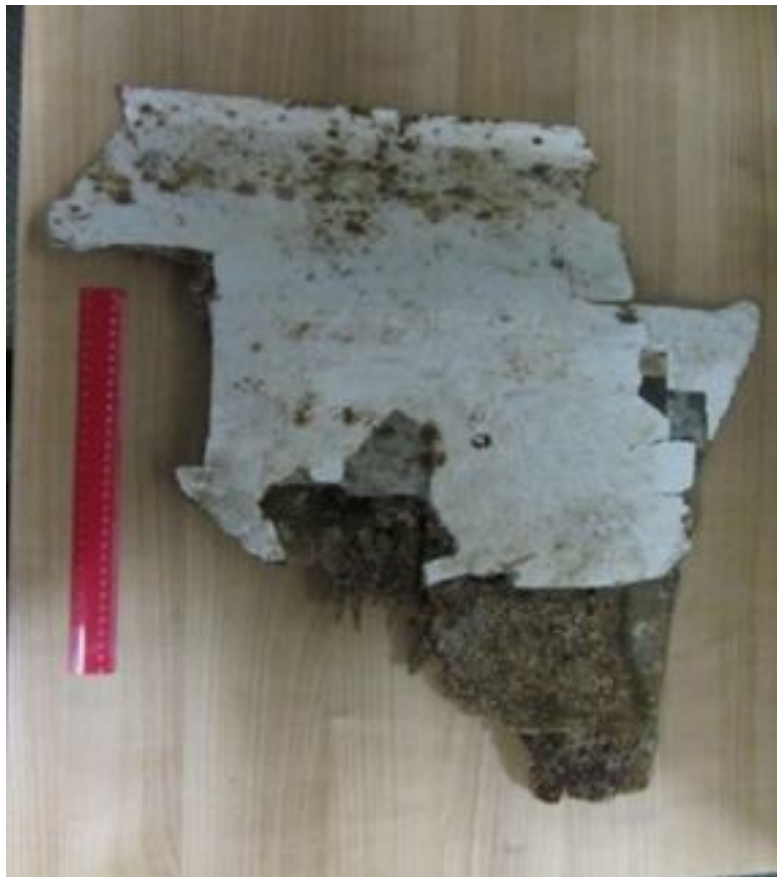
This item was recovered from Northern Kwa Zulu Natal, South Africa on 18 July 2016. It was identified as No. 21 of the items found; refer to the "*Summary of Possible MH370 Debris Recovered*".

The debris was observed to be of Carbon Fiber Reinforced Plastic (CFRP) honeycomb sandwich construction. The honeycomb core was non-metallic. The grey paint top coat was still intact. It was triangular in shape with an approximate length of 21 inches and weighed 0.87 Kg.

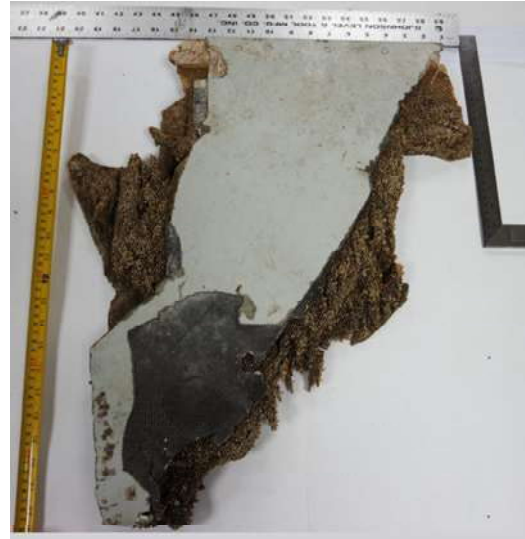
The part was fractured on all sides except on one edge. Some fasteners were still intact in position. The fibers appeared to be pulled and not kinked.

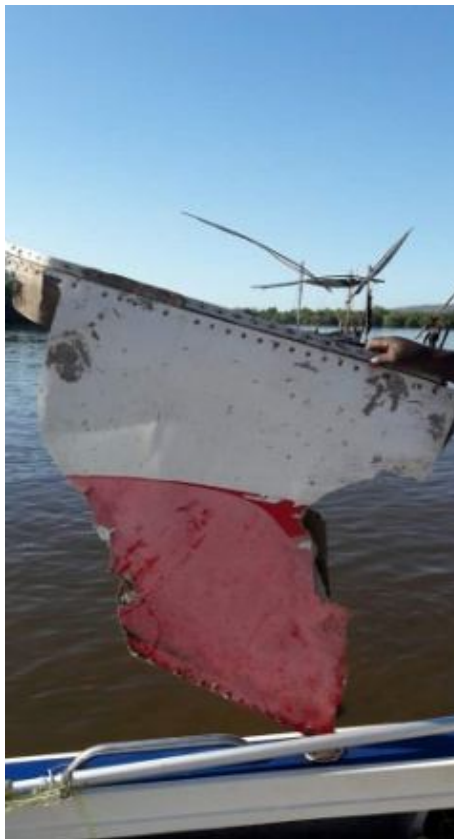
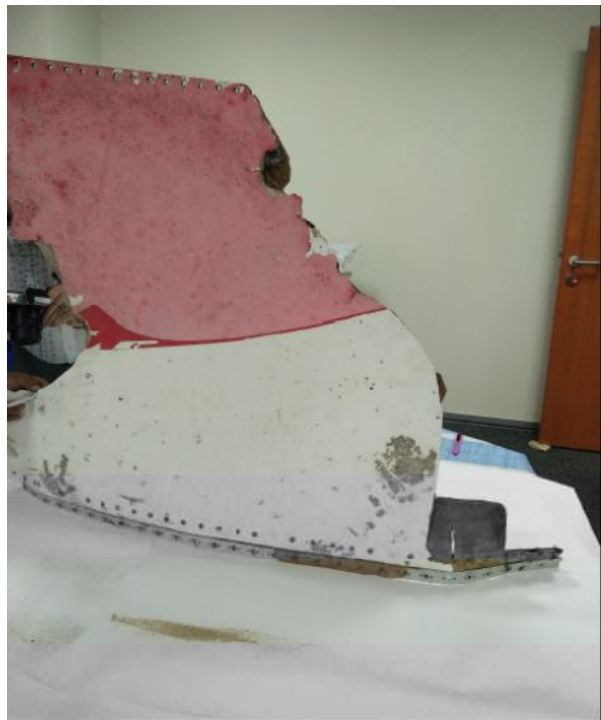
This debris was recovered at Linga Linga beach, Mozambique on 26 August 2016. The part is identified as Item No 22 of the items found; refer to the “*Summary of Possible MH370 Debris Recovered*”.

It was of Graphite Fibre Reinforced Plastic (GFRP) honeycomb sandwich with Aluminum honeycomb. The part was measured and observed to have an overall dimension of 48 inches in length and weighed 4.77 Kg.

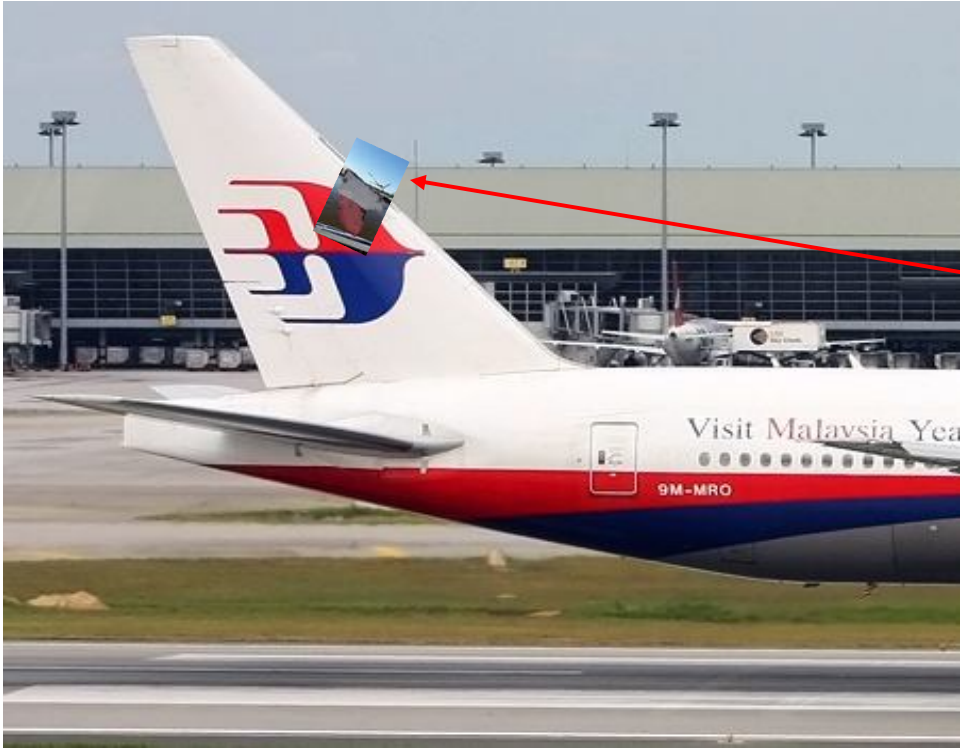
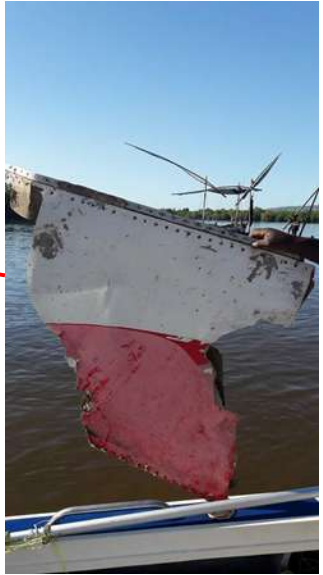
On the interior side of the part, there was still a decal with part identification numbers. Refer to the picture below. The Assembly (Assy) Number 177W3103-8 was visible. When referred to the Boeing 777 Illustrated Parts Catalog (IPC) this part was confirmed to be the right vertical stabilizer panel between the auxiliary and front spar. The red/white paint on the panel and the paint configuration appeared to match that of the Malaysia Airlines 'kite' logo on the right side of the vertical stabilizer. Refer to the photos below.

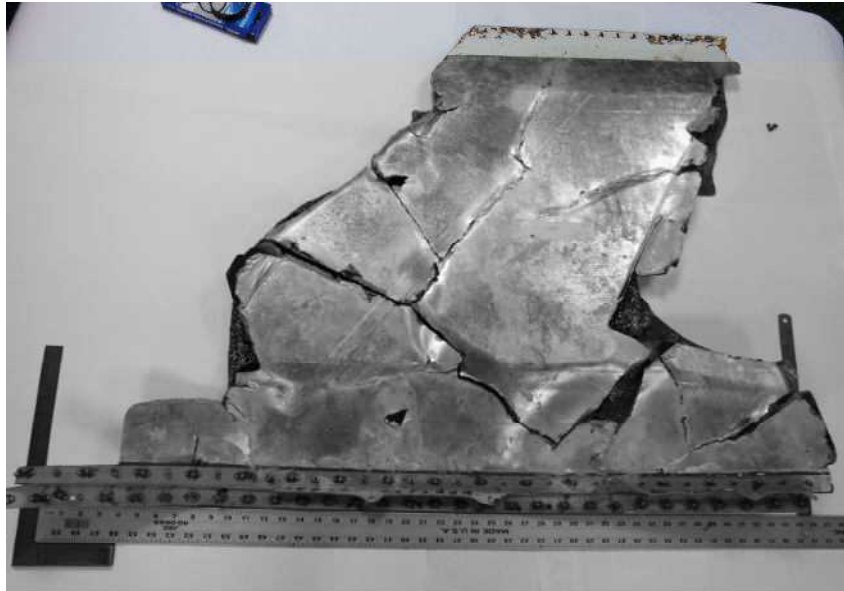
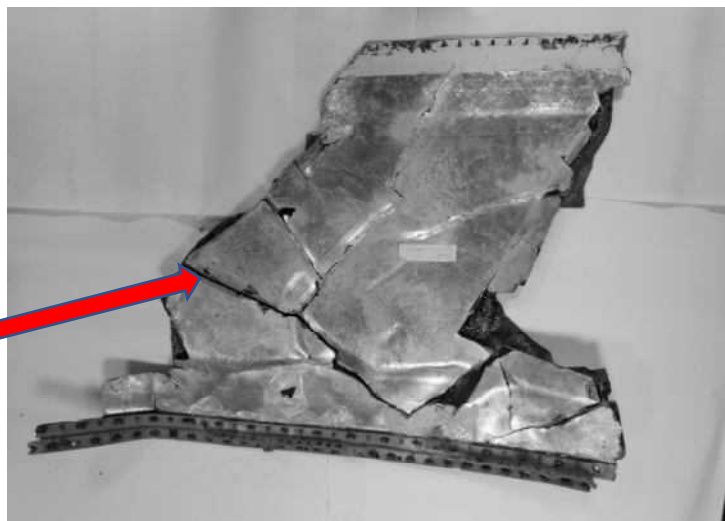
The outer skin had slightly buckled and dented but the inner skin was fractured in several places.

The internal laminate seems to be squashed

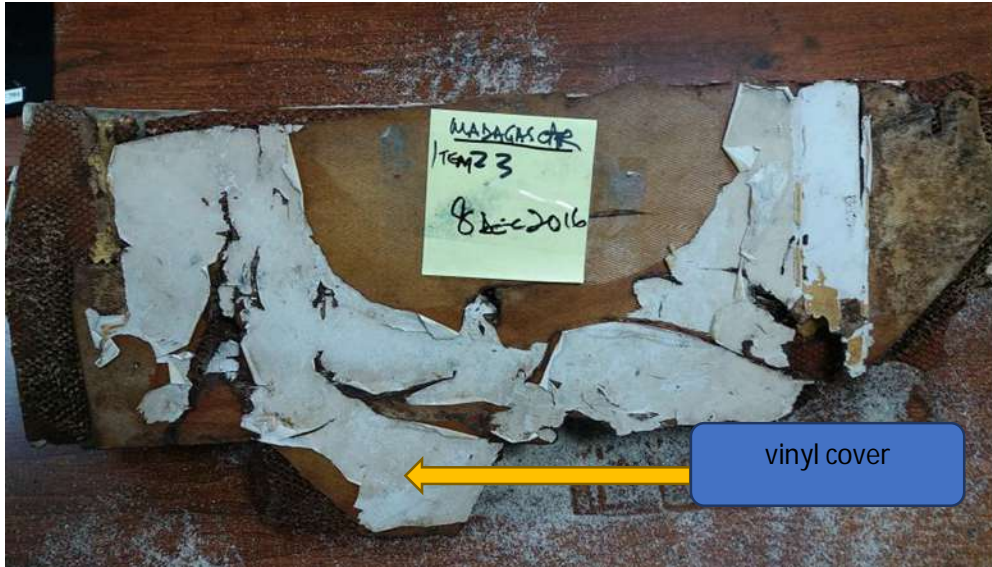
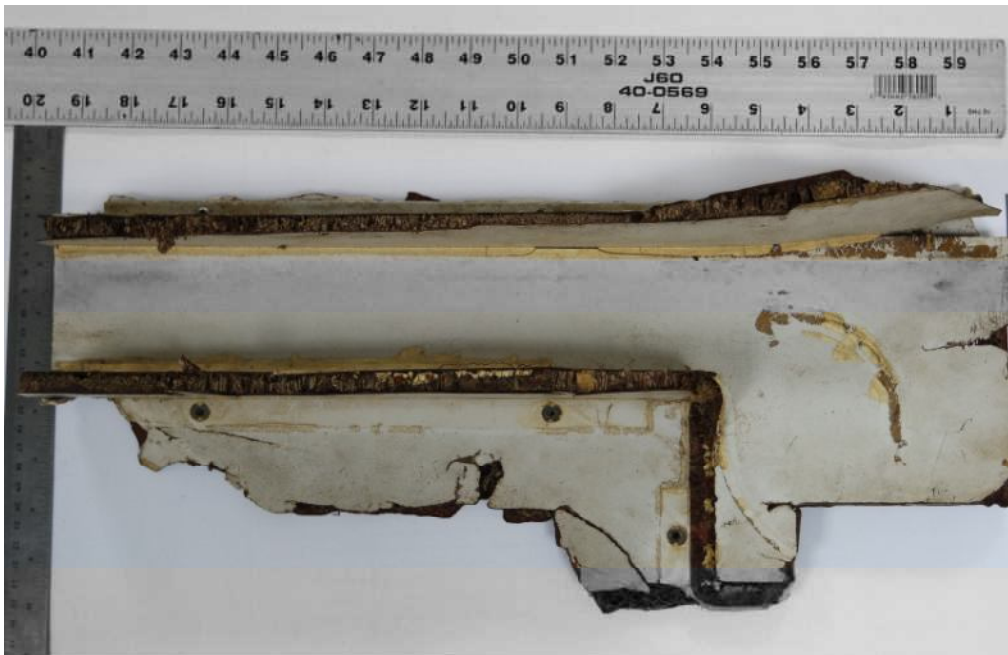
The fractured fibres on the item indicated the fibres were pulled out which could indicate tension failure on its structure.

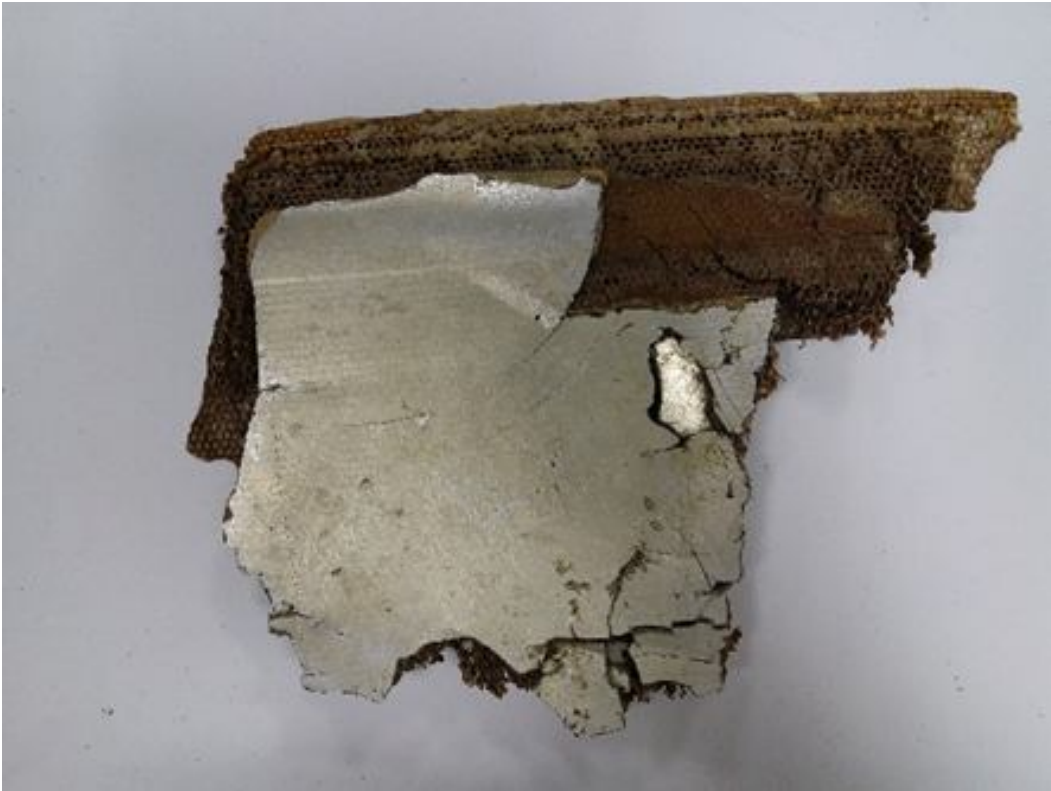
The part was fractured on all sides and some portion of the inner skin had peeled off from the core. Some section of the skin and core were crushed. Visual examination of fibers showed that they were rough and there was no visual evidence of the fibers being kinked.

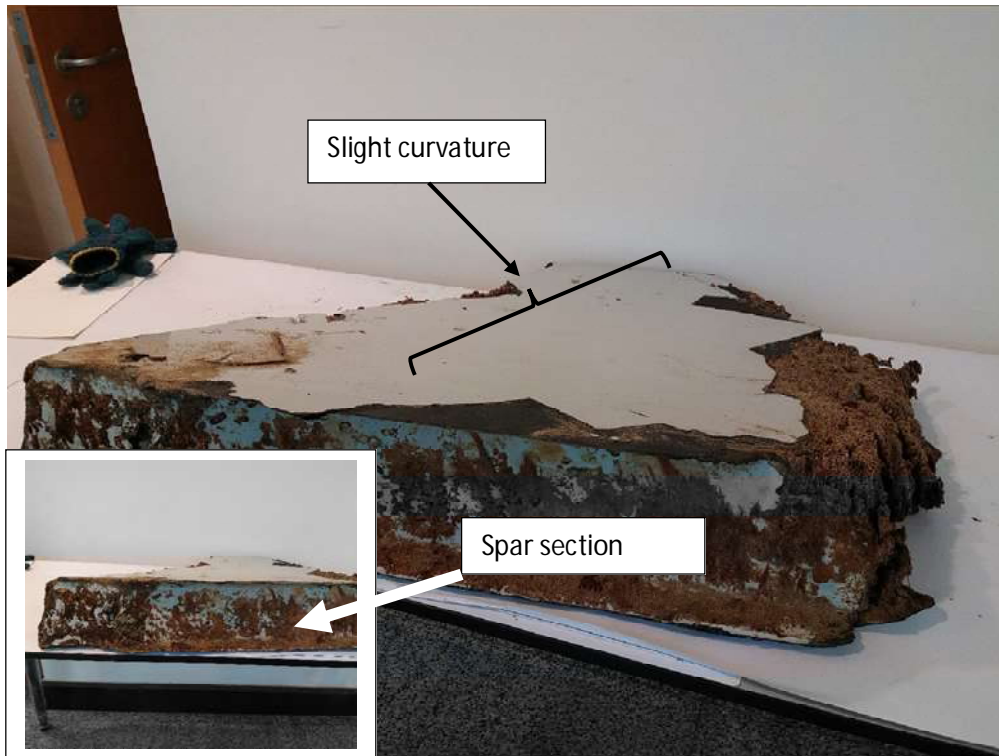
The part was non-metallic honeycomb sandwich made of Carbon Fiber Reinforced Plastic (CFRP). The skin panel was a laminated fibers structure.

The non-metallic honeycomb was soaked with water resulting in the core material to swell. The following photos show the part's characteristics including the dimension.

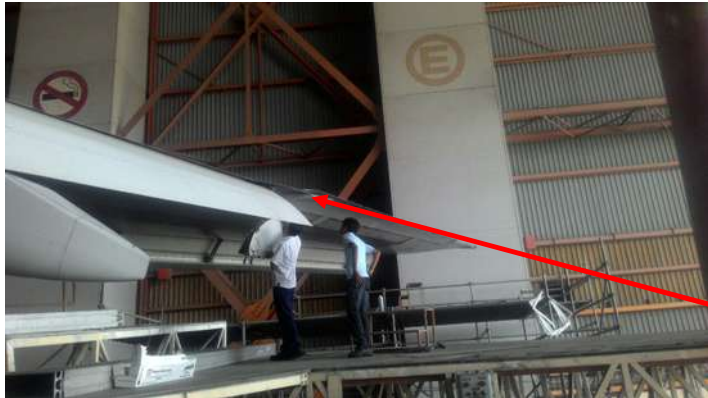
The debris closely matched the inboard section of the Right Aileron.

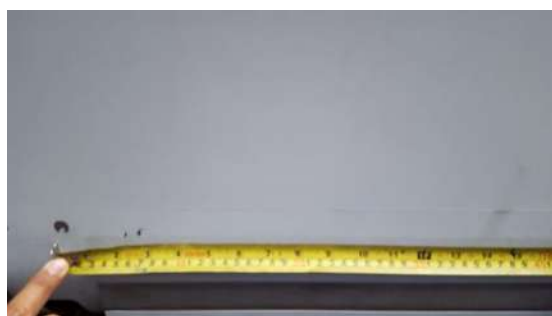
Spacing of fasteners on the aileron on aircraft

The numbers on the head of the fasteners on the debris were compared with those on the inboard section of the right aileron on the aircraft. These numbers matched. Additionally the spacing of the fasteners on the aileron also matched those on the debris. Refer to the photos above. The core and its dimensions also matched those on the inboard section of the right aileron. These confirmed that the debris is part of the inboard section of the right aileron of a B777 aircraft.

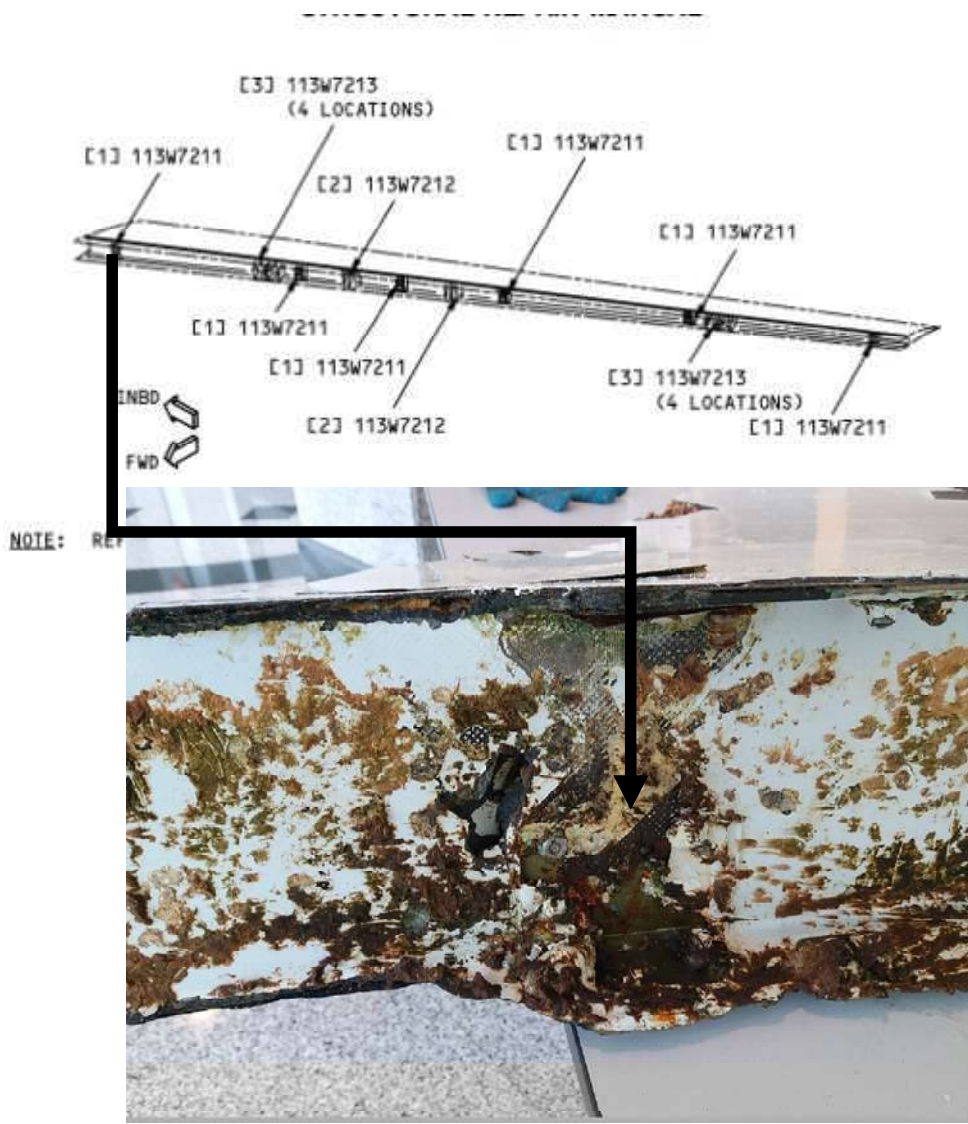
There were fractures on all sides; however, part of the spar was still intact. Several fasteners were also still intact without failures. Except for the fasteners there were no other identification numbers.

The B777 Structure Repair Manual (SRM) diagram below shows the left aileron (the right is opposite). The hinge fitting area is shown. The fitting on the debris appeared to have suffered a tension overload fracture.

Based on the dimensions and fit on the aircraft and the visible fasteners it could be confirmed that the debris is part of the inboard section of the right aileron of a B777 aircraft. From the location where it was found, and being consistent with the drift path modeling for debris from an aircraft ending its flight in the South Indian Ocean, it is highly likely that it is from MH370 (aircraft registered as 9M-MRO).

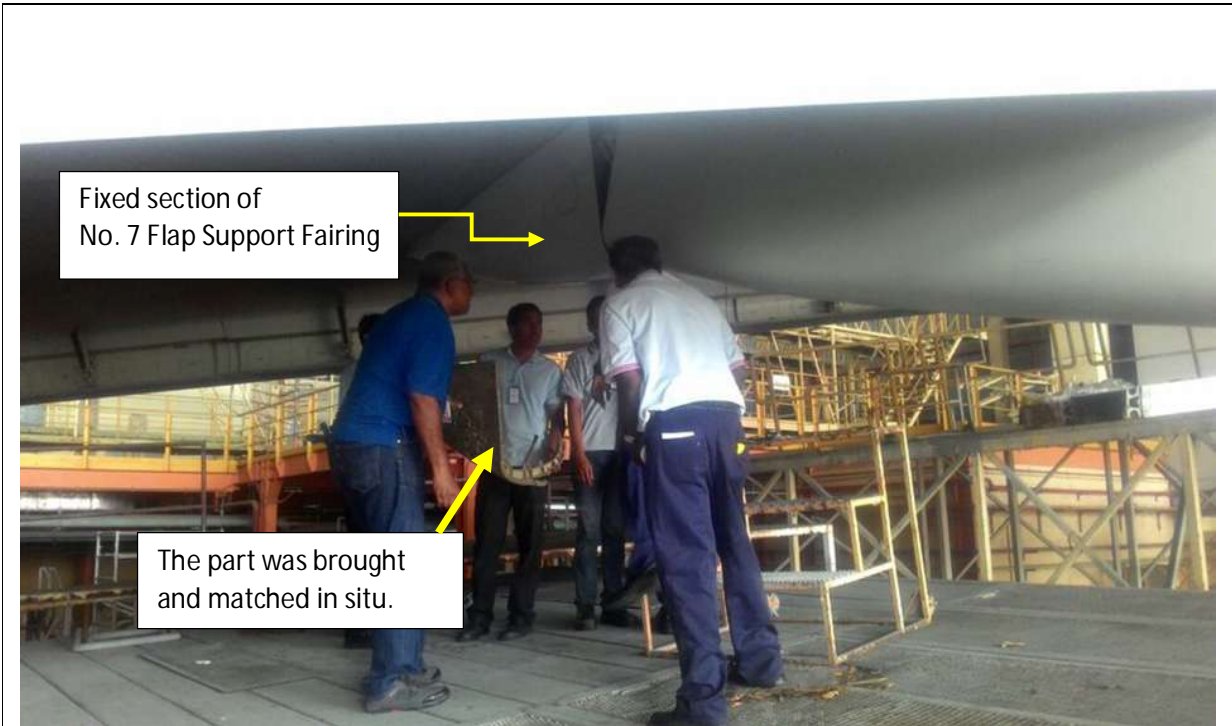
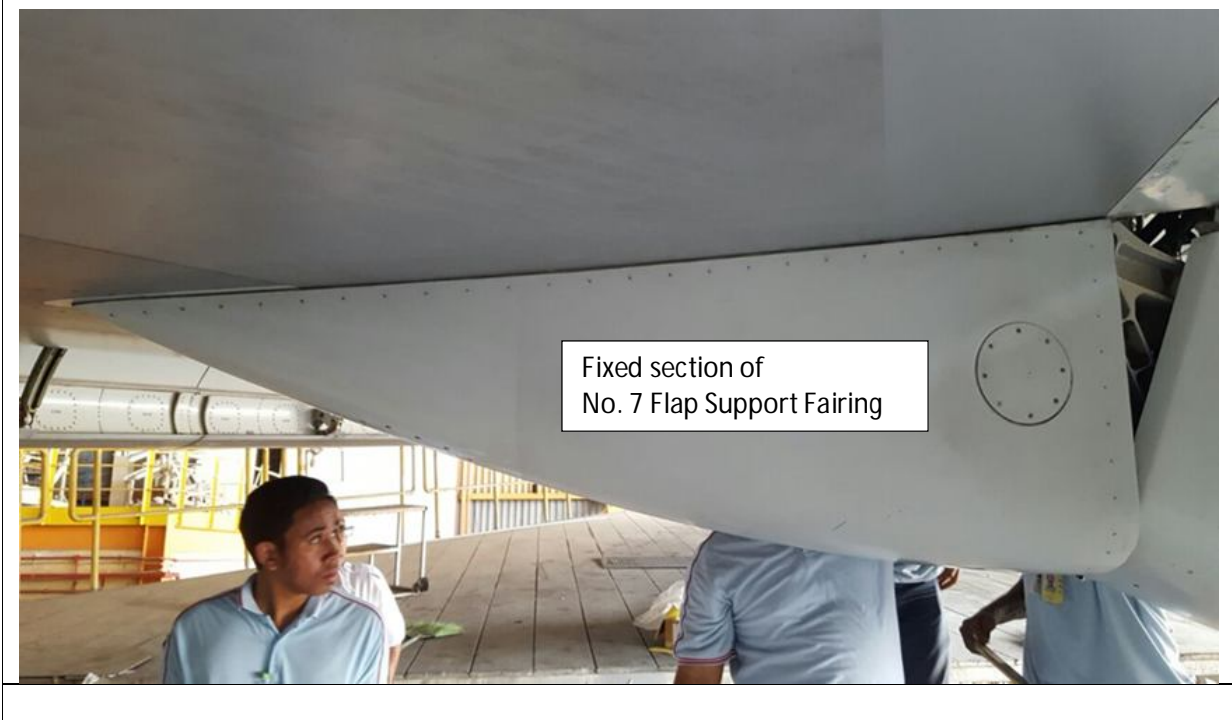
It was easily matched to the fixed, forward section of the No. 7 flap support fairing, as shown in the pictures below. Item No. 2, found on 27 December 2015 at Daghatane Beach, Mozambique, is also part of the same fairing; however it is part of the rear, moveable section.

Based on the legible part number and the match of the part on the aircraft it is confirmed that the debris is part of the fixed, forward No. 7 flap support fairing of a B777 aircraft. From the location where it was found, and being consistent with the drift path modeling for debris from an aircraft ending its flight in the South Indian Ocean, it is highly likely that it is from MH370 (aircraft registered as 9M-MRO).

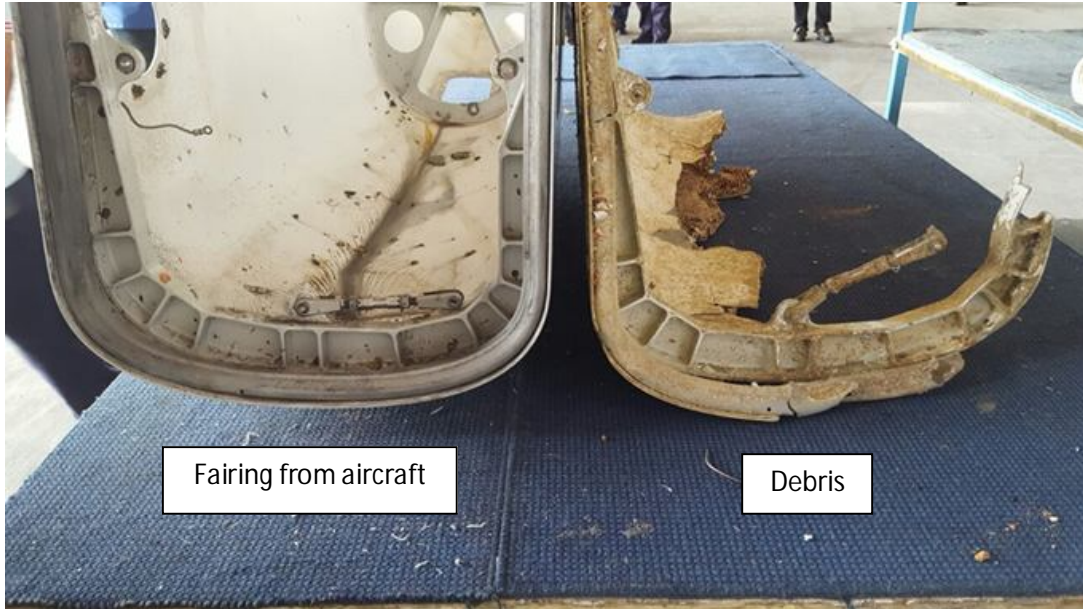
The fairing from the aircraft was removed and matched side by side with the debris as shown below. The features were found to be identical.

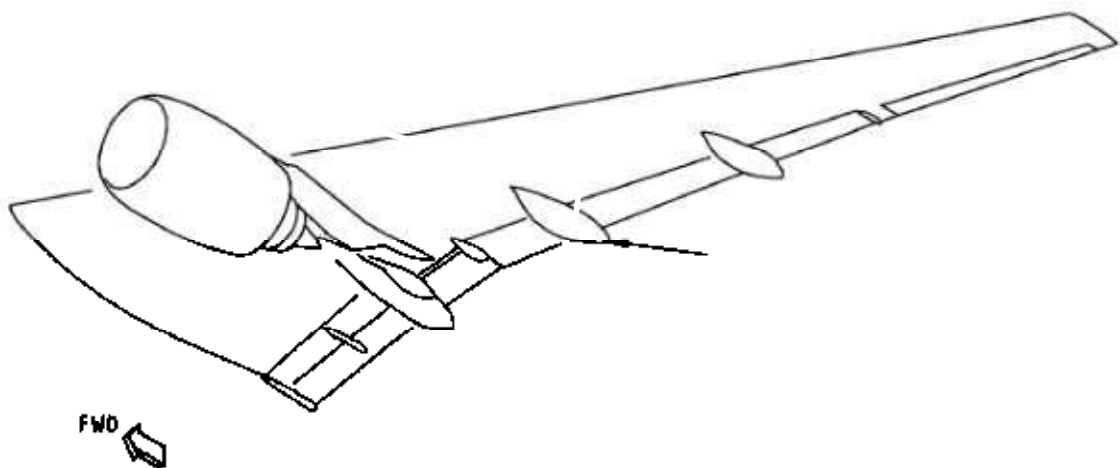
NUMBER 2 FAIRING IS SHOWN, NUMBER 7 FAIRING IS OPPOSITE

The diagrams below from the B777 Structural Repair Manual (SRM) show the location of the No. 2 flap support fairing and the complete assembly. The No. 7 fairing is in a similar location on the opposite wing.

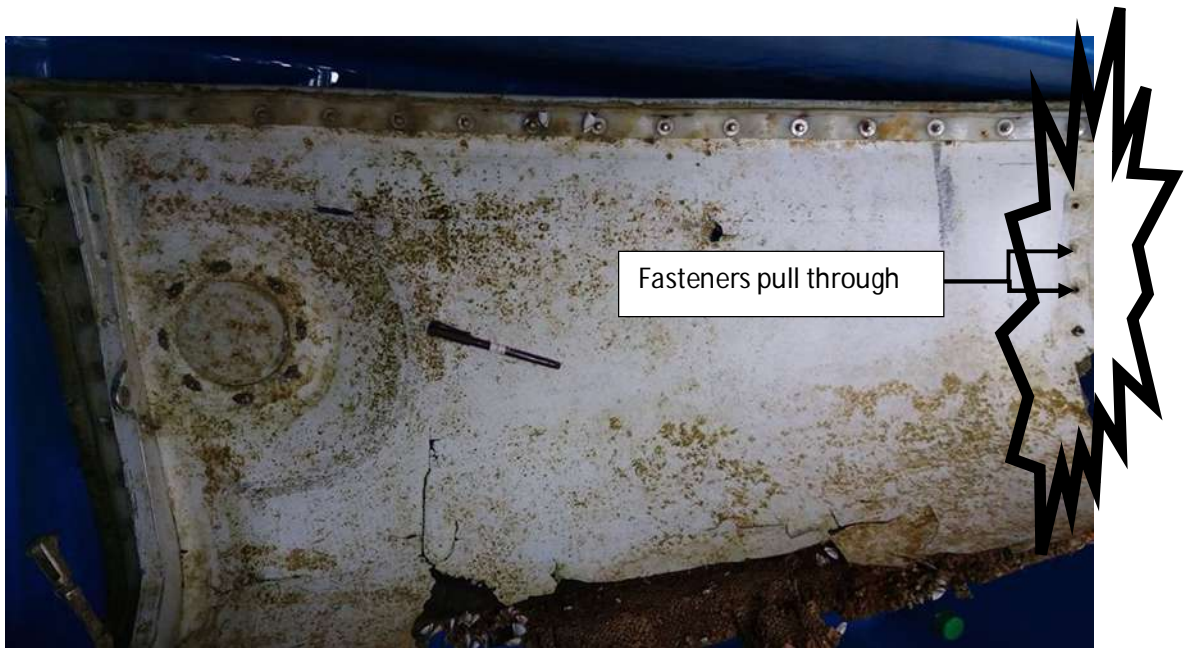
The part was fractured almost through its symmetry axis. One of the frames was completely detached from the skin. It may be due to fasteners pull through as the fasteners' holes appeared to be torn off with diameters larger than the fasteners. The bracket had broken off with some sign of twist which is evidently shown by the bent push rod.
