Missing aircraft, Boeing 777, 9M-MRO, 8 March 2014

**Identification of two items of debris
recovered from beaches in Mozambique**

ATSB Technical Examination Report

Debris examination update 1 - 19 April 2016

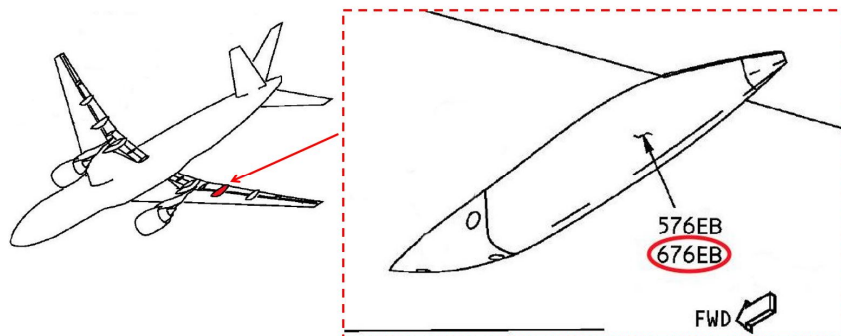
Figure 1: Location of flap track fairing panel No. 676EB

The first part was initially identified from a number stencilled on the part (676EB), as a segment from a Boeing 777 flap track fairing (Fairing No. 7) from the right wing (Figure 1). All measurable dimensions, materials, construction and other identifiable features conformed to the applicable Boeing drawings for the identified fairing.

- Part No. 1 was a flap track fairing segment, almost certainly from the Malaysian Airlines Boeing 777 aircraft, registered 9M-MRO.
- Part No. 2 was a horizontal stabiliser panel segment, almost certainly from the Malaysian Airlines Boeing 777 aircraft, registered 9M-MRO.

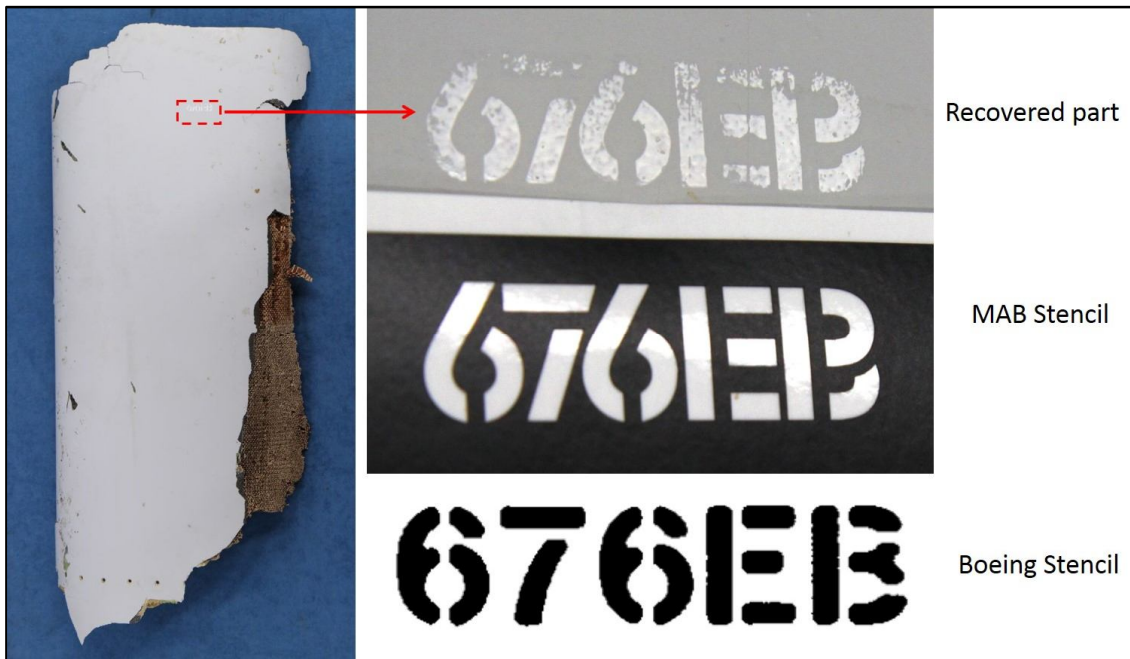
Figure 2: Flap fairing outer surface showing stencil location and comparison

The 676EB stencil font and colour was not original from manufacture, but instead conformed to that developed and used by MAB during painting operations (Figure 2). The part had been repainted, which was consistent with MAB maintenance records for 9M-MRO.

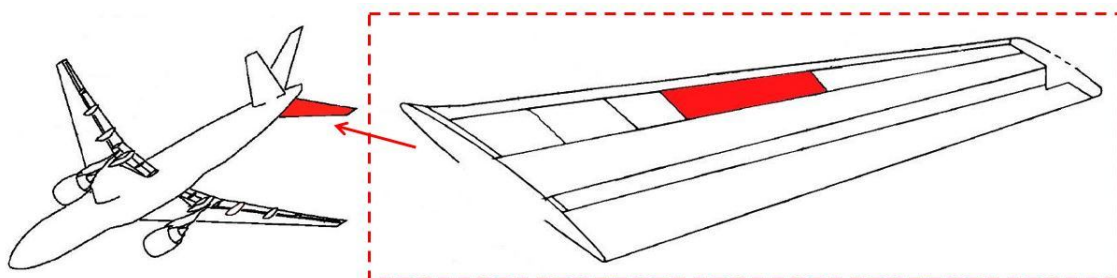
Figure 3: Location of horizontal stabiliser panel No. 3 upper

The second part was primarily identified from images showing the materials, construction and “NO STEP” stencil, as a segment of a Boeing 777 RH horizontal stabilizer panel (Figure 3). All measurable dimensions, materials, construction and other identifiable features conformed to the Boeing drawings for the stabiliser panel.

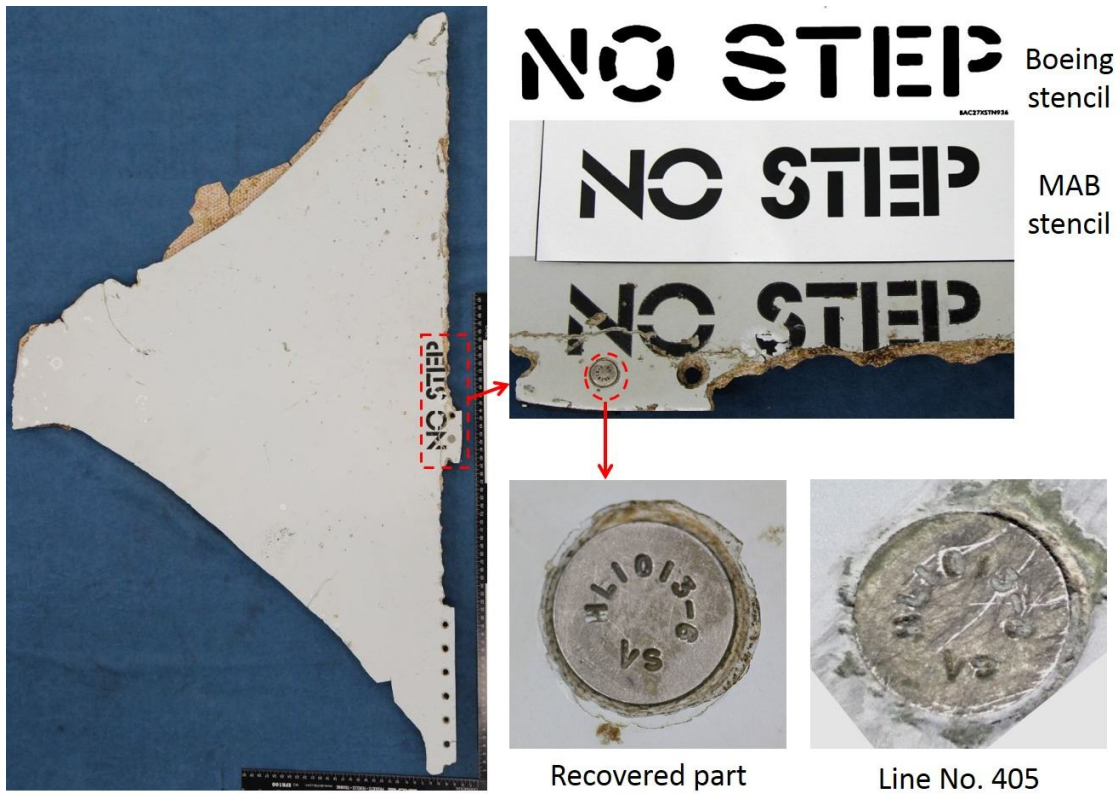
Figure 4: Stabiliser panel “NO STEP” stencil and fastener comparison

The part was marked on the upper surface in black paint with “NO STEP”. The font and location of the stencil were not original from manufacture, however the stencilling was consistent with that developed and used by Malaysian Airlines (Figure 4).

A single fastener was retained in the part. The fastener head markings identified it as being correct for use on the stabiliser panel assembly. The markings also identified the fastener manufacturer. That manufacturer’s fasteners were not used in current production, but did match the fasteners used in assembly of the aircraft next in the production line (405) to 9M-MRO (404) (Figure 4).
