## **Debris examination – update No. 4**

# **Missing aircraft, Boeing 777, 9M-MRO, 8 March 2014**

**Preliminary examination of two items of  
debris recovered near Sainte Luce,  
Madagascar**

**ATSB Technical Examination Report**

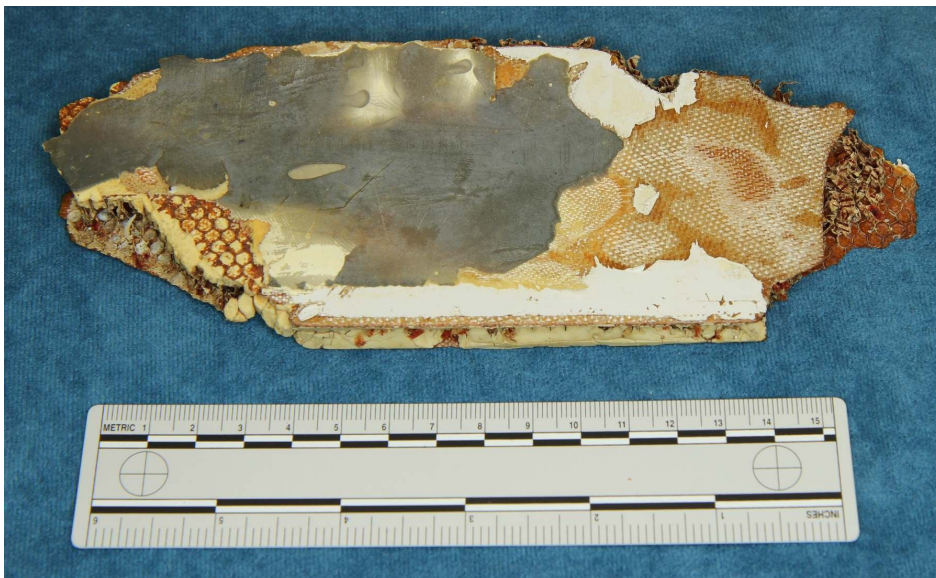
**Figure 1: Smaller composite panel**

A dark grey colouration was present on a significant proportion of both sides of each item (Figures 1, 2 and 3). Detailed examination of these areas showed that the colour related exclusively to a translucent resin that had been applied to those surfaces (Figure 4).

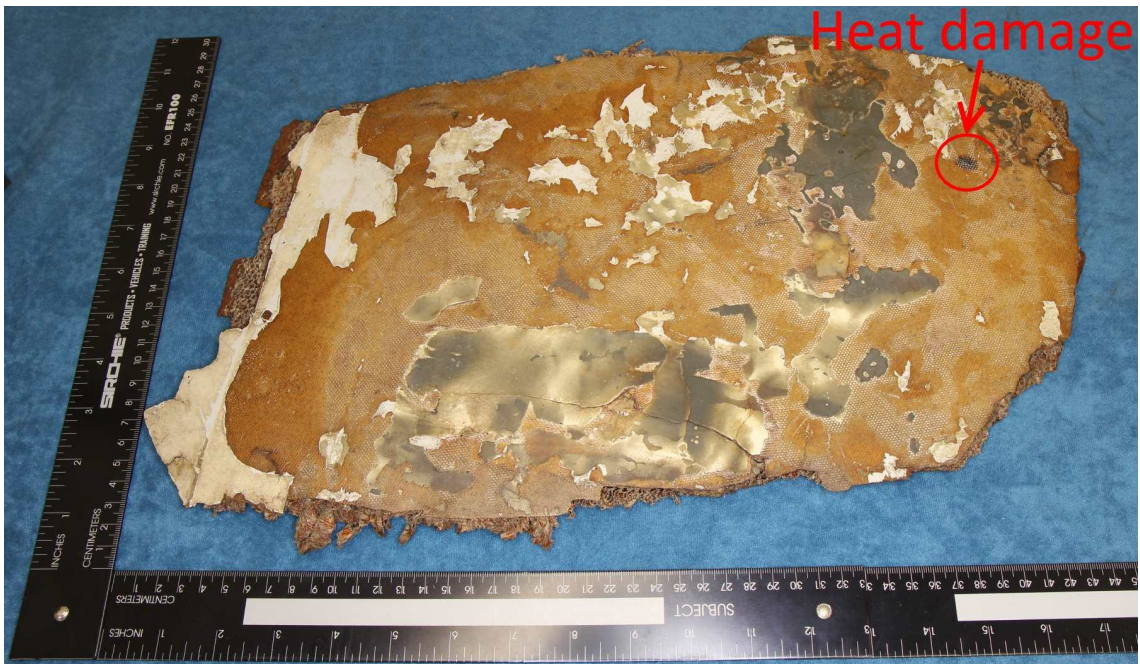
Figure 2: Larger composite panel showing discrete area of heat damage

Despite no evidence of overall gross heat damage, two small (<10mm) marks on one side of the larger item and one on the reverse side were identified as damage resulting from localised heating (Figures 2 and 3). A burnt odour emanating from the large item was isolated to these discrete areas. The origin and age of these marks was not apparent. However, it was considered that burning odours would generally dissipate after an extended period of environmental exposure, including salt water immersion, as expected for items originating from 9M-MRO.

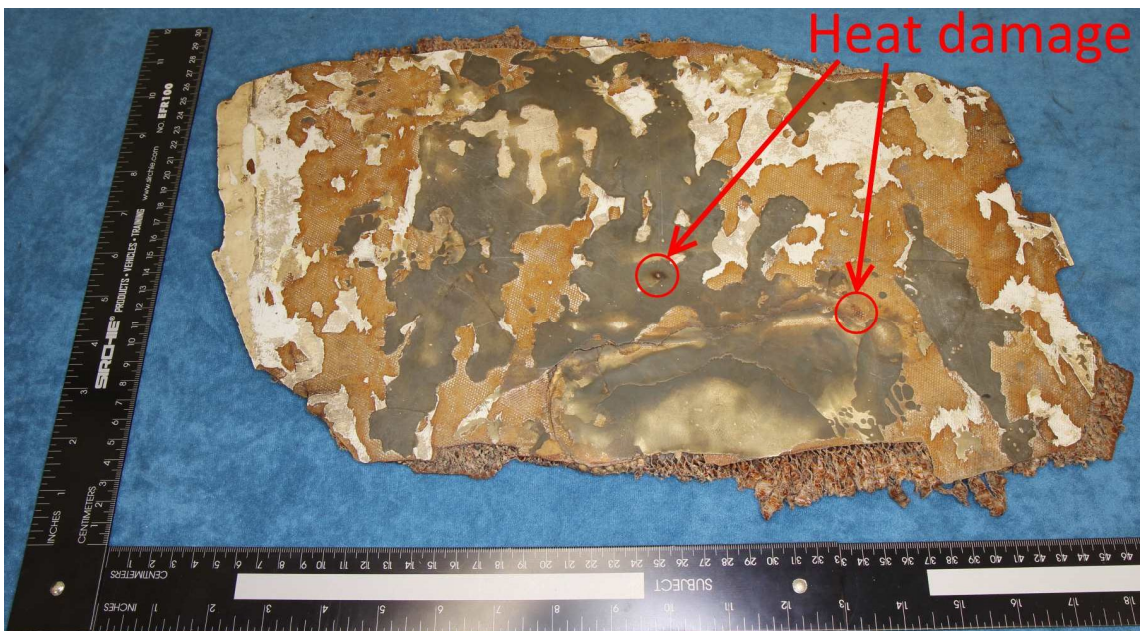
Figure 3: Reverse side of larger composite panel showing discrete areas of heat damage

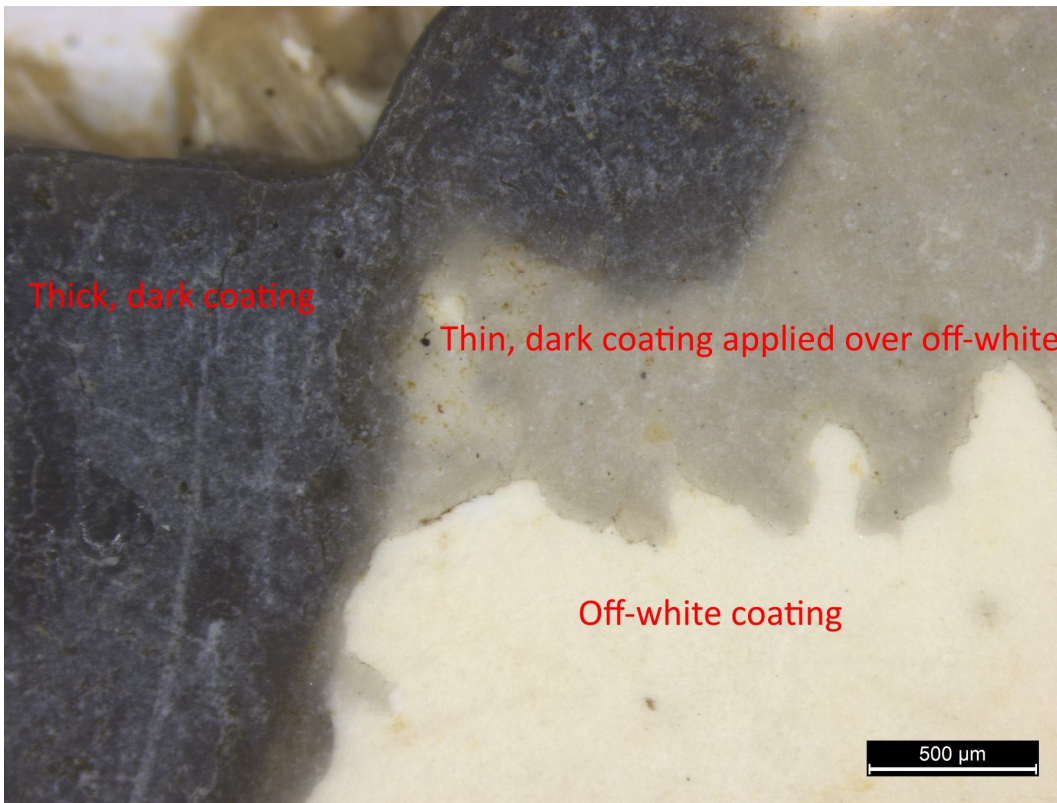
**Figure 4: Close-up of applied coatings**

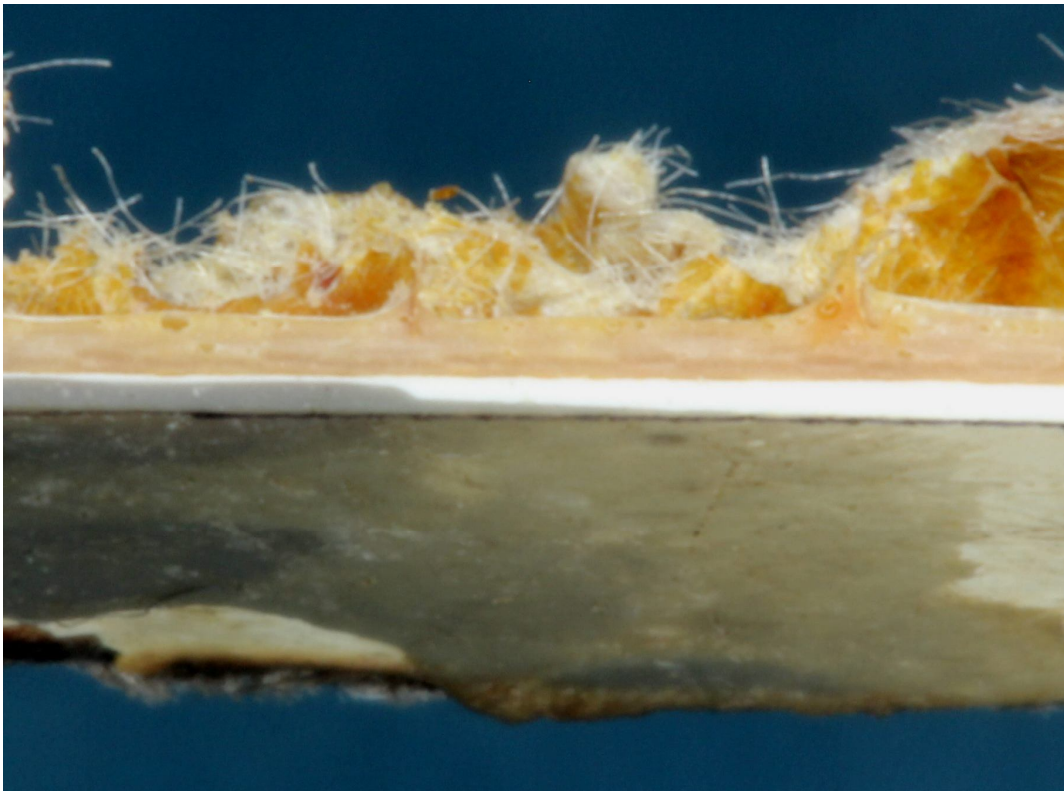
**Figure 5: Cross-section through composite skin, showing surface colouration through thickness.**

A cross section through the panel showed a clear delineation between the dark resin and the other surface coatings without any evidence of gradual transition. The lighter grey surface areas resulted from a thinner film of the same resin applied over an off-white background. Figure 5 shows the cross section directly and Figure 6 shows the same section at an oblique angle. This confirmed that the dark colour of the coating was an inherent property of the resin, and not the result of exposure to heat or fire.

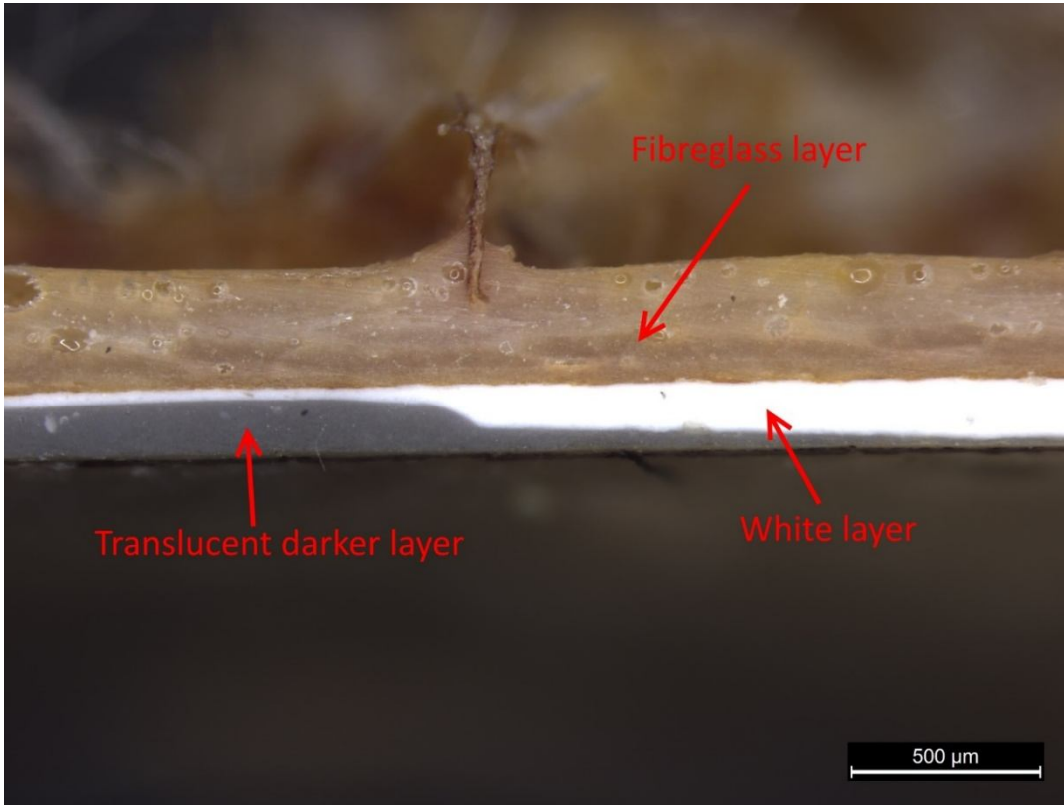
**Figure 6: Higher magnification image of Figure 5, showing clear delineation between layers**
