**SERIOUS INCIDENT REPORT NUMBER SI 01/2017
(FINAL REPORT)**

**SERIOUS INCIDENT INVOLVING MALAYSIA AIRLINES MH2718
BOEING B737-800 REGISTRATION 9M-MXX
AT SIBU AIRPORT, SARAWAK
8 APRIL 2017**

SERIOUS INCIDENT REPORT NO.: SI 01/2017

OPERATOR : MALAYSIA AIRLINES BERHAD (MAB)
AIRCRAFT TYPE : BOEING B737-800
NATIONALITY : MALAYSIA
REGISTRATION : 9M-MXX
PLACE OF INCIDENT : SIBU AIRPORT, SARAWAK
DATE AND TIME : 08 APRIL 2017 AT 2217 HOURS (LT)

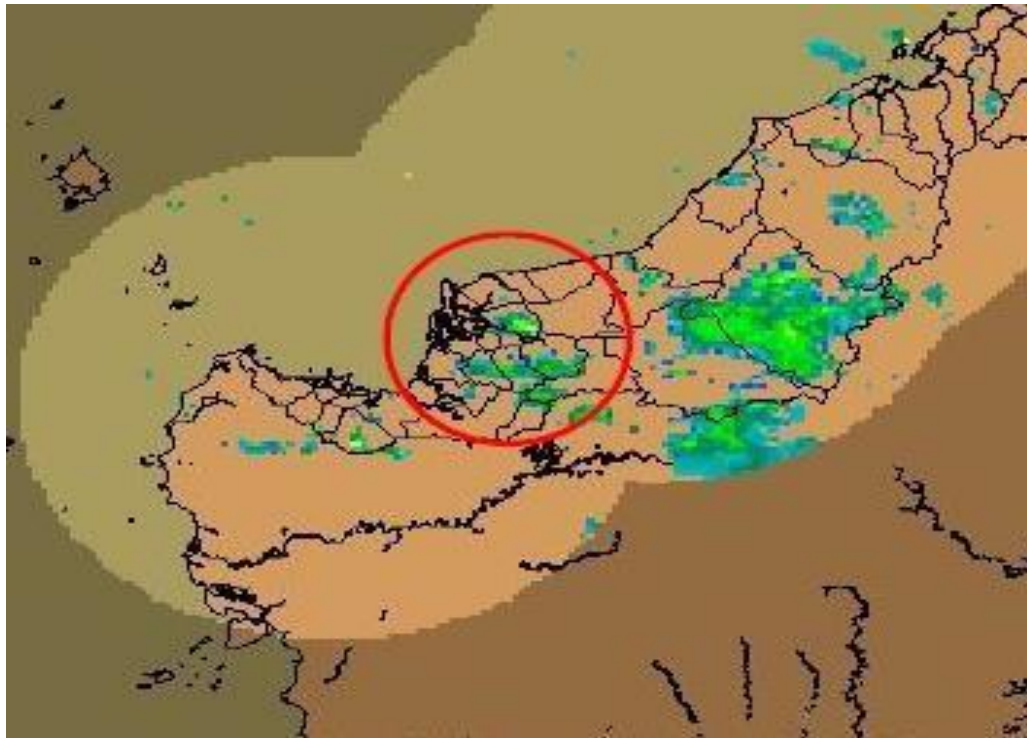
1.7.4 During the investigation, the data from the RVR readout was obtained from the Meteorological Department. This data shows the sporadic visibility pattern (associated with changing rain intensity) ranging from 450 m to 10 km throughout the period in question. The RVR data during this period is shown in Appendix P.

Figure 2: Weather radar image of cloud cover over Sibiu at 2210 LT. (Source: Kuching Meteorological Department)

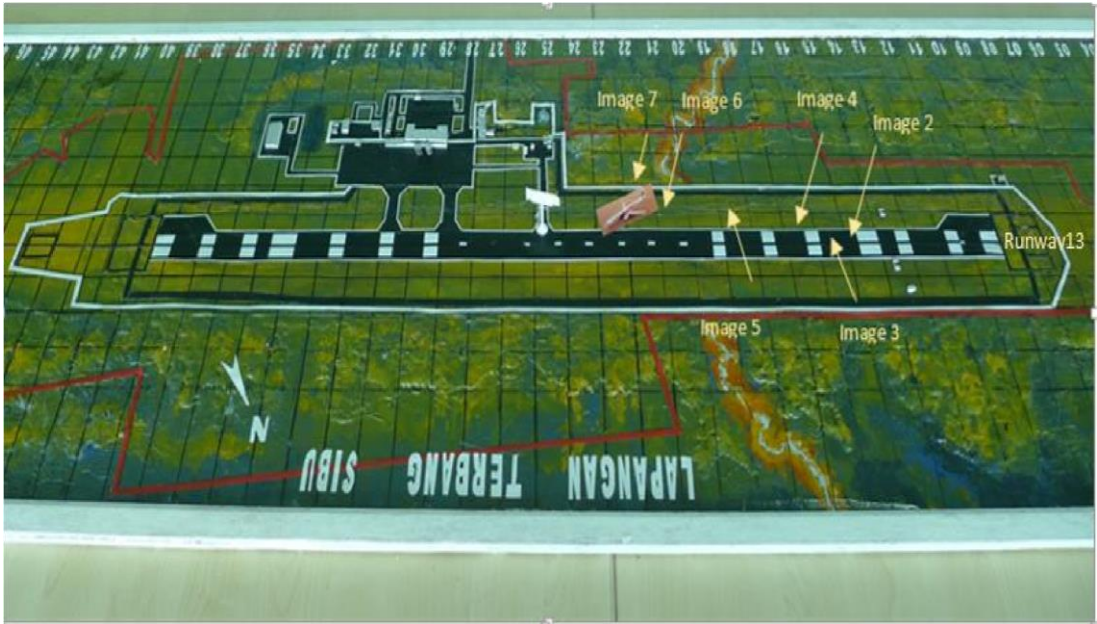
Figure 3: Layout of Sibuan Airport Runway 13/31 with reference to the images 2 to 7

1.12 **Impact Information.** Photographs were taken during the on-site inspection and assessments are provided in the following. The approximate locations of the sequence of events are shown on the Runway diagram, followed by the individual images describing the event.

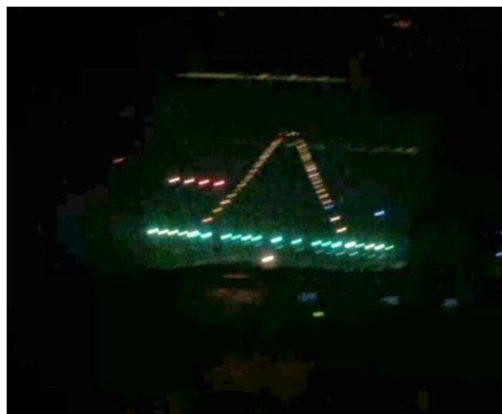
- h. Analysis of the photographs shows that the pilots would have noticed the PAPI and runway edge lights until 20 ft RA, below which only the runway edge lights would have been discernable.

Figure 17: Pilot's view-Runway 13 at 100 ft AGL.

- i. Based on the above images, the investigators collectively agreed that the flight crew had limited visual reference available while descending below 20 ft RA in heavy rain. Below this height, the PF would be looking entirely outside of the aircraft to execute flare and landing maneuvers. With only the runway edge lights available as visual reference, it would be difficult for the PF to accurately judge or detect deviation from the runway centerline, including if there was any inadvertent or deliberate bank angle induced.

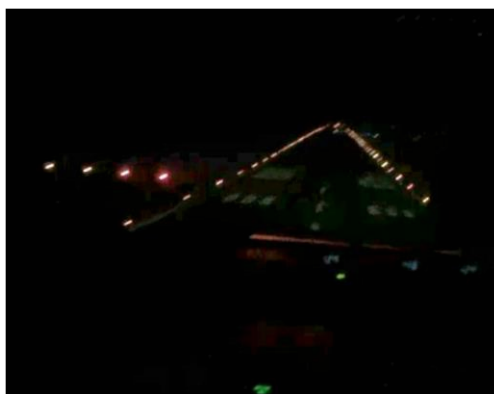
Figure 18: Pilot's view-Runway 13 at 30 ft AGL

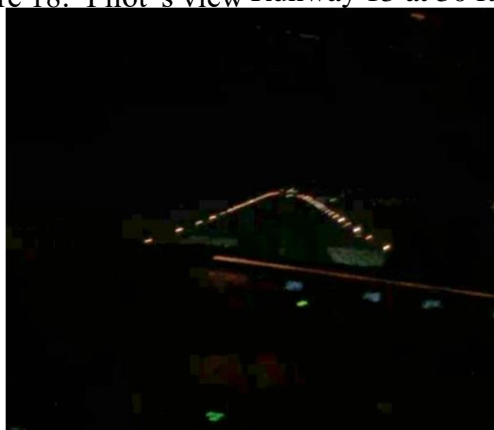
Figure 19: Pilot's view-Runway 13 at 20 ft AGL.

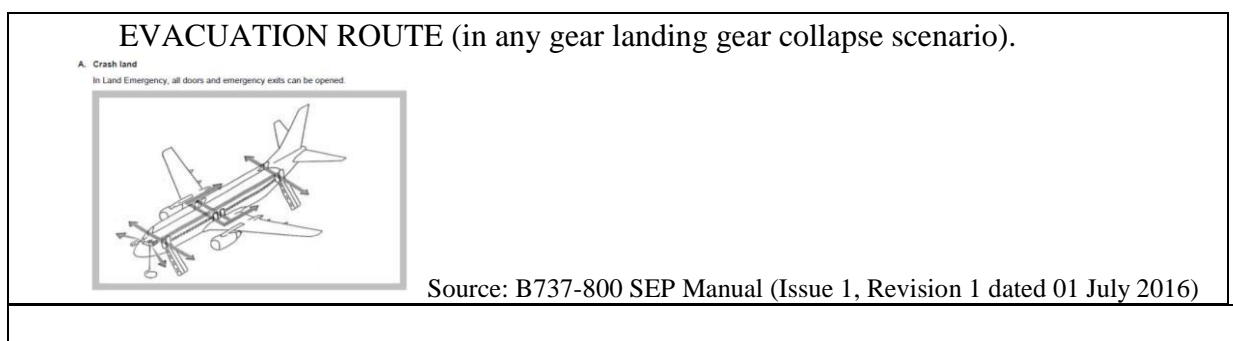
2.2.12.12 No instruction was given by the captain on the choice of door to be used for the evacuation.

2.2.12.13 Nevertheless, the procedures for evacuation following a crash land required evacuation from all primary 4 main doors (Door 1 L, Door 1 R, Door Door 2 L and Door 2 R). The over-wing window emergency exits were supposed to be opened by the passengers seated near the over-wing exits, as shown in the diagram below.

Figure 20: SEP on Evacuation Using All Available Exits

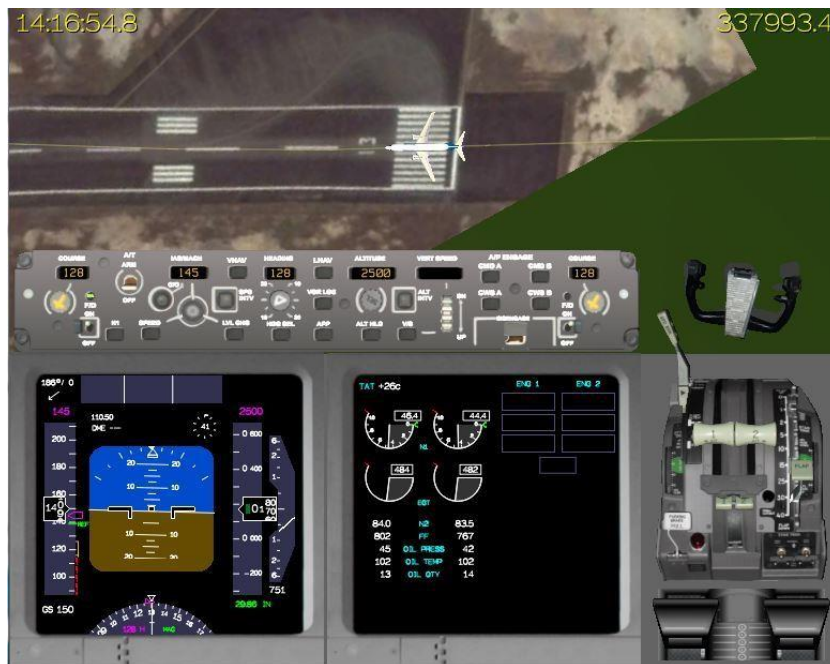
Photograph 1: Aircraft appears to be on the centreline when flying over the Threshold Runway 13 at 42ft RA. No deviation was evident at this juncture.

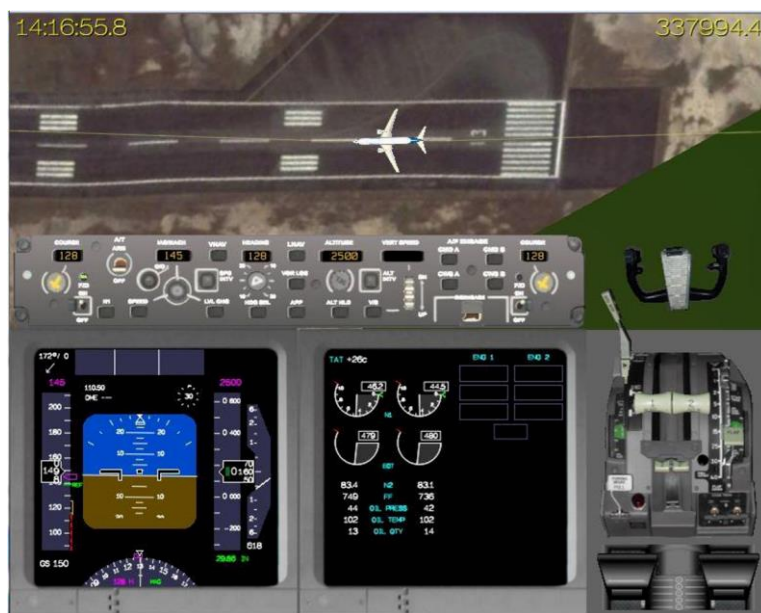
Photograph 2: Aircraft was still seen flying over the centreline of Runway 13 at 30ft RA.

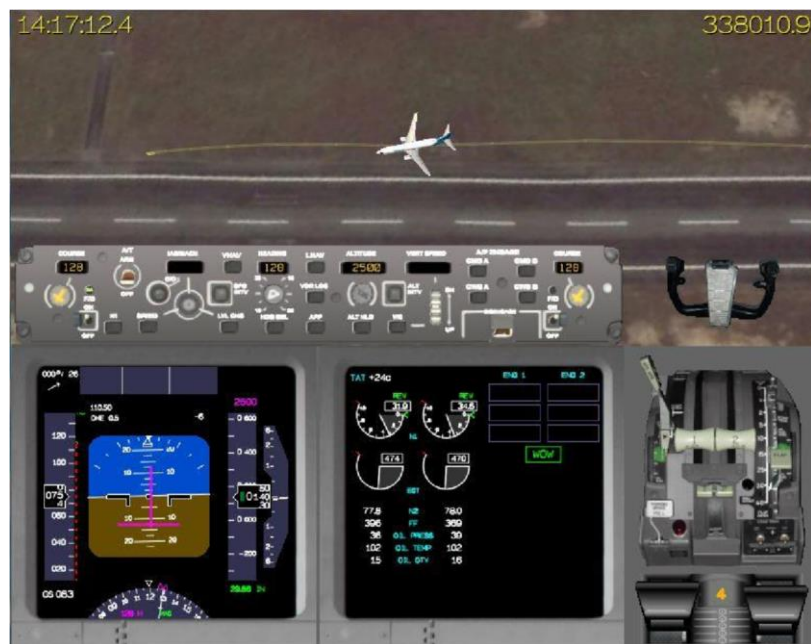
Photograph 10: Position of aircraft at 10 seconds after touchdown.

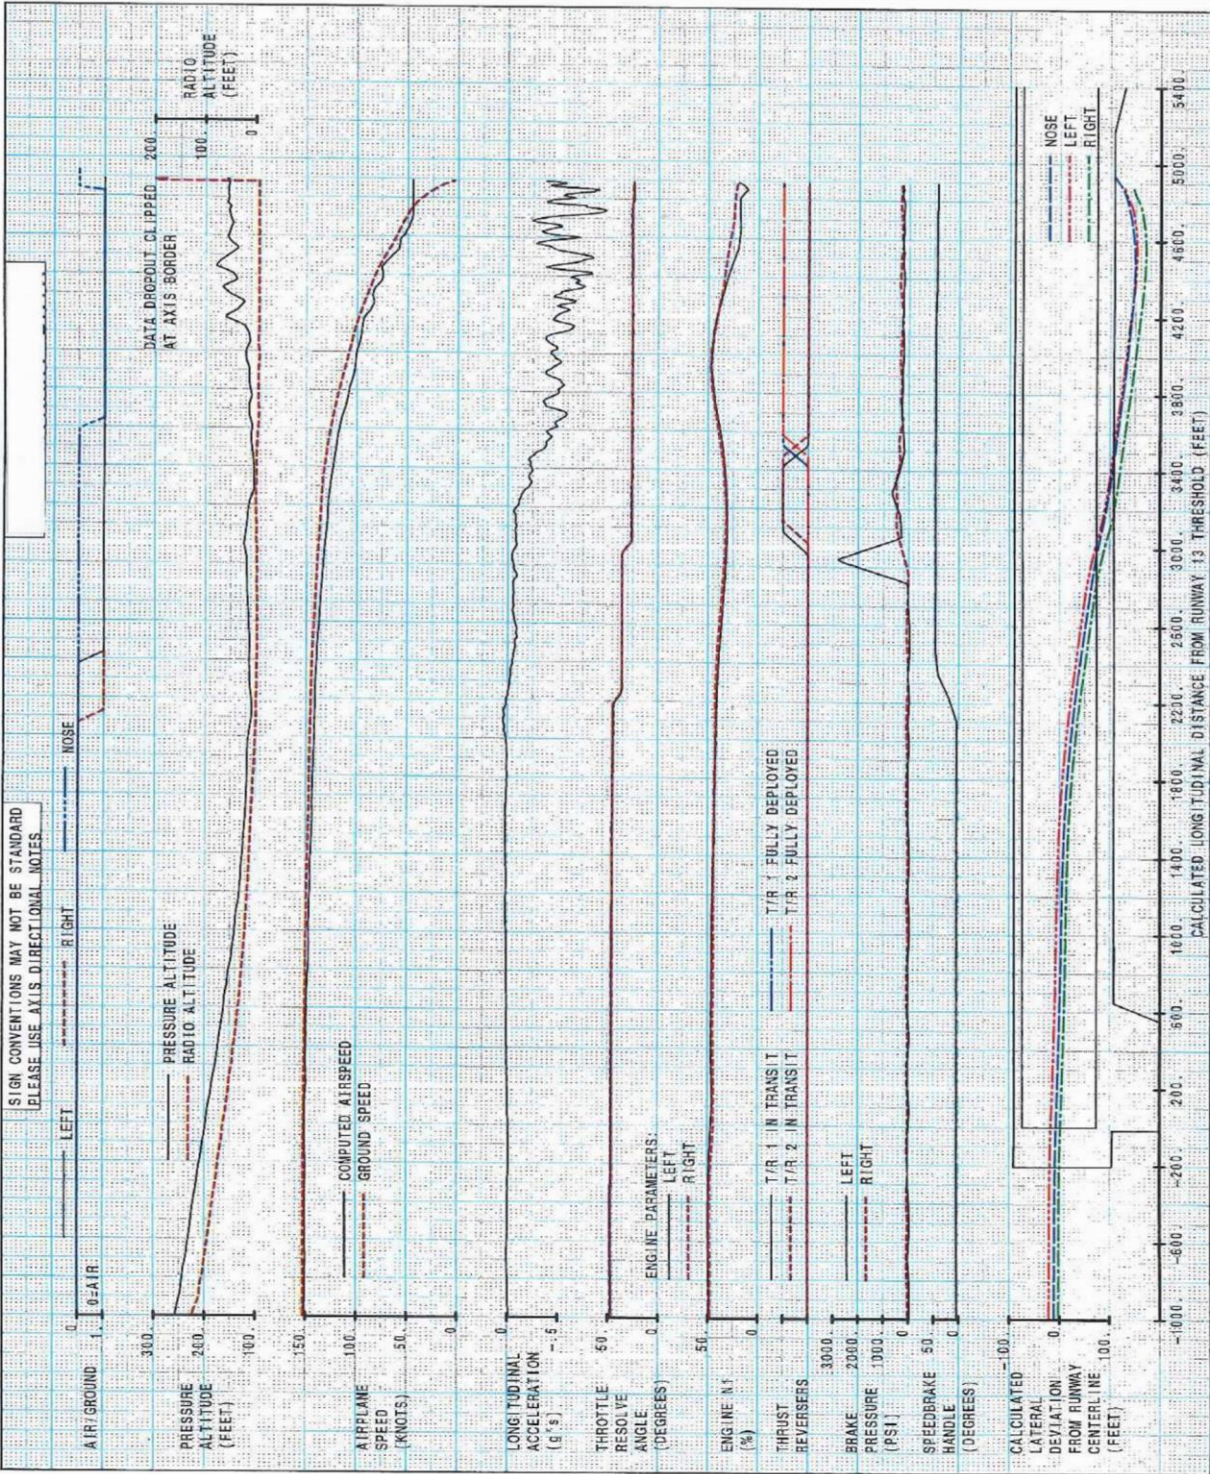
MAS 737-800 RUNWAY EXCURSION
08APR2017 ** TIME-ALIGNED FOR DATA
GROUND TRACK - LONGITUDINAL

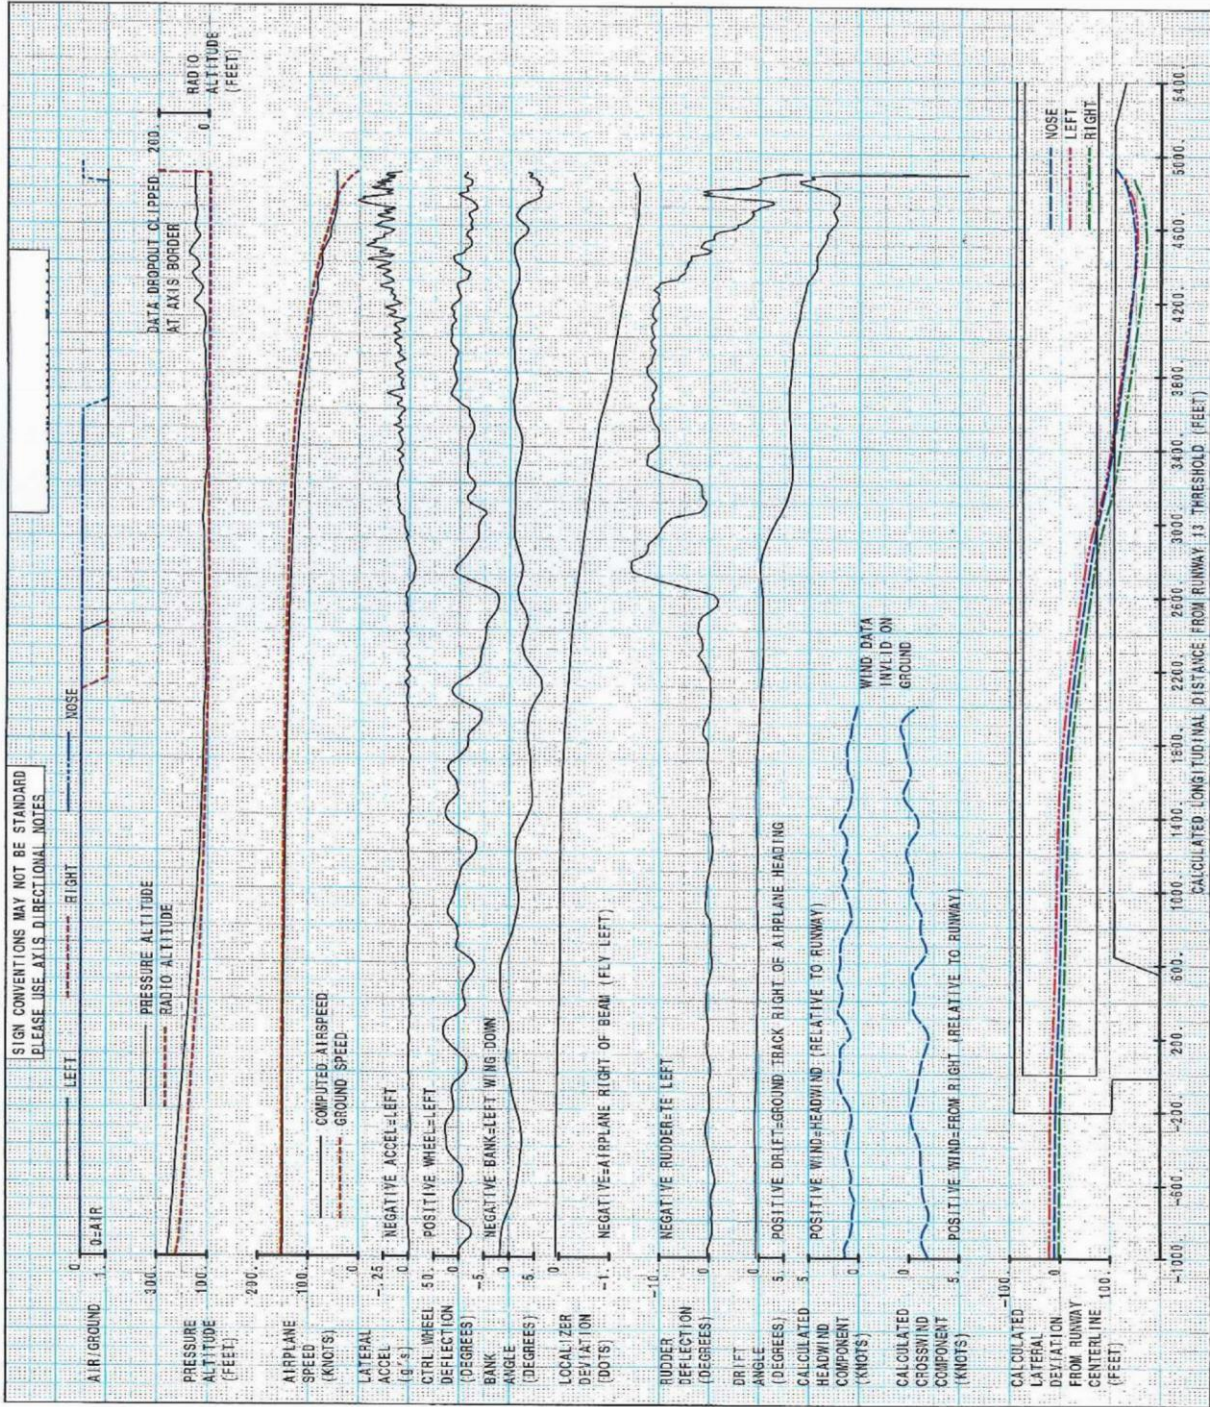
CALC	ADDITIONALS	REVISION	DATE	7/18/79-MX
CHECK				
APPD				
APPD				
MAS 737-800 RUNWAY EXCURSION 08APR2017 ** TIME-ALIGNED FOR DATA GROUND TRACK - LATERAL/DIRECTIONAL				FIGURE 4
