AIRCRAFT ACCIDENT REPORT A 02/18

**Air Accident Investigation Bureau
Ministry of Transport, Malaysia**

**Final Report on the Accident Involving
Fixed Wing Aircraft M-18A Dromader Registration VH-FOS
In Keratong, Pahang, Malaysia
On The 25th February 2018**

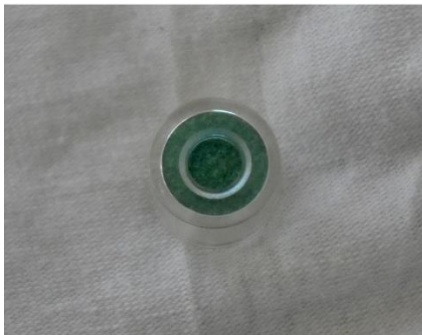
Picture 18
Water Detector capsule

The actual sampling process require the capsule to be attach to a syringe (without a needle) and then dip in the fuel sample. Using the syringe, fuel will be extracted through the capsule. If there is any water contaminating the fuel, the colour of the table will immediately change.

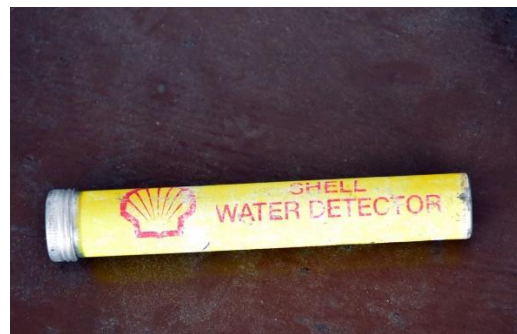
Picture 19
Capsules container

The storage life for unused Shell Water Detector capsule is nine months from the time of manufacture. Capsules used by the ground handler was manufactured in the year of 2014 (**Picture 20**)
