**FINAL  
AIRCRAFT ACCIDENT REPORT  
19 APRIL 2016**

**AIRBUS 330 9M-MUC  
HITS LAMP POST DURING TAXI AT ASTANA  
ASTANA INTERNATIONAL AIRPORT  
29 JUNE 2014**

**AIR ACCIDENT INVESTIGATION BUREAU OF MALAYSIA  
MINISTRY OF TRANSPORT  
MALAYSIA**

**ACCIDENT REPORT NO.: 07/2014**

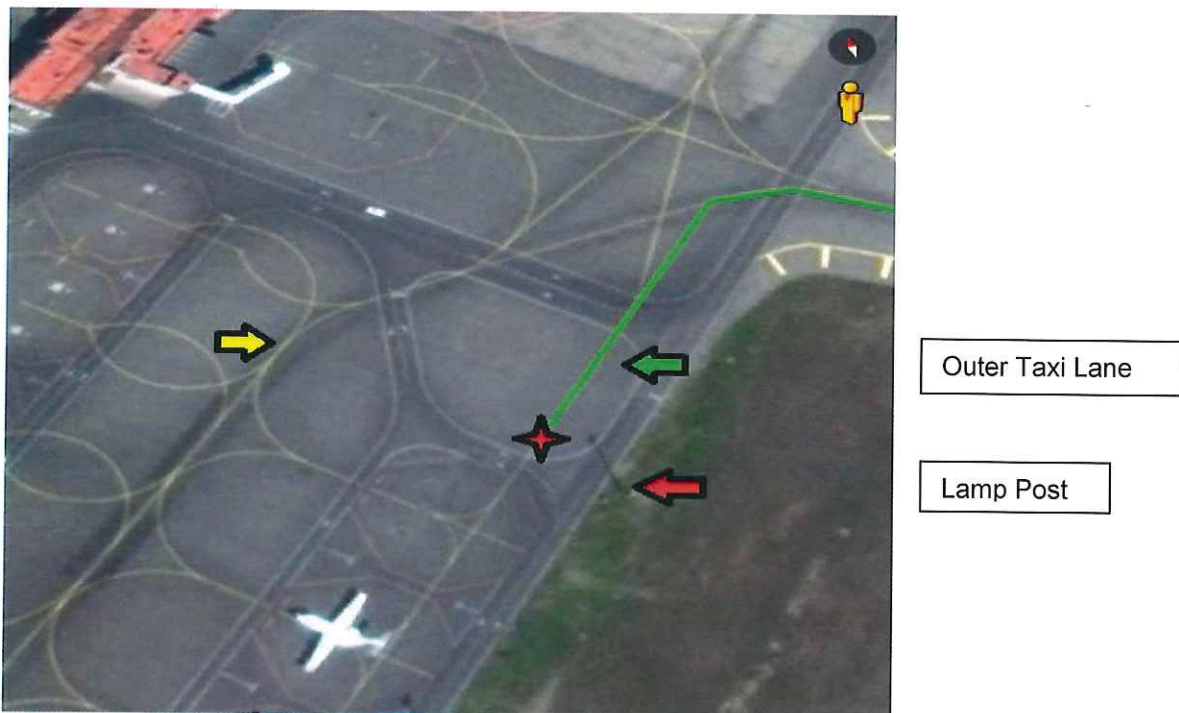
**Figure 2: Map of Astana Airport's Apron sourced on 30 June 2014**

- 1.1.4 Upon entering the Apron area, the crew observed that there were 2 separate taxi lanes adjoining Taxiway 'C'; one leading towards the main terminal and the other towards the opens bays across the terminal. These taxi lanes were not given any specific designation (name), either on the ground or on the airport charts that were provided. (see Figure 3).

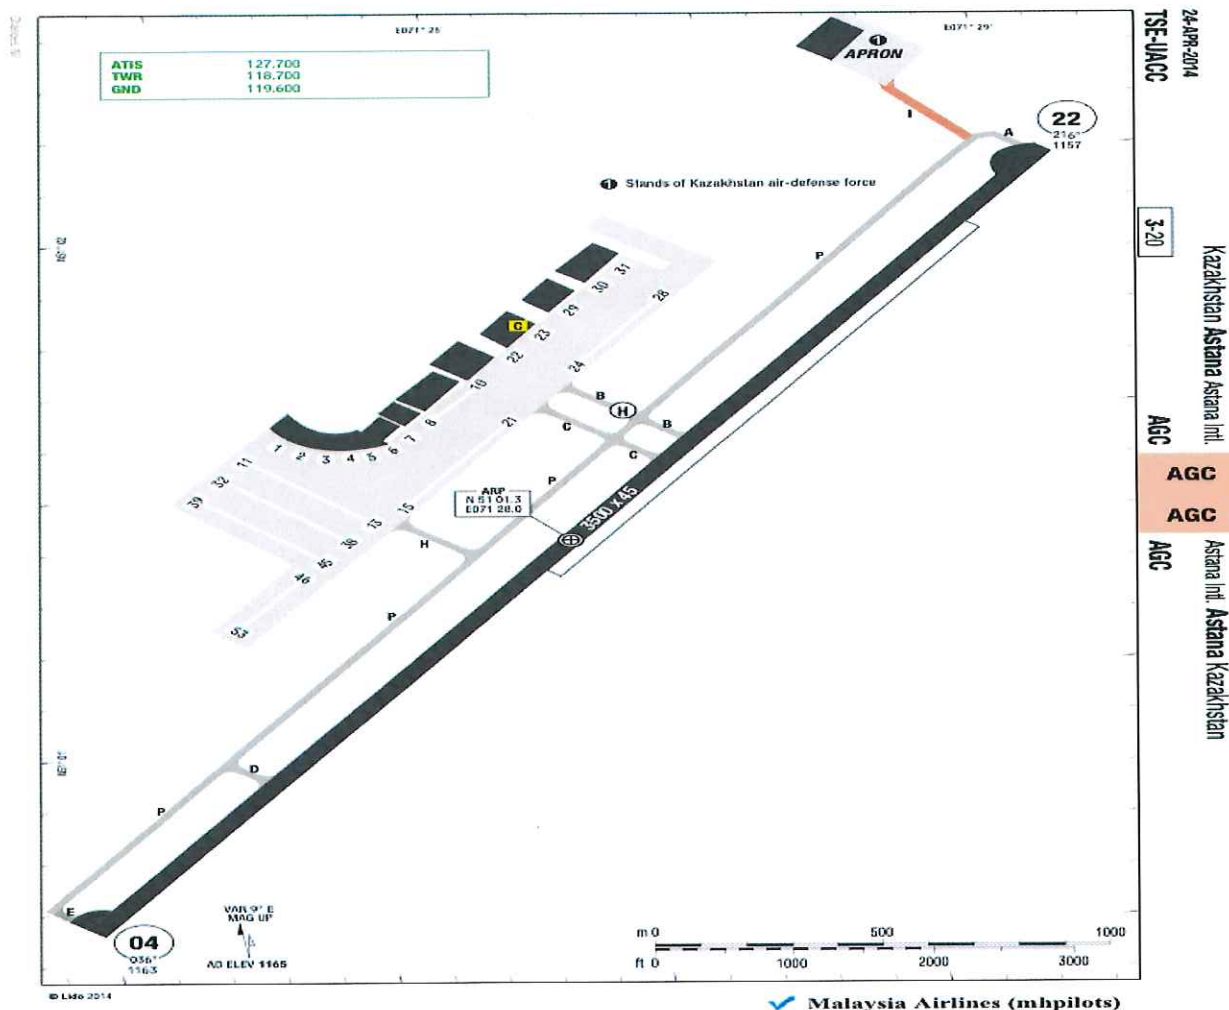
Figure 9: Astana Aerodrome Ground Chart 24 Apr 2014

- 1.10.1 The Aeronautical Information Publication (AIP) and aerodrome chart for Astana International Airport did not depict sufficient information when compared to the actual layout of the airport.

- 4.1 It is recommended that the LIDO chart provider to amend the TSE AGC chart to reflect the restriction on the taxiway.
- 4.2 It is recommended that the Kazakhstan Authority is to update the Astana International Airport AIP with the relevant taxiways and routings.
