# AIRCRAFT SERIOUS INCIDENT FINAL REPORT

SI 08/14P

**Airbus A330-200F, Registration 9M-MUC  
at Astana International Airport, Kazakhstan  
on 29 June 2014**

**OPERATOR : MALAYSIA AIRLINES**  
**AIRCRAFT TYPE : AIRBUS 330**  
**NATIONALITY OF AIRCRAFT : MALAYSIA**  
**REGISTRATION : 9M-MUC**  
**PLACE OF OCCURRENCE : ASTANA INTERNATIONAL AIRPORT  
KAZAKHTAN**  
**DATE AND TIME : 29 June 2014 AT 1046 LT**

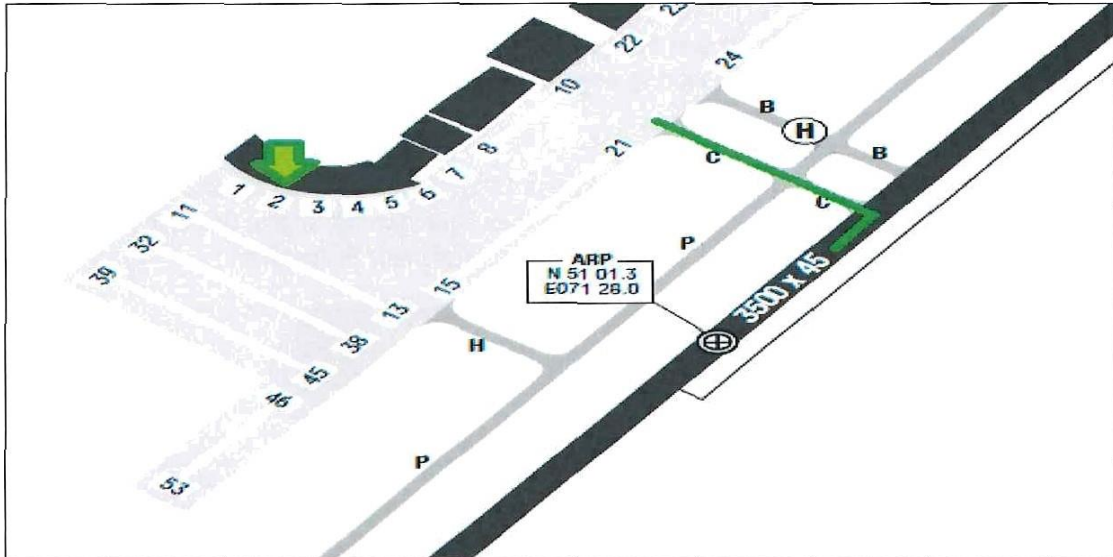
Figure 1: Section of Lido AGC Of Astana Airport 24 April 2014<sup>1</sup>

However, upon landing on Runway 04, Astana ATC cleared the crew to vacate the runway via taxiway 'C', then taxi on the apron to Gate 2. Figure 1 below shows the routing that was taken by the flight ((in green) after landing RW04 TSE and entering the apron taxiway. The parking Gate 2 also indicated (green arrow).

4.1 It is recommended that the LIDO chart provider to amend the TSE AGC chart to reflect the restriction on the taxiway.
