## **SAFETY INVESTIGATION REPORT**

**Malaysia Airlines Boeing B777-200ER (9M-MRO)  
08 March 2014**

**The Malaysian ICAO Annex 13 Safety Investigation Team for MH370**

Issued on 02 July 2018  
MH370/01/2018

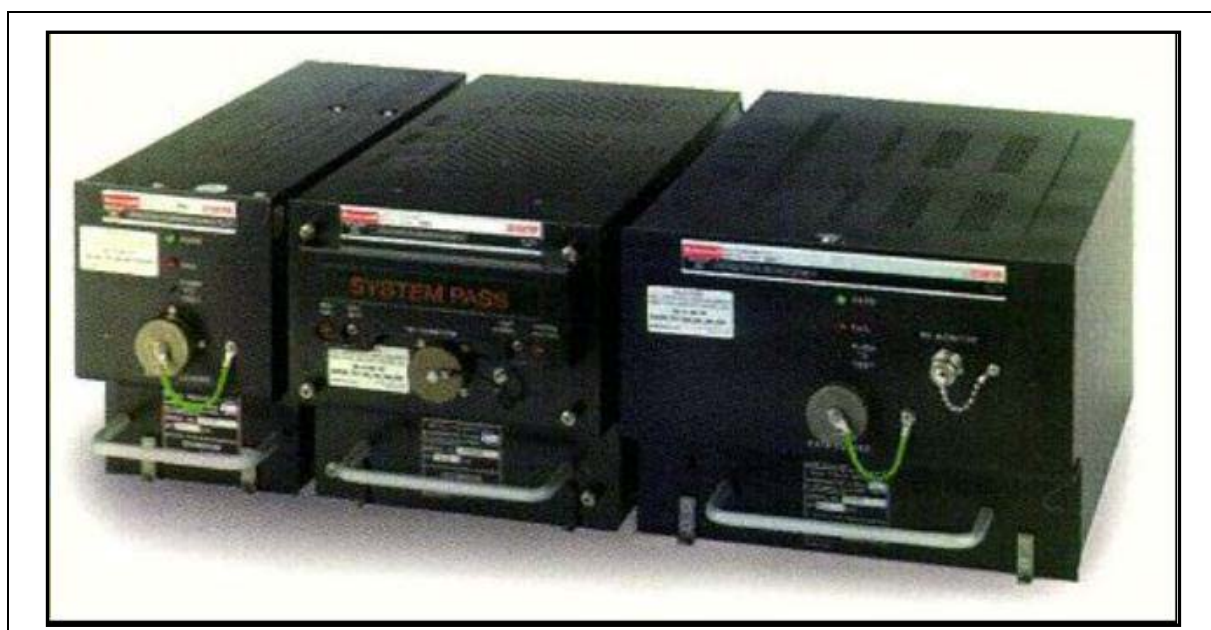
Figure 1.9L - RFU (left), SDU (centre) and HPA (right)

The photo in Figure 1.9L (below) shows the Honeywell/Racal (Honeywell/Thales) MCS-6000 SATCOM Units - RFU (left), SDU (centre) and HPA (right).

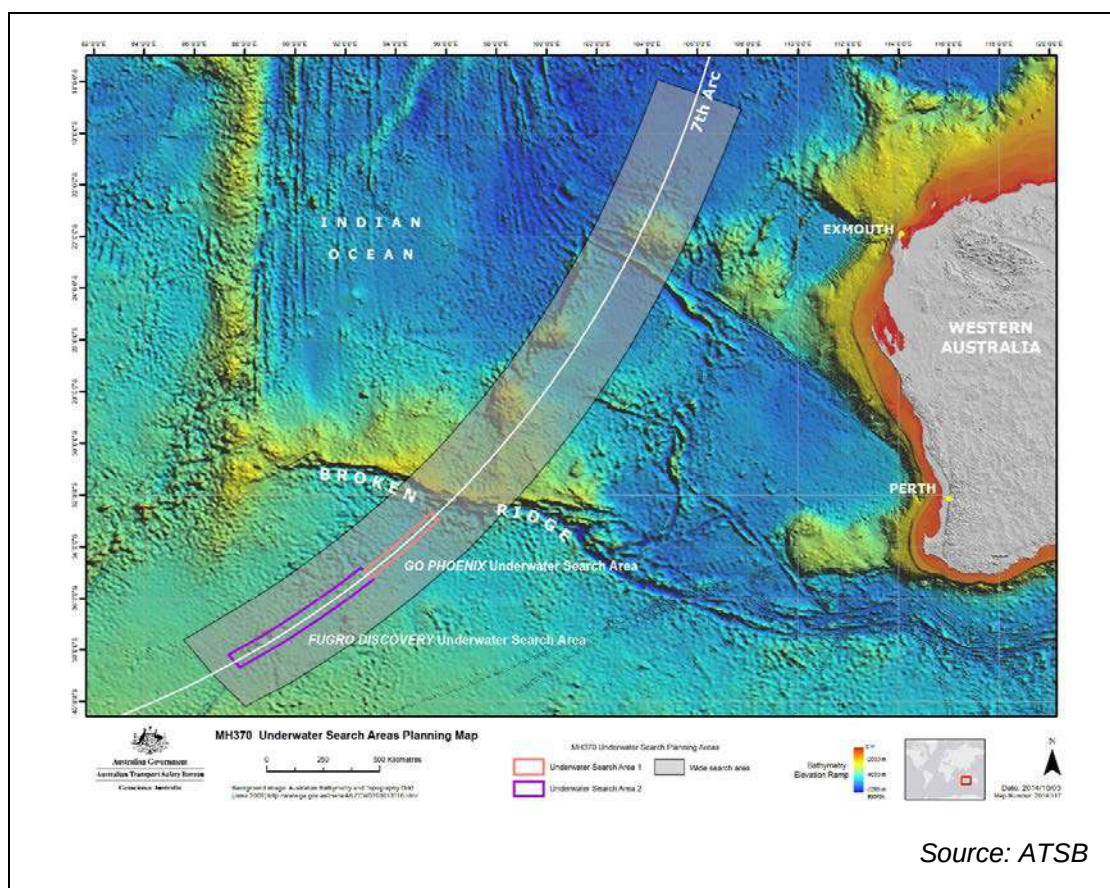
Figure 1.12A - MH370 Search Area

The ATSB led the underwater search for MH370 in the southern Indian Ocean. The search area, as shown (below) in *Figure 1.12A*, covered in excess of 120,000 sq. km at the 7<sup>th</sup> Arc.

Further search was carried out by the US company, Ocean Infinity, which covered an area of more than 112,000 sq. km towards the north of the area covered by ATSB on the 7<sup>th</sup> arc.

No wreckage of the aircraft has been found after the completion of the search. However, several floating components and debris

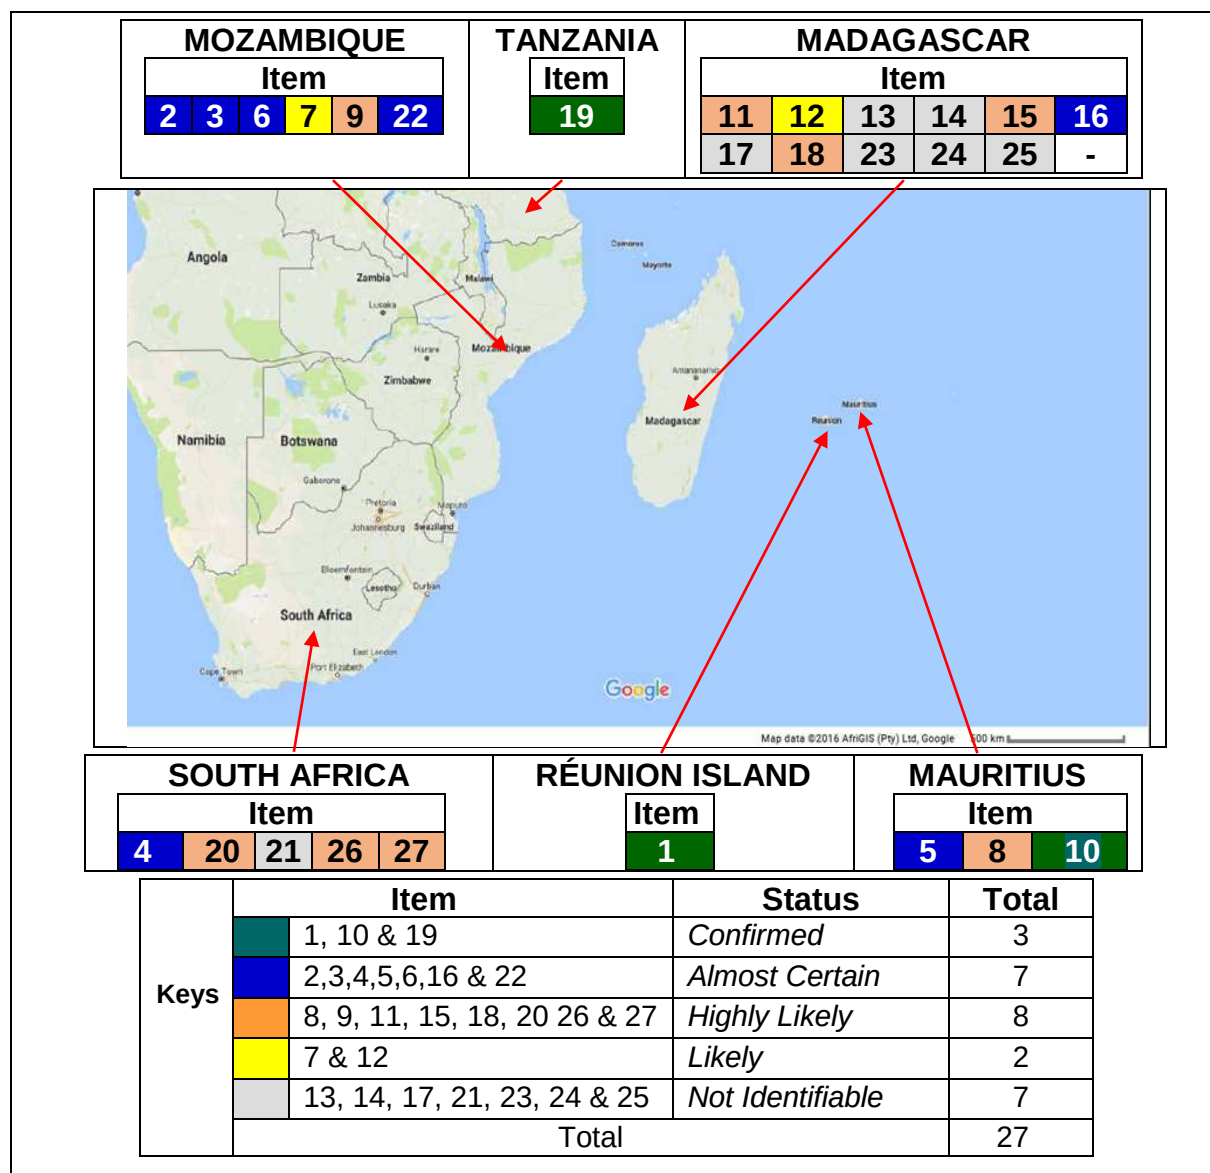
*Figure 1.12B - Locations and Status of Identification of the Debris*

After a number of assessments, more than 20 items were considered for further examination. These items were found in the north west corner of the Indian Ocean, namely in Réunion Island, Mozambique, Tanzania, Madagascar, Mauritius and South Africa.

South Africa, Madagascar and Mauritius. *Figure 1.12B* (above) shows the distribution of the debris found in the above respective areas. *Table 1.12A* (below) provides a summary of the items of debris examined.

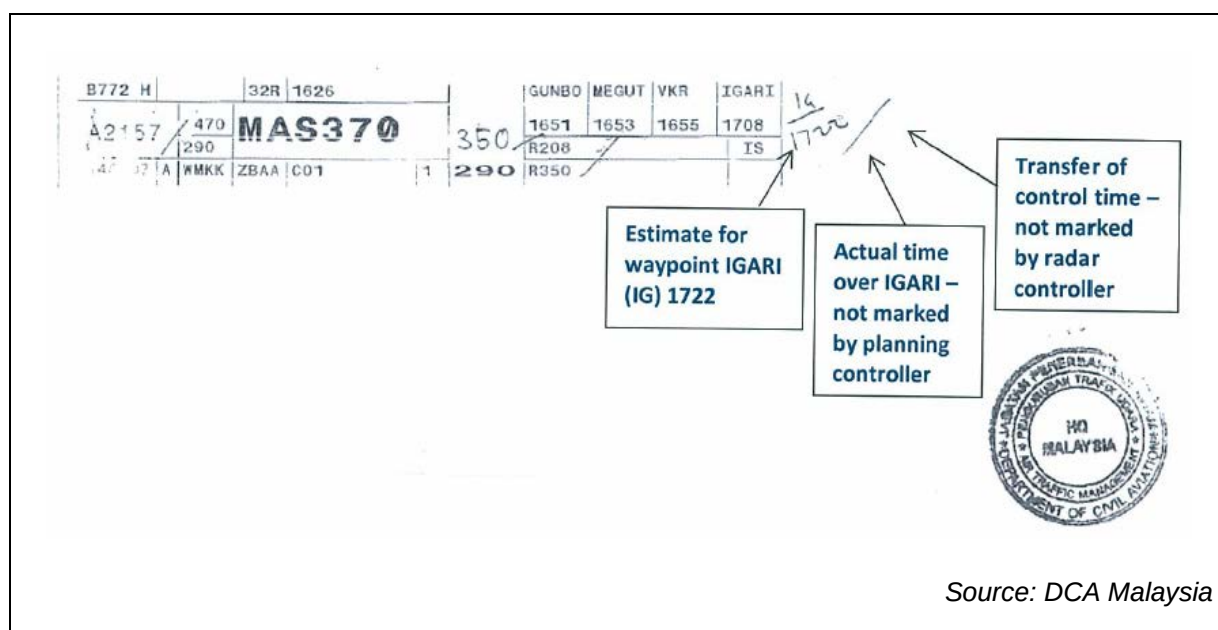
*Figure 2.2G - Flight Progress Strip on MH370 from KL ACC*

i) Two markings have been left out on the flight progress strip (FPS), *Figure 2.2G*, (below) of MH370:

- (1) The actual time (1721) when MH370 passed over IGARI - FPS' Estimate IG (abbreviation for IGARI) 1722, and
- (2) The transfer of control time (1719) on the FPS.

Since the two recordings on the Flight Progress Strip for MH370 were not marked by the Air Traffic Controllers (Planner and Radar) KL ACC did not have the record of the time of the last radio contact and the actual time of MH370 passing over waypoint IGARI.

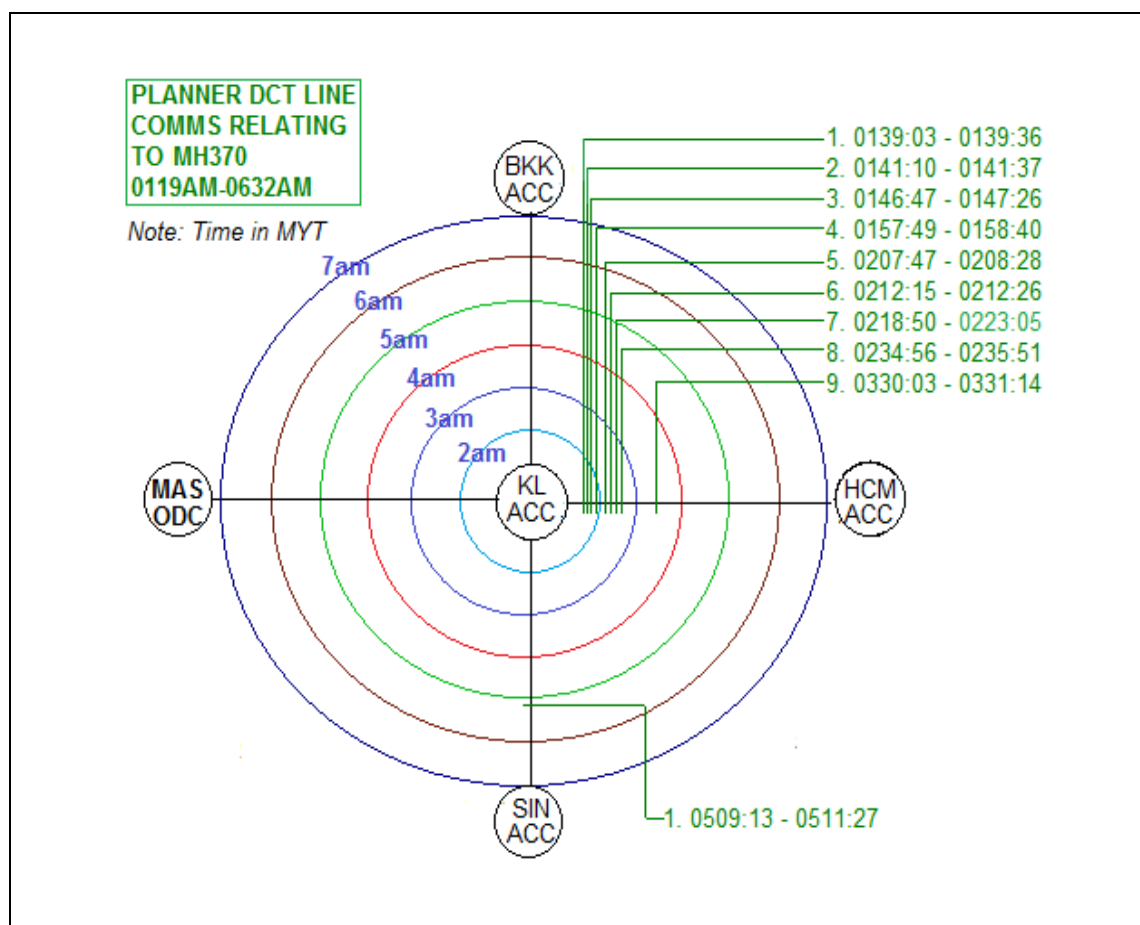
Figure 2.2J - Planning Controller Direct Telephone Line Communication Exchanges between KL ACC and HCM ACC, KL ACC and Singapore ACC from 0119 to 0632 [MYT]

- (1) The period between 1739 UTC [0139 MYT] and 2120 UTC [0520 MYT] revolved with ATC communications activities between HCM ACC and KL ACC, and. between KL ACC and ODC, for information on MH370. It also included KL ACC requesting HCM ACC to check with the adjacent FIRs namely SANYA, HONG KONG and BEIJING.

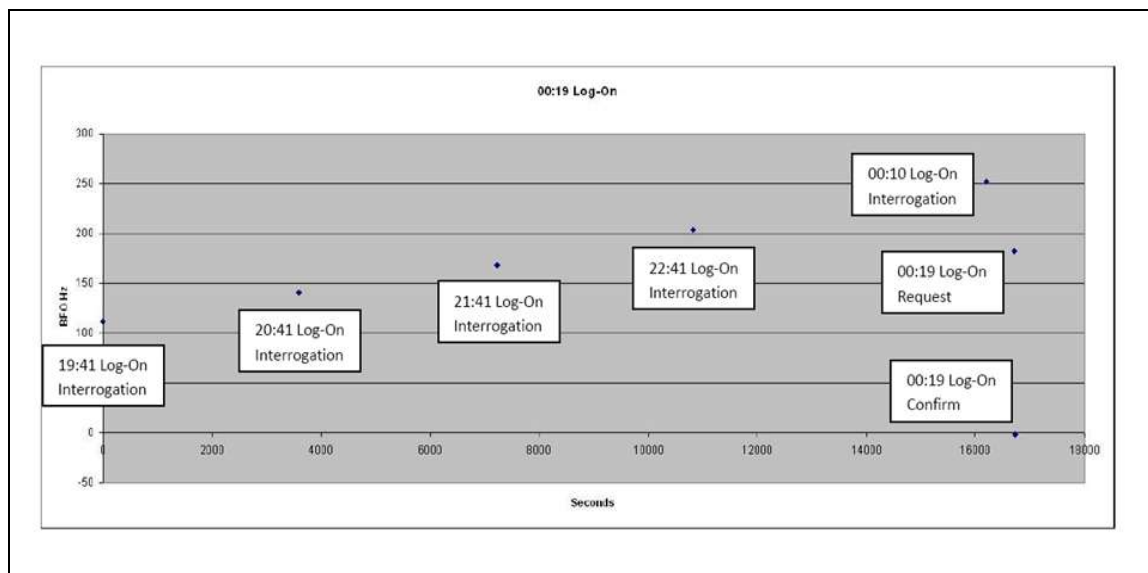
*Figure 2.5D - Log-On Interrogation Transmissions*

11) The plot (*Figure 2.5D*) below shows a series of MH370 Log-On Interrogation transmissions, which steadily rise in frequency (due to the satellite ephemeris). However, the 0019 Log-On Request and Log-On Acknowledge transmissions diverge from the steady state slope.

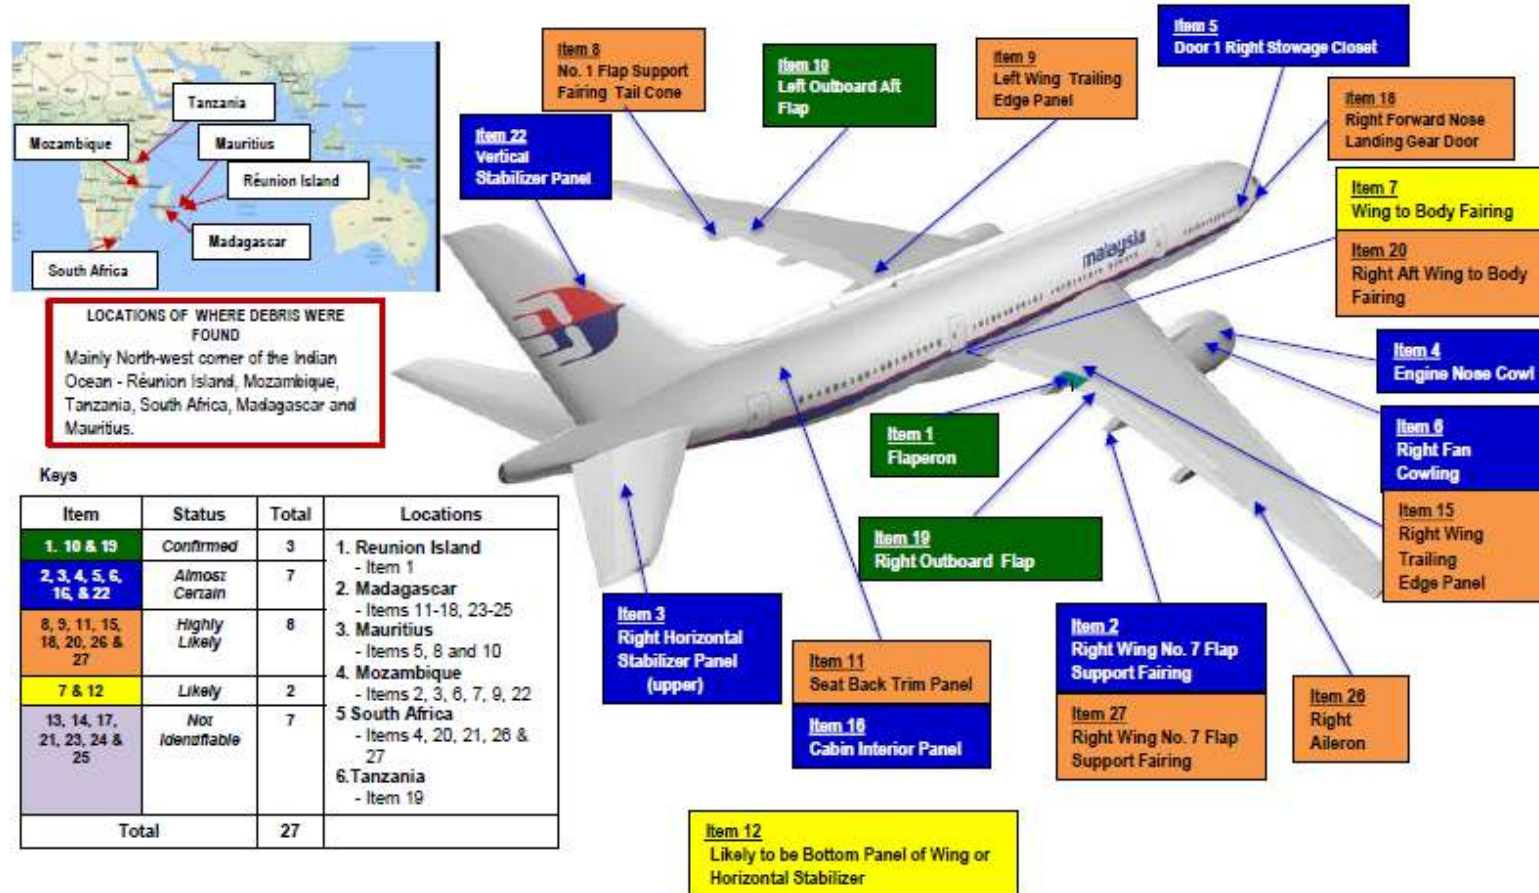
Figure 2.6A - Location of Parts and Debris Found with respect to Aircraft

Item 4 (part of the Engine Nose Cowl) is depicted to be from the right engine. There were no significant differentiators on the cowl segment to assist in determining whether the item of debris was from the left or right side of the aircraft, or the inboard or outboard side the cowl. Similarly, although Item 6 (part of the RH fan cowl) is depicted to be from the right engine in *Figure 2.6A*, there is a possibility that it could also be from the left engine. As for Item 7 - Wing body fairing - this too could be from either side of the aircraft.

Based on the identification of the parts and debris found, it shows that most of those parts and debris were from the right hand side of the aircraft.

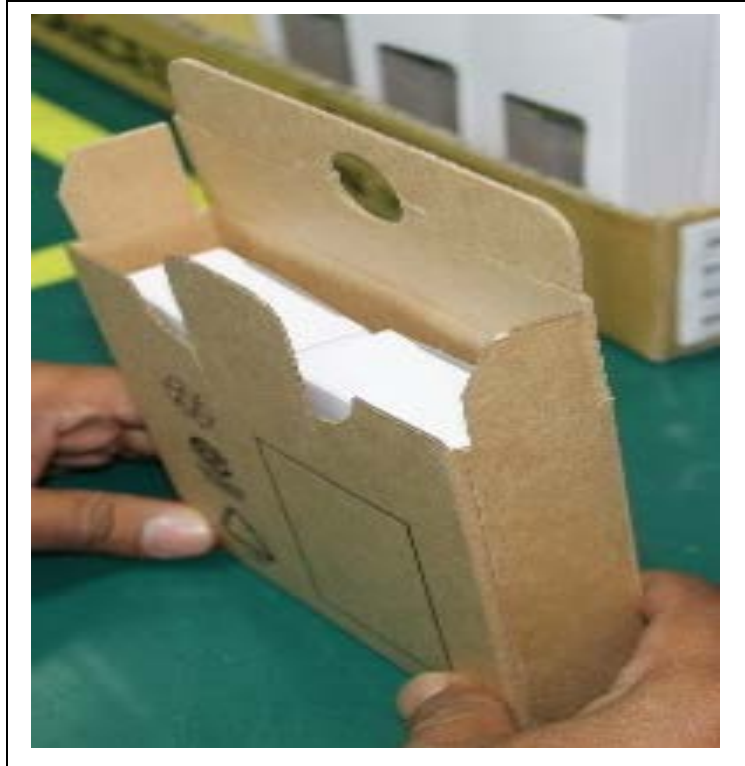
The tests were carried out with batteries (window white box in brown box (*Figure 2.8A*, [below]) dropped at a height of 120.92 cm (48 inches) on to a wooden platform. It was found that the batteries had no observable physical damage and functioned normally.

*Figure 2.8A - 2 Batteries in window white box and placed in a brown box*
