AIRCRAFT ACCIDENT REPORT SI 05/15

**Air Accident Investigation Bureau
Ministry of Transport, Malaysia**

**Final Report on the Serious Incident involving
Fixed wing aircraft ATR72-600 Registration 9M-LMG
in Penang, Malaysia on 28th May 2015**

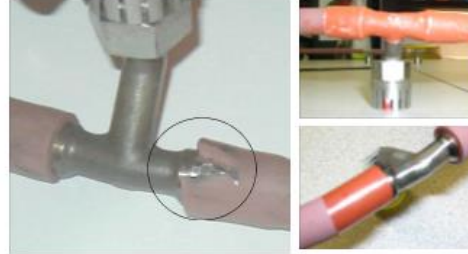
Minor repair per EMM, 72-01-00

Limited to fire retardant protection
Manifolds did not receive this repair

Major repair

Proprietary repair to HS-Marston
No cracked B-nut were received for repair

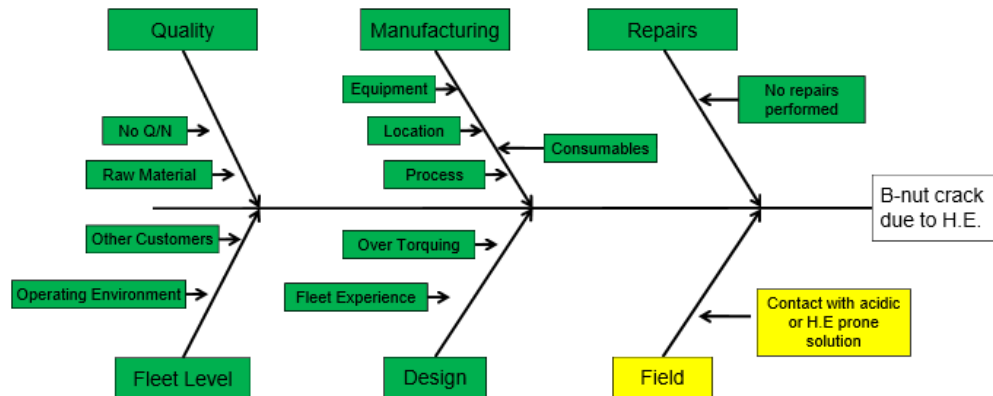
INVESTIGATION SUMMARY

Challenges

- Source of Hydrogen Embrittlement (H.E.) not identified
- No methods available to segregate manifold affected to H.E.
- No repair possible for parts affected by H.E.
- H.E. causes sudden failure of parts when under stress

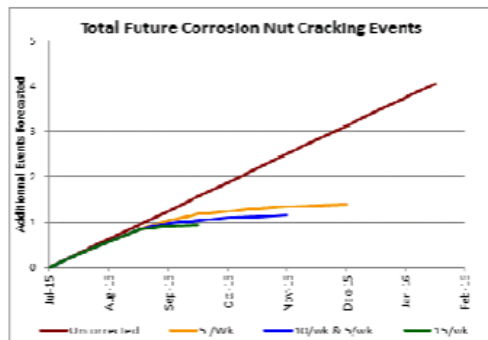
RISK ASSESSMENT / PRIORITY

Priority levels

- Per risk assessment
- At aircraft level
- Following SI 71-2015 results
