AIRCRAFT ACCIDENT REPORT 03/15

**Report on the accident to Helicopter Dauphin,
AS 365 N3 Registration 9M-IGB near Subang Airport,
40 Nautical Miles South East of Subang Airport,
MALAYSIA**

Aircraft Type	:	Eurocopter Dauphin
Model	:	AS 365N3
Owner	:	Orion Corridor Sdn. Bhd.
Nationality	:	Malaysian
Year of Manufacture	:	1990
Aircraft Registration	:	9M-IGB
Serial Number	:	6374
State of Registration	:	Malaysia
State of Operator	:	Malaysia
Place and State of Occurrence	:	40 Nautical Miles SE of Subang Airport, MALAYSIA (N 03 00.64 E101 51.19)
Date and Time of Accident	:	04 April, 2015 at 1654 hours (Local Time)

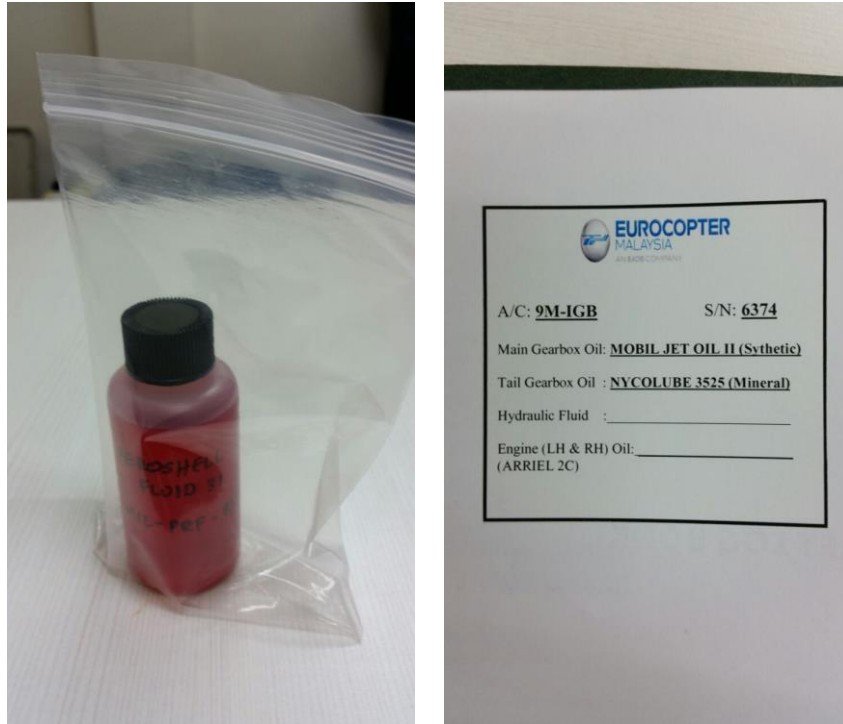
Fig. 12

Test result from the Chemistry Department of Malaysia shows that the sample taken at the SK Ladang Kota Bahagia is consistent with the Mobil Jet Oil II (Synthetic) of the AS365N3 helicopter hydraulic fluid specification.

The hydraulic fluid may indicate evidence of some leakage from the helicopter hydraulic system at the field where the aircraft landed.

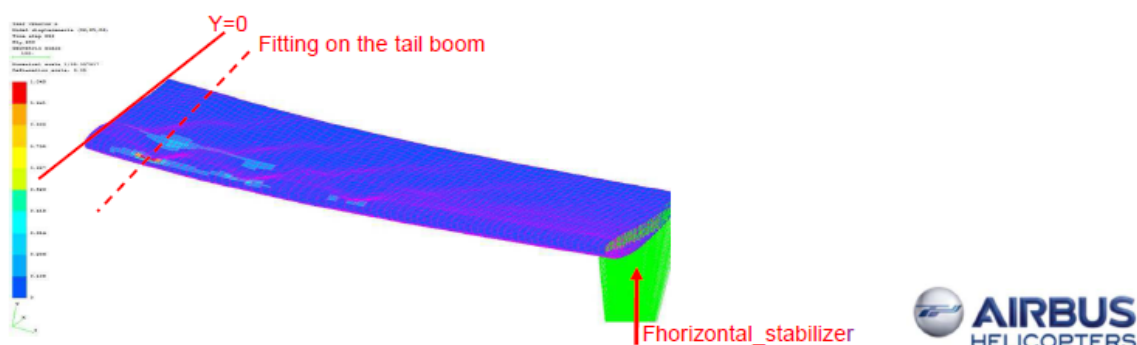
Fig.27

- The horizontal stabilizer begins to damage for a vertical load at its extremity of 160daN.
(\ll Fleft_mlg = 1874 daN when outboard tail fin contacts the ground)
- Under $F_z=160\text{daN}$ the horizontal stabilizer bent of 45mm.
(\ll 237mm when the Left landing gear is in the soil of 40cm)

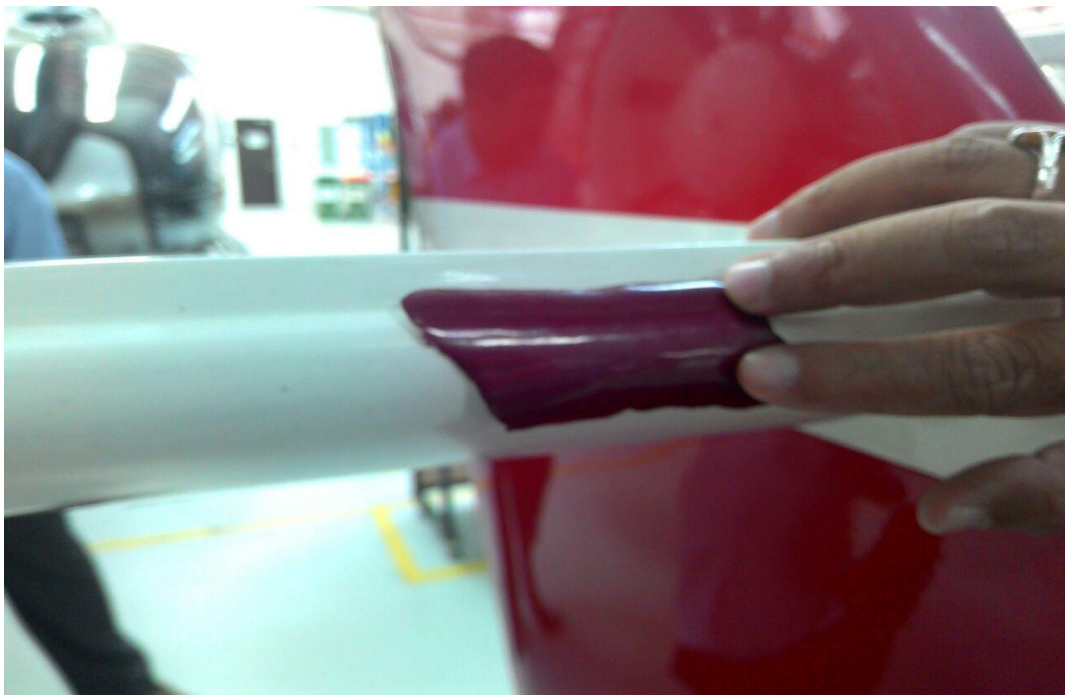
Fig 30

A small chip off paint was found at the last landing field on the second visit by the investigation team. The chip was curvature in nature and having the colour of the horizontal stabiliser on the outer and white colour with cross grain in the inside. This paint chip most probably came from the missing left horizontal stabiliser because the right stabiliser was found intact. When the critical area of the leading edge was subjected to bending, and when the outboard fin contacted the ground, the critical area experienced compressive stress to buckling. In these conditions, delamination and failure of fibres on one of several plies can occur causing it to buckle. The paint could have chipped off from the left stabiliser which had been weakened by the bending stress. (See Fig 28 and Fig 30)

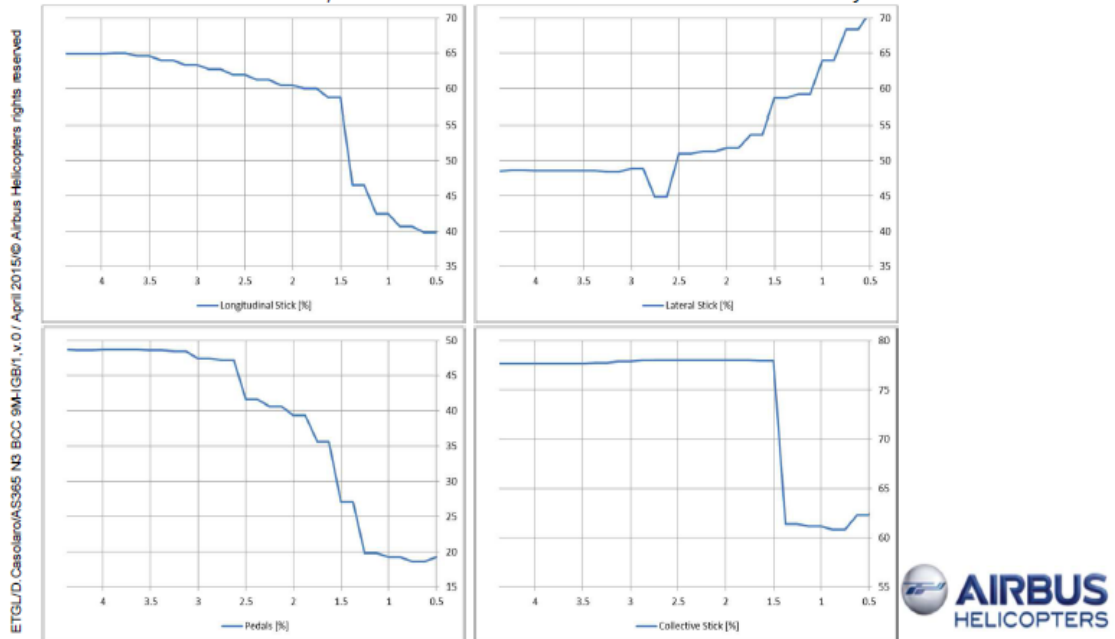
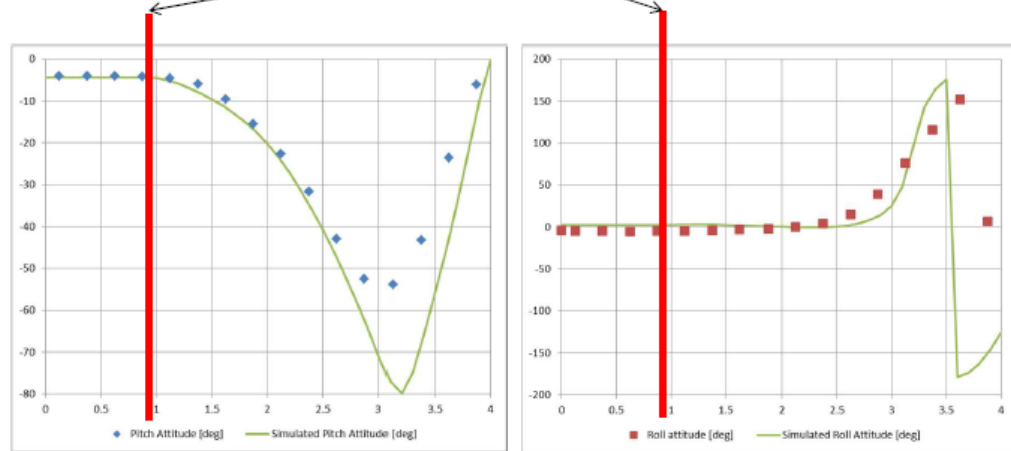
Fig 32

Suspected Loss of the left
horizontal stabilizer

Nota: Once the vertical load factor $-1g$ is reached the simulation can differ from the real flight as the aircraft is completely outside of the certified flight envelope

The observed result of the simulation is consistent with the FDR
