AIRCRAFT ACCIDENT FINAL REPORT
A 04/15P
Air Accident Investigation Bureau (AAIB)
Ministry of Transport Malaysia

Helicopter Bell 206B III, Registration 9M-LLM
at Kota Kinabalu International Airport, Kota Kinabalu, Sabah
on 28 May 2015

REPORT NO.: A 04/15P

OPERATOR : LAYANG-LAYANG HELICOPTER ACADEMY
AIRCRAFT TYPE : BELL JETRANGER III
MODEL : B 206 B III
NATIONALITY OF AIRCRAFT : MALAYSIA
REGISTRATION : 9M-LLM
**PLACE OF OCCURRENCE : KOTA KINABALU INTERNATIONAL AIRPORT
KOTA KINABALU, SABAH**
DATE AND TIME : 28 MAY 2015 AT 1151 LT

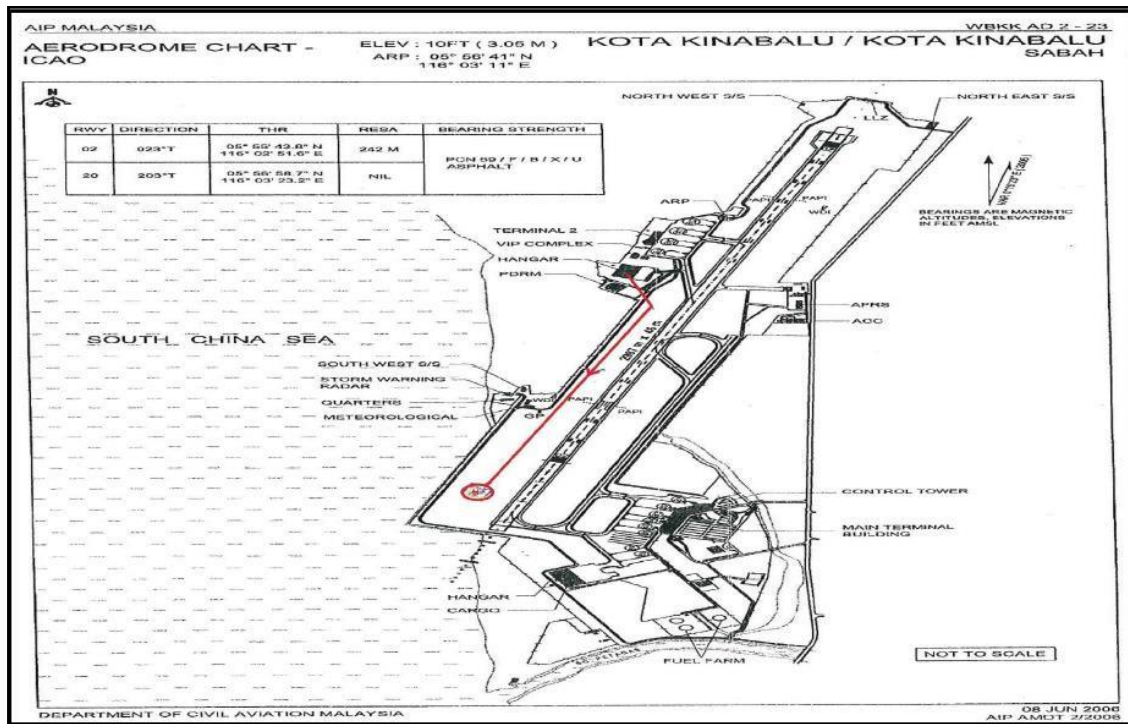
Figure: 9M-LLM hover taxi route from hangar to marker H

On 28 May 2015, a female student pilot was cleared for a solo flight after being assessed by her instructor for 1 hour in the morning. After conducting a satisfactory external check, the student pilot did a start up at 1130 LT and engaged the rotors to 100 percent with temperature and pressure in the normal condition. The helicopter had lifted off from Layang-Layang Helicopter Academy (LLHA) hangar and hover-taxed to the Helipad Marker H adjacent to threshold runway 02. It landed on the Marker H unevenfully. (Refer Figure 1 below for the flight path to Marker H).

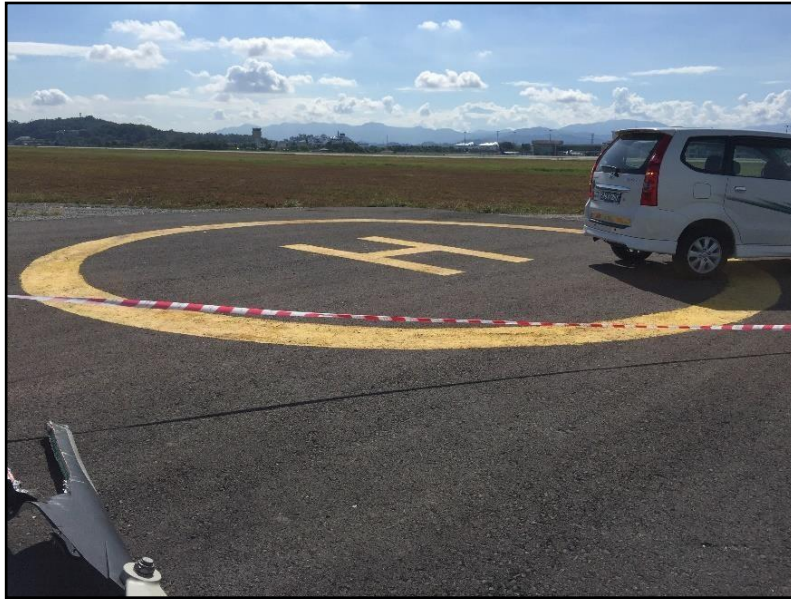
Figure 2: Helipad

The helipad is measured 40 feet by 40 feet in dimension with a layer of hard tarmac. It has a yellow circle for the helicopter to land and has been in operation for several years. The picture of the Helipad is as per Figure 2 below.
