**SOCATA TB 20, 9M-SOM**  
**CONTROLLED LANDING WITH UNDERCARRIAGE UP**  
**AT SUBANG AIRPORT**  
**10 OCTOBER 2016**

**SERIOUS INCIDENT REPORT NO.: SI 09/2016**

**AIRCRAFT TYPE : SOCATA TB 20**

**REGISTRATION : 9M-SOM**

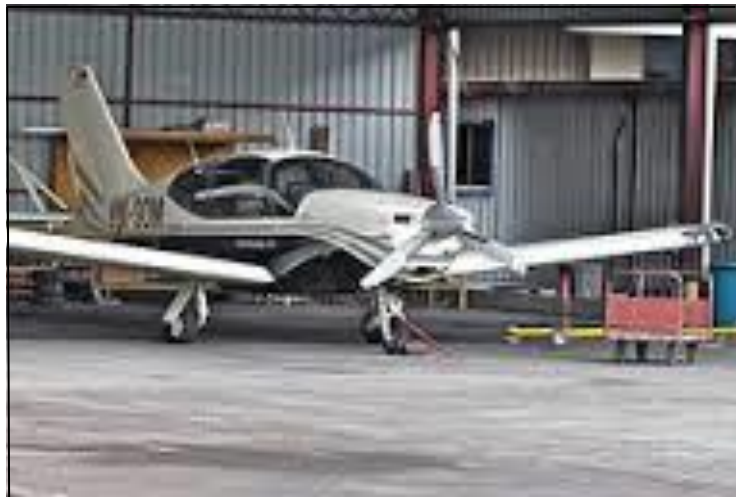
The three blades propeller curled after contacted with the runway. The trailing edge flap, part of the belly area and tire rims were slightly damaged.

- 2.5 The airplane spun 180 degrees upon stopping on the runway. There were extensive damages on the propeller tips due to contact with the runway surface while the airplane gliding on its belly. Both pilots escaped the airplane safely.
