# Ground handling occurrence involving Airbus A330, 9M-MTB

Melbourne Airport, Victoria | 31 March 2016

**ATSB Transport Safety Report**  
Aviation Occurrence Investigation  
AO-2016-028  
Final – 13 September 2016

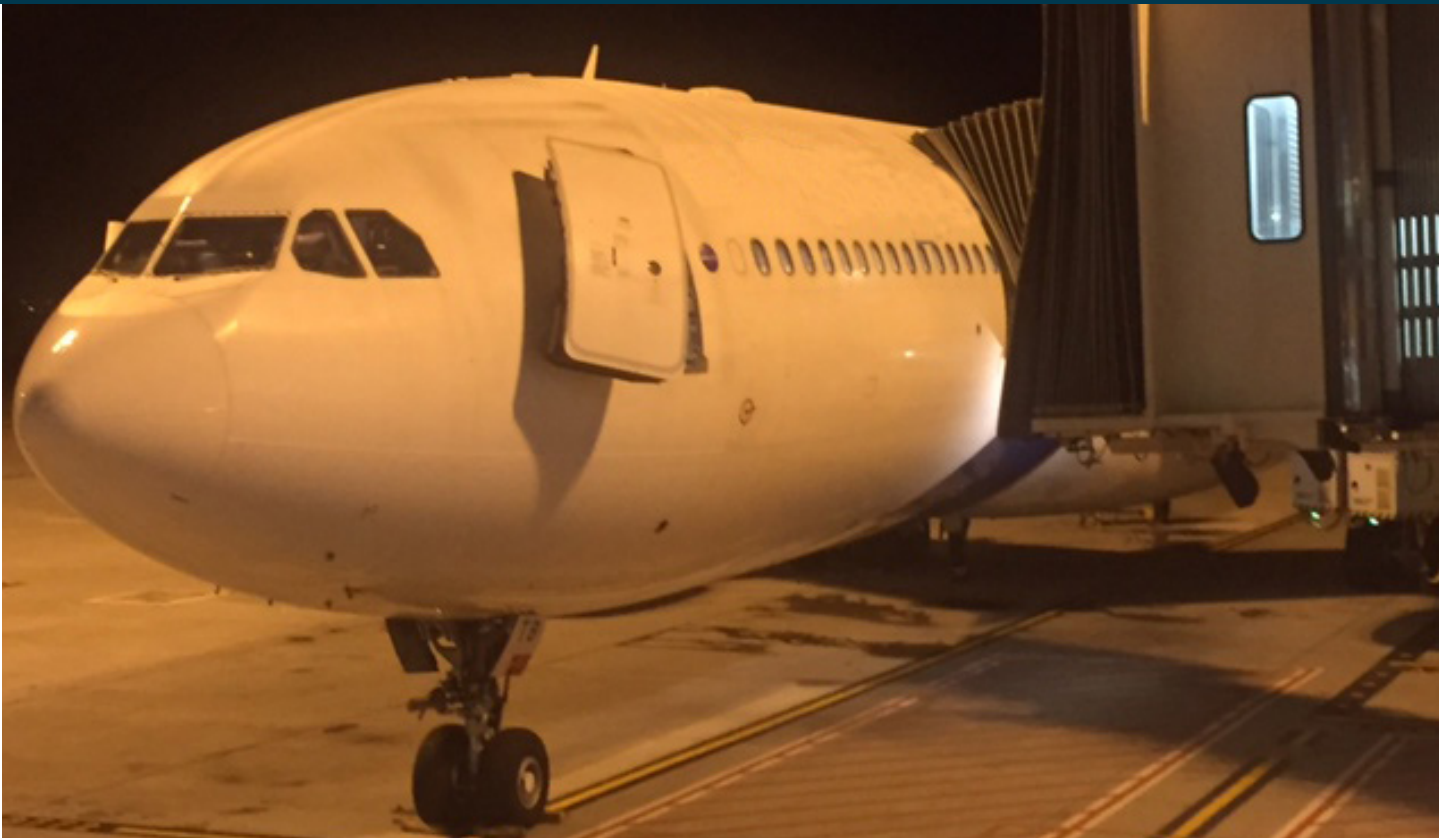
Damaged door of 9M-MTB

The aircraft's forward-left door was dislocated by the contact with the aerobridge (Figure 2). The door, hinges, and aerobridge were damaged and there was slight indentation of the fuselage skin forward of the door. There was no major structural damage. There were no injuries.
